Tightening the RAM Locking Cradle

Product: Navistream Supplied RAM Locking Cradle
Error: Loss of connection due to gradual loss of tightness
Solution: Tighten the cradle to setting "8"

Revised Date: 2019-01-15

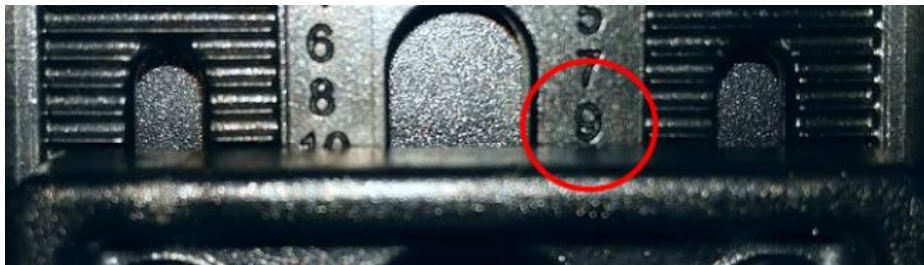
- 1) Locate the adjustment slide on the back of the cradle. This is a notched sliding gauge with numbers and ridges on it. It will look something like the image below and may be set to setting 9.

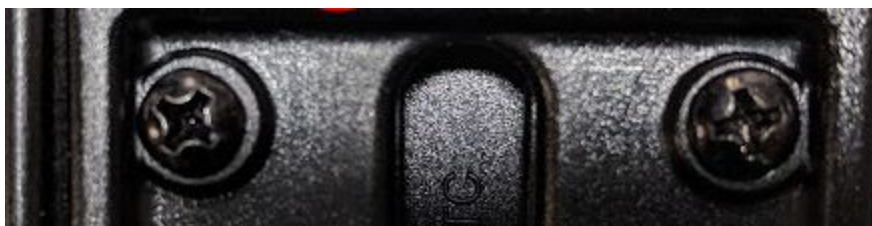
- 2) Use a Phillips head screwdriver to slightly loosen the two screws on the adjustment slider.

Note: Please only loosen these by one or two rotations as there are locking nuts in the back that will fall loose if undone too far. If these nuts were to fall off, then the cradle would need to be damaged to recover the nut.

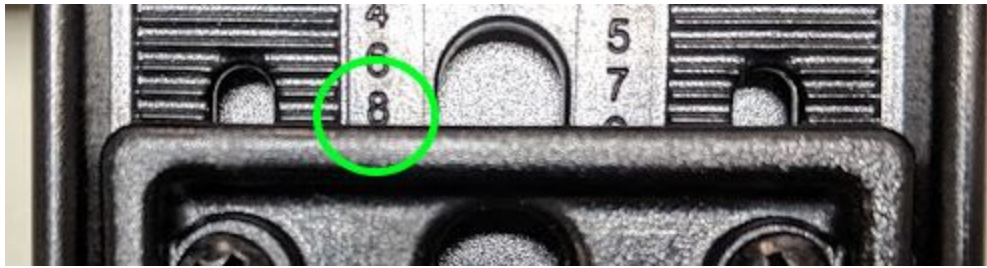
- 3) Adjust the cradle down a few notches, so that the “8” is fully exposed and only the tip of the “9” is visible.

- 4) Tighten the screws, then re-insert the Navistream tablet with Intelliskin attached into the cradle.

Note: This adjustment may be very snug and it could take considerable force to lock the cradle using the locking arm. If you're unable to get the cradle closed at this setting, or concerned that you may damage the hardware while locking the cradle then please contact the Navistream support desk.
