ROYSONS CORPORATION FIRE TEST REPORT

NFPA 286 TESTING ON 2-PLY 20 oz. OSNA VINYL WALCOVERING WHEN INSTALLED TO AN INTERIOR WALL

103551102SAT-002

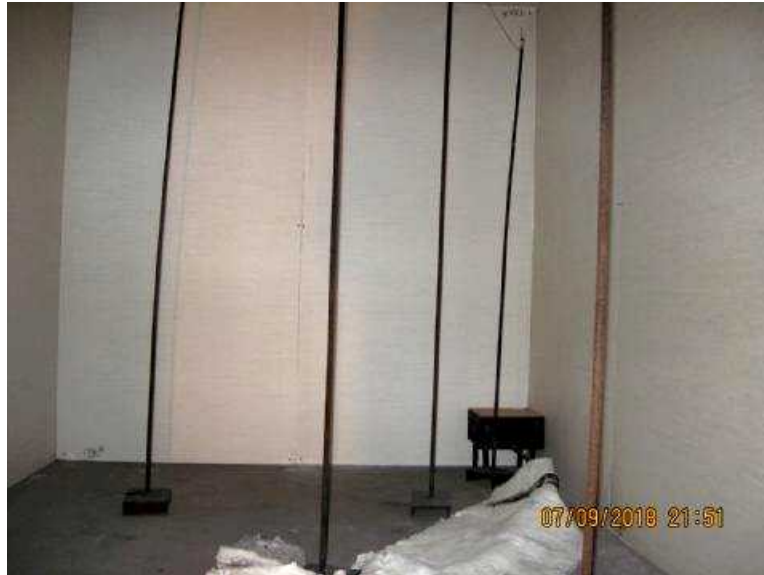
Photo No. 1
Pretest photo

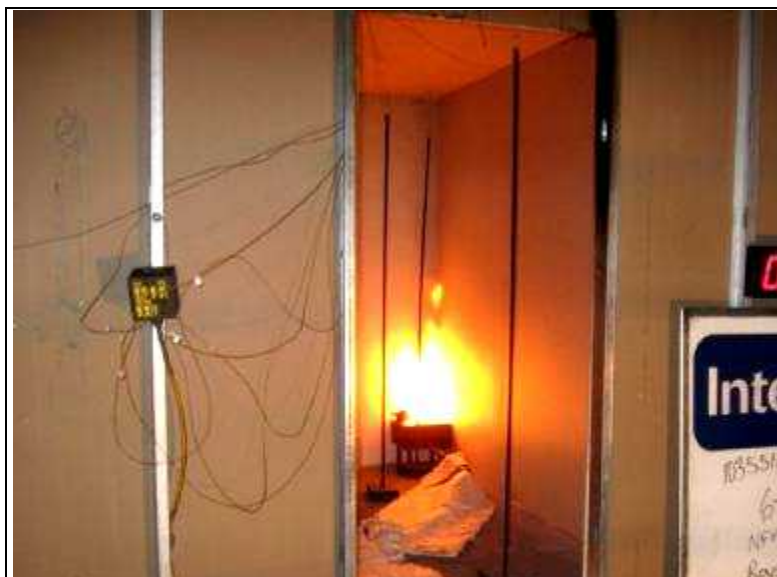
Photo No. 2
40kW

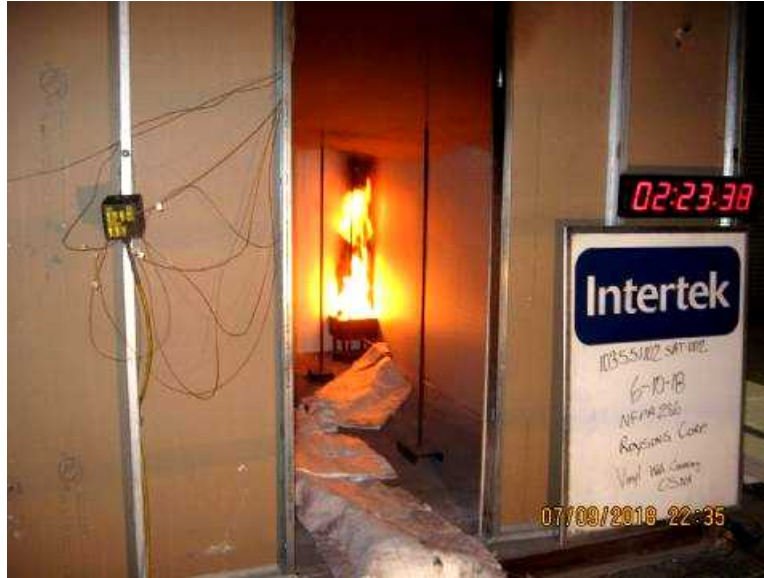
Photo No. 3
Flame spread/smoke density at 40kW

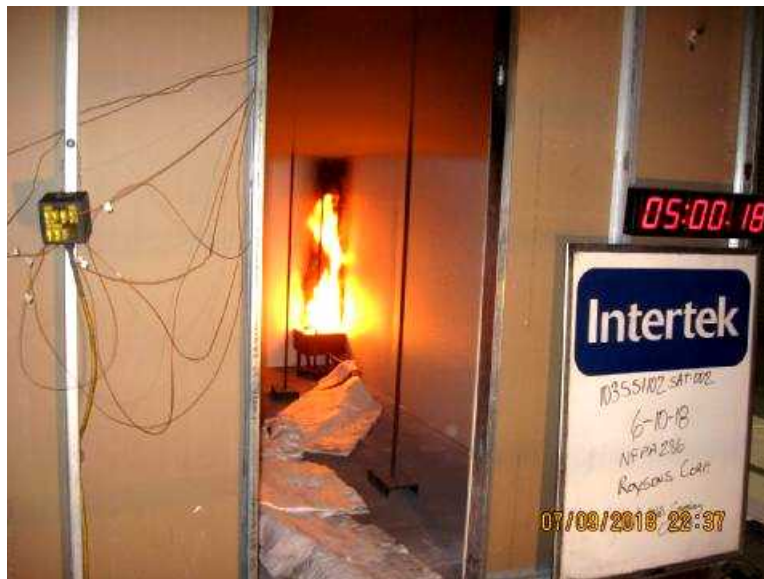
Photo No. 4
End of 40kW exposure

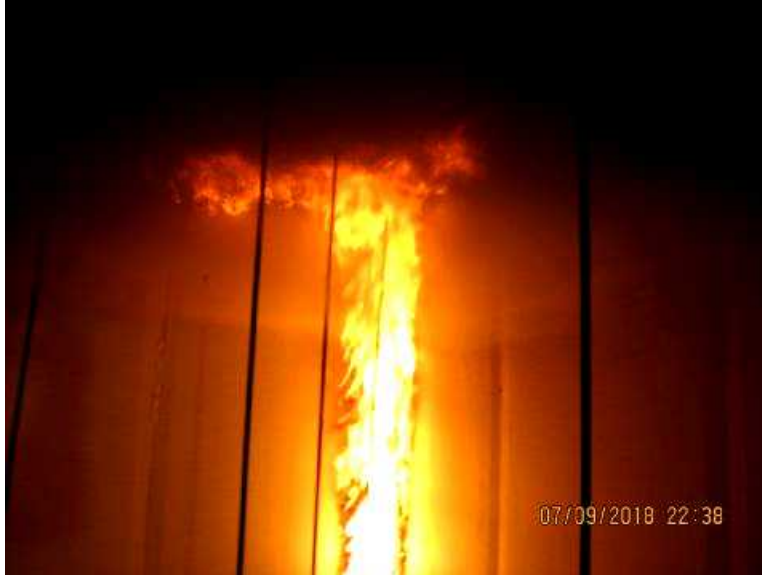
Photo No. 5
160kW

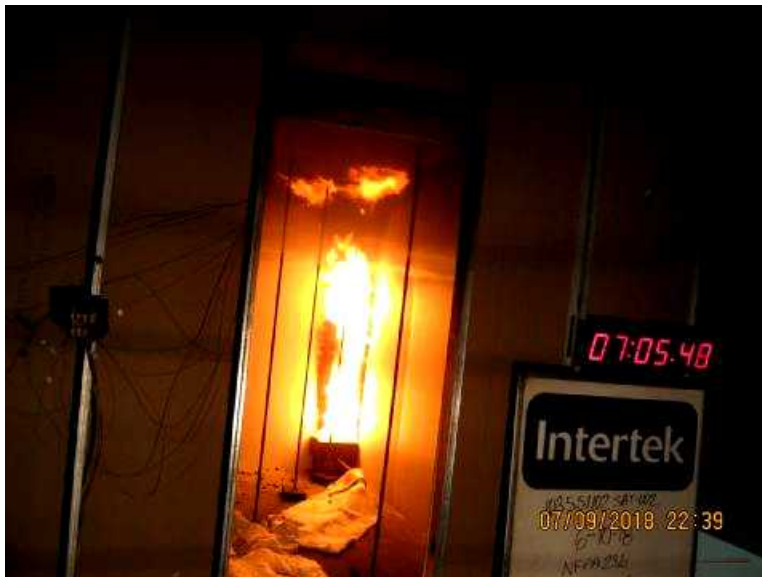
Photo No. 6
160kW

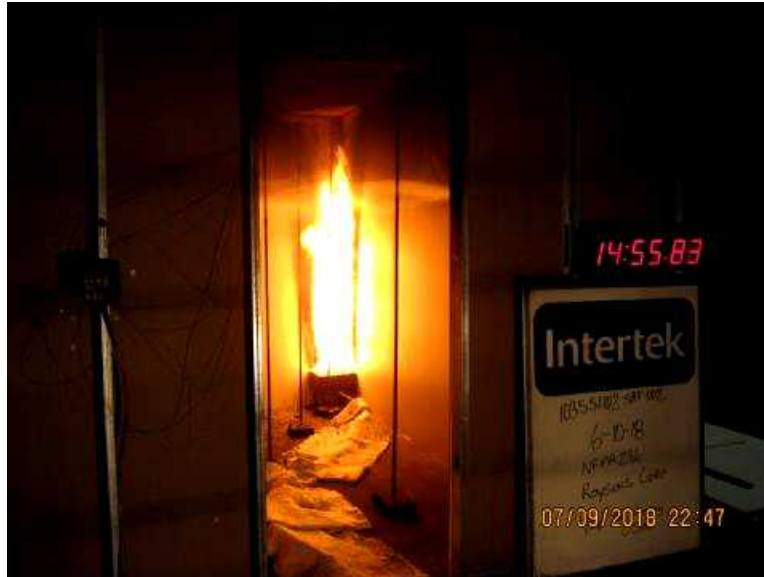
Photo No. 7
End of test

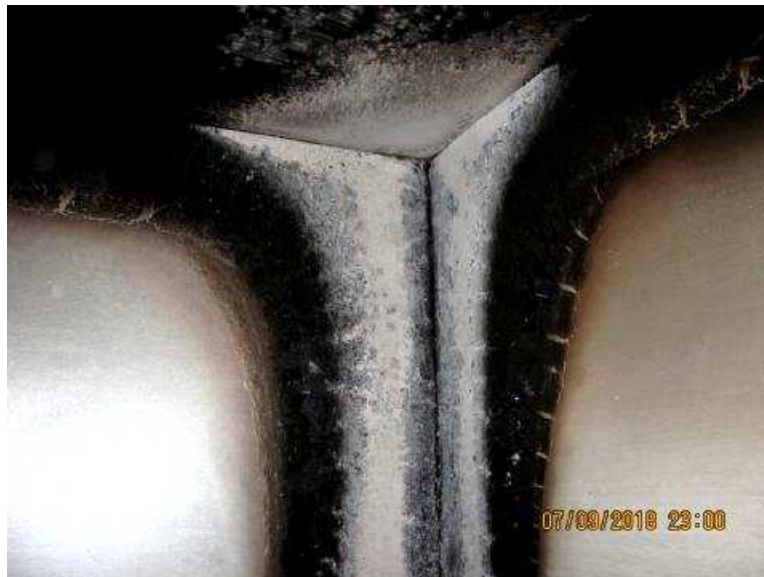
Photo No. 8
Post test photo

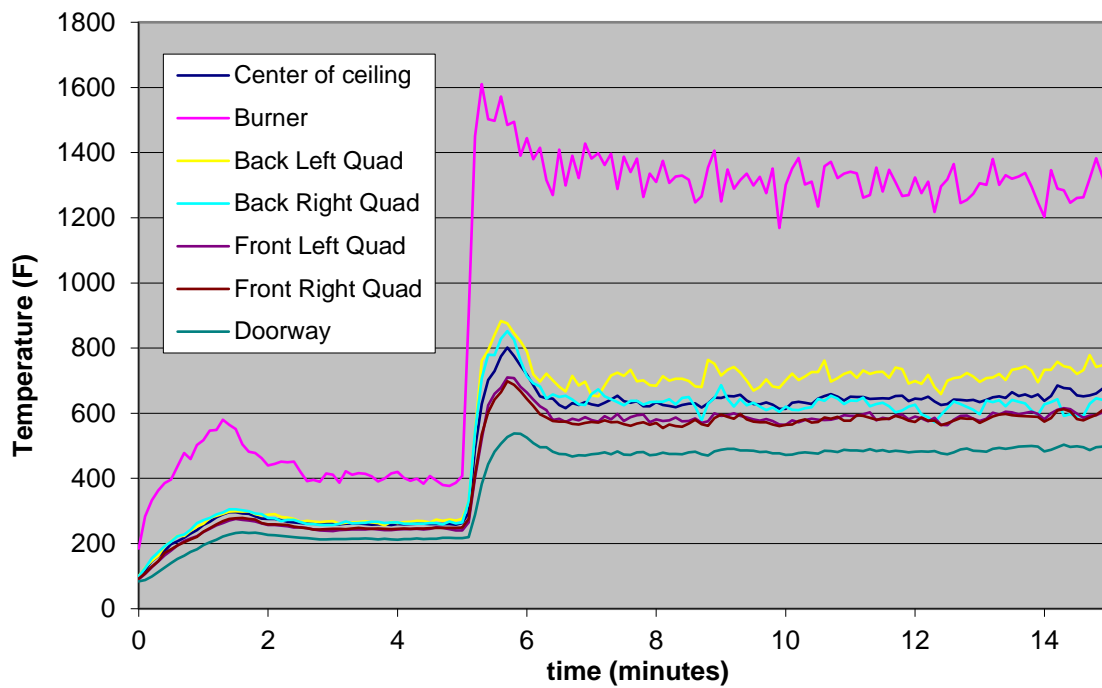
Graph No. 1
Thermocouple Data

2015 IBC SECTION 803.1.2.1 & NFPA 286 ANNEX C PERFORMANCE CRITERIA	TEST OBSERVATIONS	PASS/FAIL
During 40 kW exposure, flames should not spread to the ceiling.	Flames did not spread to the ceiling during the 40kW exposure.	PASS
During the 160 kW exposure, the interior finish should not spread to the outer extremity of the sample on any wall or ceiling	Flames propagation to the outer extremities did not occurred during the 160kW exposure.	PASS
<p>During the 160 kW exposure, the interior finish should not flashover as defined by NFPA 286.</p> <ul style="list-style-type: none"> •Peak Heat Release > 1 MW •Floor Heat Flux > 20 kW/m² •Average Upper Layer Temperature > 1,112°F •Flames exiting doorway •Auto ignition of Paper Target <p>Flashover is considered to have occurred when any two of the above criteria were met during the test.</p>	<ul style="list-style-type: none"> •Peak Heat Release = 217.1 kW •Max Floor Heat Flux = 2.95 kW/m² •Max Average Upper Layer Temperature = 787.5°F •No Flames exited doorway •The flashover indicators did not ignite. 	PASS

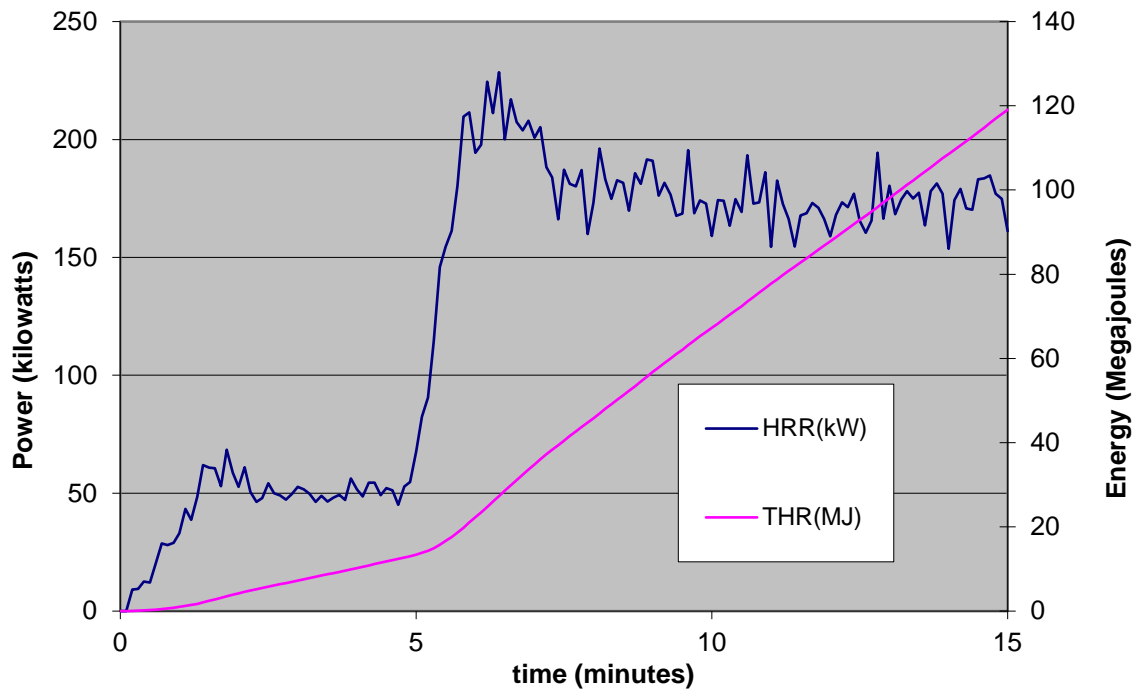
Graph No. 2
Heat Release Data

The peak rate of heat release throughout the NFPA 286 test should not exceed 800 kW.	The peak heat release rate was 217 kW	PASS
The total smoke released throughout the NFPA 286 test should not exceed 1,000 m ² .	The total smoke released during the entirety of the test was 21.4 m ²	PASS

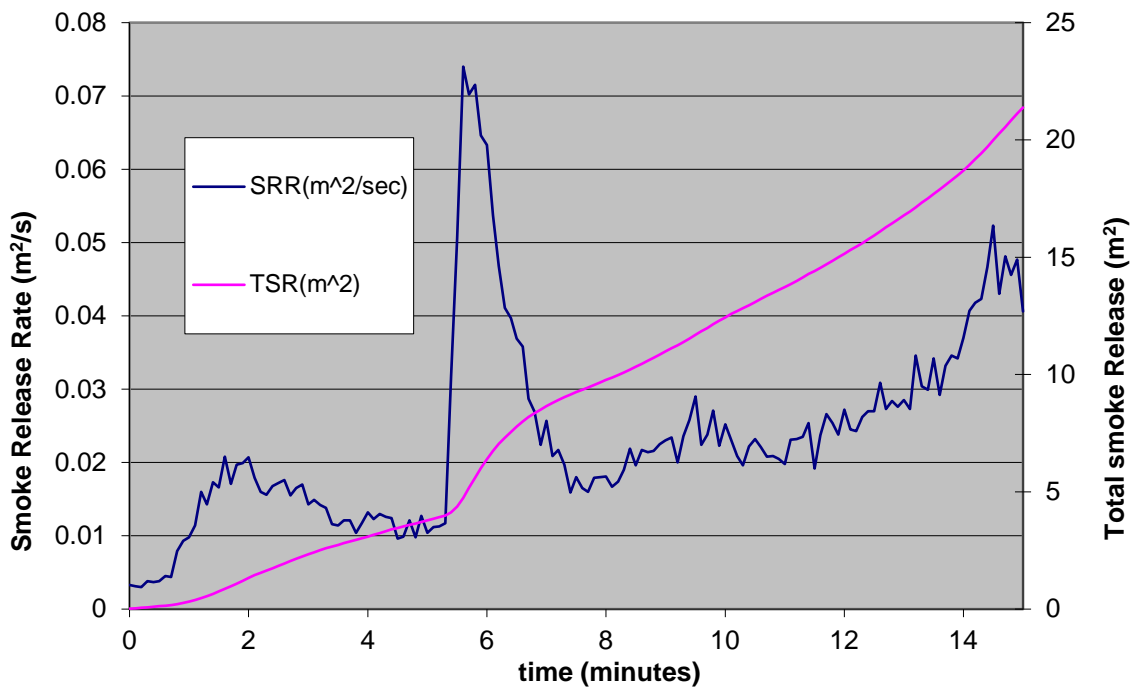
Graph No. 3
Smoke Release Data

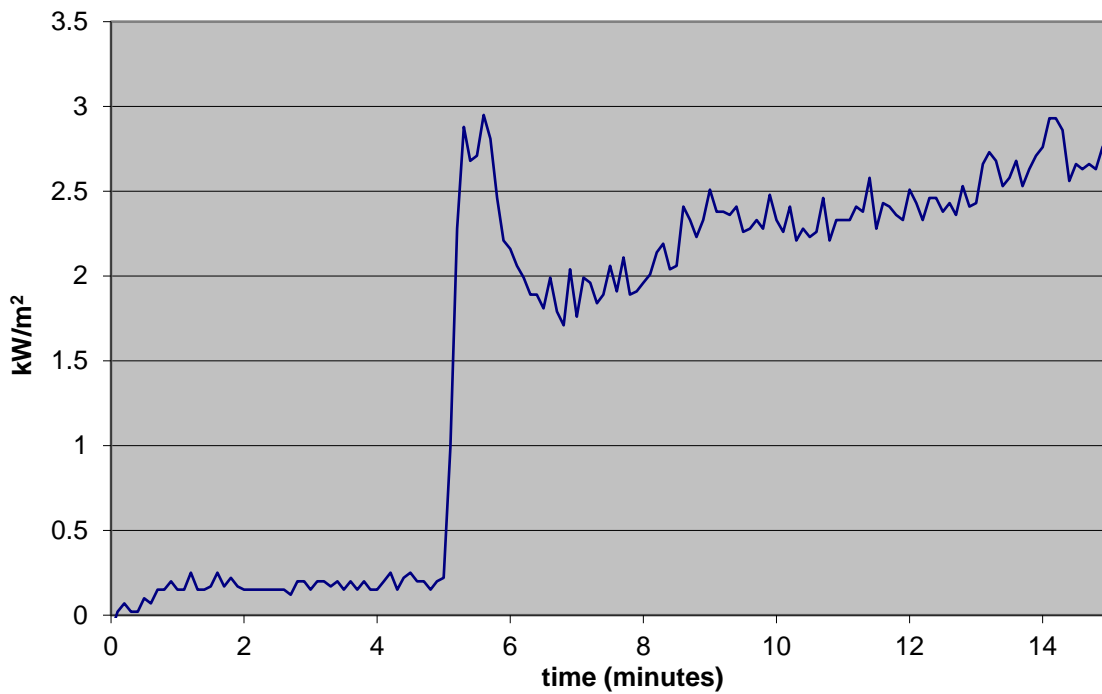
Graph No. 4
Floor Heat Flux

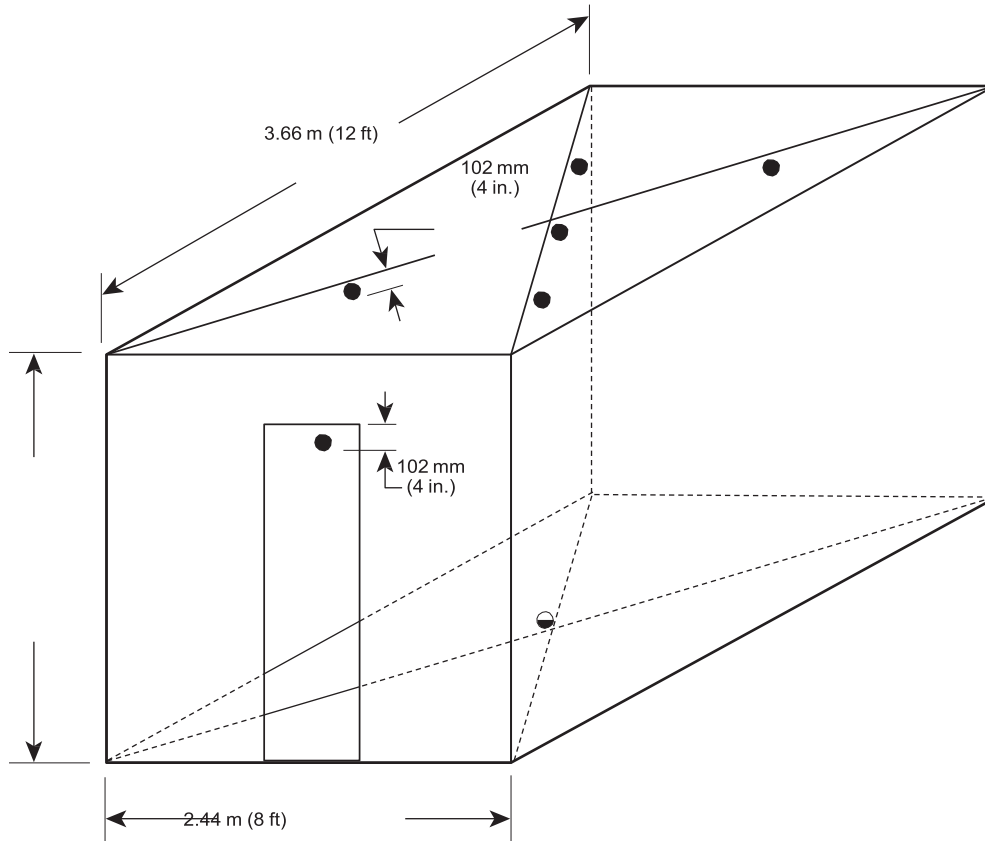
TC and Radiometer locations

The interior dimensions of the floor of the fire room, when the specimens are in place, measures 8 feet, by 12 feet. The finished ceiling is 8 feet \pm 0.5 inches above the floor. The four walls are at right angles defining the compartment. The compartment contains a 30 inches wide (\pm ¼ inch) by 80 inches high (\pm ¼ inch) doorway in the center of the 8 feet by 8 feet wall on the edge of the hood calorimeter apparatus. No other openings are present to allow ventilation. Below is a detailed description of the assembly:
