Locking Piston-Cable Assembly with Loctite and Spring Tensioning Washers ECO Units

ECO Units with serial number below 12160000, where a #5 Counterweight is to be installed / re-installed.

To prevent possible loosening of the handle adjustment cable within the locking piston, after the counterweight is installed. Also to remedy any issues of the handle locking piston exhibiting any symptoms of insufficient locking piston spring tension (such as the handle falling out of set position, while unit is running).

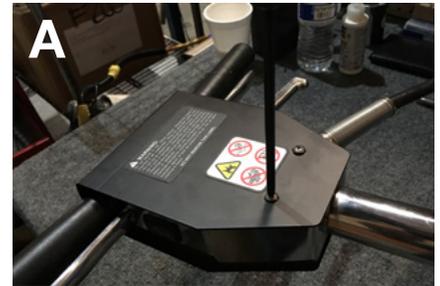
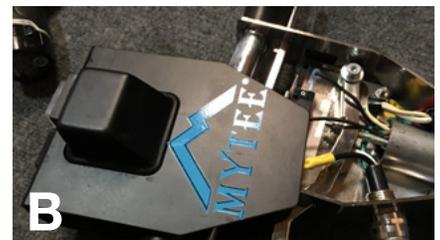
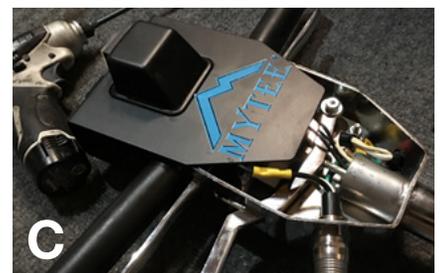
Do not slide cover upward more than shown here (Figure B), as the rocker switch wiring may accidentally be pulled free, and be extremely difficult to re-attach. (Figure C)

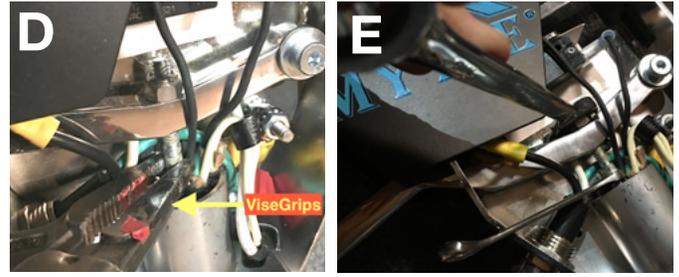
Step 5: Using Needle-Nose Vise Grips, take a clamped firm hold of the crimp section of the Adjustment Cable end. This will prevent the cable from turning, as you remove the nut above the lever (on the threaded end feeding through the Handle Lever.) (Figure D)

Step 16: Re-attach the ViseGrips to the crimp portion, to again hold the cable from turning. **(Refer back to Figure D)**

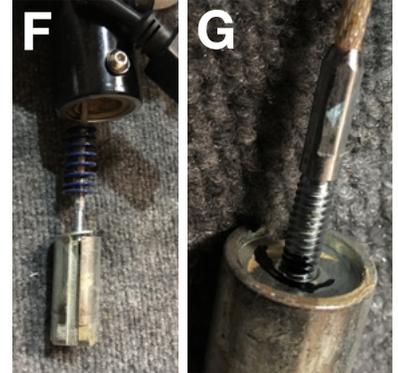
Step 7: Grasp the Locking Piston and remove from the handle assembly, along with the cable. Take care not to lose or remove the spring and washer from the cable. (Figure F)

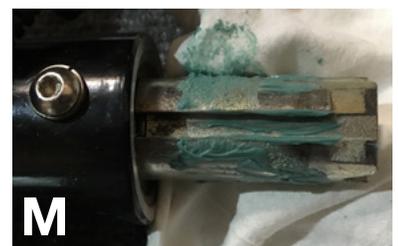
Step 14: Re-insert the cable into the handle assembly, but leave the locking piston exposed for the application of grease. (Figure L & M)

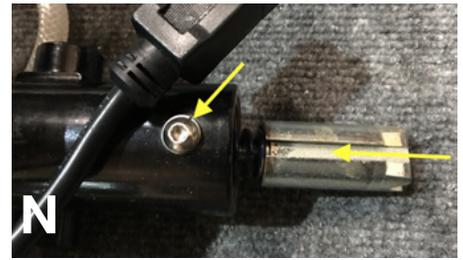
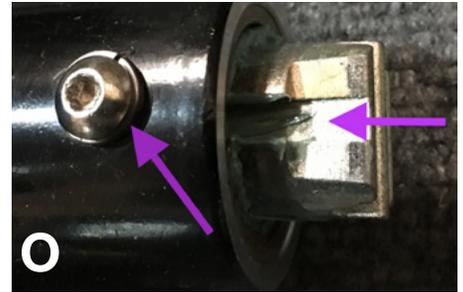
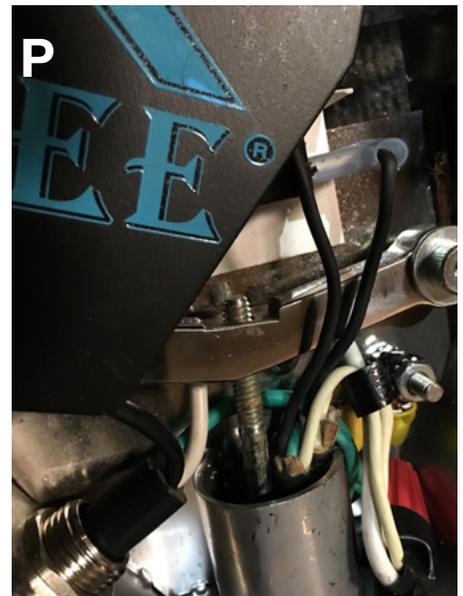
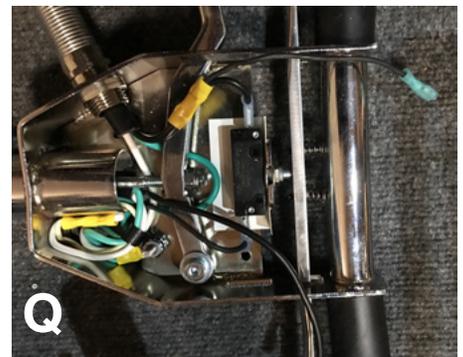
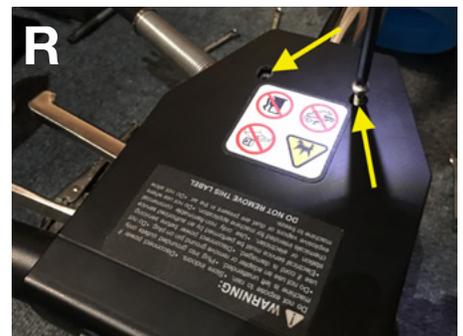
Step 14: Insert the Locking Piston into the handle assembly, taking care to line up the slot in the piston with the guide bolt, as shown. **(Figure N & O)** While doing so, guide the other cable end to go through the hole in the Handle Adjustment Lever. **(Figure P)**

Step 17: Using the 7/16" open-end wrench, tighten the Locknut, just enough to take all slack out of the cable, plus ¼ turn. **(Refer back to Figure E + Figure Q)** This should expose no more than two threads above the locknut. If more than two threads are exposed, you will need to remove the cable assembly, and adjust the amount the cable threads into the Locking Piston. Consult Sales Engineering at Mytee for help or details, if needed.

Step 19: Replace the Switch Box Cover Phillips screws. **(Figure R)**
