Endako Mine Tailings Dust Suppression 2016

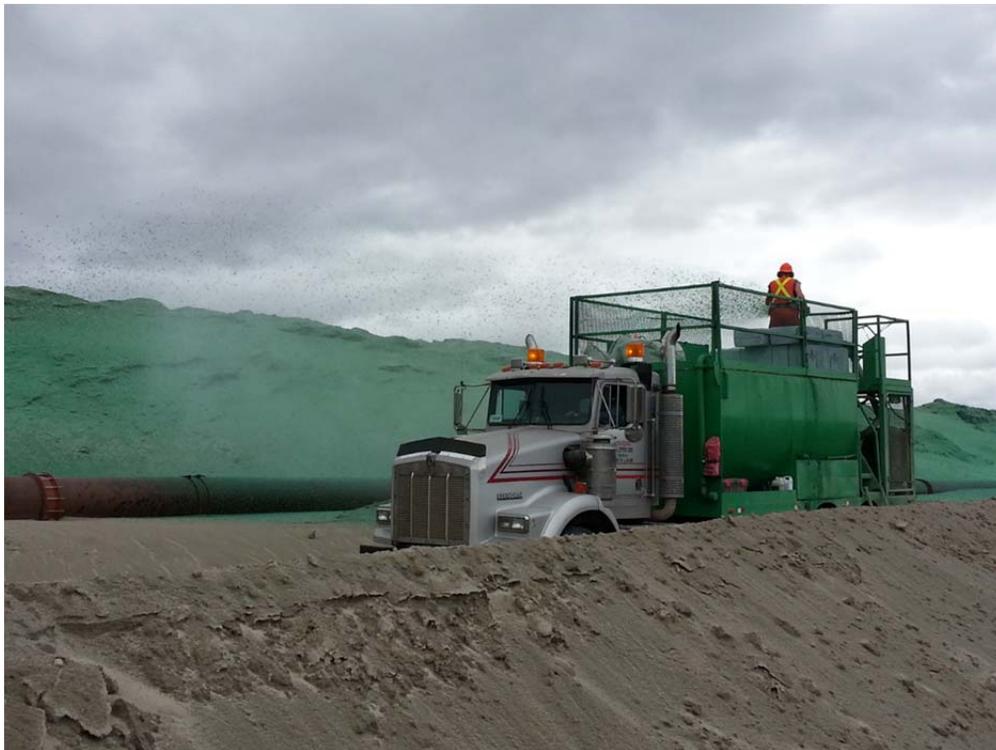
A hydroseeding program was undertaken using a mix of fall rye, fertilizer and mulch. 24+ hectares on the outer slope of #1 tailing pond were hydroseeded.

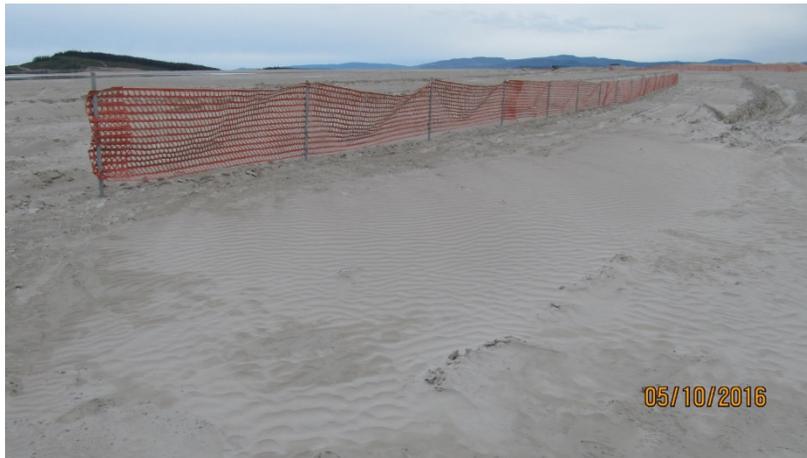
Snow fencing and trenching was done for approx. 1.5 kilometers along the east side of #1 pond.

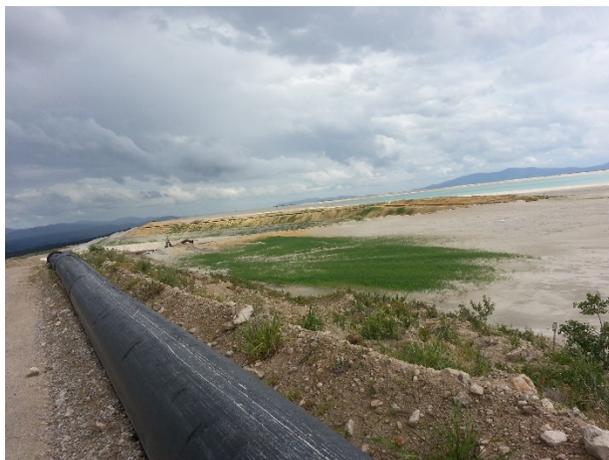
12 hectares of Hydro seeding was done on the north benches of #1 pond.

Previous Hydroseed growth. Yellow is new hydroseeding.

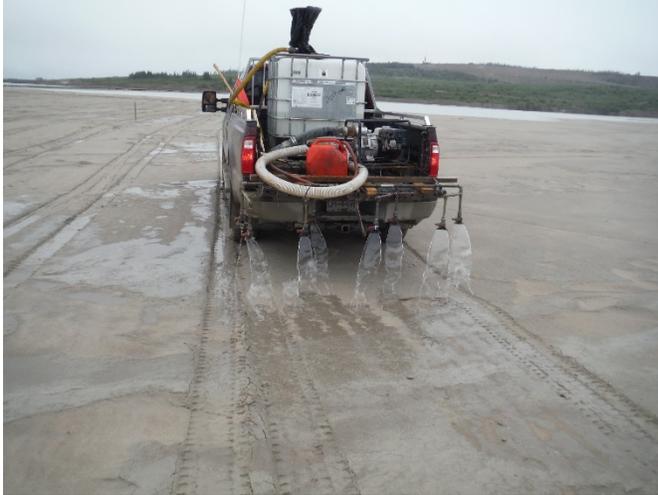
Soil stabilizer being applied on #3 tailing pond.

First test was done using Magnafloc #336 as a soil stabilizer. Preliminary results were positive.

Test was done using IPAC 6832 as a soil stabilizer. Results showed this material to be ineffective.

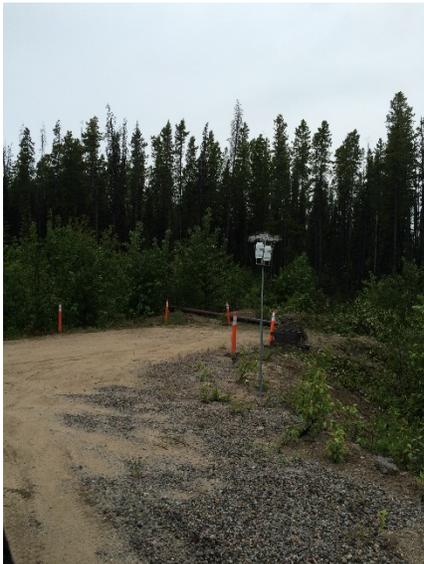
Collectors for dust fall monitoring were put up to collect data on potential dust leaving the mine site.
