The Partnership:

Background and Impetus to Conduct the Environmental Audits

Goals and Organization of the Upper North Branch Environmental Audits

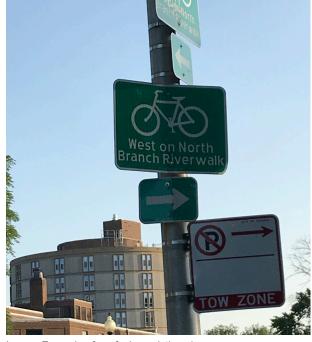
Image: Example of confusing existing signage

1. Improved Wayfinding

Echoing the 2018 North River Communities Plan, there is a lack of clear wayfinding along the Upper North Branch route.

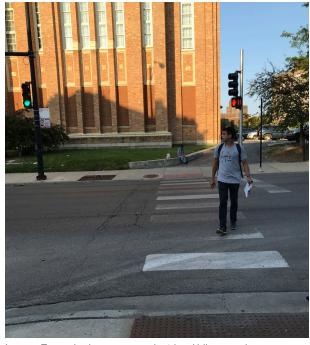
Image: Example dangerous pedestrian / bike crossing

6. Improve Safety of Major Intersections

- Foster Avenue and Kostner Avenue: Need to repaint crosswalks, increase visibility of bikers and pedestrians on a high traffic and high speed road.
- Carmen Avenue and Drake Avenue: Relatively high traffic for a residential street, crosswalk not visible, no pedestrian signage in place.
 Could be a place for curb bump outs and raised sidewalk.
- Carmen Avenue and Kimball Avenue (Von Steuben): Bikes required to use the sidewalk instead of being able to merge on to Kimball Avenue.
- The street-to-trail transition at Carmen Avenue and Central Park is unsafe and difficult for cyclists to navigate. Carmen Avenue leads directly into a curb, with curb cuts for a crosswalk on either side of the Park District path. Rather than allowing bikers to continue straight through the intersection, it forces them to use the pedestrian crosswalks.

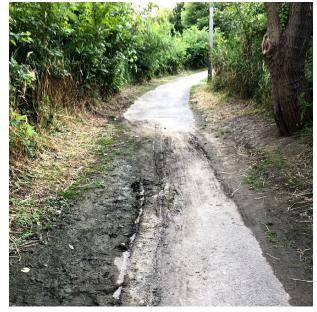
- The trails within Kiwanis Park are overgrown and the trail surface is poor in many places.
 Designated as a Chicago Park District Natural Area, there is currently no site Steward in place at Kiwanis Park.
- There is also a need for improved lighting in Kiwanis Park, especially along the "lower trail" sections.

Image: Erosion on the Kewanis Park trail

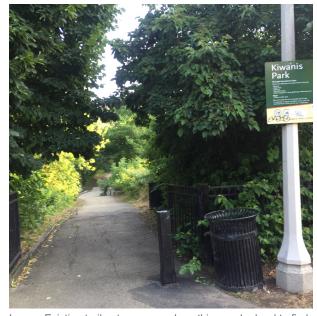
Image: Existing trail entrances, such as this, can be hard to find
