# Restoration of Historic Denver Park

by John Heap, President, CLI - Clear Water Construction

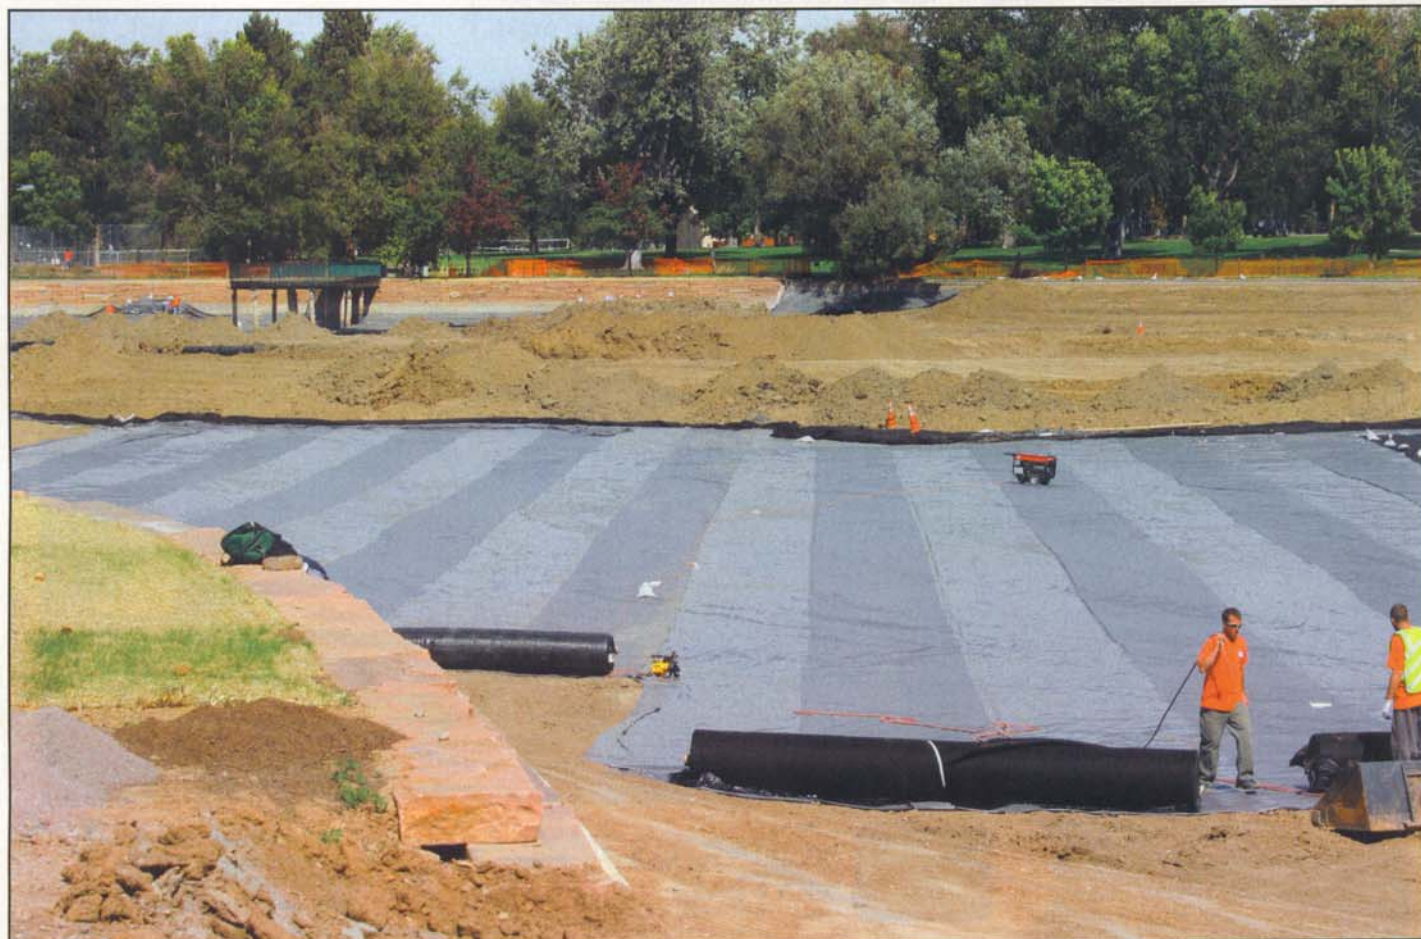
The cover soil is placed over the PVC geomembrane while work continues on the other side of the pond.

To solve the problem of a lack of a stockpile staging area, the cover soil was placed inside the pond area on one side. The PVC geomembrane and geotextile were installed on the opposite side of the pond. Once installation of the geomembrane and the geotextile was complete on the first half of the pond, then the task of moving the cover soil to the lined side of the pond had to be done. The second half of the PVC geomembrane was installed and the cover soil was placed over the entire pond. This was a time-consuming process and required close coordination between CLI-ClearWater, Denver Water, Denver Parks and American West Contracting.

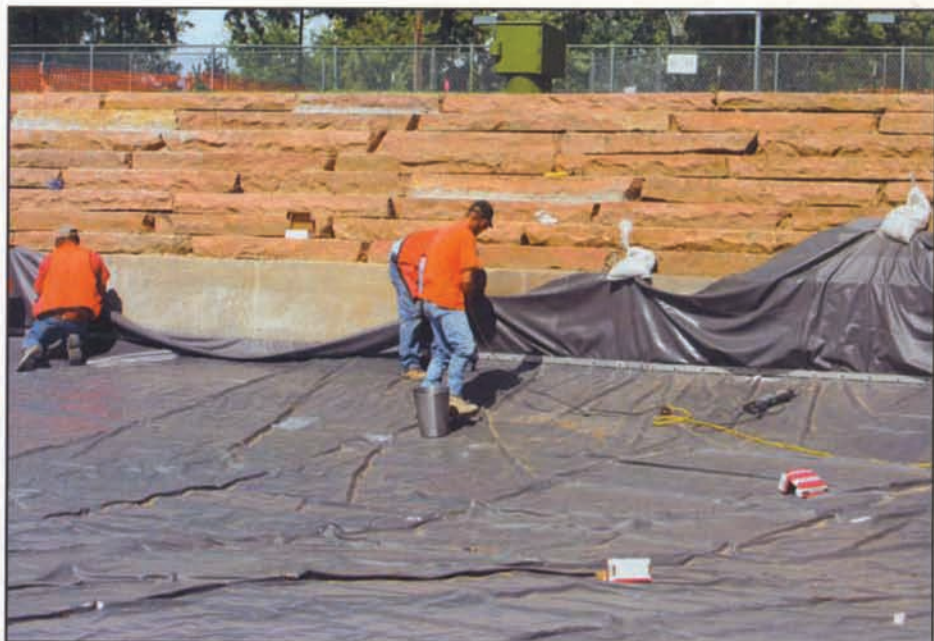
Large panels of PVC geomembrane are pulled out and battened to the concrete wall surrounding most of the perimeter of the pond.

The original hardscape perimeter of sandstone rocks set on a concrete wall makes up the majority of the lake perimeter. Portions of the concrete wall had to be repaired. The PVC geomembrane was then attached to the concrete wall using aluminum batten bar attached with an anchor bolt every 6". There was 5200 lineal feet of concrete wall surrounding the lake perimeter. Boots were also constructed around the base of the pier posts using a hot air gun and adhesives to
