HISTORIC RESOURCES – BUILDINGS AND SITES

Site / Building Name Chapman Farmstead / Kent, William, House and Barn-Studio
 Artist / Writer Name Kent (aka Williamson), William Theme: Connecticut as refuge
 Street Address or Location 269 Howd Road
 Town/City Durham Village _____ County Middlesex
 Owner(s) William Kent Charitable Foundation, 328 Tri Mountain Rd, Durham CT 06422 Public Private

HISTORIC RESOURCES – BUILDINGS AND SITES continuation sheet

269 Howd Road, Durham CT

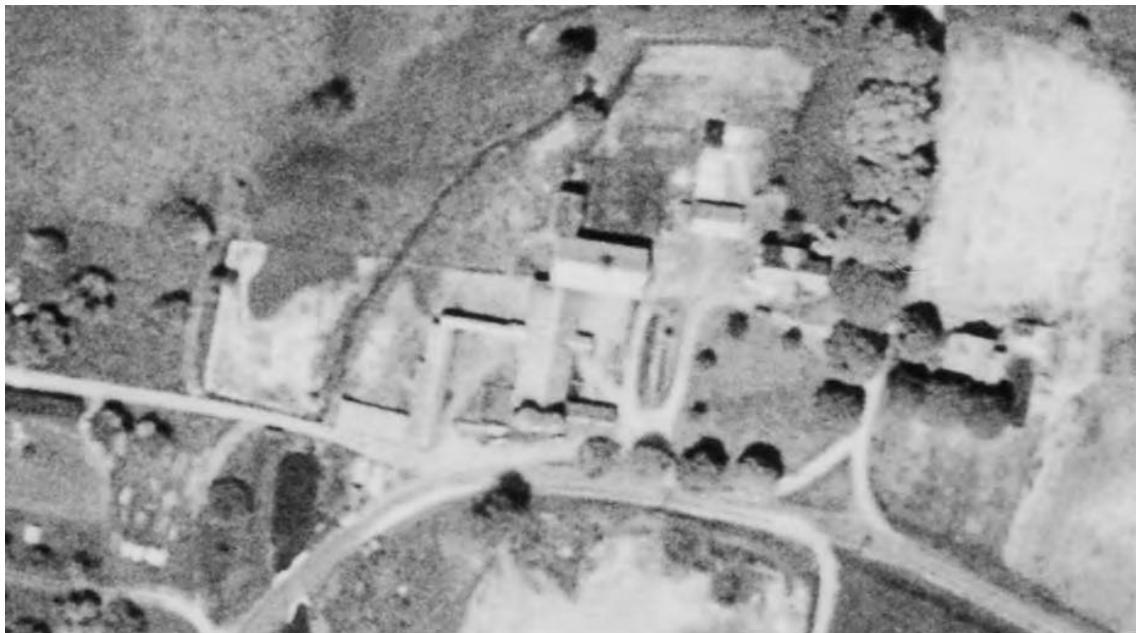
4. 1934 Fairchild aerial photograph – detail showing the property at 269 Howd Road. From UConn MAGIC, http://magic.lib.uconn.edu/mash_up/1934_aerial_index.html , accessed 8/12/2014. Note the twin silos against the south end of the extant barn, a taller barn with cupola to the north, and other farmstead structures.

The east side is similar, with a corresponding 1-story gable-roofed addition, which may have been a milk room or feed room. Aerial photography shows that a taller barn with a cupola formerly stood to the north, attached at the north end of the existing building. Other structures formerly stood to the east and northeast. The barn/studio is covered with asphalt shingle siding and the window trim is painted wood; roofing is asphalt shingles.

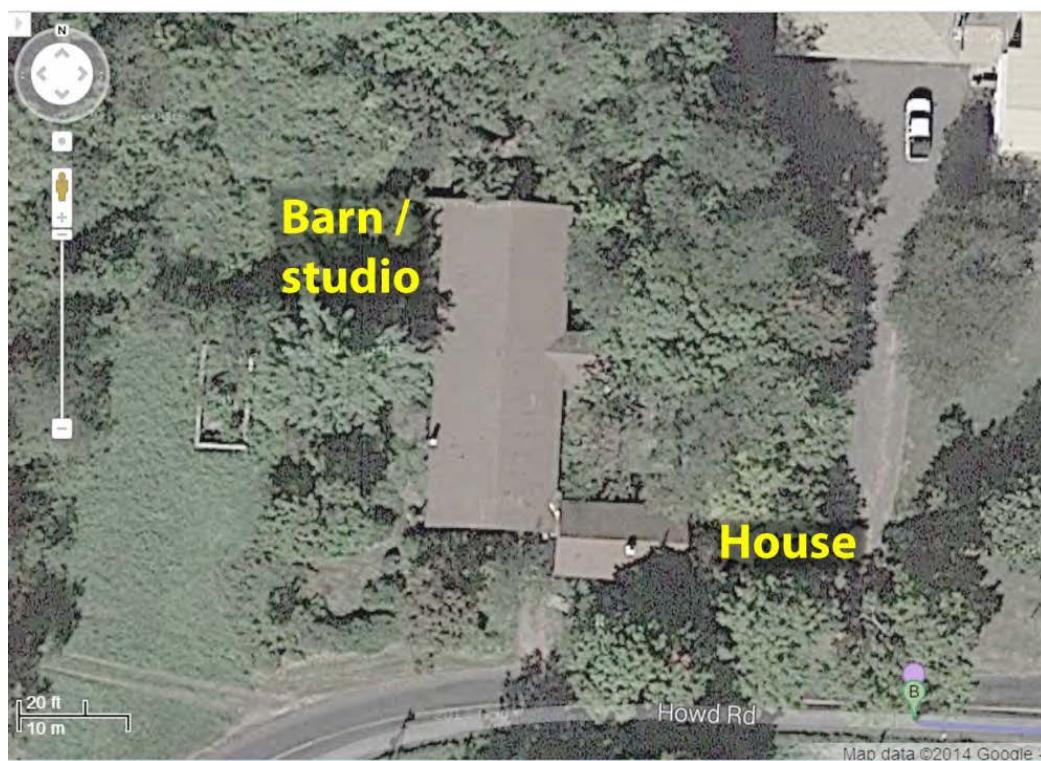
5. Detail Site Plan showing contributing resources. Base image from Google maps.

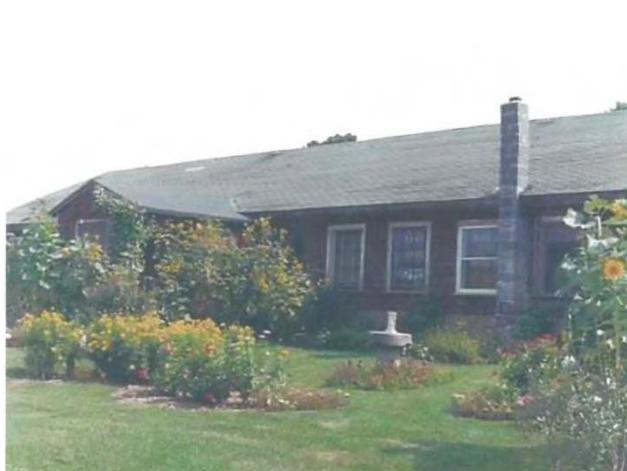
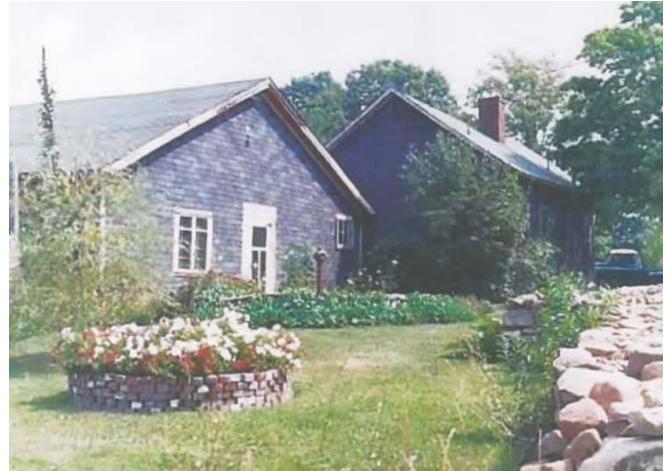
6. Southwest view of Barn/studio (left) and House (right rear), camera facing northeast. Photographs from the 1990s, courtesy of the Willam Kent Charitable Foundation.

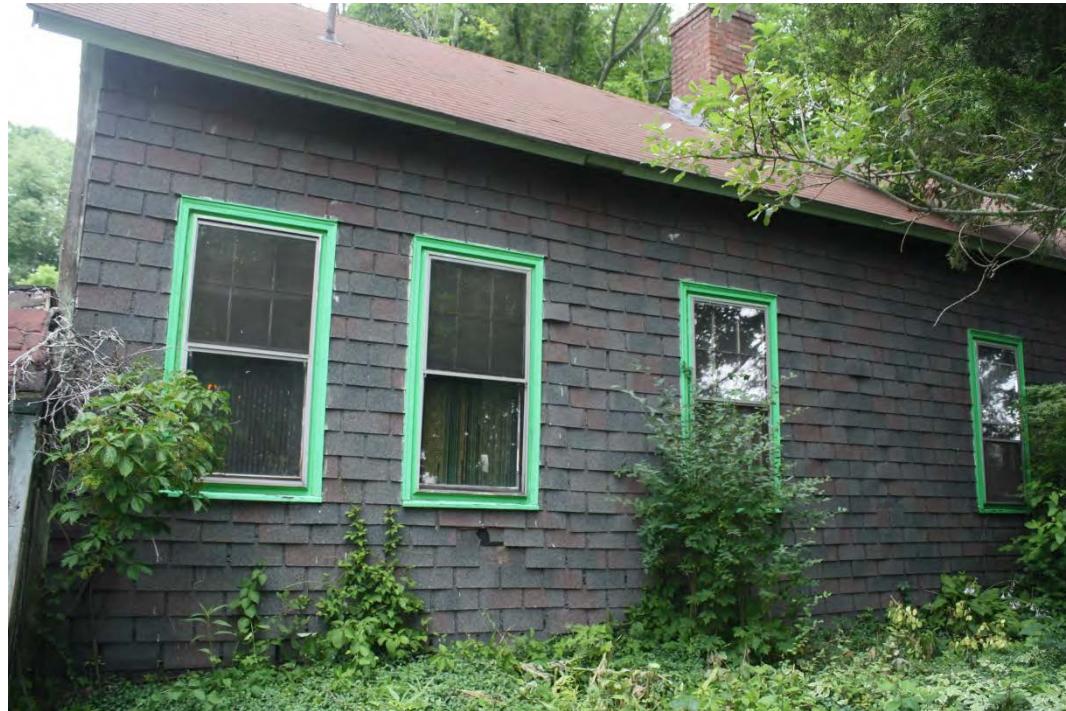
8. South view of House, camera facing north.

The house is a small 1 1/2-story gable-roofed Cape-style building with its ridge-line oriented east-west and its south eave façade facing south toward the road. The wood-framed structure is approximately 20' x 46' and has five six-over-six double-hung windows irregularly spaced across the south eave-façade. The east gable-end has a similar window toward the left and a door to the right, with a modern wood deck and ramp leading to grade. There is a two-pane attic window above. The west side is covered by a partially-collapsed shed addition. A connecting passage from the northwest corner of the house leads to the southeast corner of the barn/studio. A brick chimney is off-center toward the east at the ridge-line. The roof has overhangs at the rakes and eaves. Windows are wood-trimmed while walls are covered with asphalt shingle siding. The interior is partitioned into several small rooms including a kitchen at the southeast corner and spaces that are now used for storage of artwork.

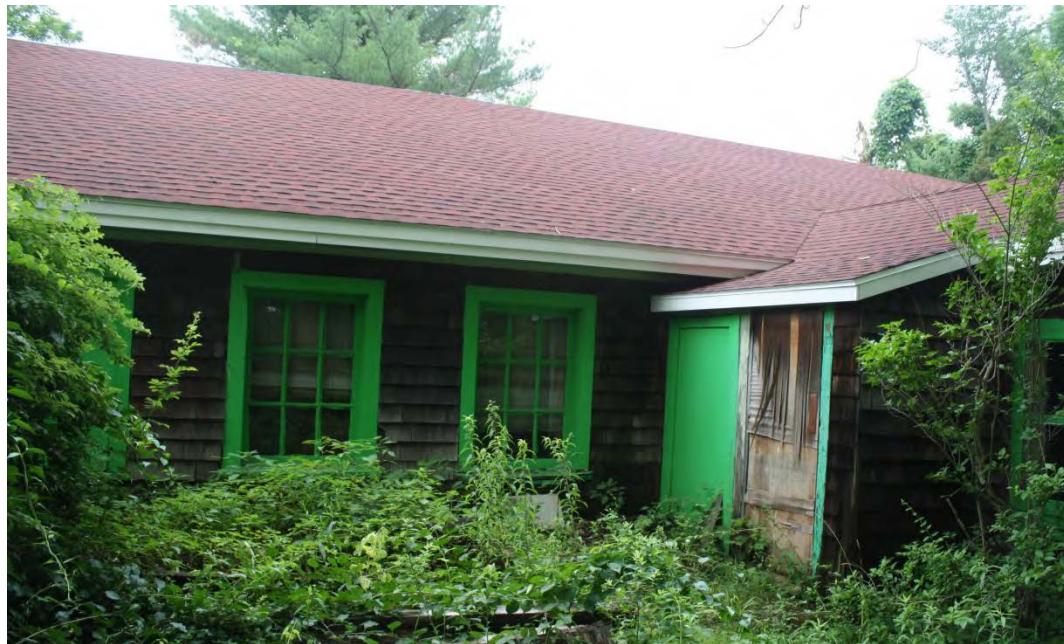
10. East detail view of Barn/studio, camera facing west. Note nine-pane dairy barn windows and attached shed.

The south gable-end has a pass-through entrance door at the center, flanked by a pair of windows to the left and a single six-pane window to the right. Along the west eave-side is a series of windows, some of which are nine-pane sash of a type that was common in dairy barns of the early 20th century. Off-center toward the north, a gable-roofed wing extends westward. A historic aerial photograph shows that this formerly extended farther and connected to another long narrow structure (possibly a poultry house), of which a partial foundation remains. A concrete masonry exterior chimney is located off-center toward the right (south) and to the right of this are a multi-paned picture window and French door which appear to be non-original.

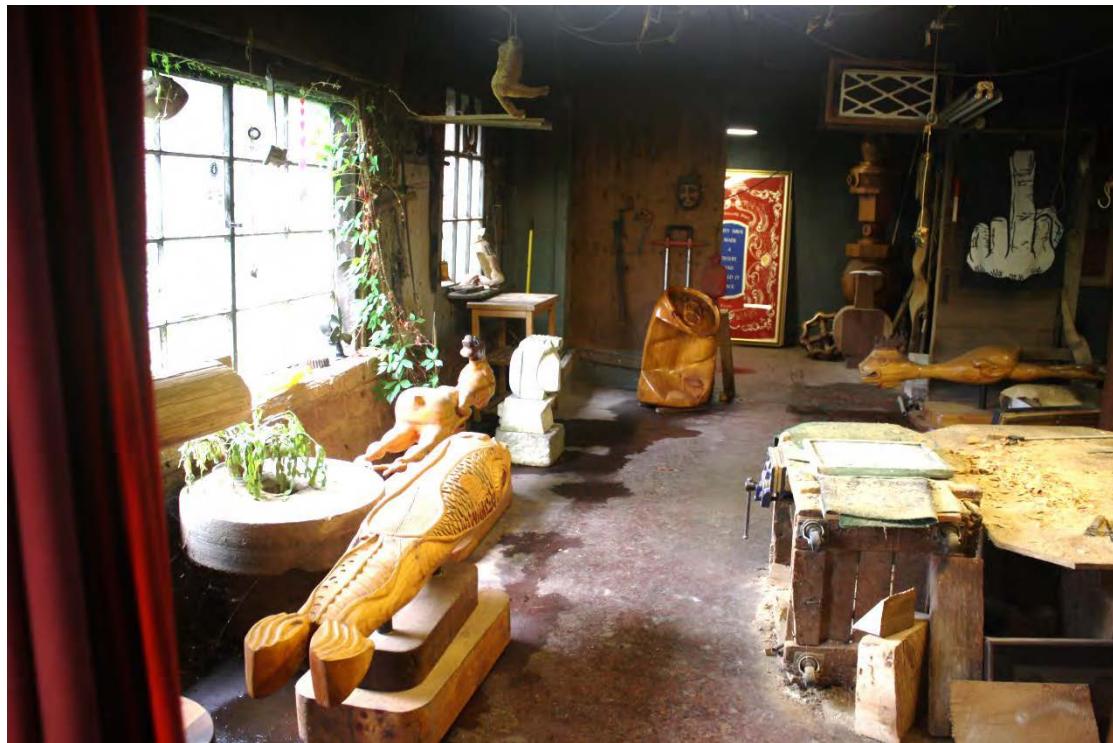
11. Interior view of Barn/studio, camera facing northwest, showing the workbench at left with artworks.

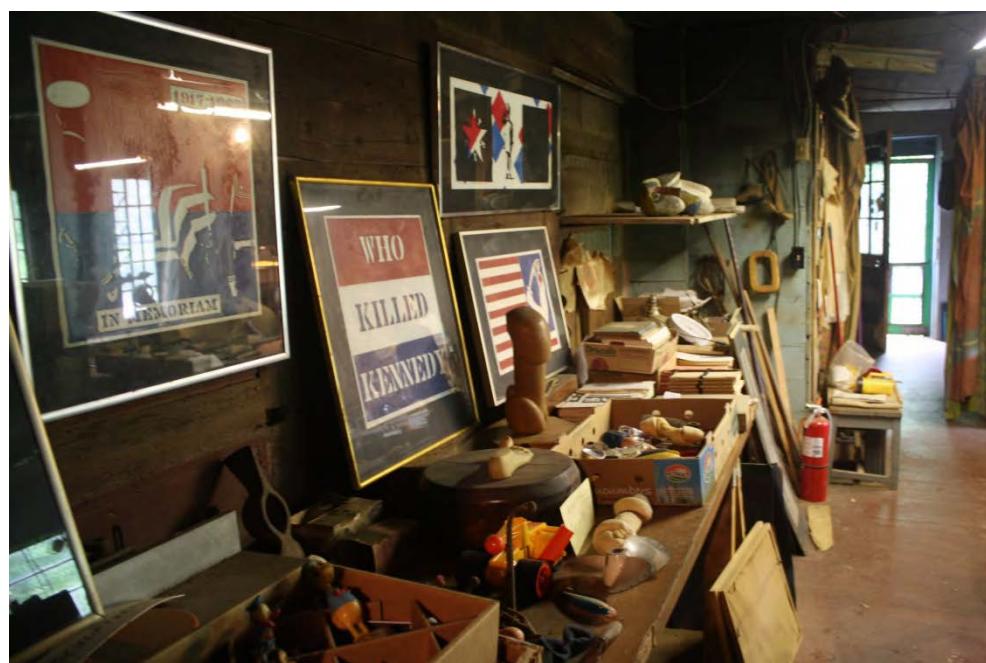
15. Interior detail view of Barn/studio, camera facing south, showing prints and small objects used as models.

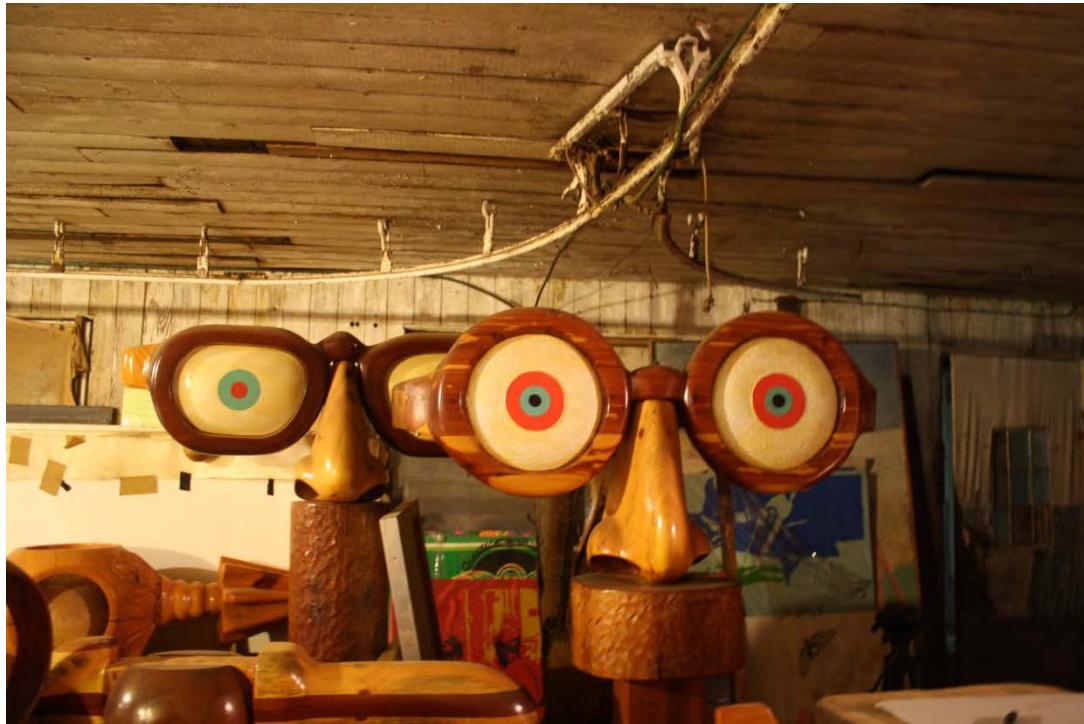
16. Interior detail view of Barn/studio, camera facing east. Note wall finishes typical of dairy design, and overhead tracks left from dairy or slaughtering functions.

The interior has two rows of steel columns, consistent with the design of typical dairy stable barns, and is finished with flush-board wood paneling at the walls and ceiling, also typical of the stable barn type. The remains of overhead track systems are visible suspended from the ceiling. The floor is concrete. Some interior partitions have been added, creating an entry area at the south end, a work space along the west side, and a gallery/office on the east side.
