Federal Republic of Germany Project
Tomb of Jan Baba at WHS Makli, Thatta
Experts' Committee Meeting, 22-23 July 2015

REPORT

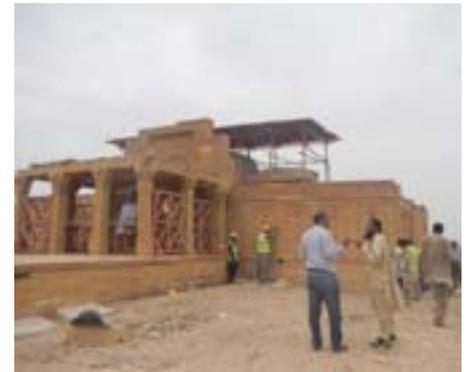
Tomb of Jan Baba with bamboo barriers and temporary roof providing protection.

- A temporary roof structure sloping toward the east in bamboo, clearly identified as a reversible roof cover, above the Zanana walls may be constructed for safe-guarding of structure.

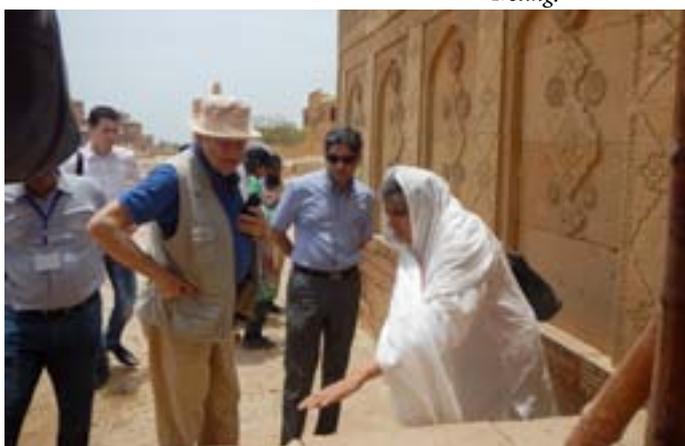
Discussion on treatment of damaged stone steps.

- For the damaged stone at the steps wooden nosing may be used.
- Where possible remove cement used earlier for surface repair on columns. At highly damaged surfaces of columns matching mixture of mud and lime may be used.

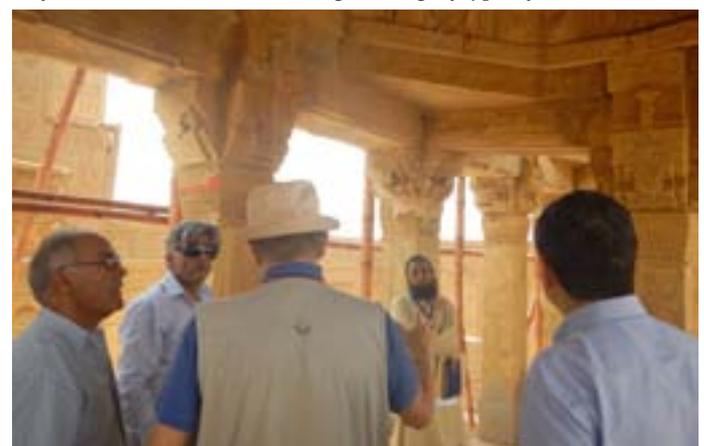
Examining the settlement of columns and central dome.

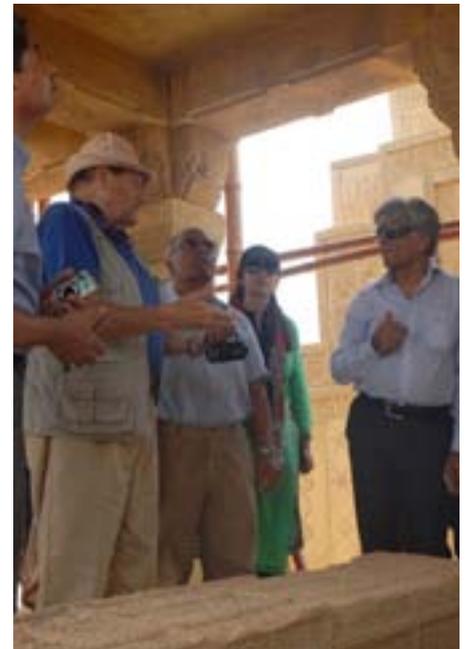
The condition of graves under discussion.

- Atmospheric data regarding rain, wind velocity & humidity to be collected.
- Surface temperature to be monitored.
- Wind directions to be recorded using weather station.
- Monitoring to be carried out for internal graves canopy for movement in the stone structure.
- Tell tales to be fixed in order to calculate the movement of stone structure at the settlement areas. The levels of the settled columns and their verticality tilts to be recorded for development and final rehabilitation treatment recommendations by geo technical engineer.
- The movement in the central dome above the grave canopy to be monitored by periodic examination and joints to be filled with matching grouting.

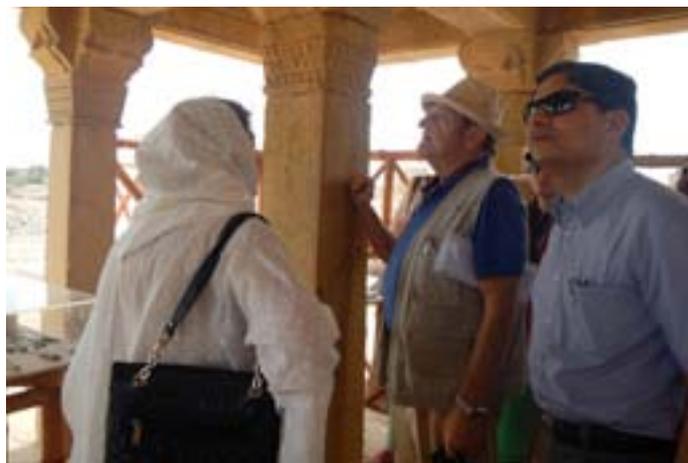
Examining the soffit of stone slabs in the entrance canopy.

- Matching lime sand water proof layer to be applied to damaged surfaces of stones above the entrance canopy. Proper drainage should be maintained to discharge on east side.

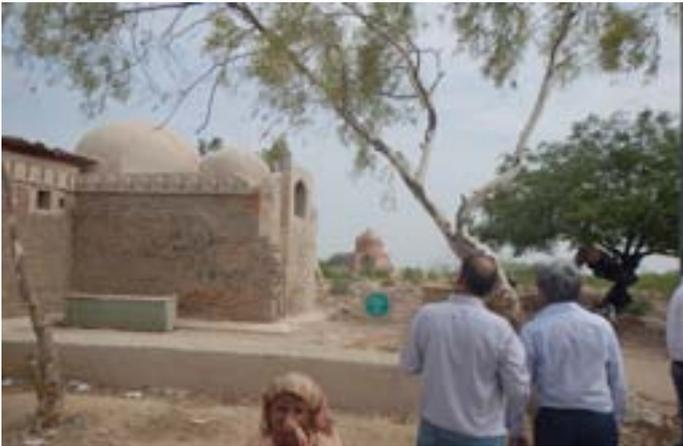
Application of L-EPI on Mosque of Ashabi.

It was explained that the mosque was provided first aid at comparatively low cost and within comparatively short period. The value of L-EPI in providing stabilization to endangered structures in order to buy more time for the large number of structures that require immediate attention.

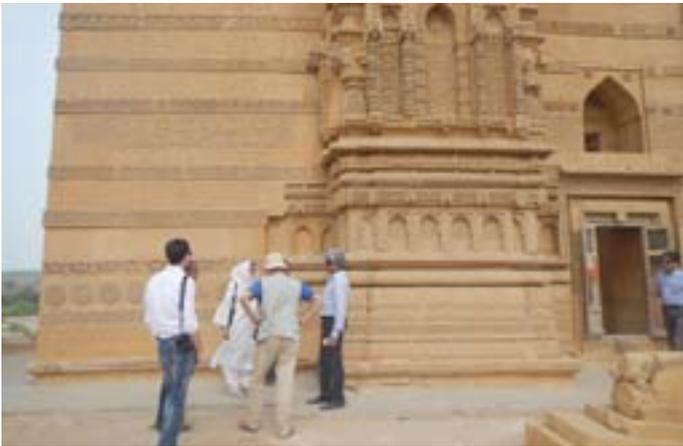
Experts discussing the cracks appearing in tomb of Jam Nizam al-Din

The engineering experts explained that the ridge required stabilization and it was constantly being eroded. Unless immediate action was taken, many structures, including the tomb of Jam Nizam al-Din were in danger.

Ar. Yasmeeen Lari agreed to get track monitors installed in order to monitor the movement in the structure, which she directed will be done in the subsequent week.

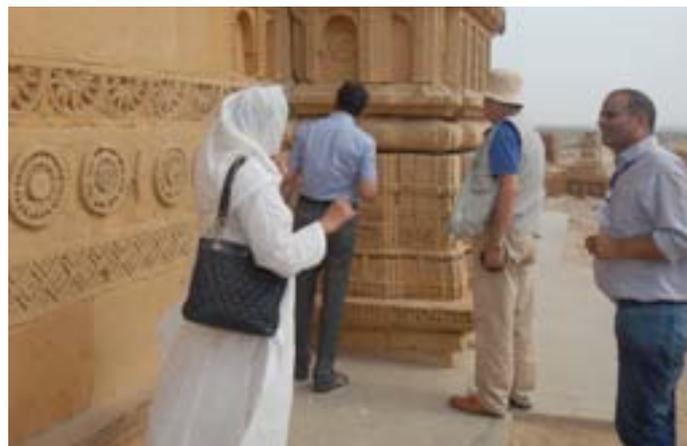
Discussion on installation of crack monitor.
