Mid-Atlantic Tidal Rapid Assessment

2014 Update

Mullica River and Dennis Creek

Mid-Atlantic Tidal Rapid Assessment 2014 Update: Mullica River and Dennis Creek, New Jersey

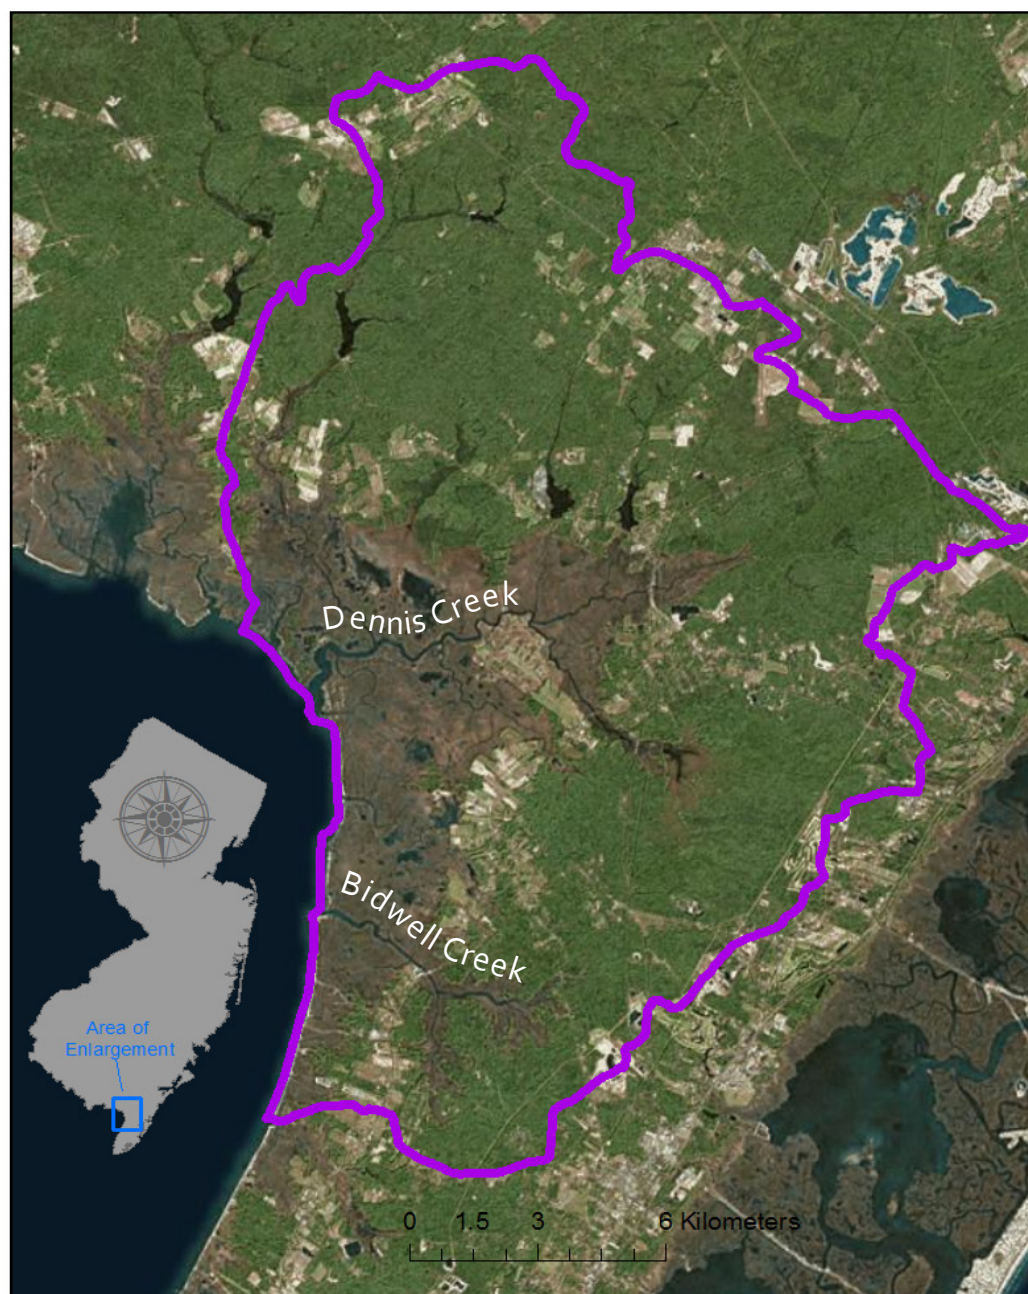
Figure 3. Dennis Creek watershed (HUC12; purple outline).

The Dennis Creek HUC12 watershed is located in Cape May County, New Jersey (Figure 3). Dennis Creek drains directly into the Delaware Bay. Notable townships in the watershed include Dennisville and Cape May Court House. According to the NWI, this watershed consists of approximately 9,432 acres (3816 hectares) of saline, intertidal,

emergent marshes dominated by *Spartina alterniflora*. A unique feature of Dennis Creek salt marshes is the prevalence of red cedar (*Juniperus virginiana*) snag forests that line the upland margins, especially along the northern shore (Figure 4). Major tributaries include East Creek and Sluice Creek. To the south, Bidwell Creek is also part of the Dennis Creek HUC12, although it also drains directly into the bay. Tidal amplitude, or the distance between mean higher high water and mean lower low water, at Dennis Creek is about 1.9 meters. This is similar to other marshes along the Delaware Bayshore.

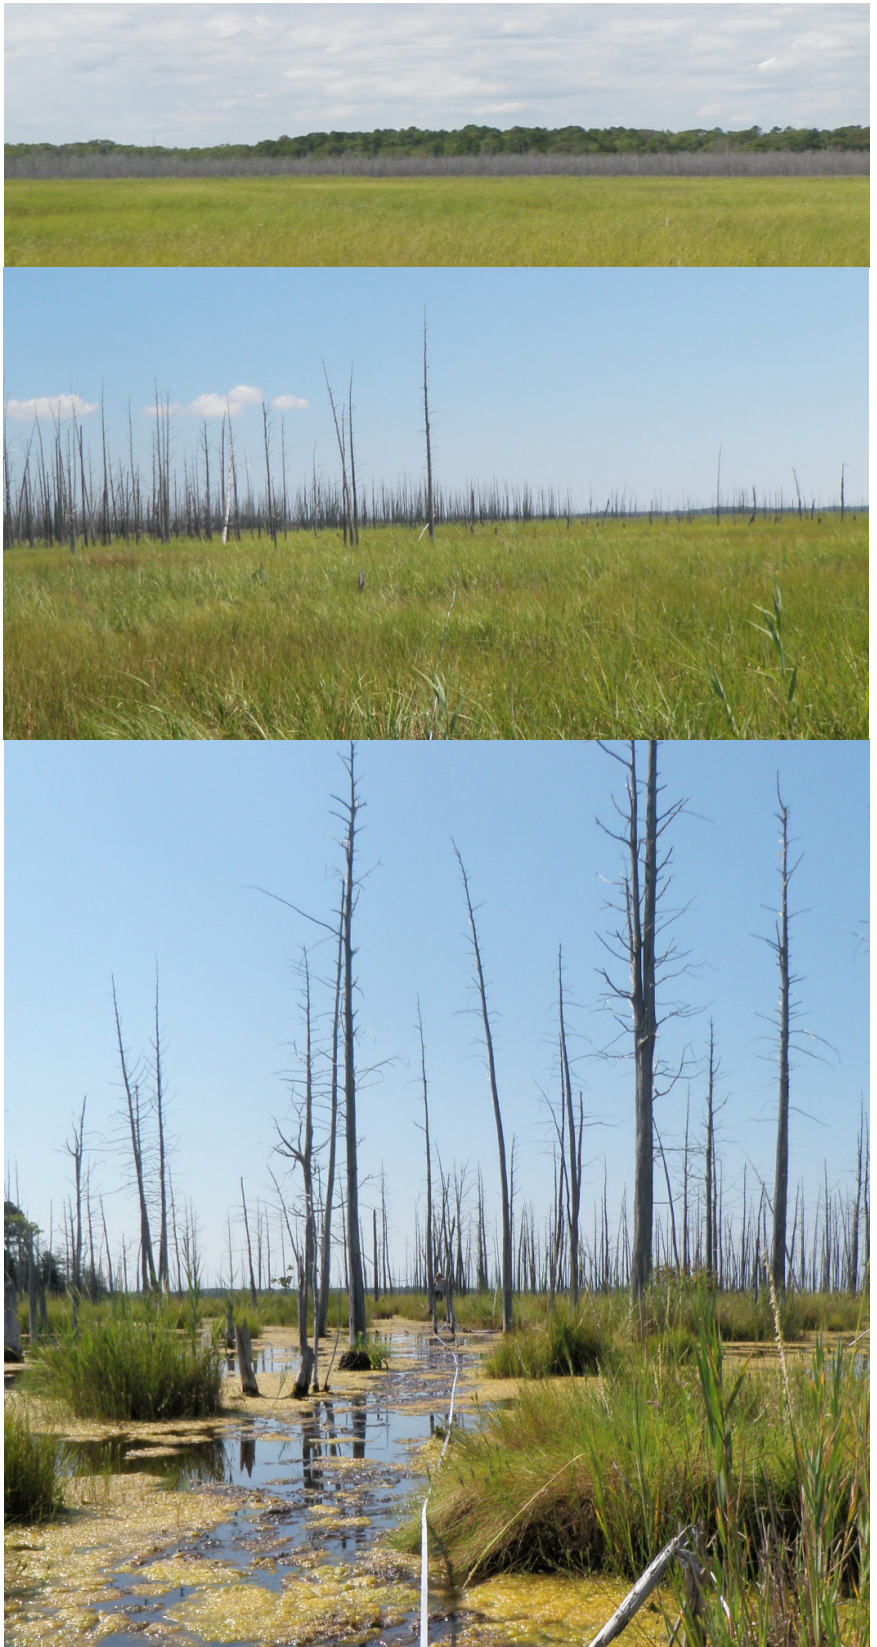
Figure 4. Cedar snag forests near upland margins at three different sites on the northern shore of Dennis Creek.

In the mid to late 1800's, Dennisville was a center of commerce, supporting large scale excavation of ancient white cedar (*Chamaecyparis thyoides*) for shingle making, which eventually depleted much of this resource by the turn of the century (Cultural Resources Digest 2005). At that time, it was also home to several large scale schooner building companies. Little of this infrastructure remains, as shifts in technology caused a cessation of activity more than 100 years ago. Only the causeways that were constructed across Dennis Creek and its major tributaries remain. Another industry found in the watershed is salt marsh hay (*Spartina patens*) farming. Although mostly an older agricultural practice, there are some salt marsh hay farmsteads along Dennis Creek. This type of farming intentionally alters tidal flow through sluices and levees. Alterations to enable both historical commerce and farming likely have lasting effects on marsh condition and resilience.

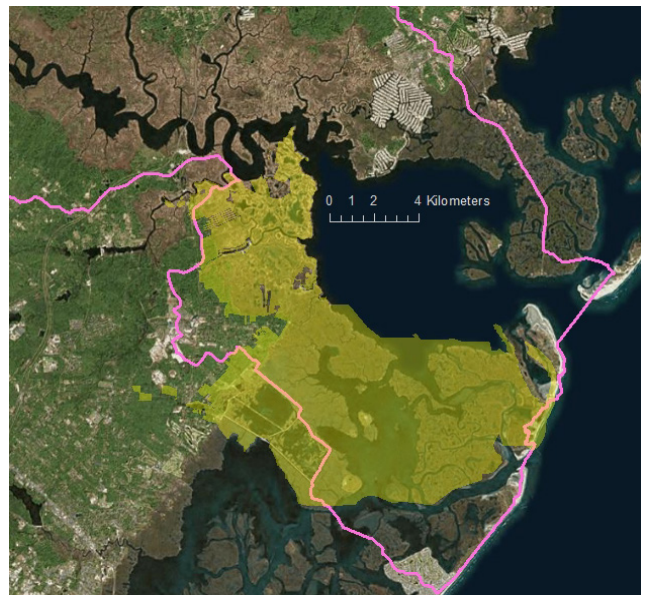
Figure 7. Marshes along the SSW shore of Great Bay owned by U.S. Fish and Wildlife Forsythe (yellow).

A large portion of the salt marshes along the SSW of Great Bay are protected and actively managed as an avian sanctuary by the Edwin B. Forsythe National Wildlife Refuge (NWR) Brigantine of the United State Fish and Wildlife Service (USFW), which was established in 1939 (Figure 6). In 2008 and 2009, USFW performed their Salt Marsh Integrity Index (SMI), a study on marsh condition congruent with Mid-TRAM, on their properties in the Mullica River watershed along Great Bay. Their findings could eventually be used in parallel with our Mid-TRAM results to offer a robust, cross-agency validation on salt marsh condition assessments within the Mid-Atlantic. Furthermore, SMI is used in other areas of the conterminous coastal U.S., which would allow us to gauge our Mid-TRAM condition results on a nation-wide scale as those reports become available.

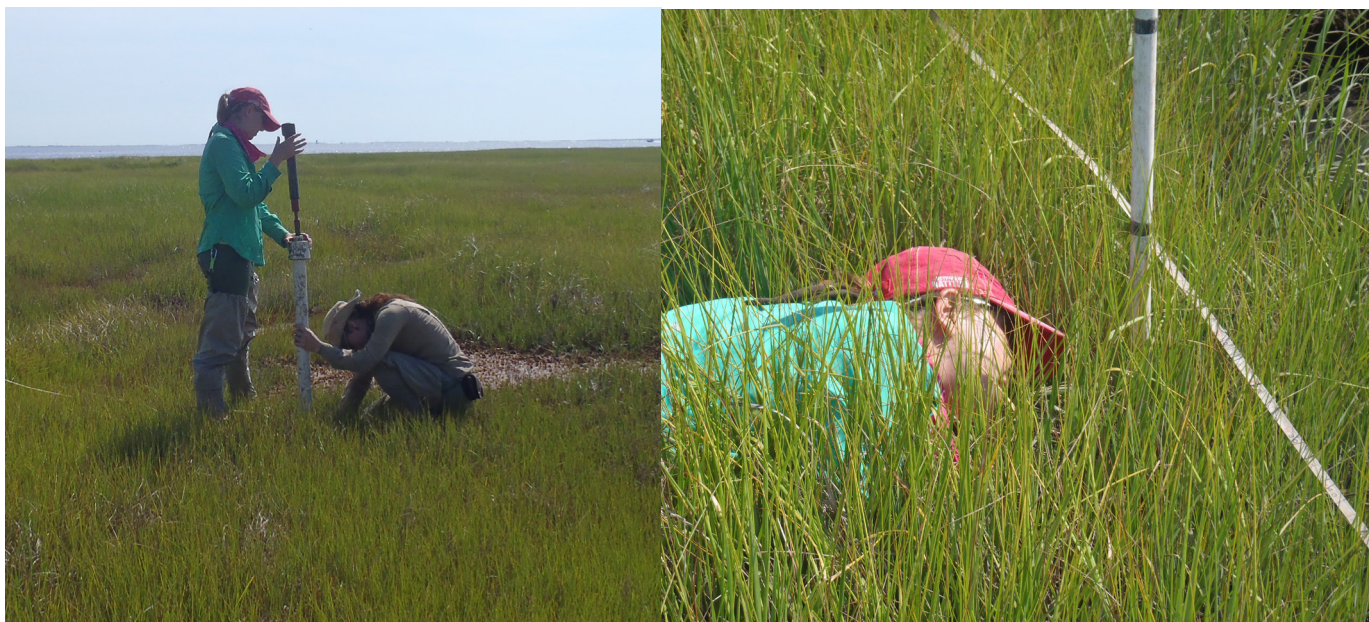
Figure 14. PDE and BBP staff using Mid-TRAM field techniques: on the left, bearing capacity; on the right, looking through *Spartina alterniflora* to obtain horizontal vegetation obstruction (i.e. canopy density)
