INDEX OF BIOTIC INTEGRITY STUDY ABOVE AND BELOW A DAM TO BE REMOVED ON THE DARBY CREEK, DREXEL HILL, PENNSYLVANIA

Kathryn Goddard, Adam DiCaprio, and Rachael Vietheer.

Department of Biology, Ursinus College, Main Street, Collegeville, PA 19426, kgoddard@ursinus.edu.

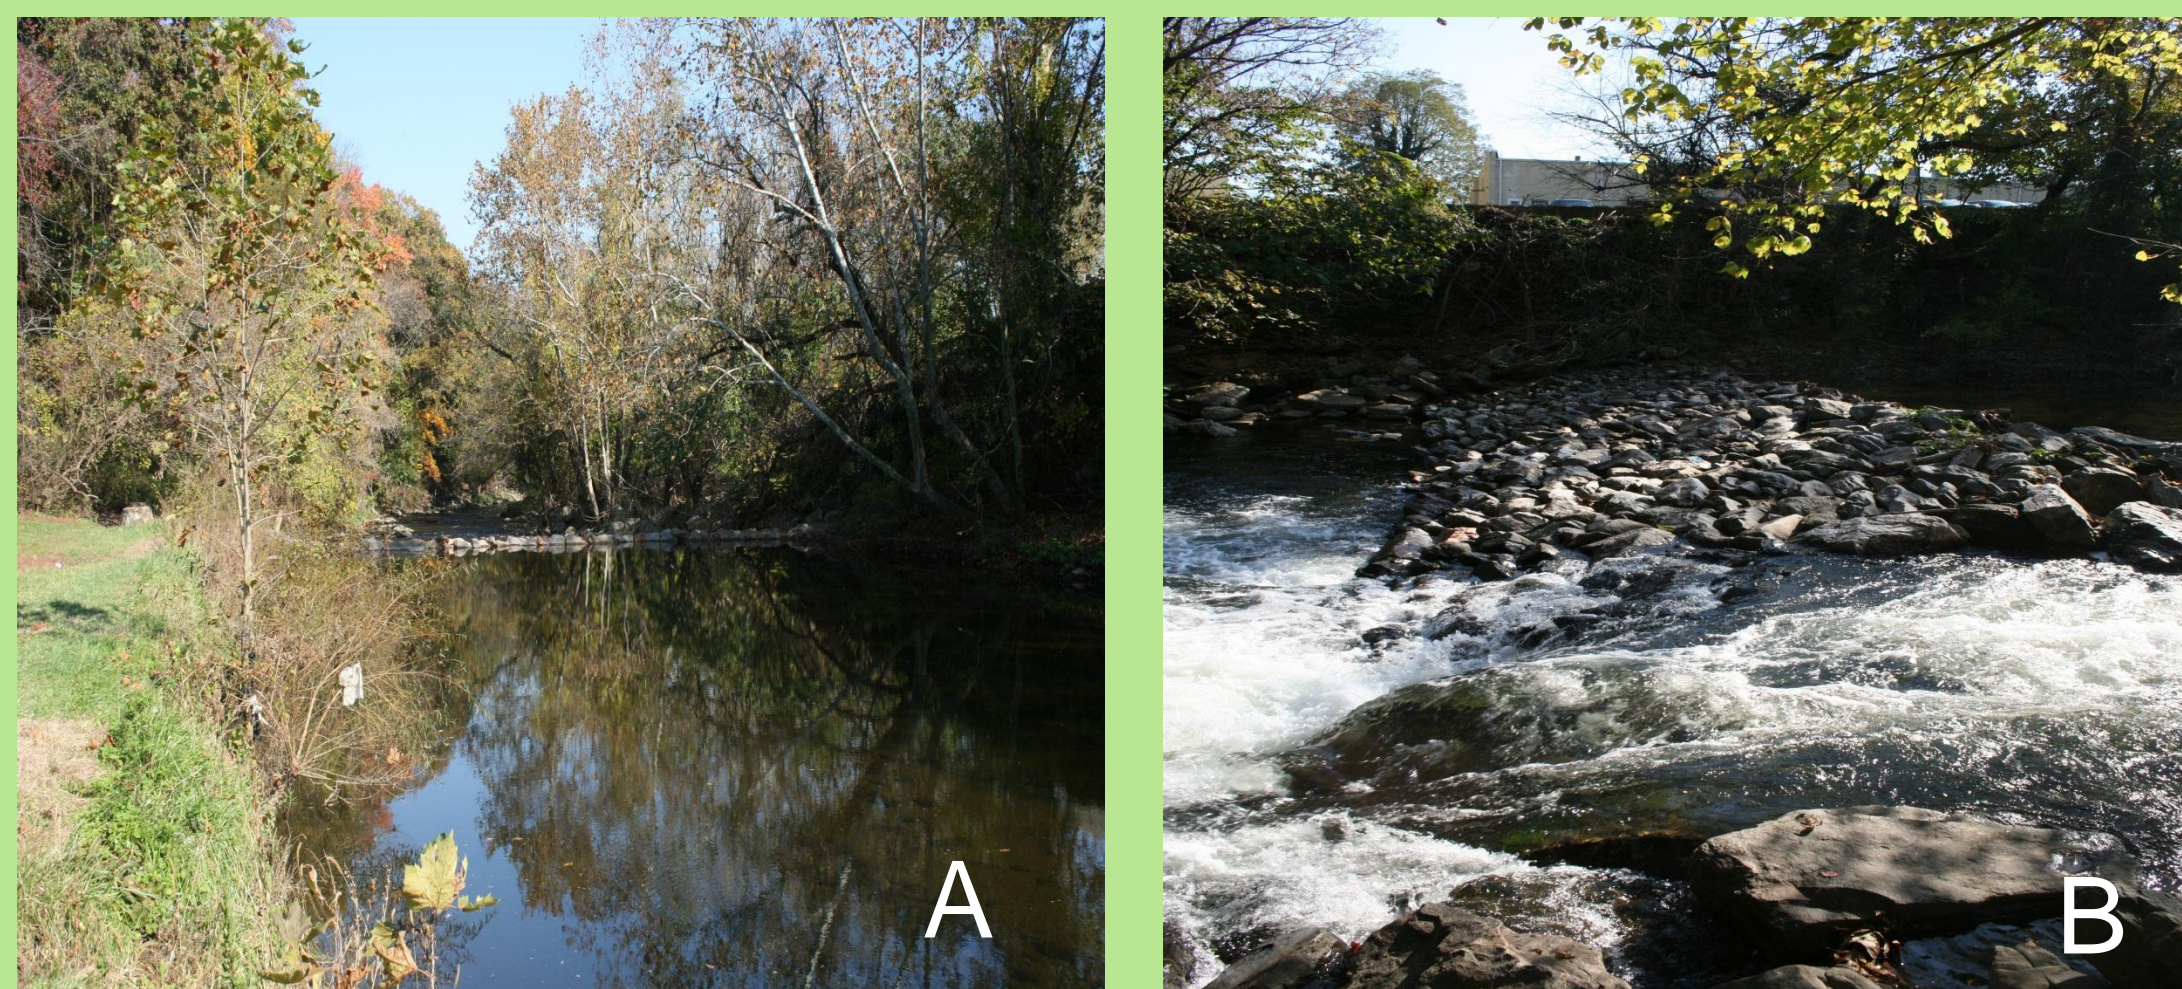
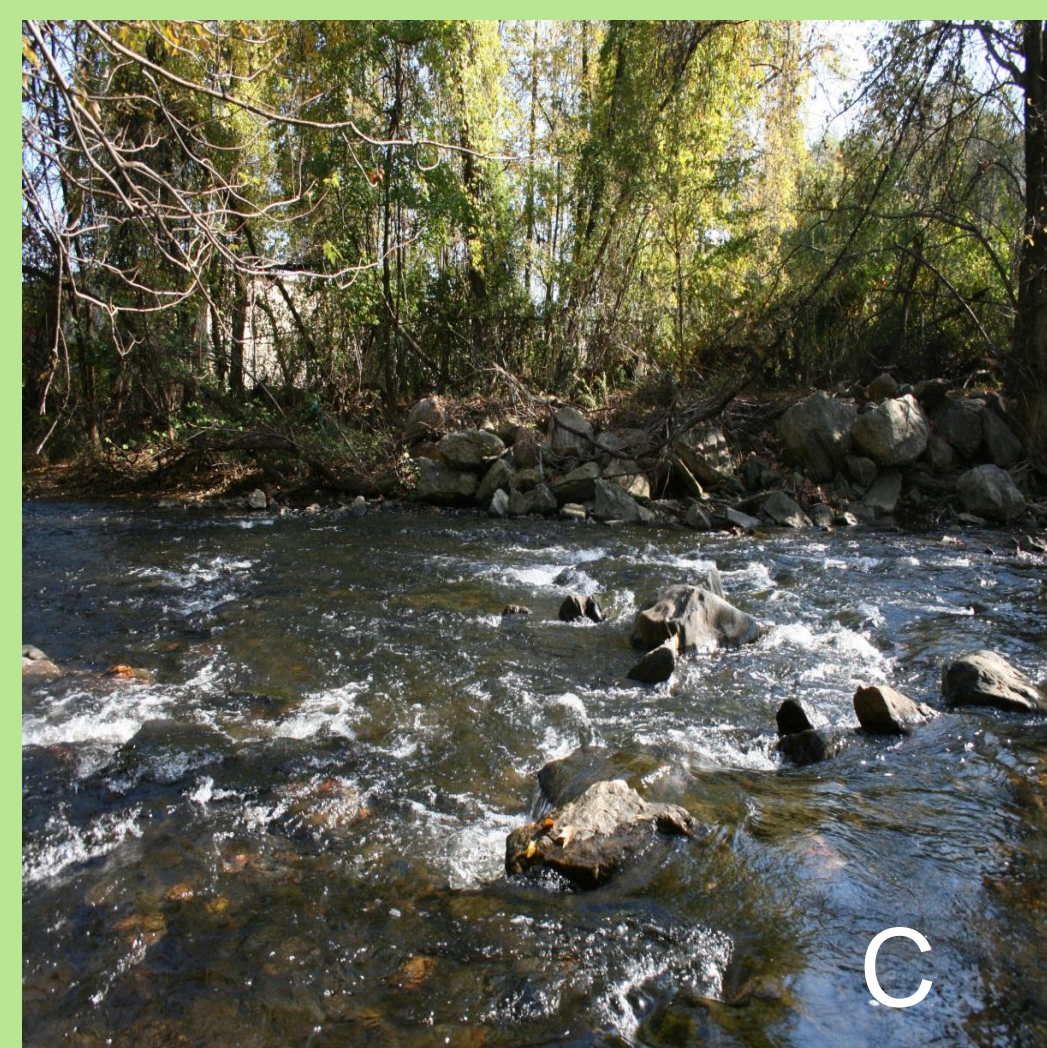
Figure 1.

- A. Water above dam was 4-5 ft. deep with soft, silty bottom.
- B. Dam of several rows of large boulders, rapid turbulent flow through breach on the left side facing downstream.
- C. Downstream of dam was boulder and cobble substrate with low embeddedness (bottoms of rocks exposed and provide habitat) with riffles, runs, and pools.

- All above-dam samples prior to dam removal were characterized by high percentages of taxa tolerant of stream impairment such as worms (oligochaetes), midge larvae (chironomids) and amphipods and a lack of intolerant organisms such as caddisflies, stoneflies and mayflies.
- The below dam scores were generally higher as indicative of a healthier habitat and stream community; no doubt the availability of rocky habitat in which to live was a factor.

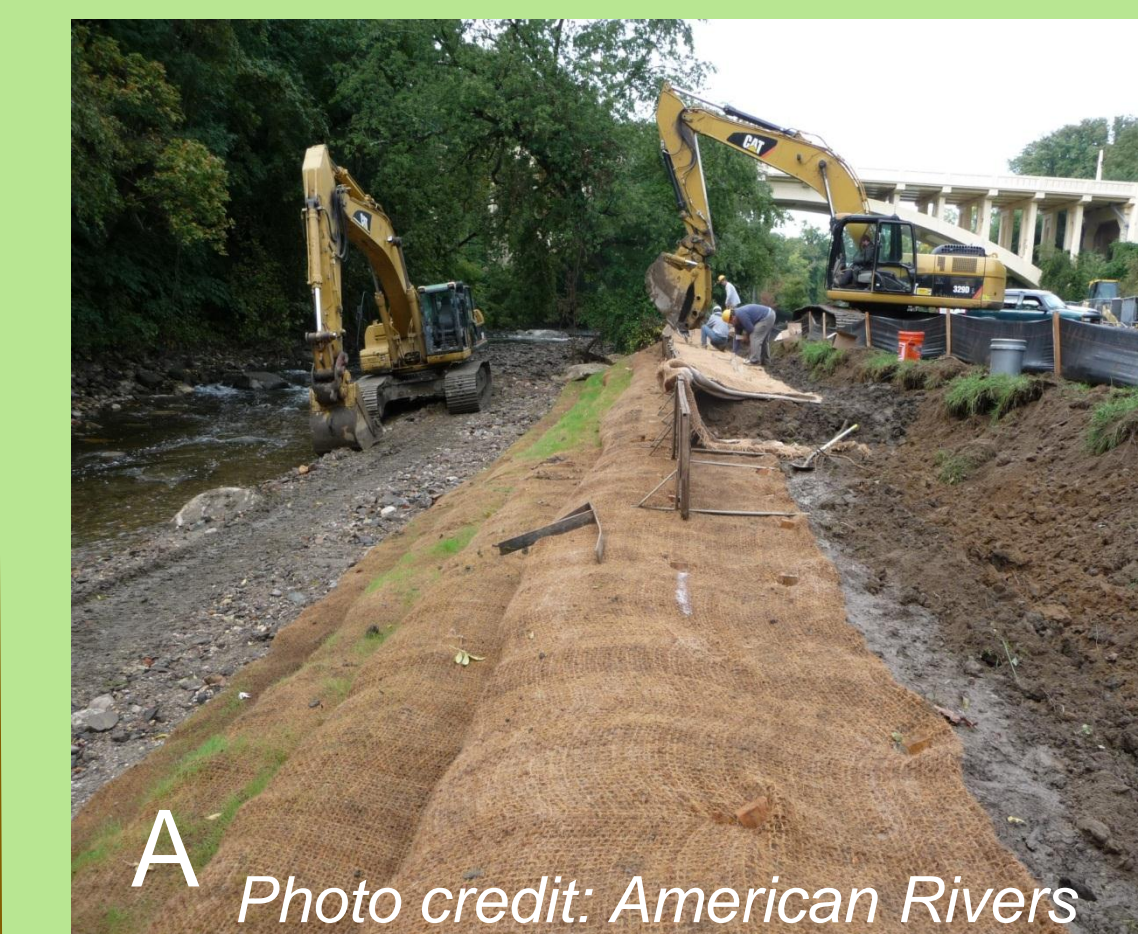
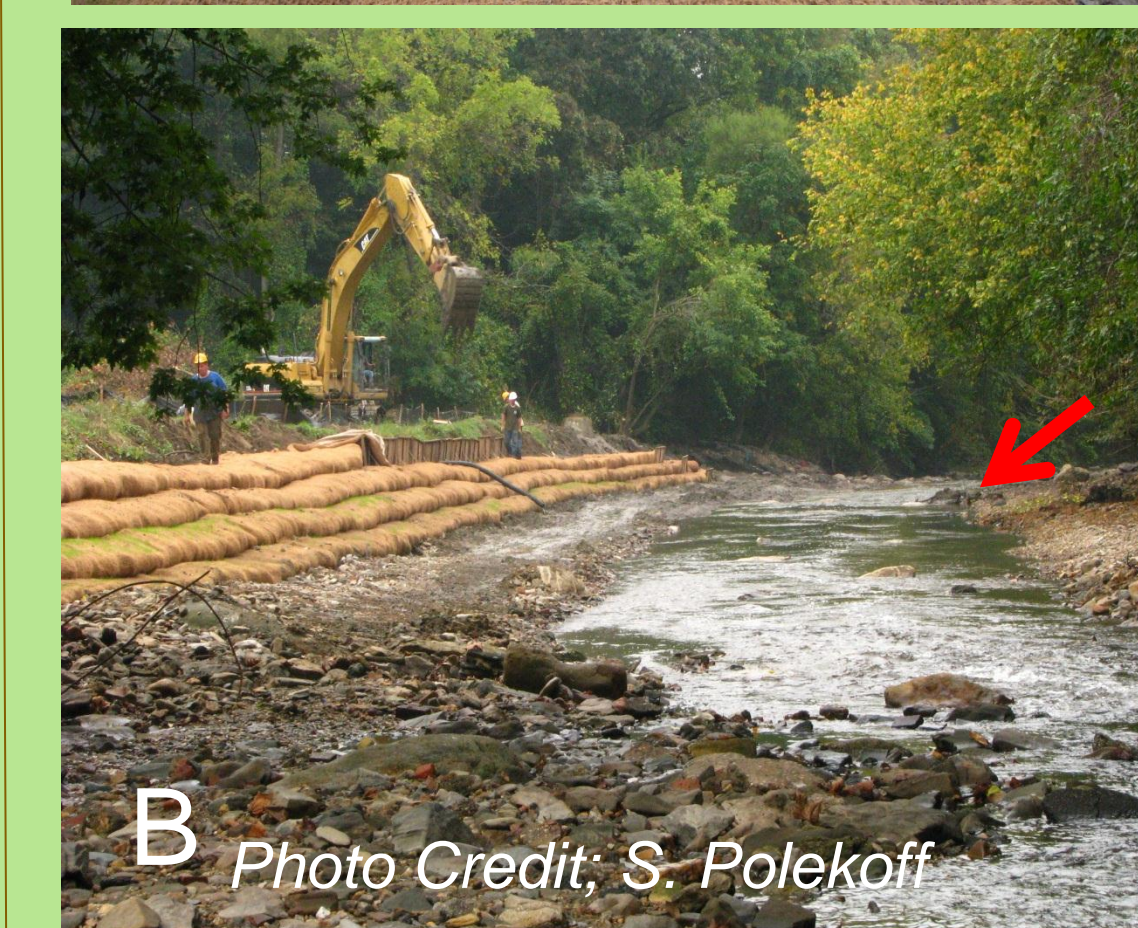
Figure 2.

- A. Rolls of coconut fiber used to create "soil lifts" filled with soil and loose rock to stabilize the bank, then seeded. Looking upstream from former dam site.
- B. Arrow indicates site of former dam. Rocks from dam supplement rocks re-exposed in stream bed after sediments flushed away --creating macroinvertebrate and small fish habitat.

- After dam removal the IBI score for the above dam site rose to 35.5. The number of EPT taxa and percent taxa intolerant of stream impairment increased, number of taxa was unchanged.
- Vermiform organisms, mollusks, and zooplankton vanished, while riffle beetles, mayflies, and caddisflies have appeared.
- We will analyze the remaining post-dam removal samples and continue to monitor this site over time for additional changes.
- Rapid recovery to a healthier stream seems to be occurring.
