EVALUATING THE RESTORATION OF THE FAIRMOUNT DAM FISHWAY WITH APPLICATION TO ANADROMOUS FISH RESTORATION IN THE SCHUYLKILL RIVER, PENNSYLVANIA

Office of Watersheds, Philadelphia Water Department

Bureau Of Laboratory Services, Philadelphia Water Department

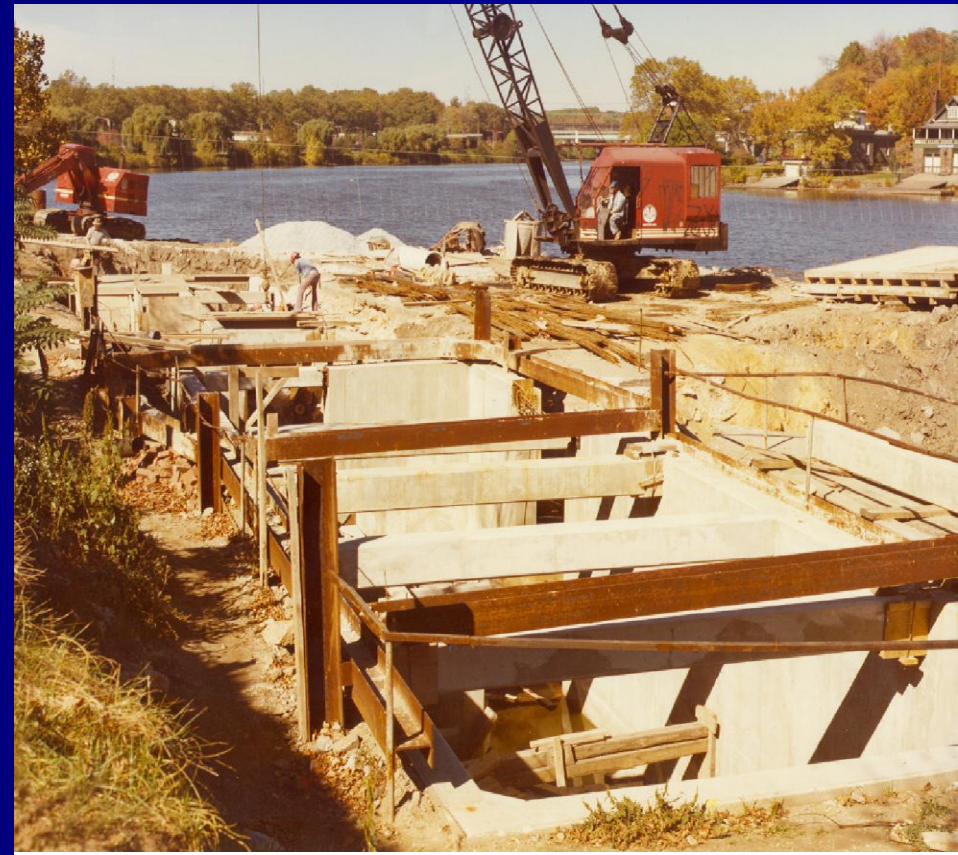
Construction Of Fairmount Fish Ladder, 1978

- Completed In 1979
- Vertical slot fish passage facility
- Heavily used by resident fish species
- By 1984, restoration and monitoring activities of migratory species were diverted to other drainages.

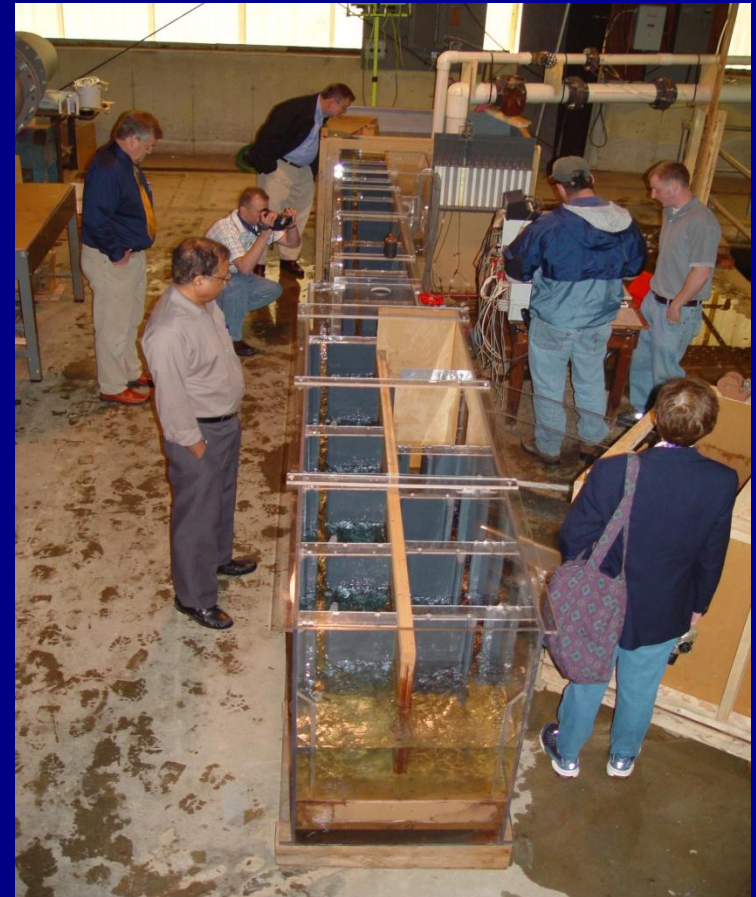
9:1 scale of the Fairmount Fish Ladder
(Alden Laboratories, Worcester, MA)

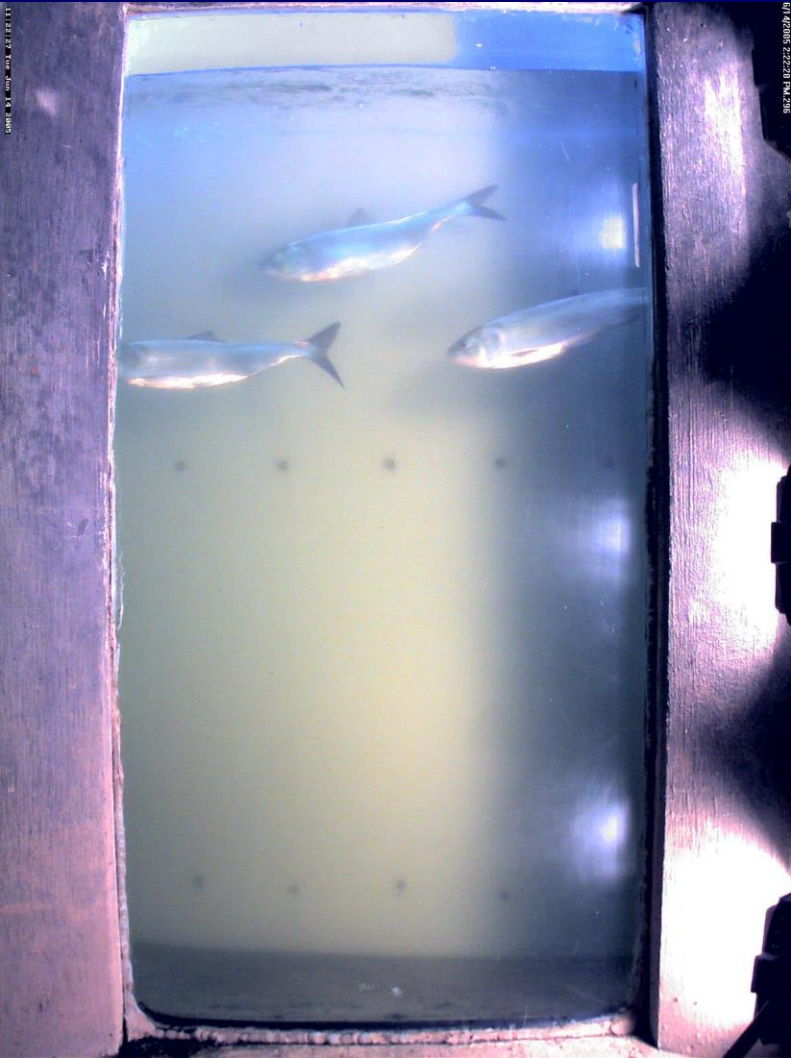
Video Transmission

Video Monitoring System:

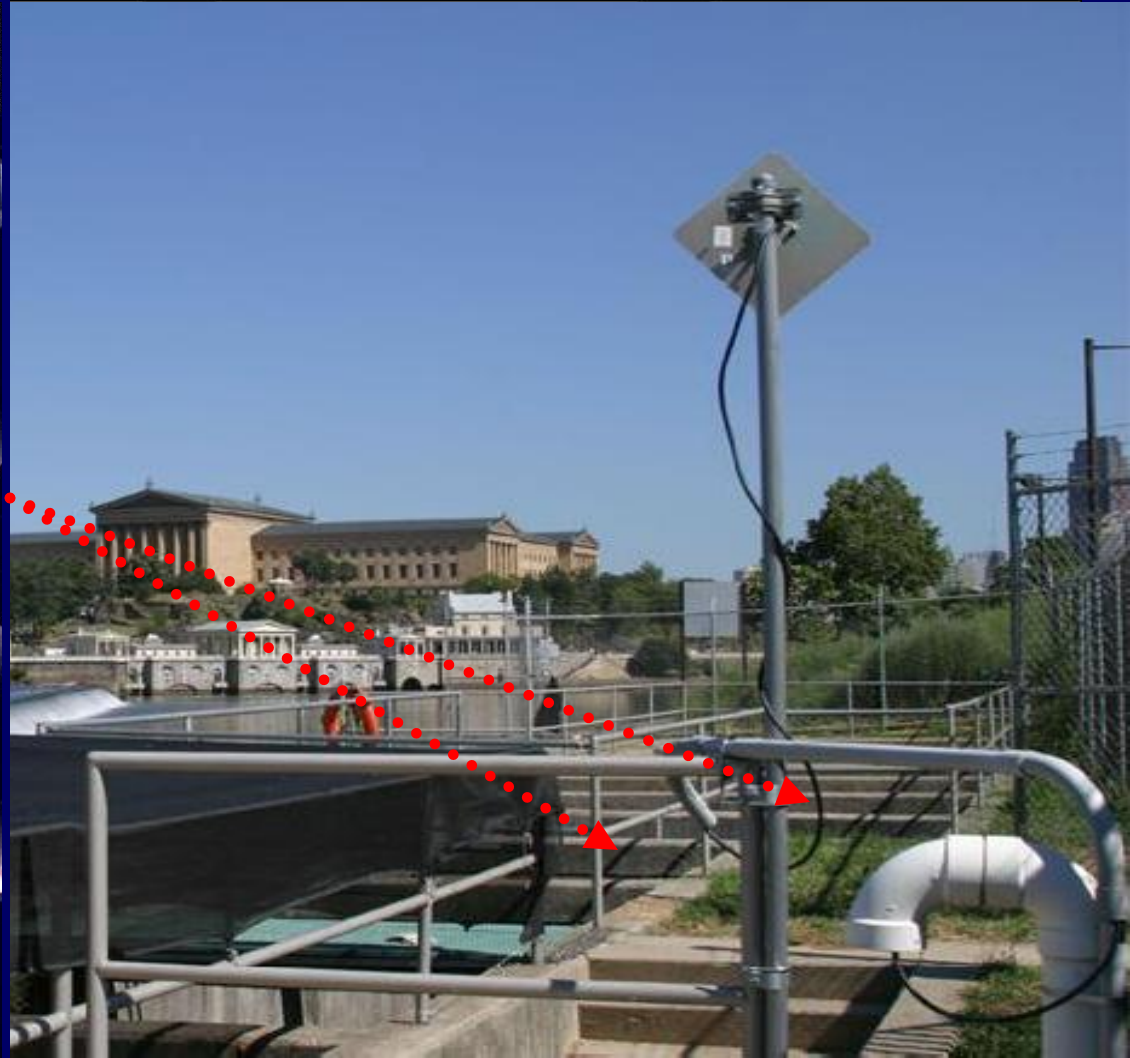
Wireless Transmitter

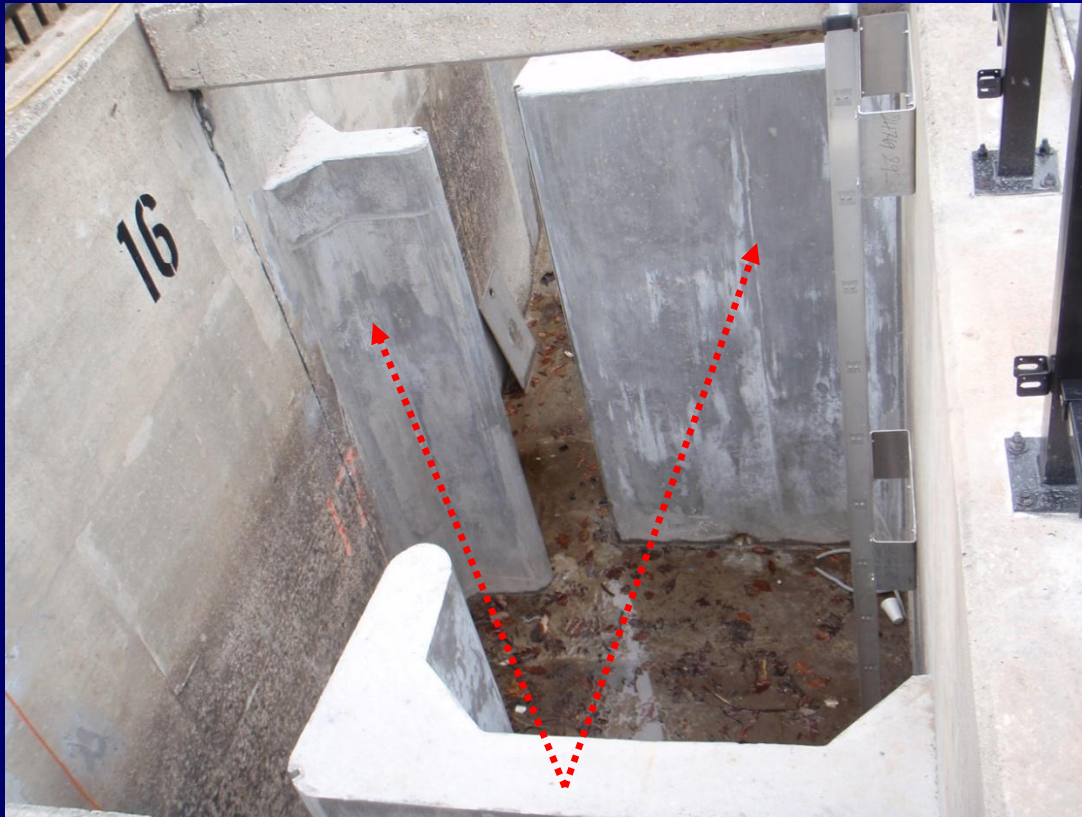
New chambers

- Major structural modifications

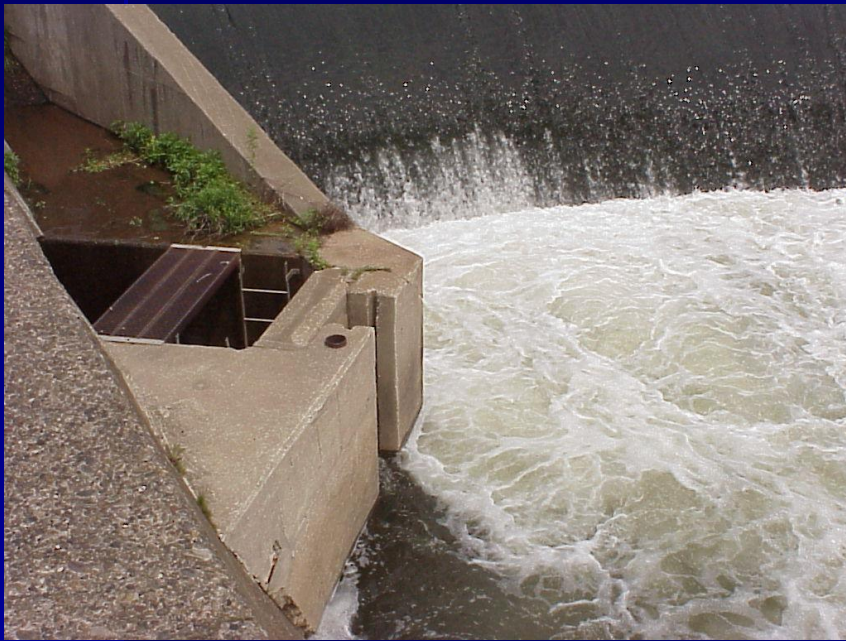
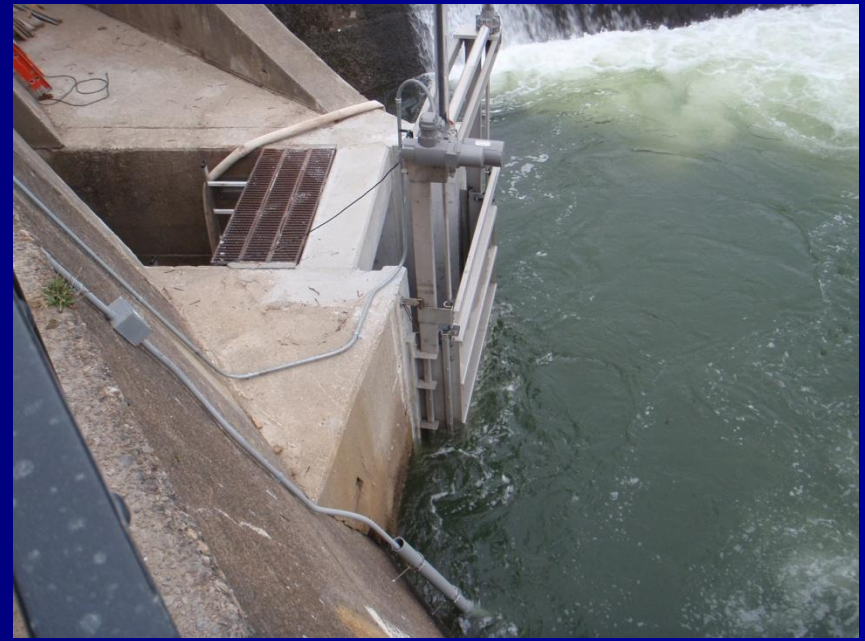
Before

After

New entrance channel with automated gate system

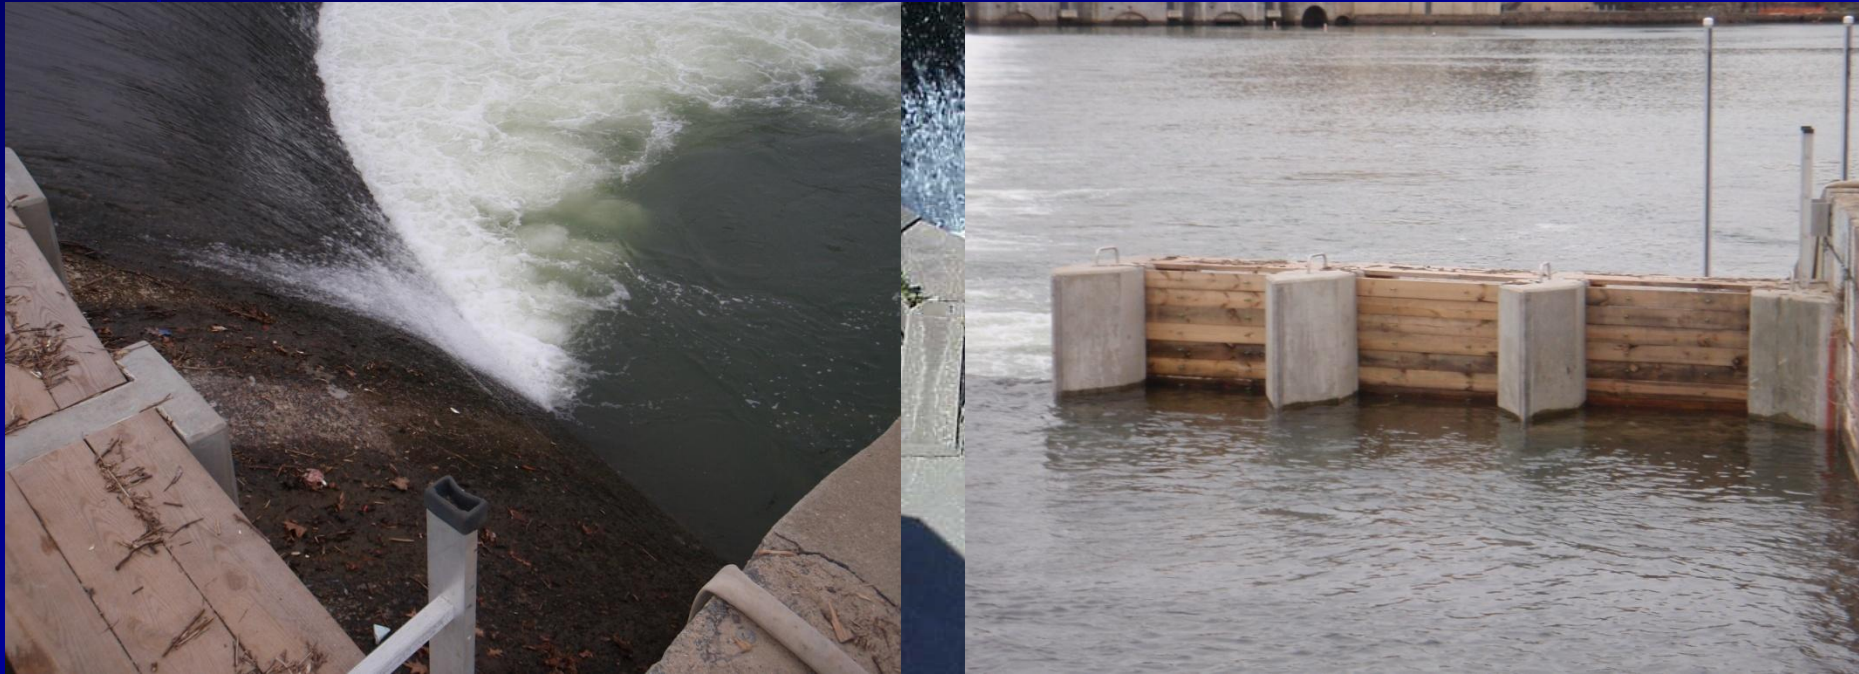
After
Before

New "Non-Overflow" section of fish ladder

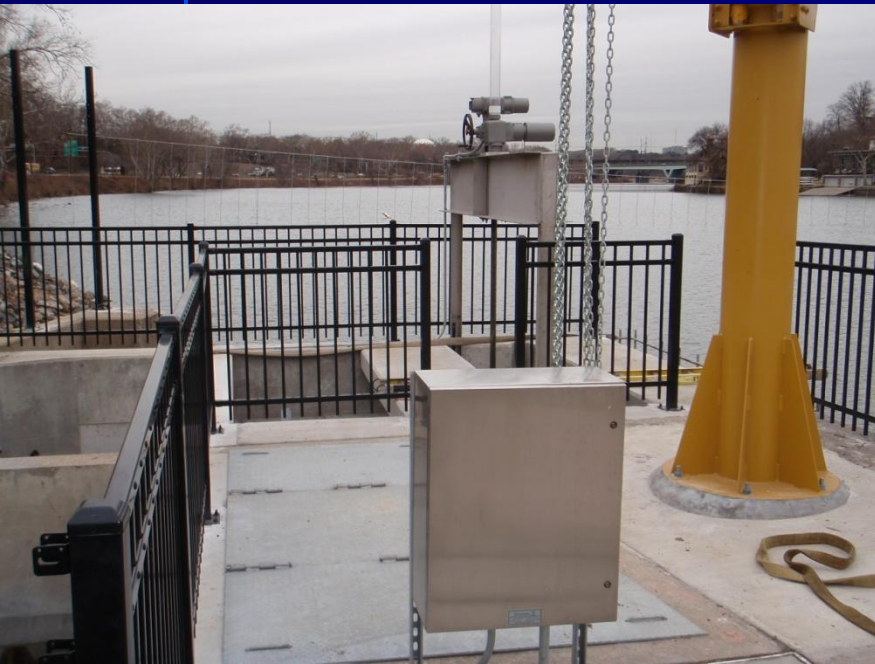
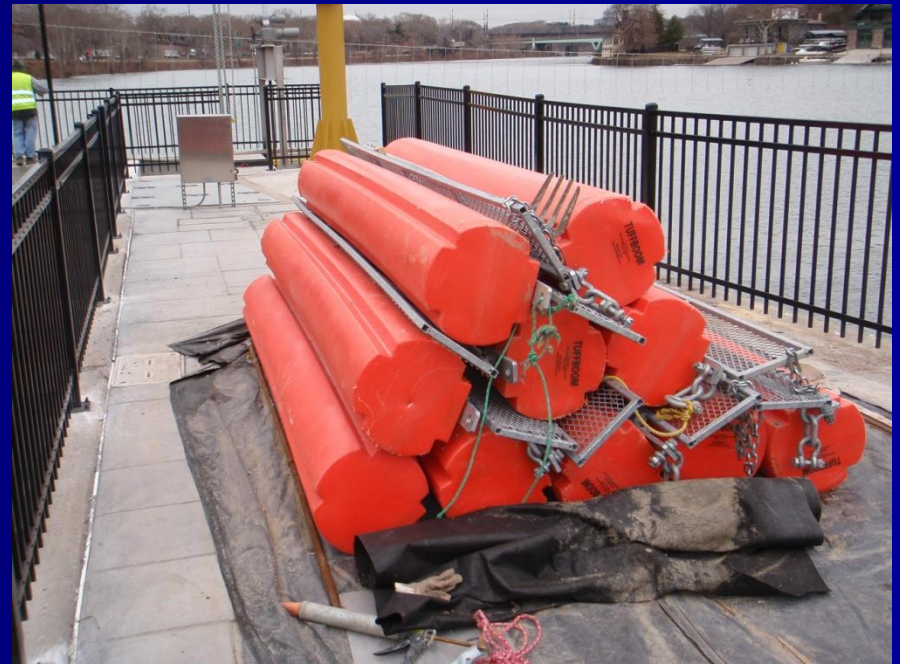
After
Before

New exit channel with attraction flow system and debris deflection system

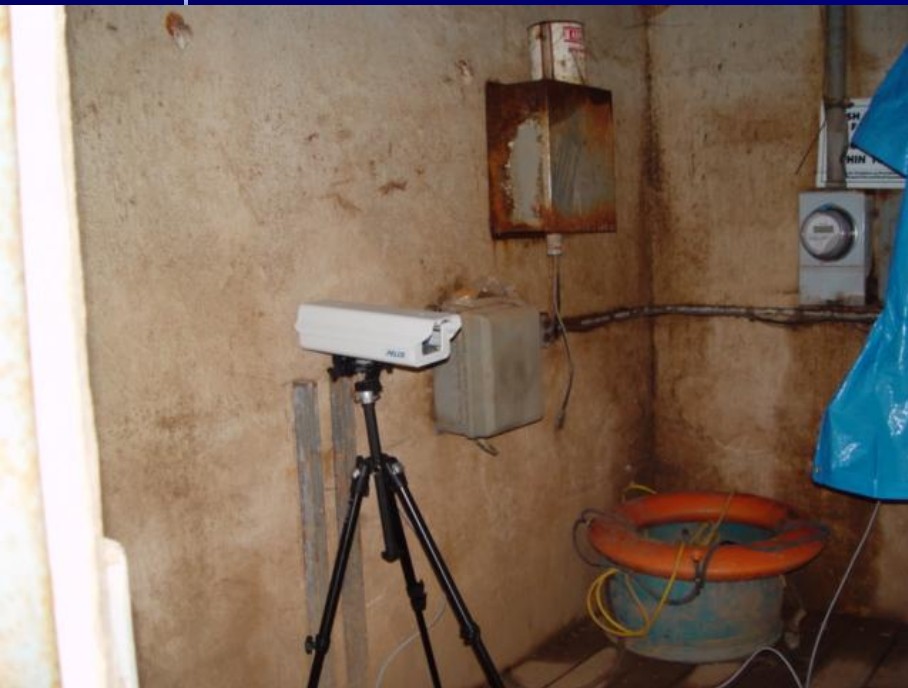
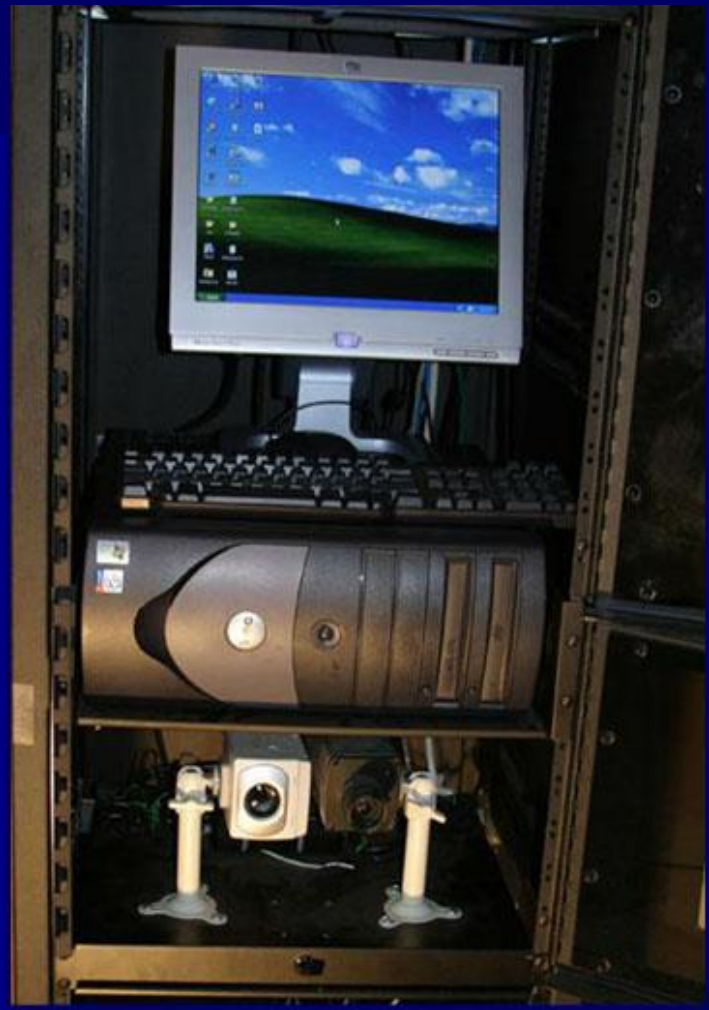
2004

2009

Updated Scientific Monitoring System

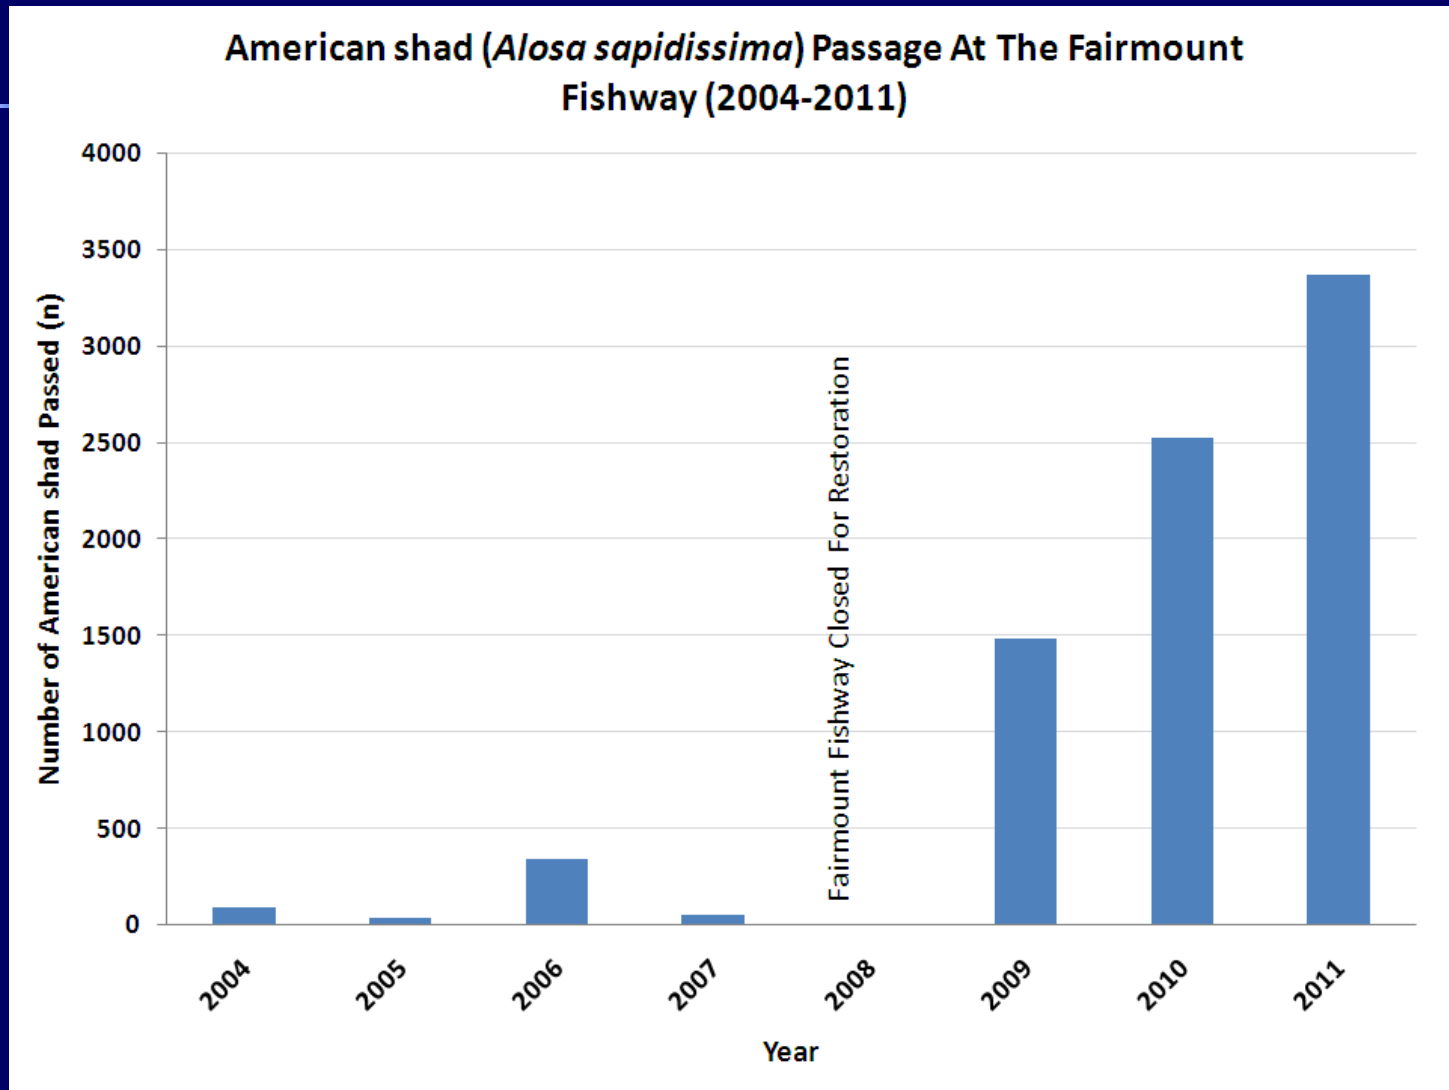
Pre-Restoration vs. Post-Restoration

Video Monitoring Results (2004 – 2011)

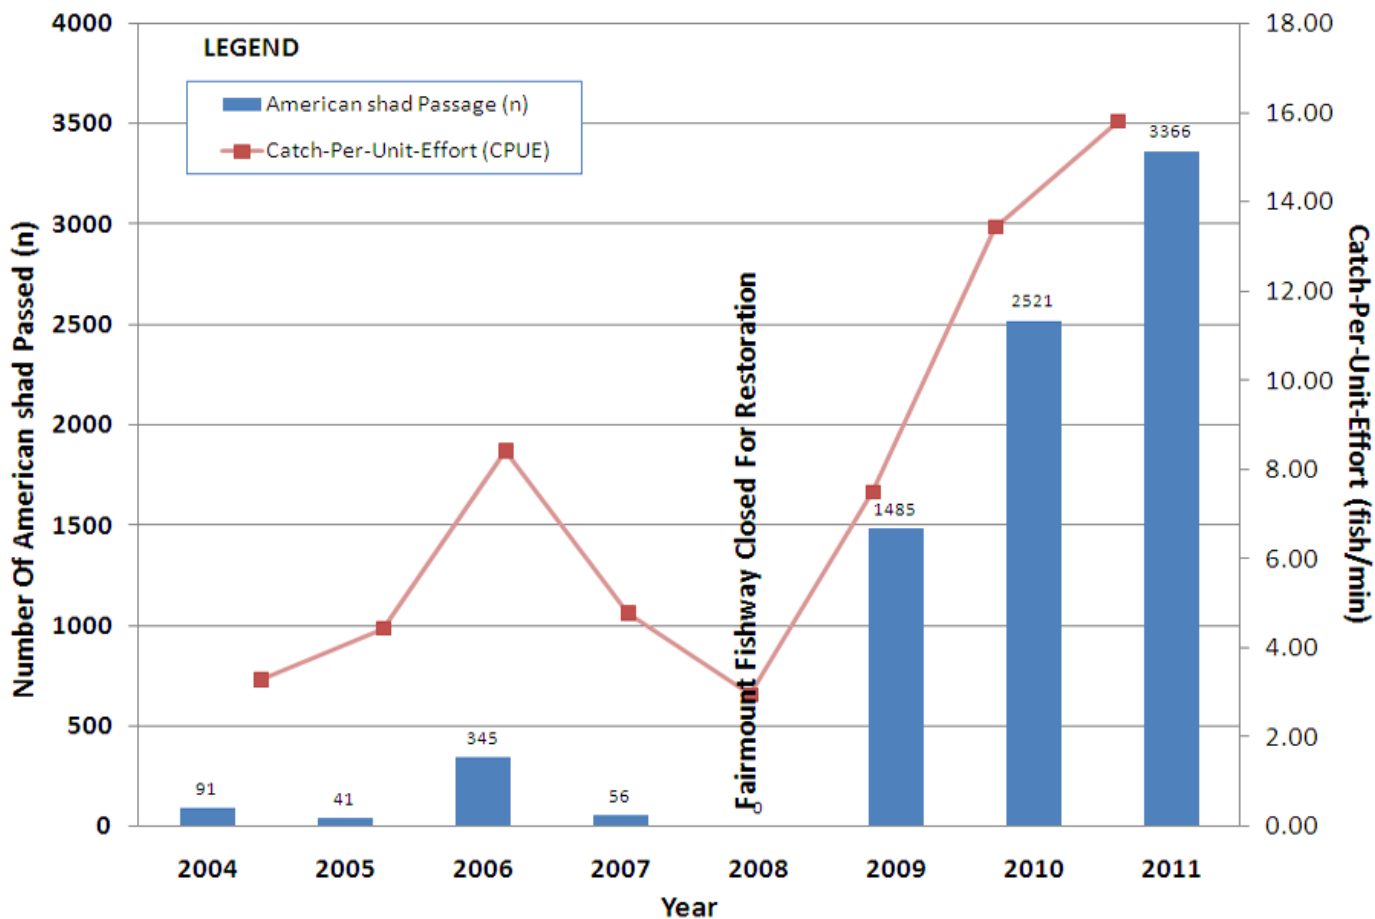
Catch-Per-Unit-Effort (CPUE) vs. American Shad Passed

Schuylkill River American Shad Passage & Relative Abundance At Fairmount Dam (2004-2011)

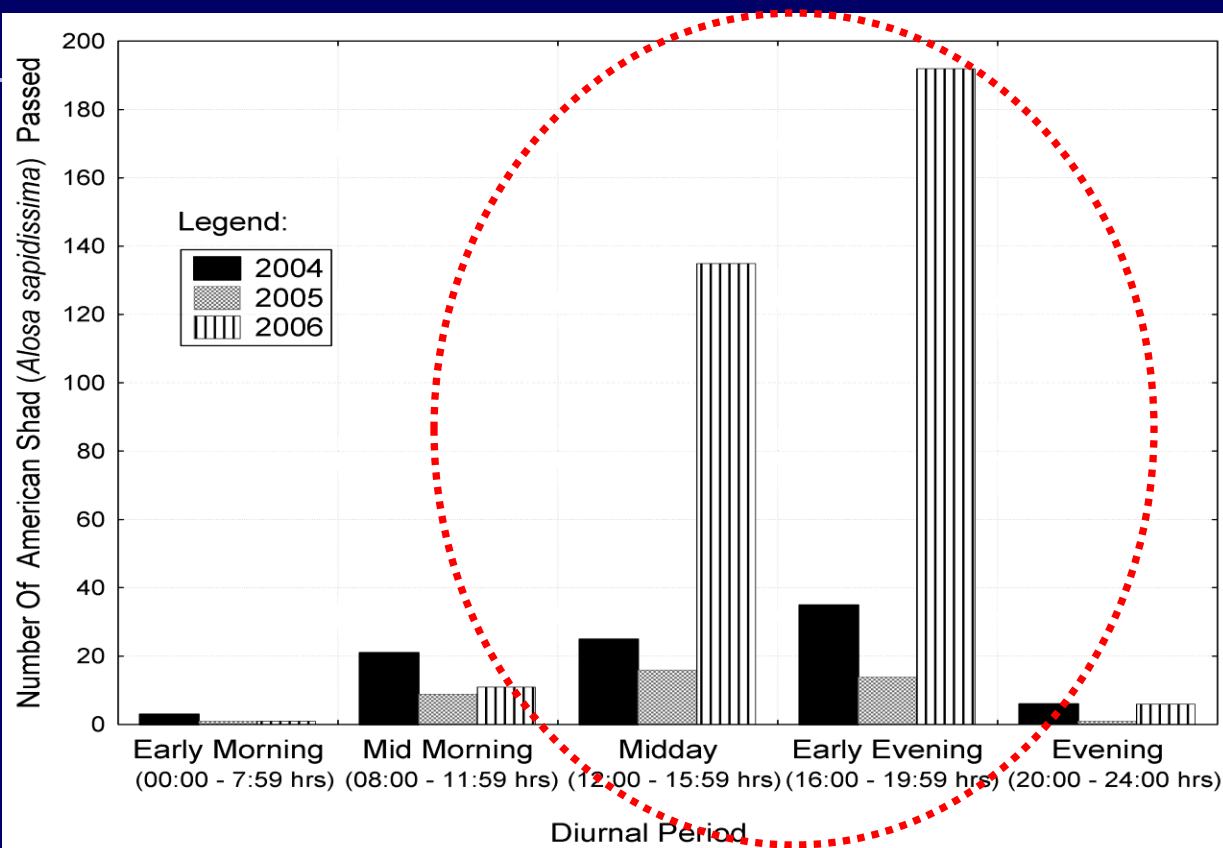
Preliminary Findings: *Pre-Restoration (2004-2006)*

Temporal Variability In Passage Of American Shad-
Environmental Or Biological Trigger?

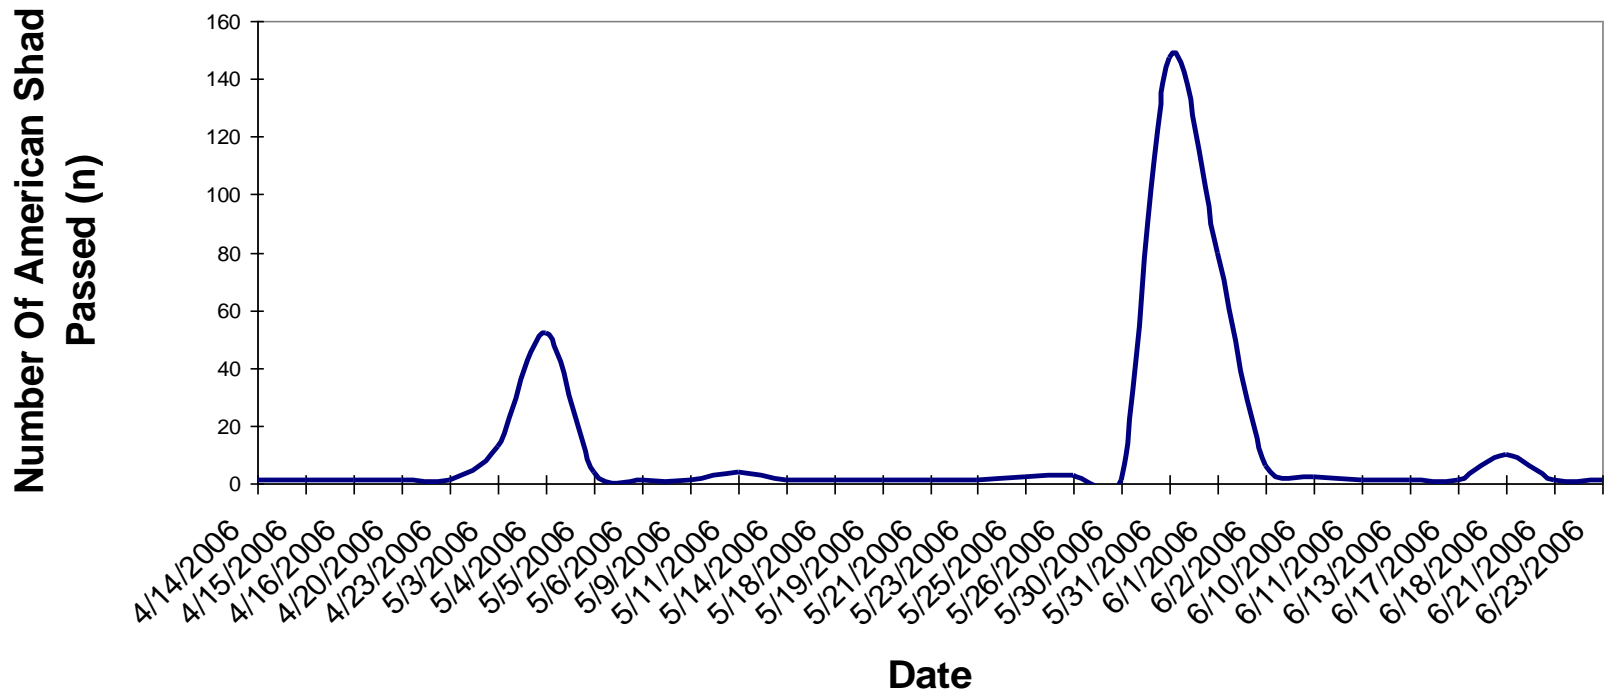
Effects of Seasonality

2006 American Shad Passage

Temporal Variability Of American Shad Passage-
Environmental Or Biological Response?
