# Shaken, Not Deterred

AFTER MORE THAN A DECADE, THE COMPLEX RESTORATION OF EARTHQUAKE DAMAGED LIMESTONE ON THE WASHINGTON NATIONAL CATHEDRAL NEARS ITS FINAL PHASES.

#### Washington National Cathedral Earthquake Restoration – Washington, DC

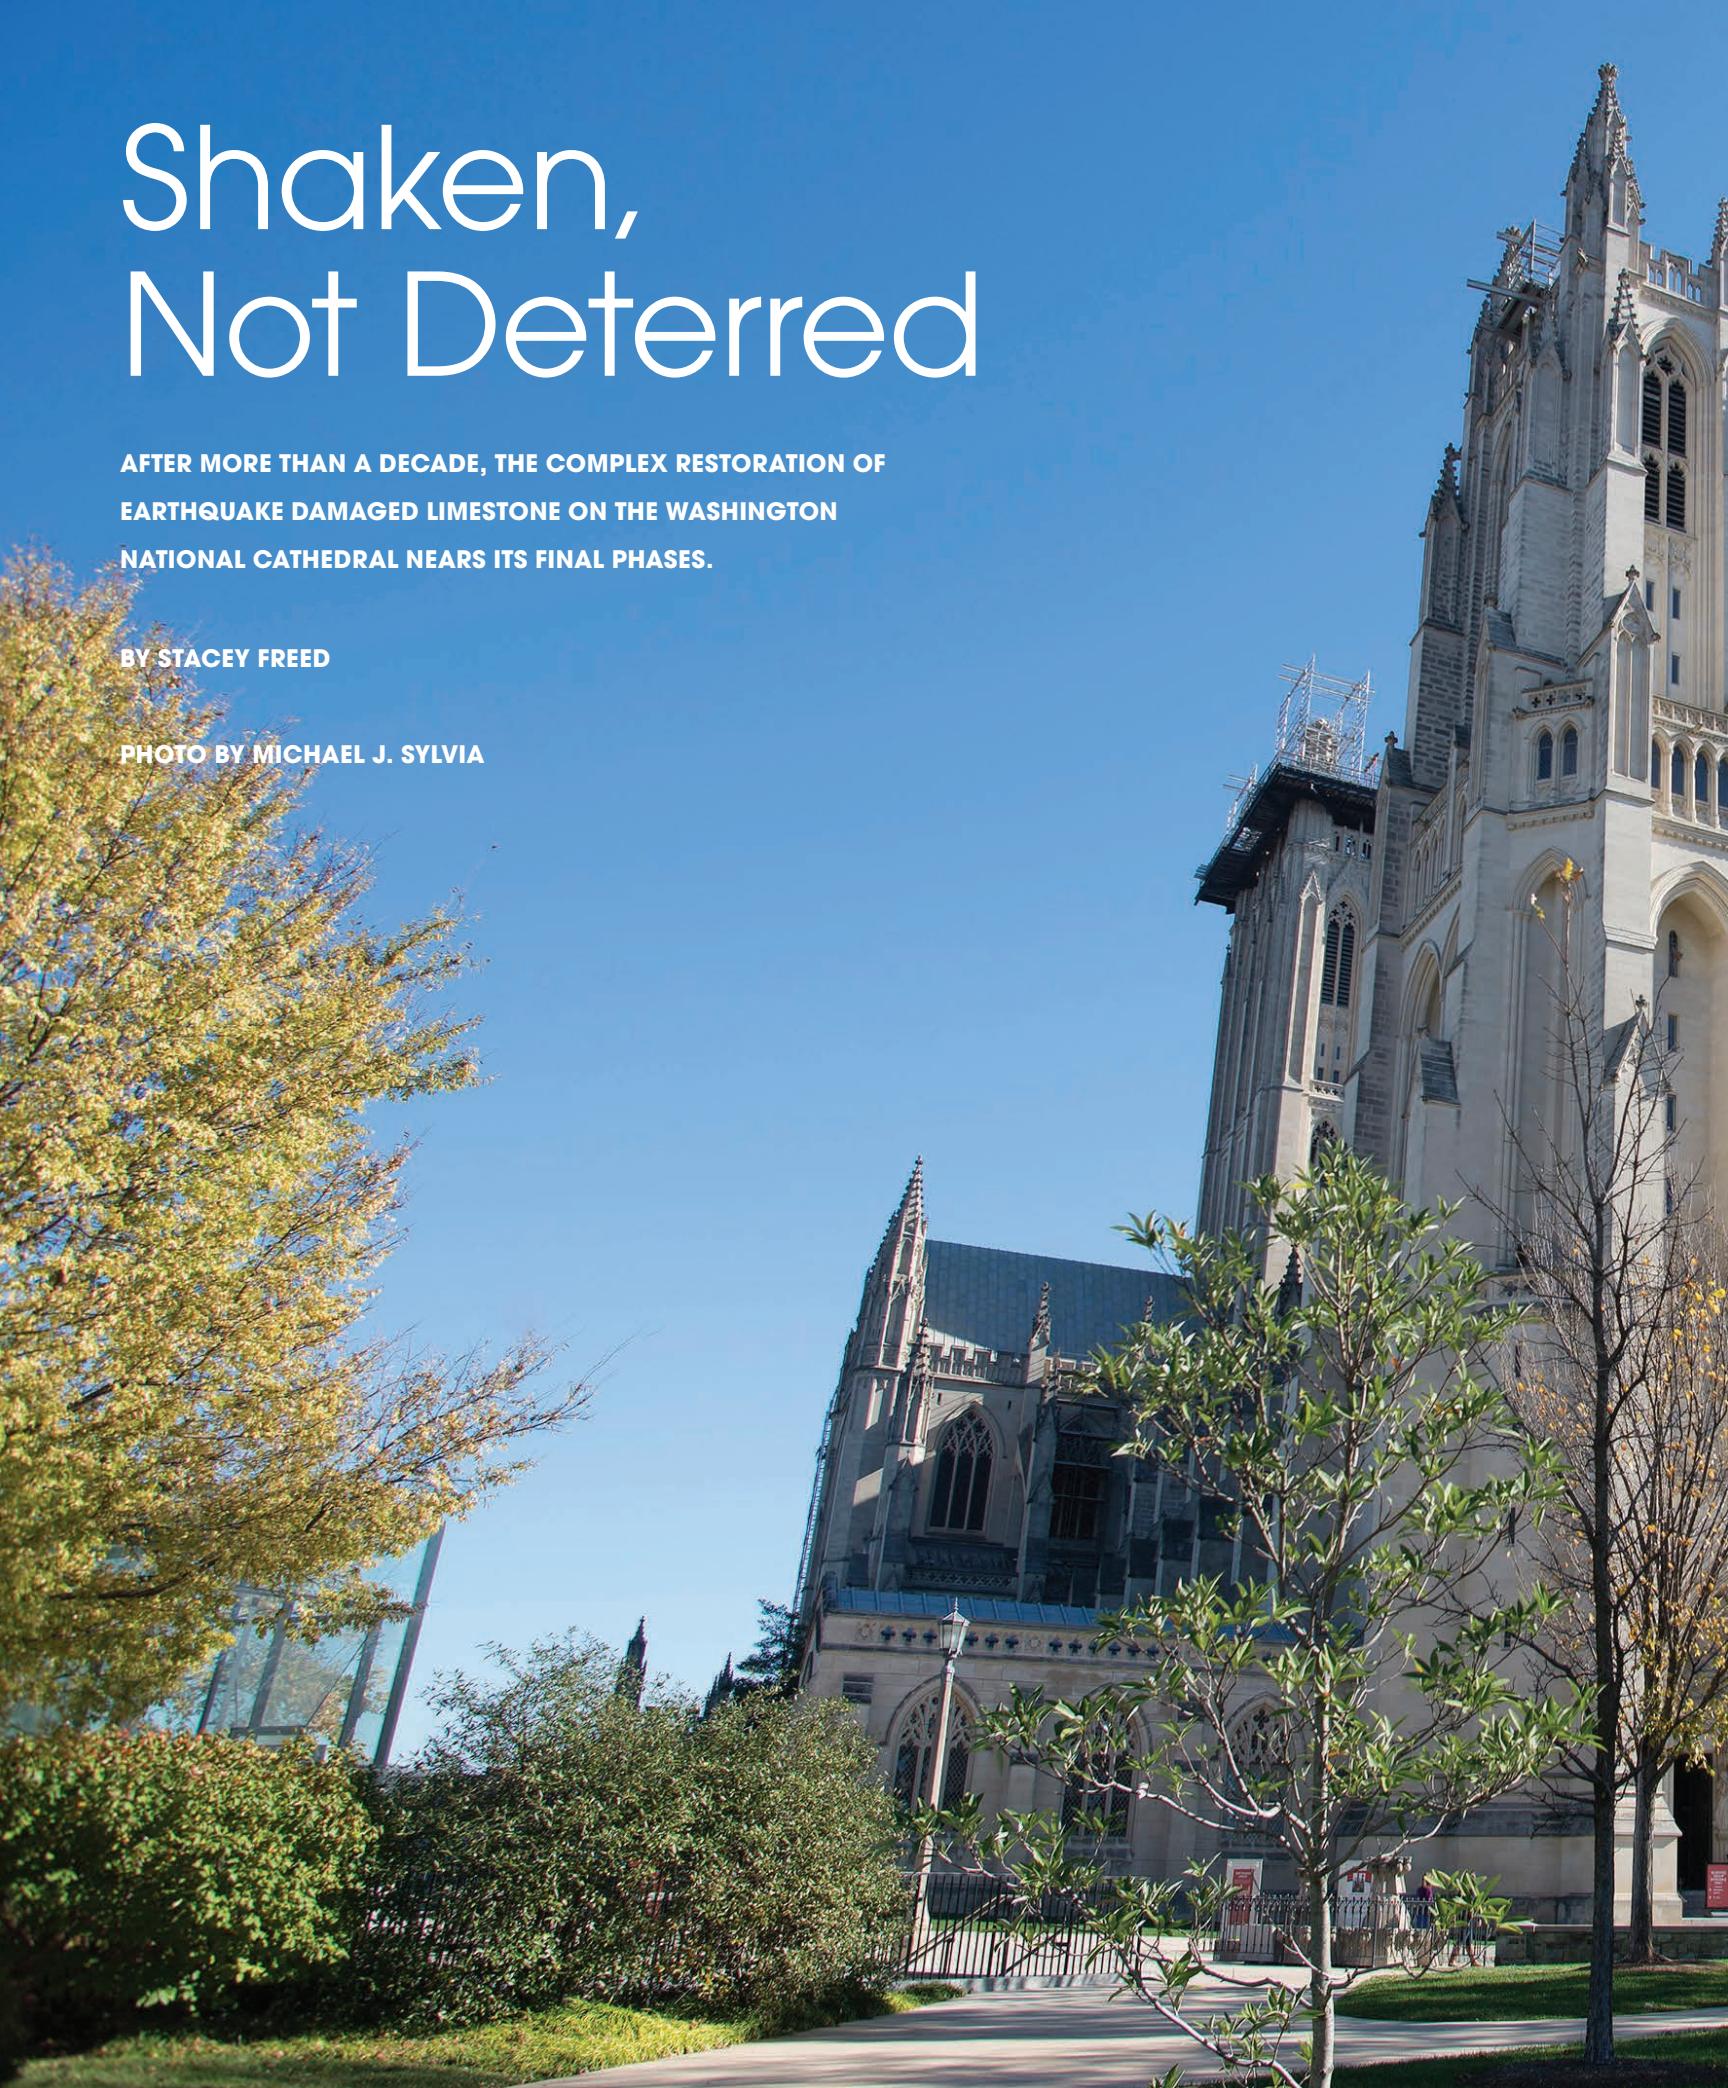
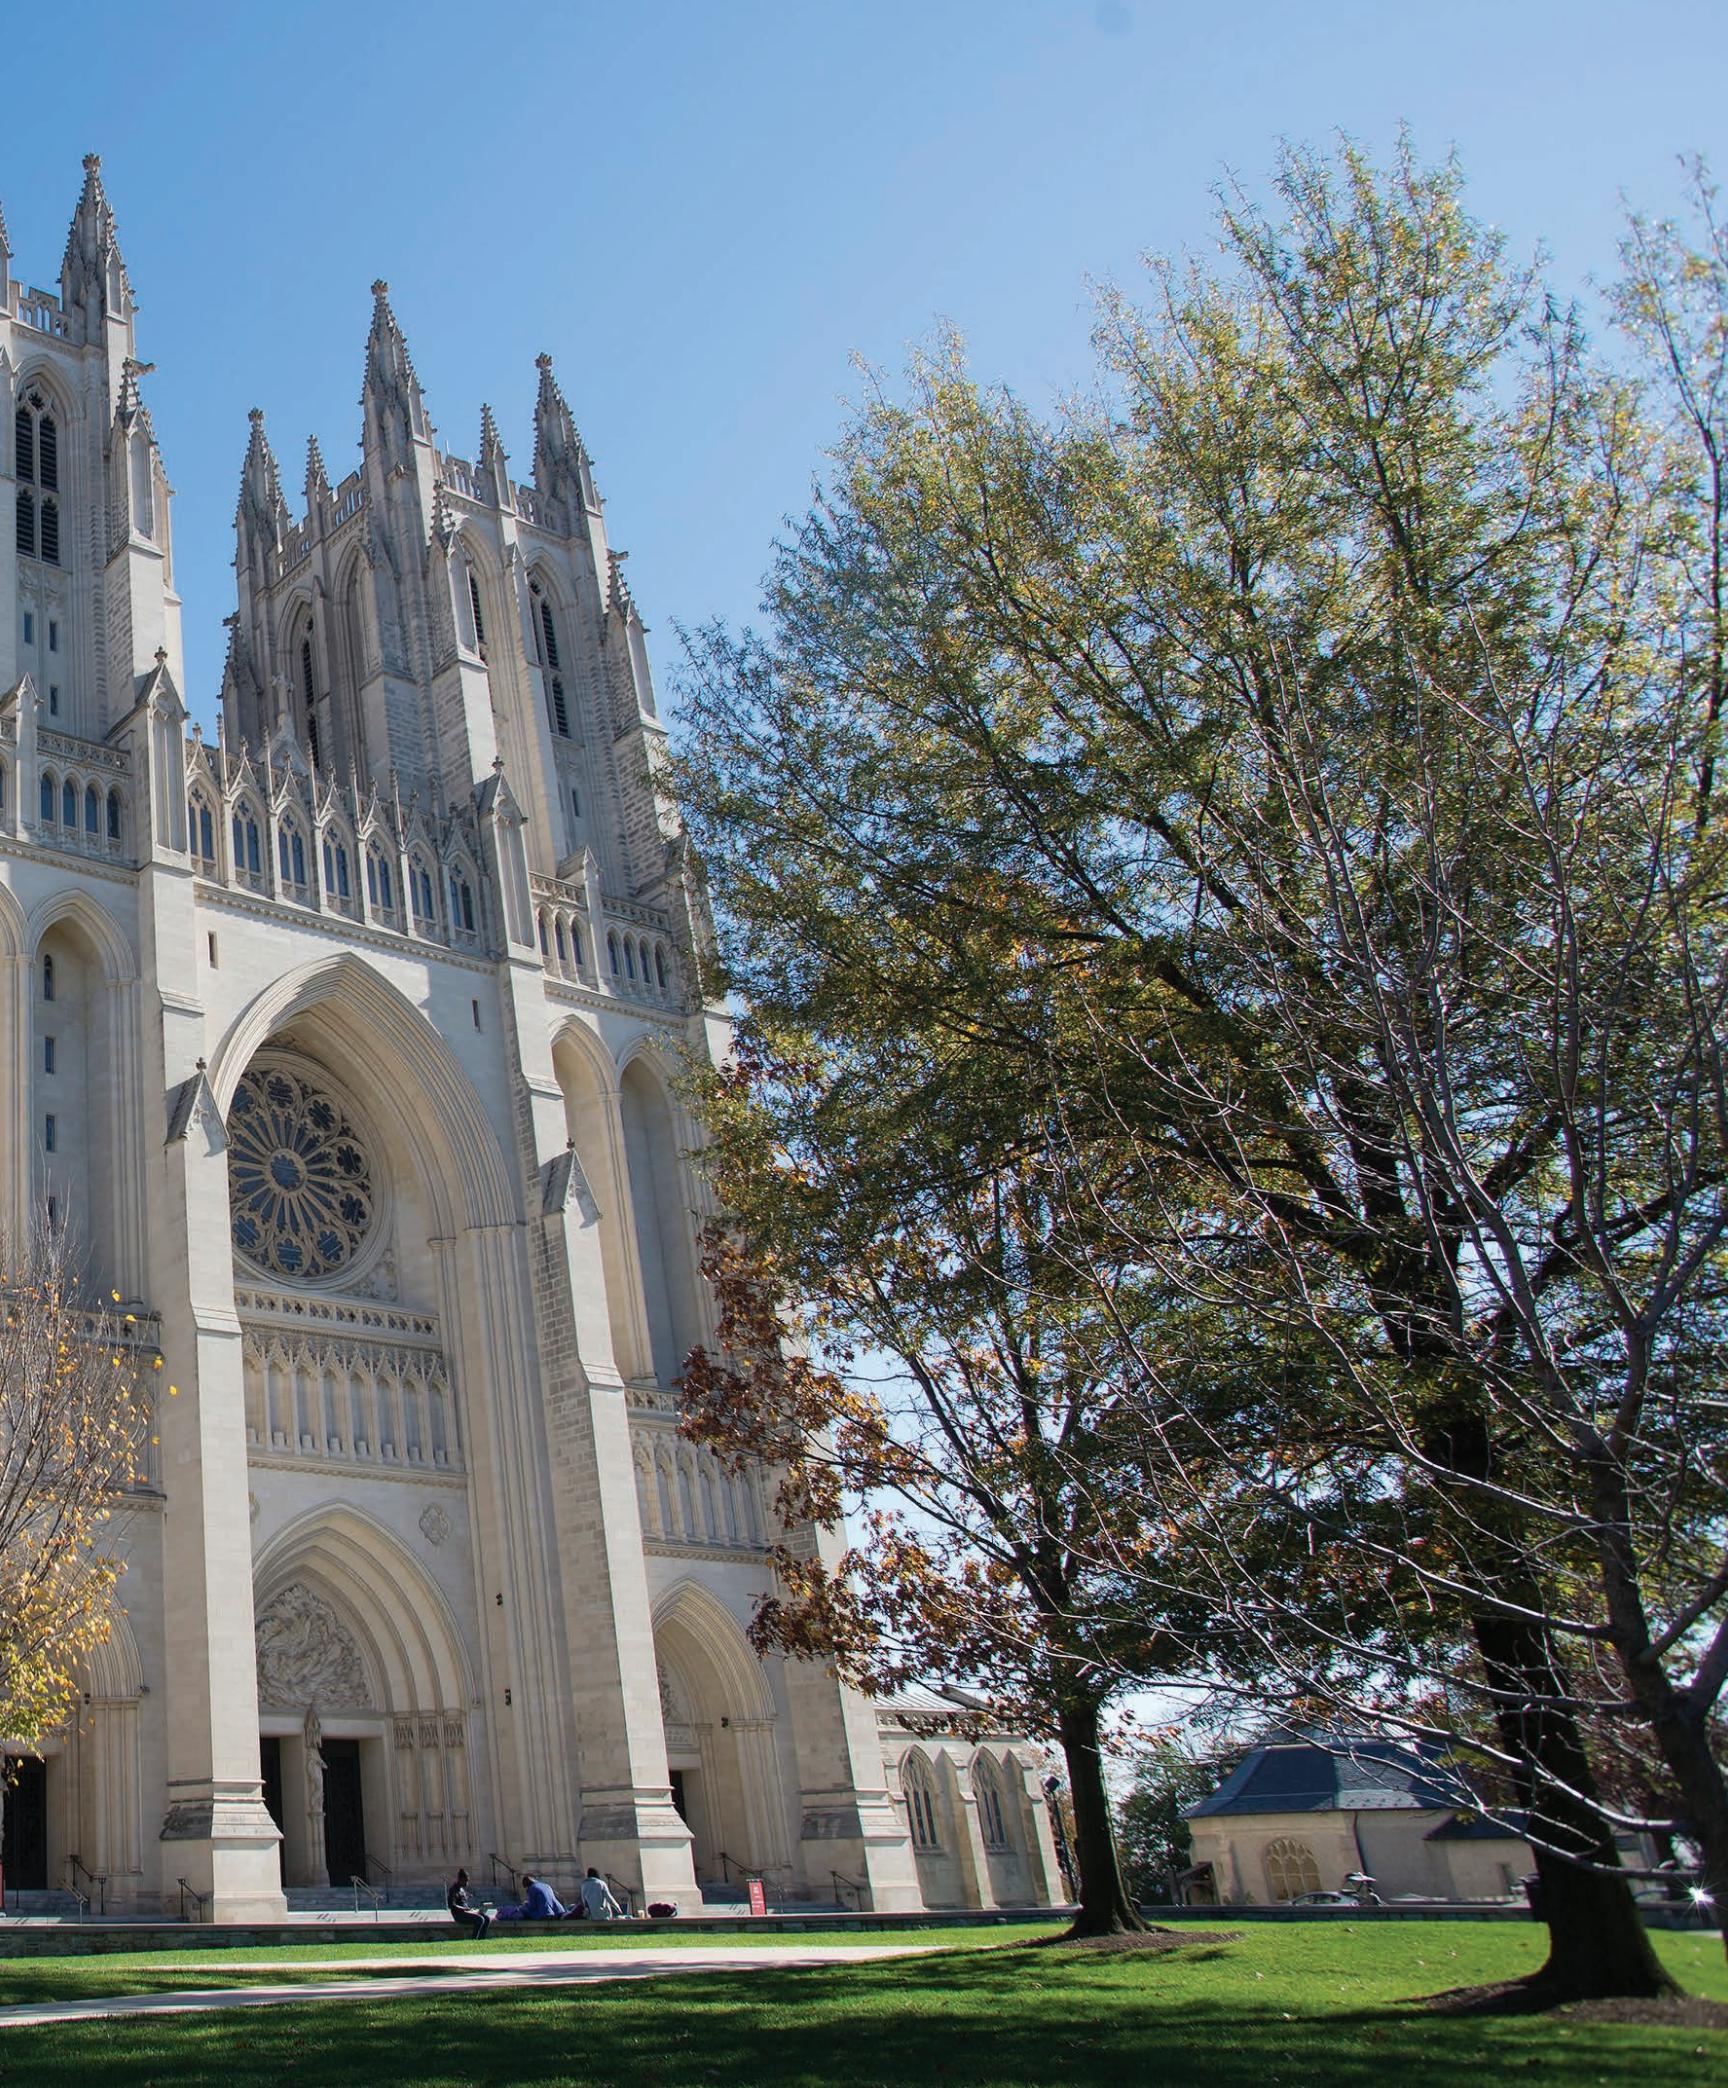
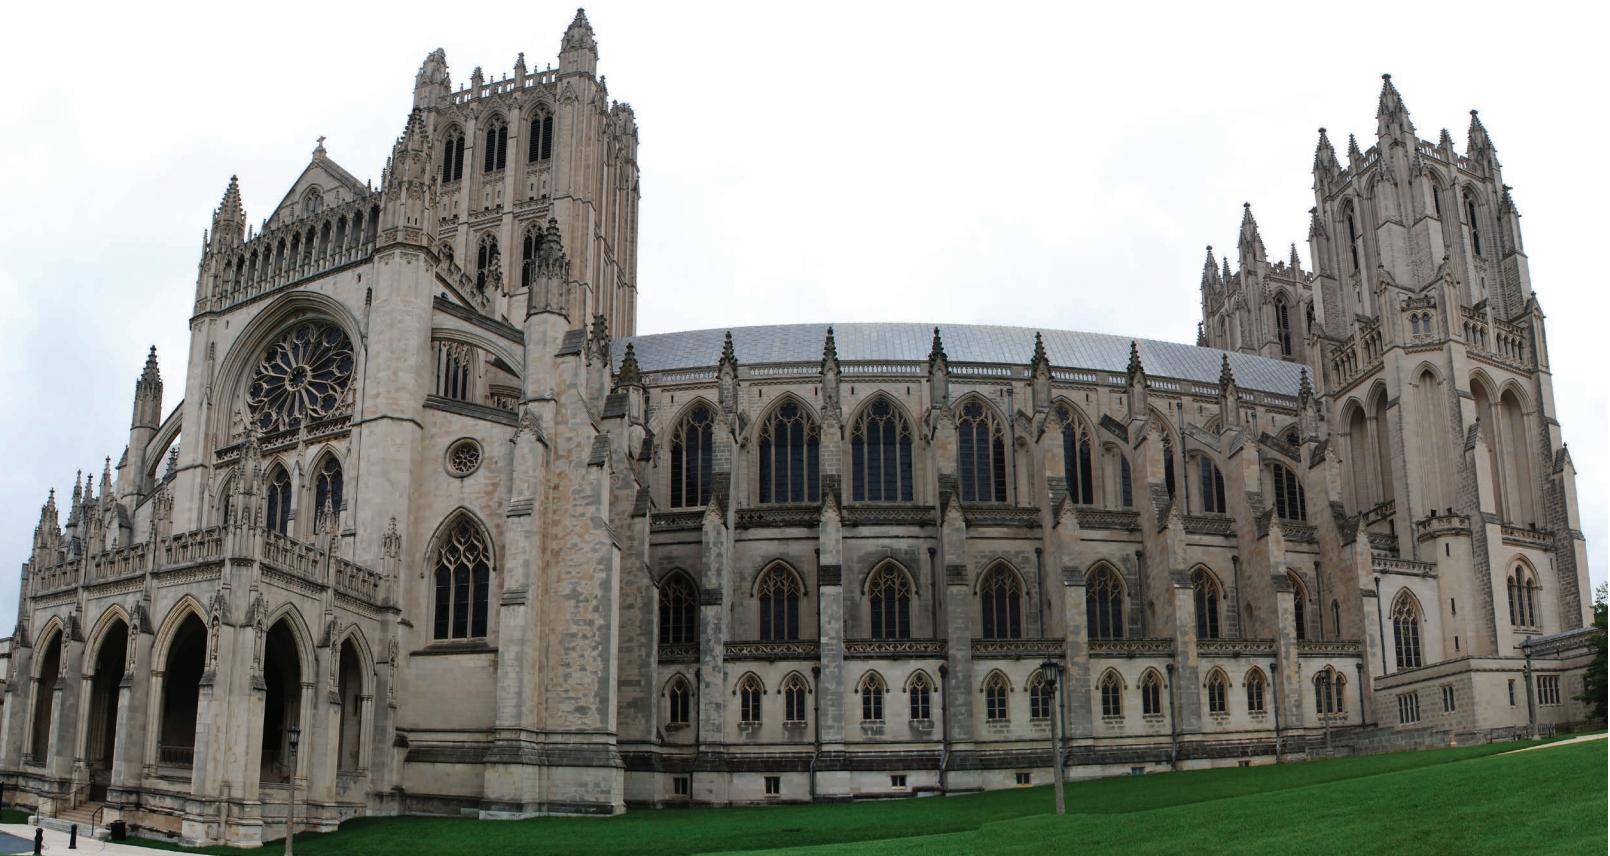
The 117-year-old Cathedral Church of Saint Peter and Saint Paul, the Washington National Cathedral, has been nearly restored to its original grandeur after being damaged by a 5.8 magnitude earthquake in 2011. The east end, the oldest part of the church, will celebrate its 118th anniversary on September 29, 2025. Photo courtesy of Wiss, Janney, Elstner Associates

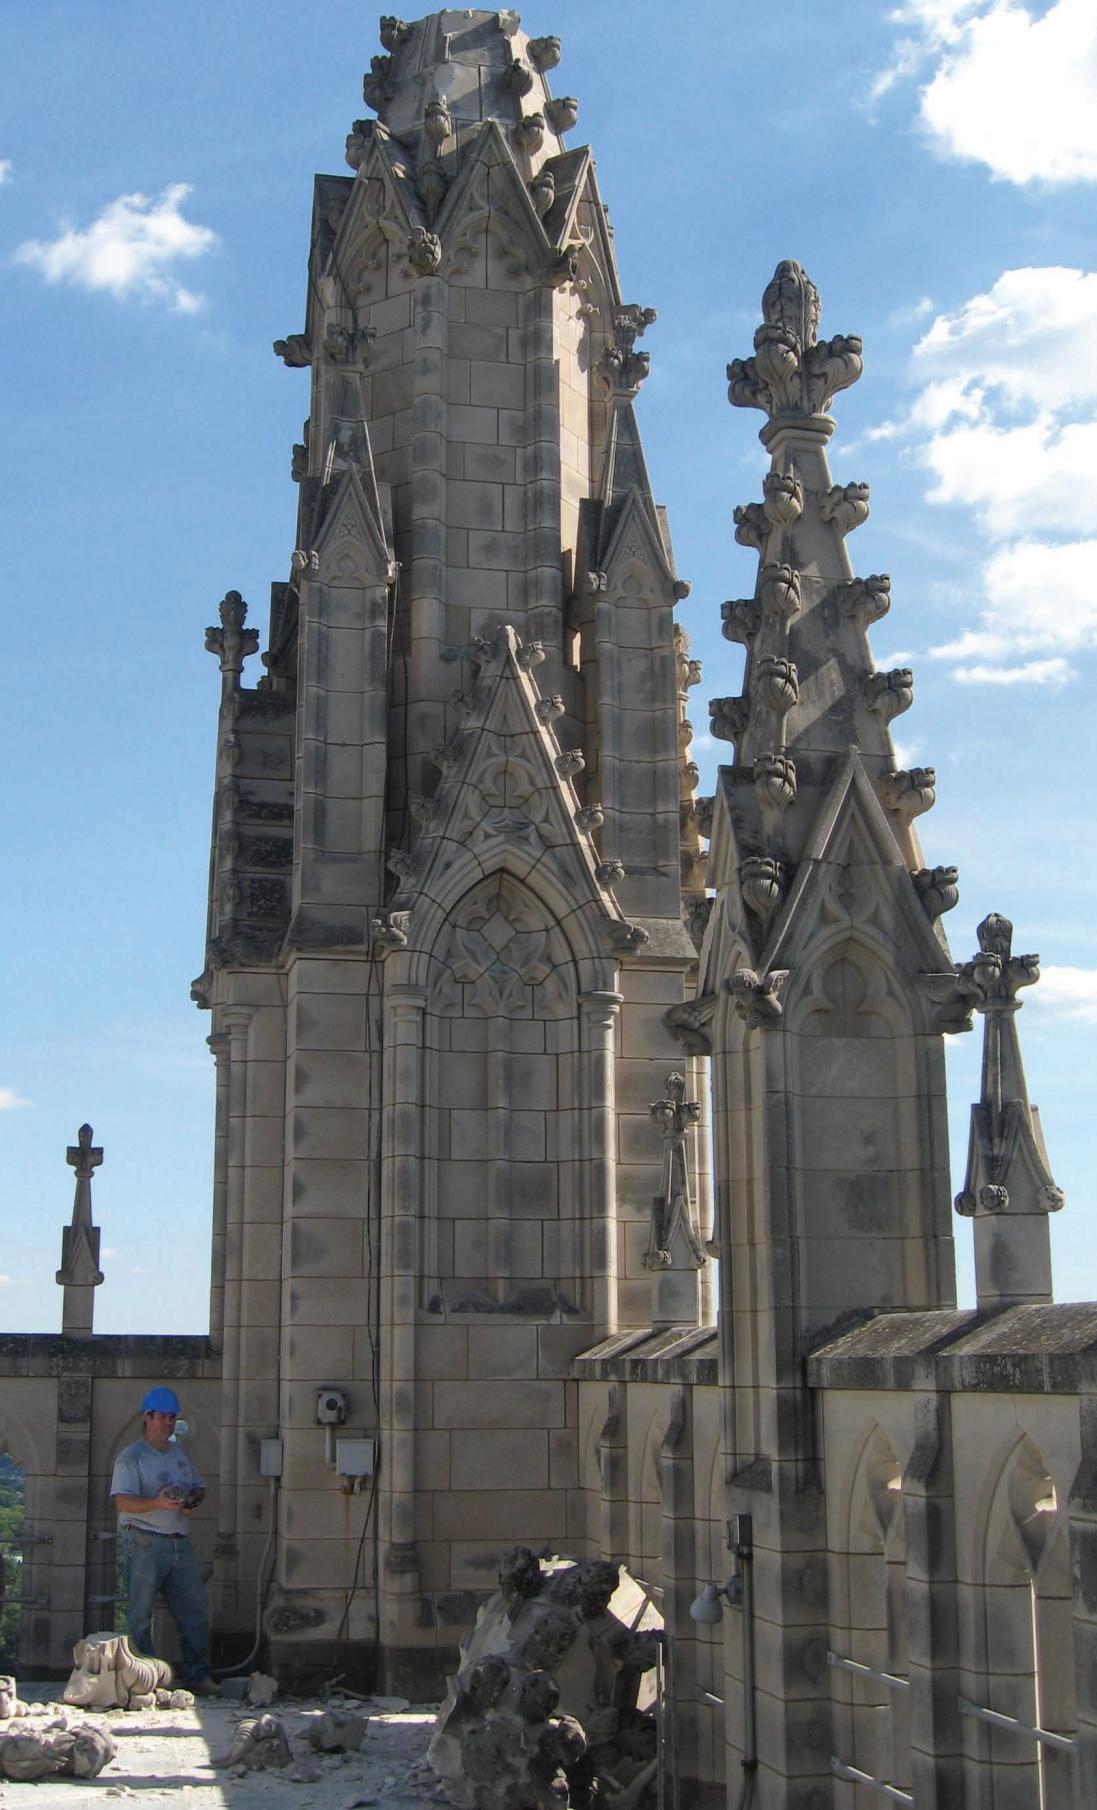
More than 75% of the cathedral's pinnacles were damaged, including all four grand pinnacles. Image courtesy of Washington National Cathedral

Many chunks of stone had fallen to the ground. More than 75% of the cathedral's pinnacles were damaged, including all four grand pinnacles. One of them on the central tower was missing its top. Flying buttresses on the east end, the oldest section of the church, had shifted and cracked. The finials from the southeast and northeast pinnacles had fallen onto

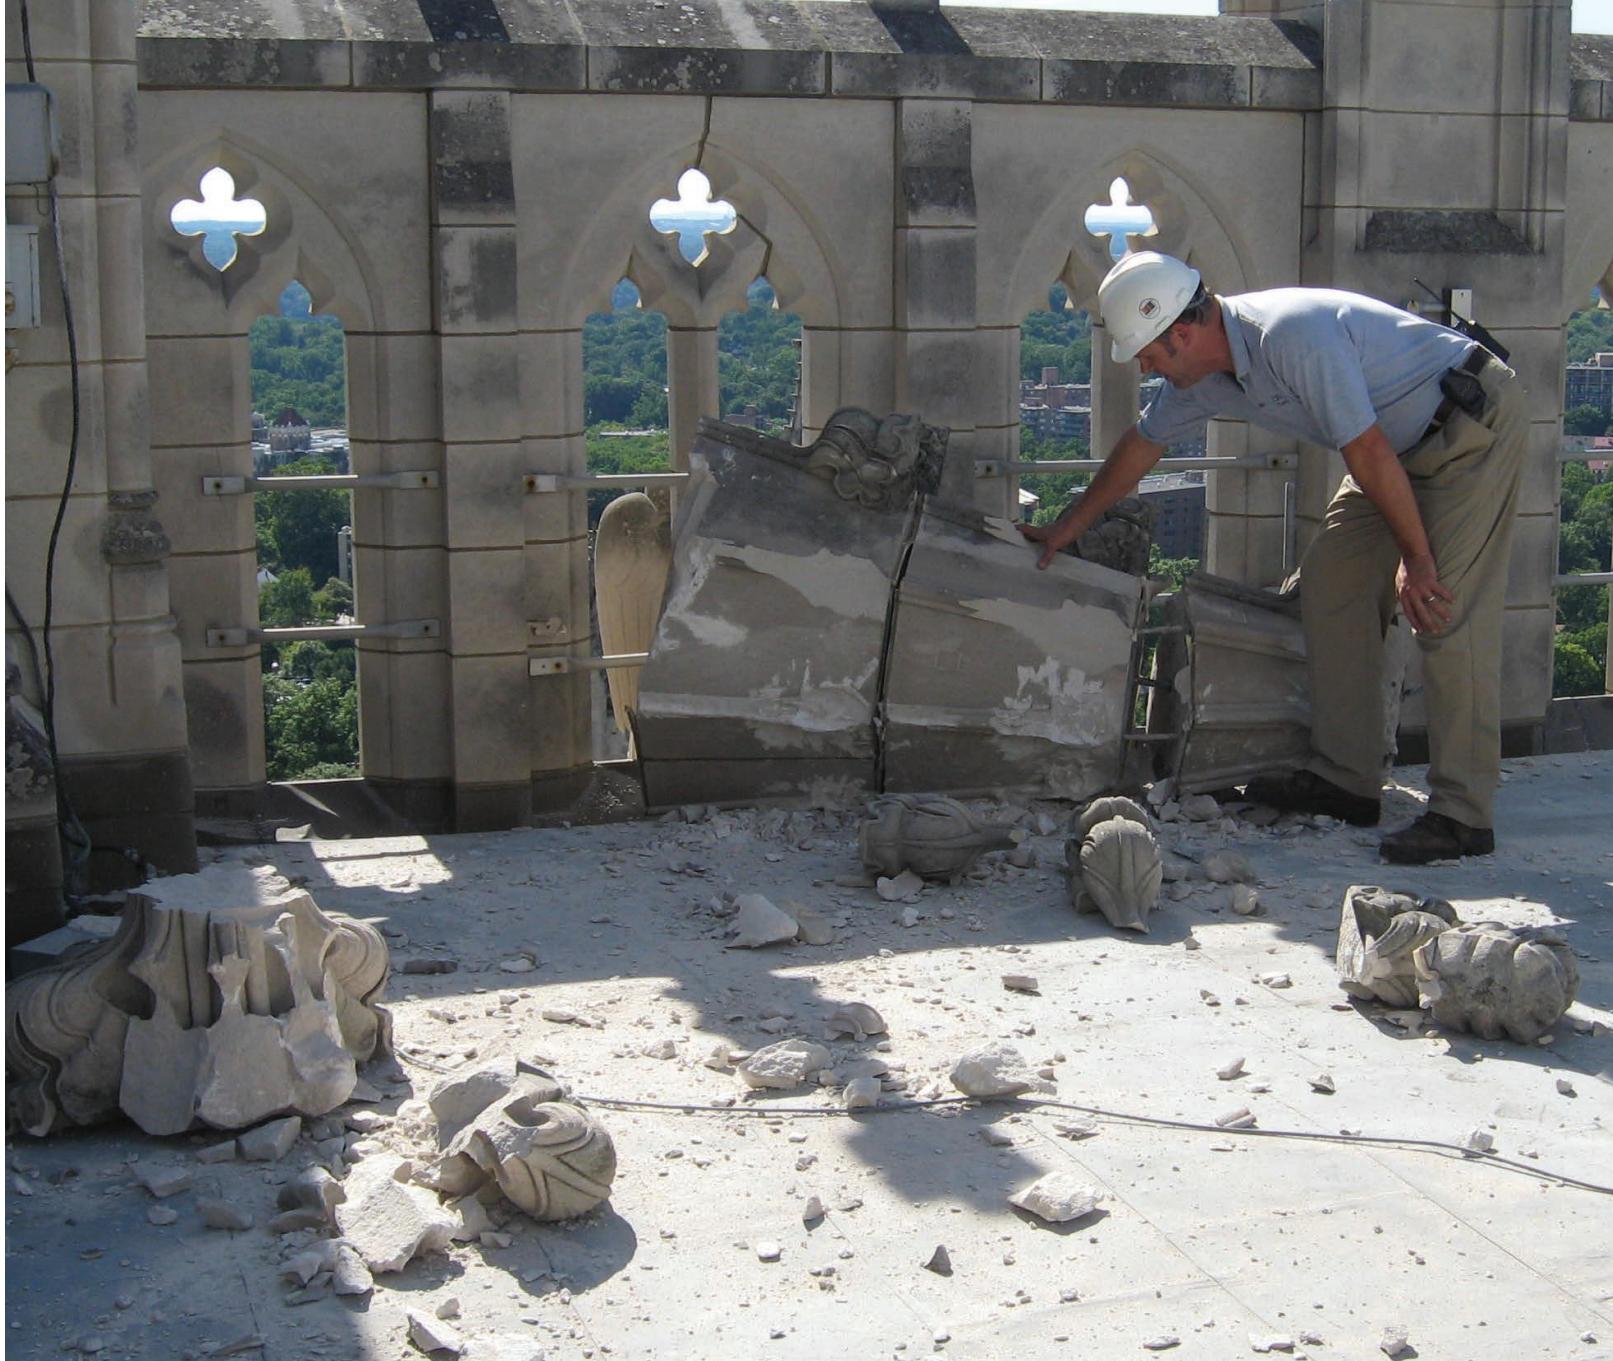
For forty years head mason Joe Alonso has tended to the stone needs of the cathedral. Here he begins "mason triage" during early visual assessments after the rare 5.8 magnitude earthquake shook the 118-year-old structure to its core. Image courtesy of Washington National Cathedral

In the days and months after the quake, Alonso says, they walked the perimeter and "did 'mason triage.'" He and his crew, along with Matthew Farmer, senior principal at Wiss, Janney, Elstner Associates (WJE) and project manager for the cathedral project, mapped the damage and did a visual assessment of every part of the building and grounds. "We did what we call 'make safe operations,'" Farmer says. They looked for cracks and displacement, making sure "the load paths for all the

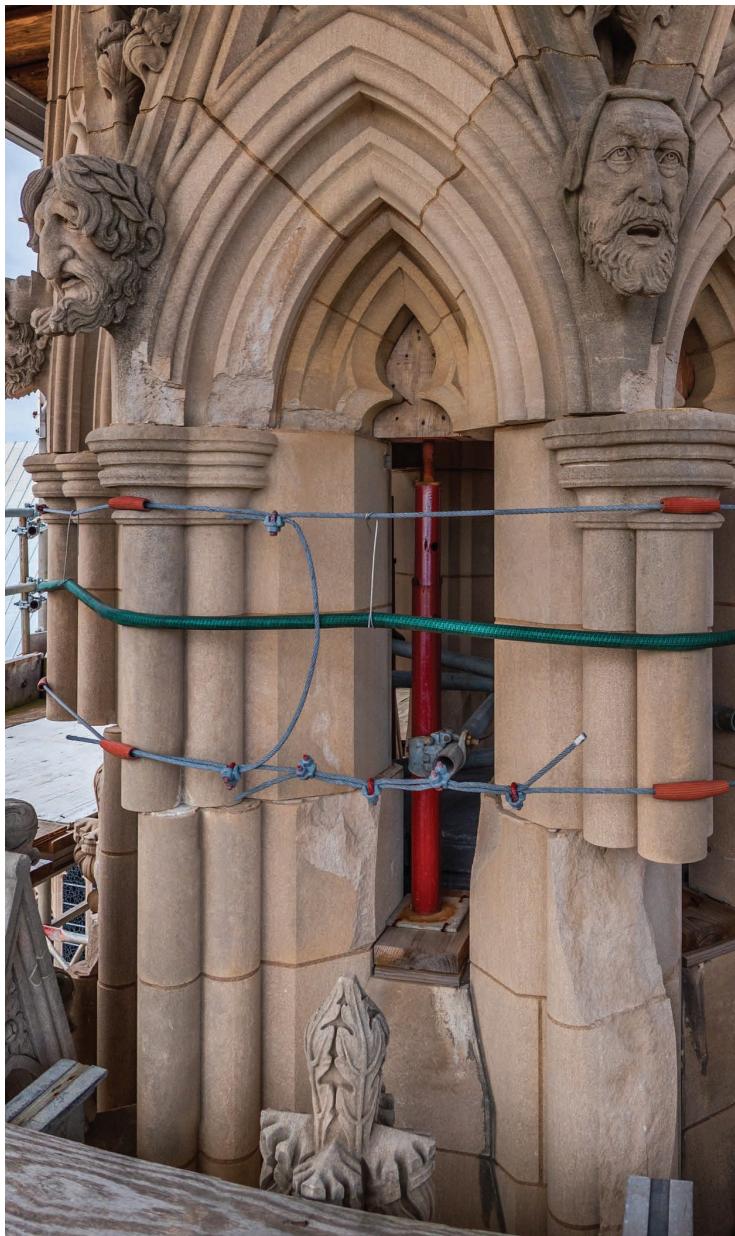
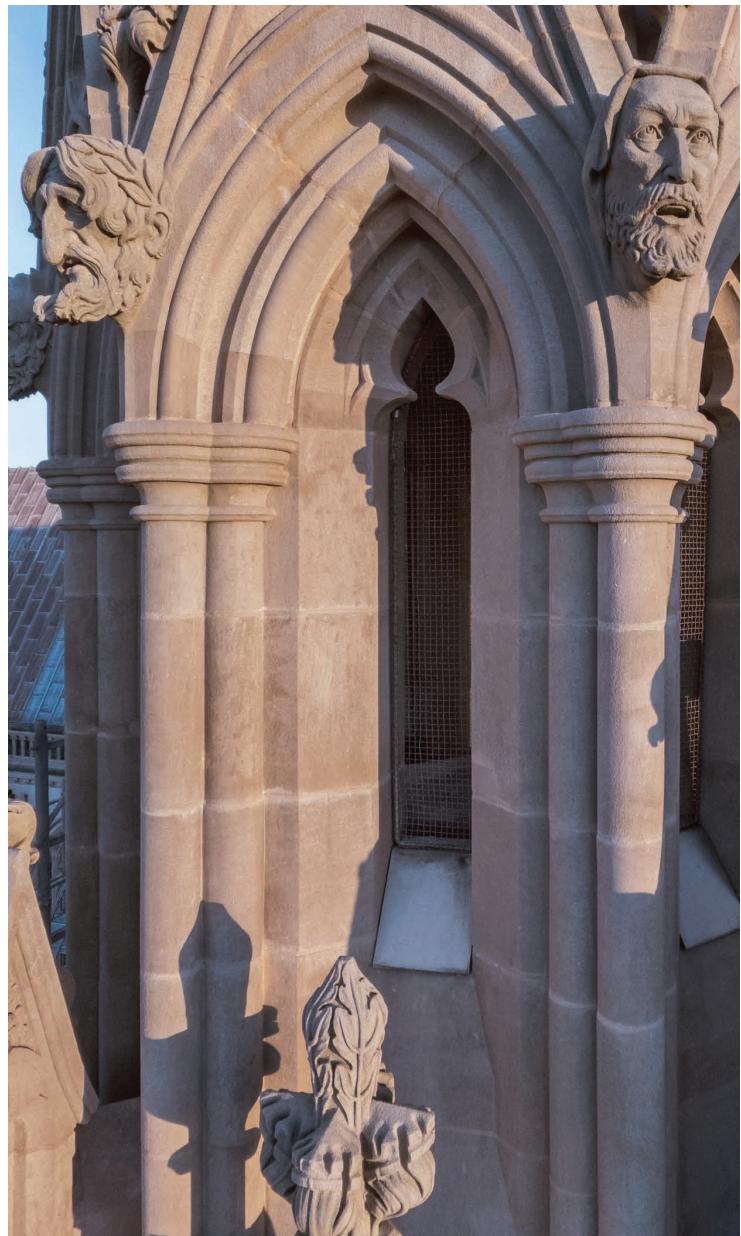
Above and opposite page before and after images. The earthquake shook the elements of the cathedral, loosening the stones. This is one of the grand pinnacles of the south transept, which rotated severely on eight slender columns that supported almost 30 tons of limestone. The pinnacles were disassembled, structurally enhanced and reassembled. Photo courtesy of Lorton Stone, LLC

So that the cathedral wouldn't face earthquake damage again, WJE worked with its San Francisco office to come up with a plan for seismic upgrades. Lorton Stone subcontracted the work of core drilling to Baltimore-based Masonry Solutions International, a specialty drilling firm. They core drill three-inch-diameter holes down 18 to 30 feet through the limestone columns. They also core sample the flying buttresses. "Sometimes we hit steel or rebar and have to redrill," Flynn says, acknowledging that earlier construction practices sometimes had no rhyme or

reason. They then install a steel rod into the shaft and pump in a cementitious grout.

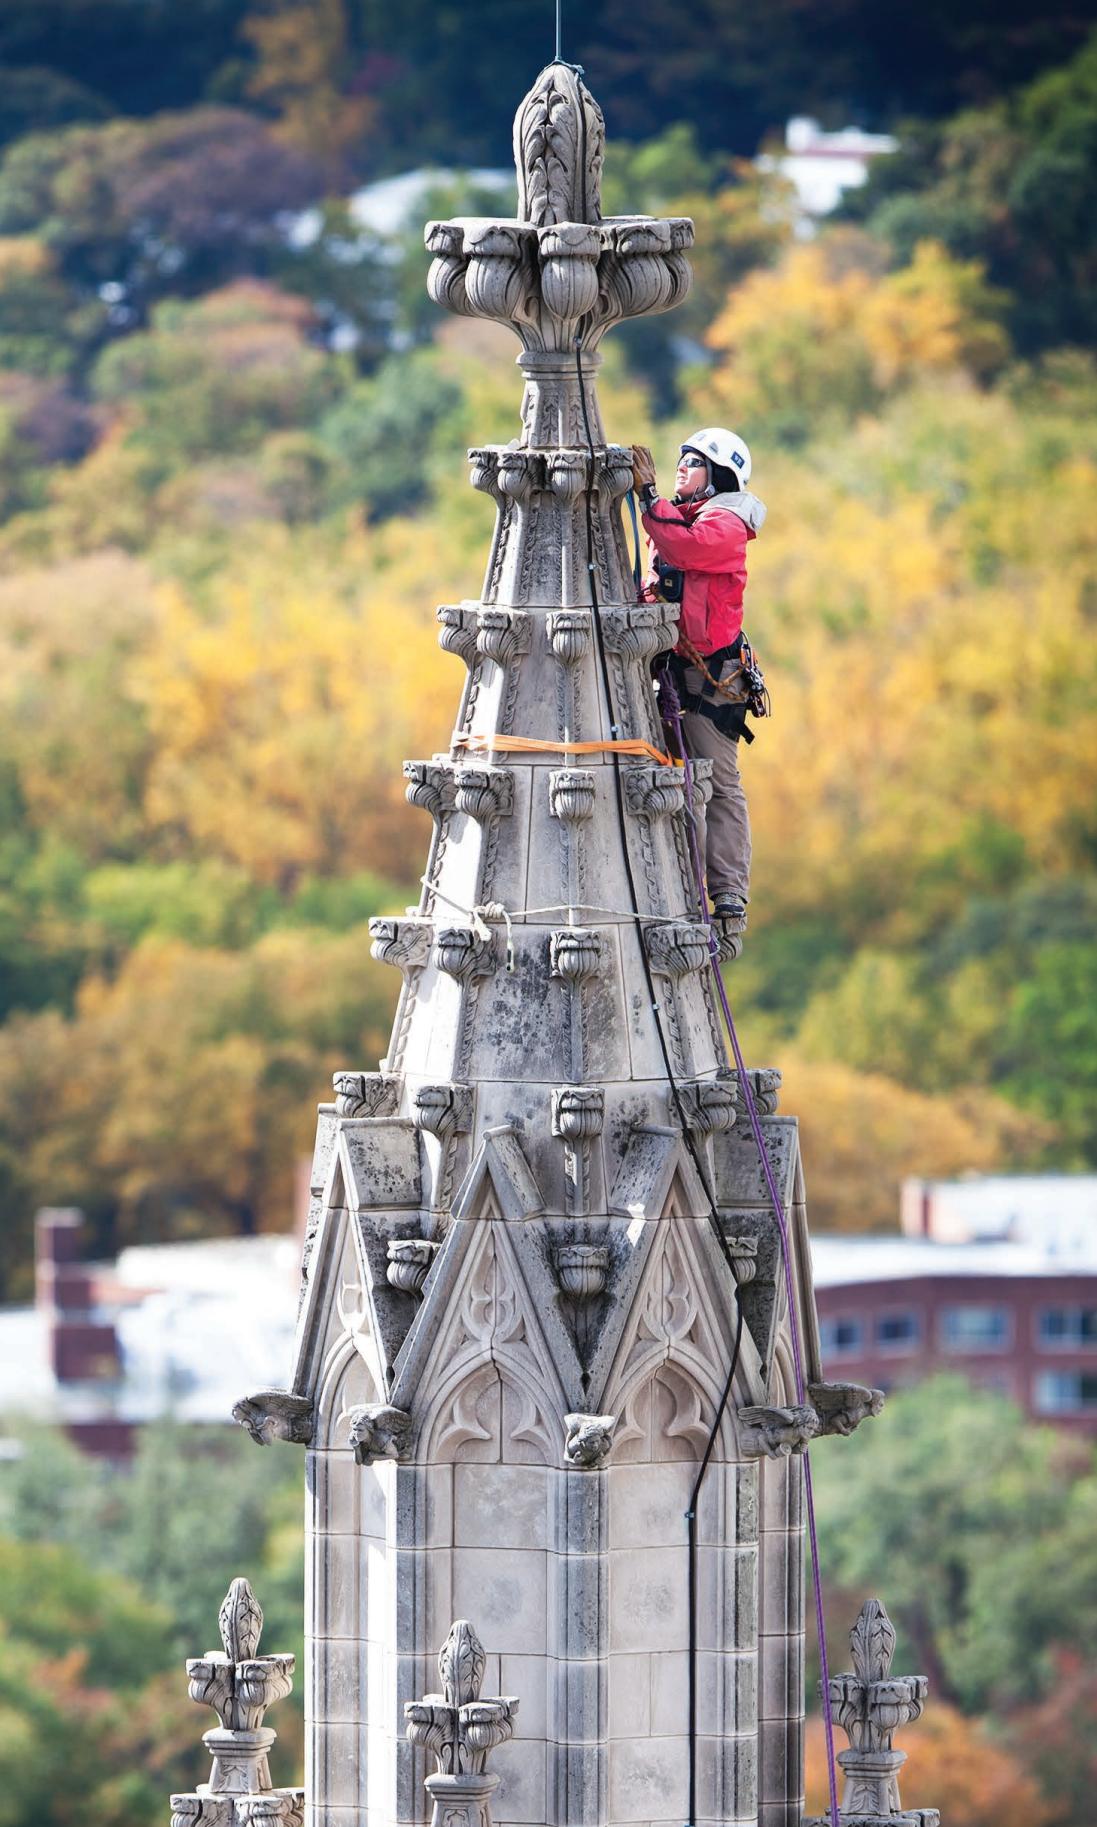
The rope access team from Wiss, Janney, Elstner Associates rappelled off the exterior to inspect stone and continue the 'pick and clean' process to remove loose and unstable material that otherwise might remain and potentially become disrupted downstream. After this point, the team felt confident that the public could safely return. Photo courtesy of Wiss, Janney, Elstner Associates

That gave them a little more time for the "rope access folks who rappelled off the exterior to continue the 'pick and clean' process, where we remove loose and unstable material that otherwise might remain and potentially become disrupted

downstream," Farmer says, adding that "at that point, we were able to feel confident that we could have the public return in early November."

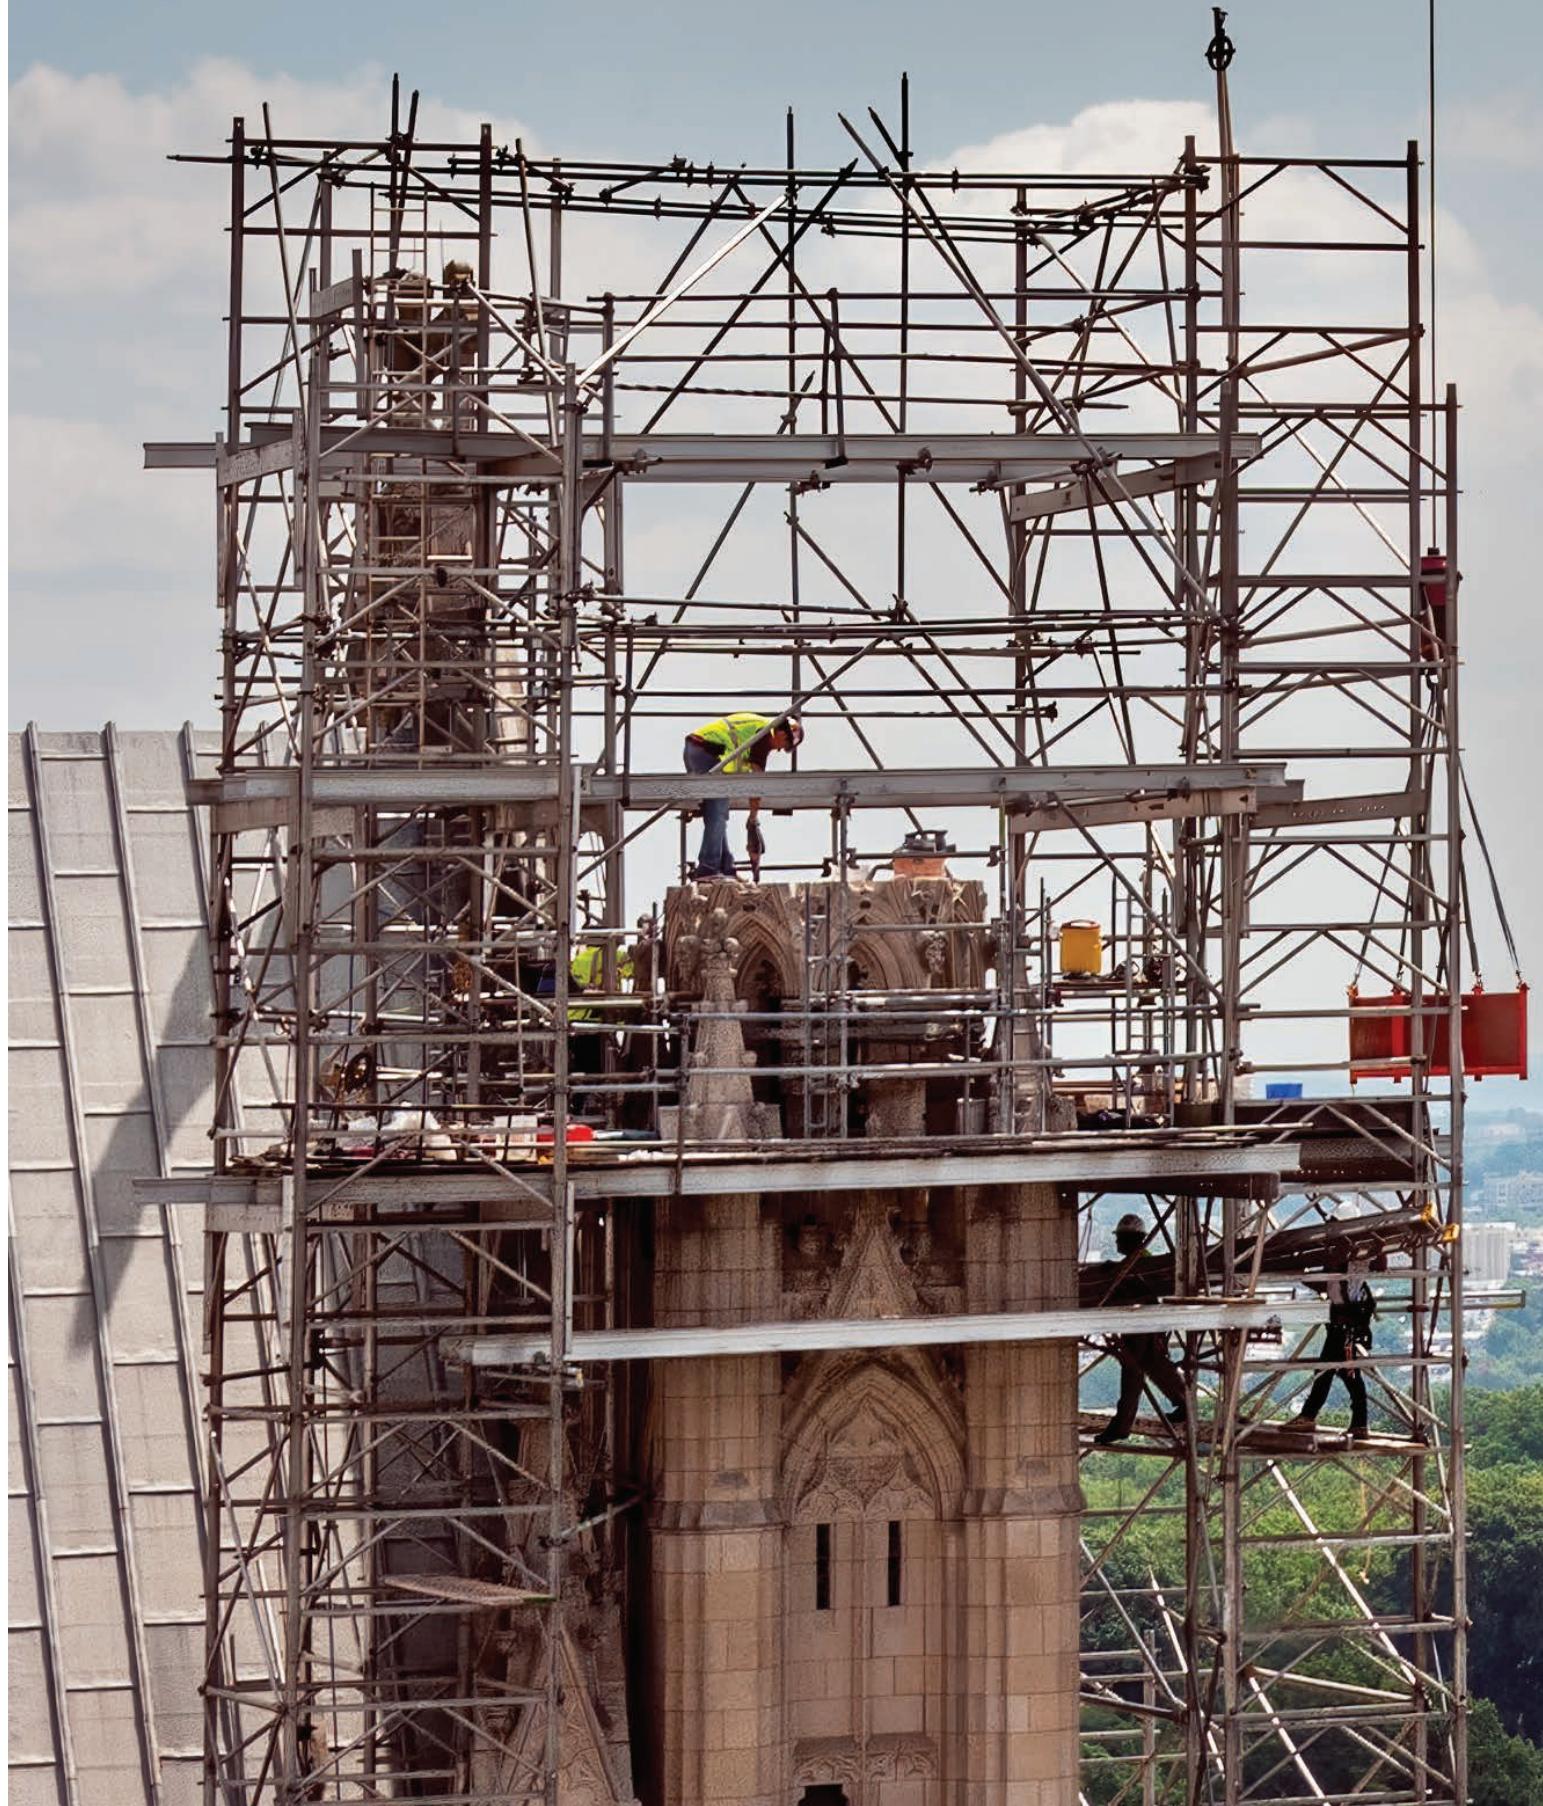
Painstaking work takes place high above the city. Building the scaffolding alone can take months. Then damaged or unstable stones are removed with a crane. Salvageable stones are taken into the shop to be repaired, and if needed, new pieces are made. Then structural upgrades are completed and the stones re-set with a crane. Photo courtesy Lorton Stone, LLC

Every element has to be catalogued, repaired and cleaned before it can be reinstalled. One finial can weigh 1,000 pounds or more. Depending on the damage, it might be repaired in situ with mortar and limestone, or it might be craned to the ground, "which is stressful as you have to worry about wind," says Shane Flynn, project manager at Lorton Stone. "Typically, we bring them down as one piece, but if there are smaller pieces

we strap them together and bring them down as one."

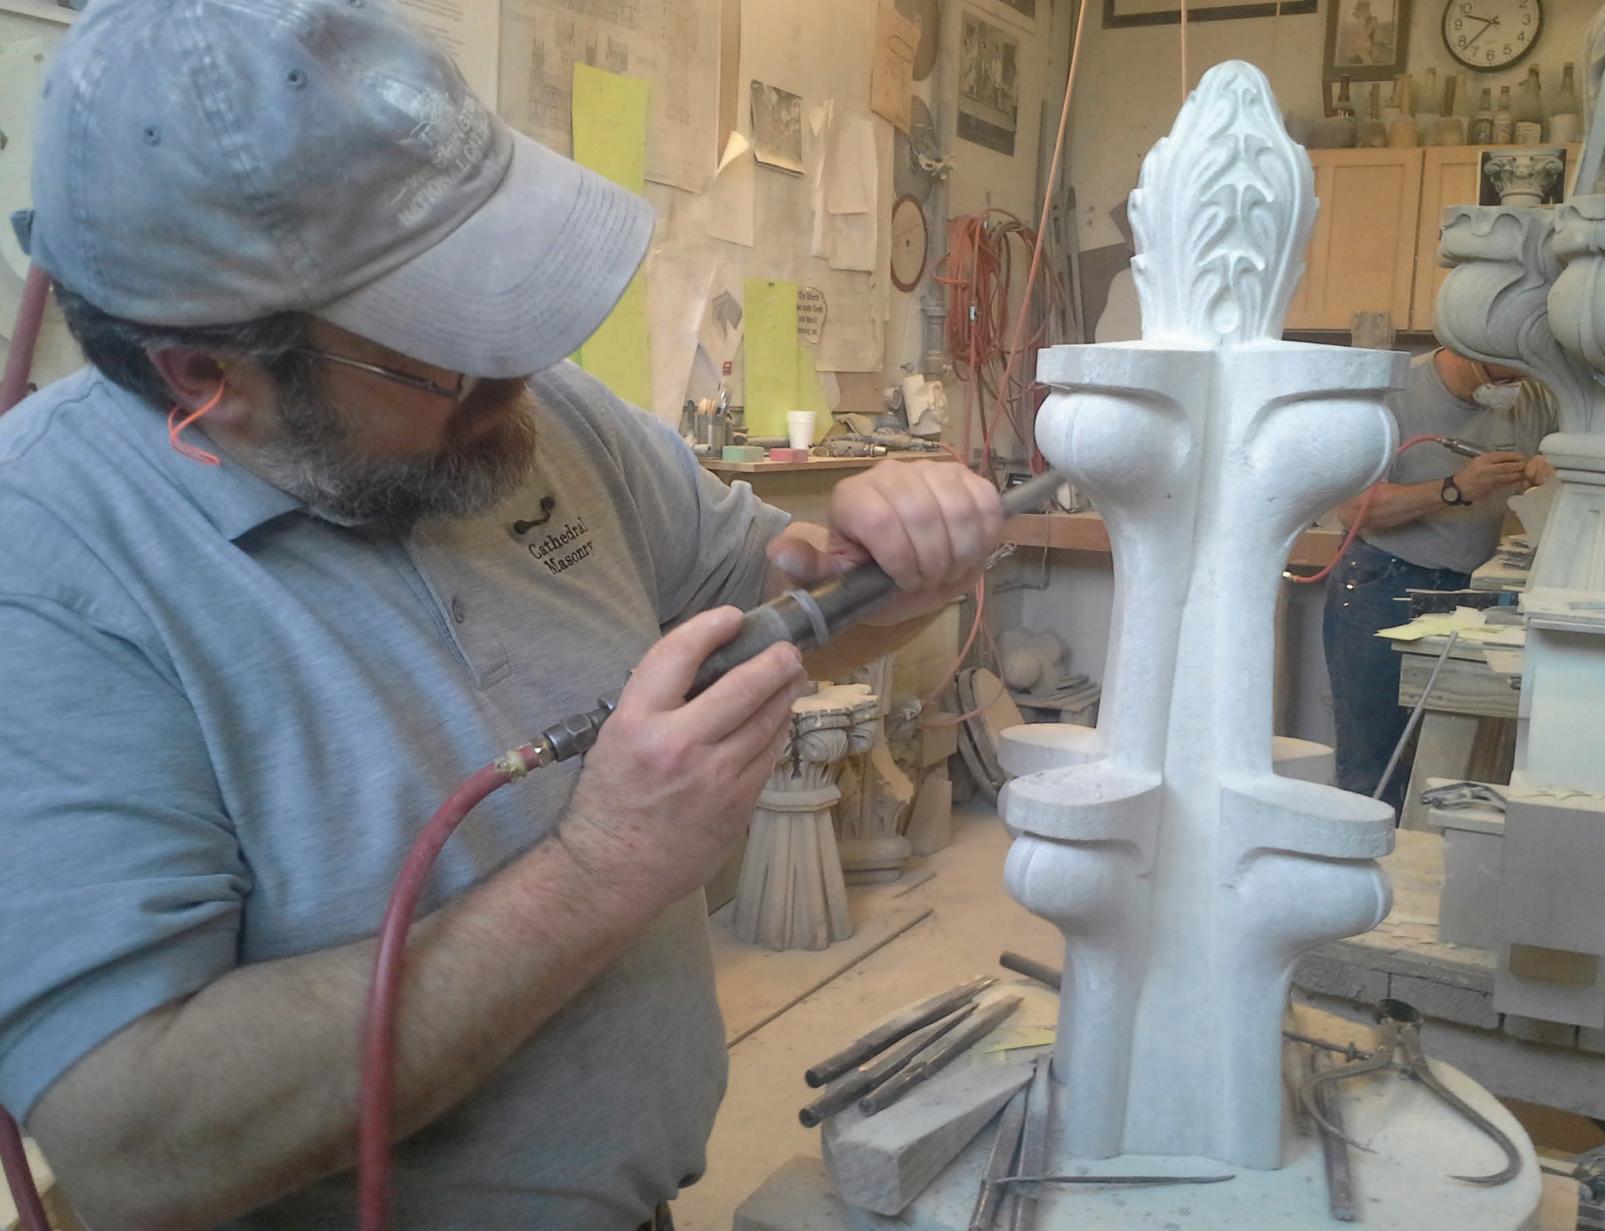
Sean Callahan, a cathedral stone carver, finishes one of the rough cuts done by robotic carving. It takes about eight weeks to go from rough to ready. Photo courtesy Wiss, Janney, Elstner Associates

When elements need replacement Alonso sends the damaged pieces out to be scanned into a CAD system. From there, blanks are roughed out by a CNC machine.

Stone carvers at the cathedral then finish the rough pieces by hand. "It takes about eight weeks to go from rough to ready depending on the type of piece," Alonso says. One thing he's excited about is getting to see how the stone artistry changed over time. He points out the differences to the crockets—grapefruit-sized decorative elements in the shape of a bud or curled leaf—carved in the 1930s and the crockets
