PROPERTY INSPECTION REPORT

Concerning: 8675309 Jenny Ln, Fort Worth, TX 76244
(Address or Other Identification of Inspected Property)

By: Graham Waring, Lic #22823 01/03/2018
(Name and License Number of Inspector) (Date)

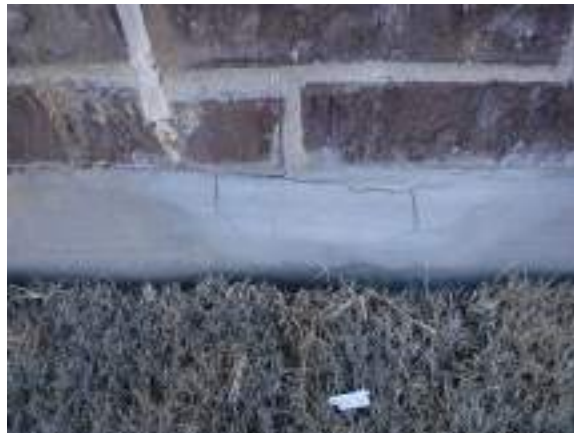
- Minor vertical cracking was observed in the foundation. This type of cracking is usually the result of shrinkage of the concrete as it cures. Shrinkage cracks are very common and should not be cause for alarm.

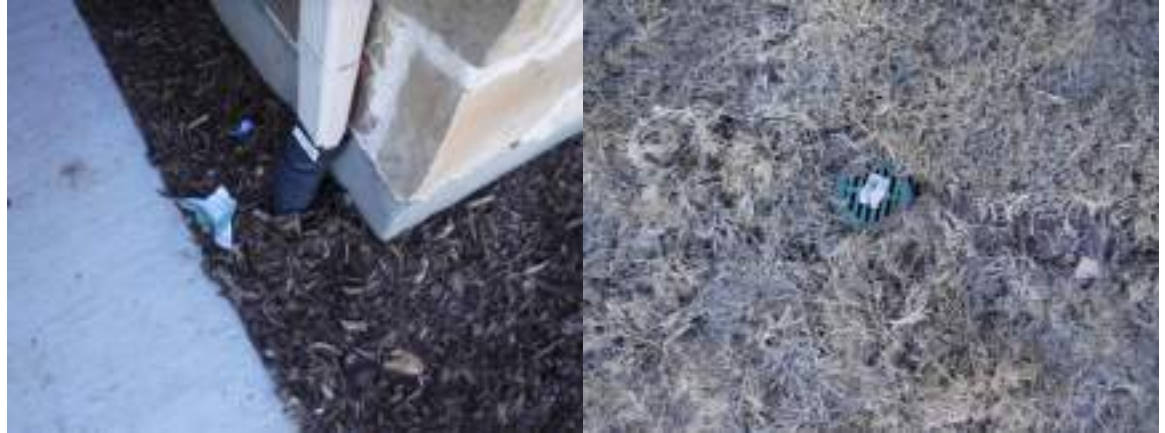
- Notice: There is an underground and/or surface drainage system in place. The inspector cannot and will not be able to verify the operation, sizing, efficiency or adequacy of the underground and/or surface drainage system. If there are any questions or concerns with this system or the effectiveness of the system, you should consult with the current homeowner or the appropriate specialist related to this type of system.

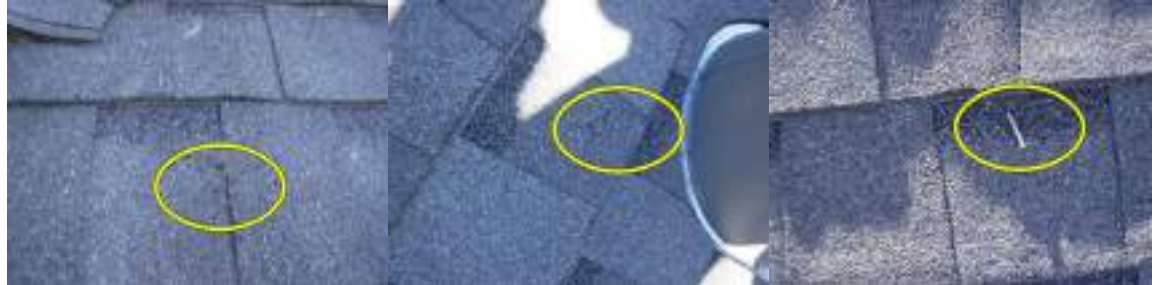
Roof Covering

- A few damaged shingles and leftover nails were observed on various exposures of the roof structure commonly found a newly installed roof.

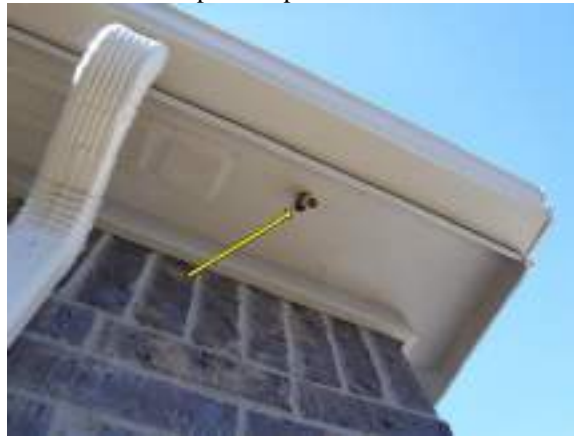
Eaves

- The primary drain needs to be sealed to prevent pest intrusion.

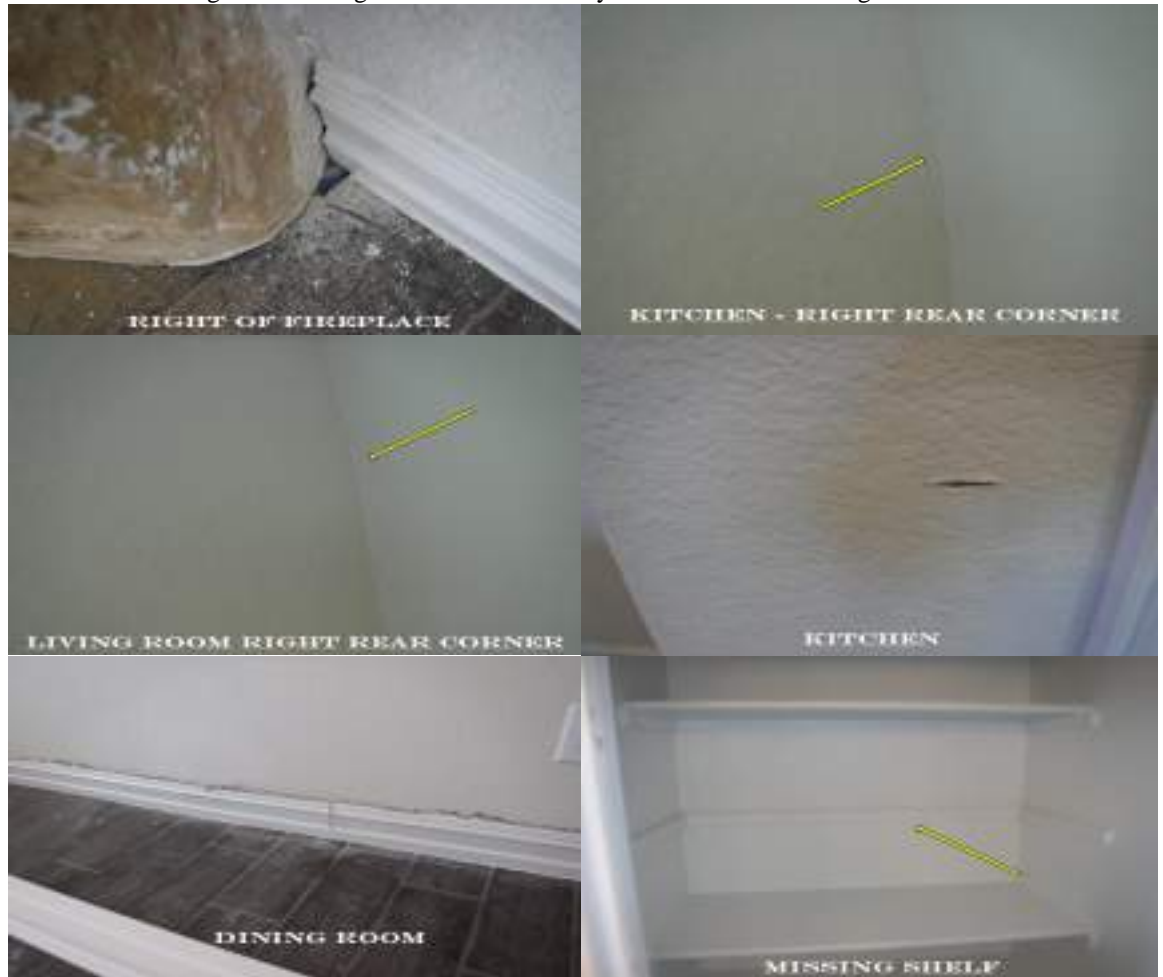
Interior Walls & Surfaces

- The right side of the fireplace is unfinished.
- There is drywall damage are various locations in the garage area.
- The fireplace needs mortar improvements in several areas.
- The master bedroom crown molding is coming apart in several areas.
- There is missing shelving in the downstairs hall bathroom closet.
- There is damage and missing baseboard at the entry from front hall to living room.

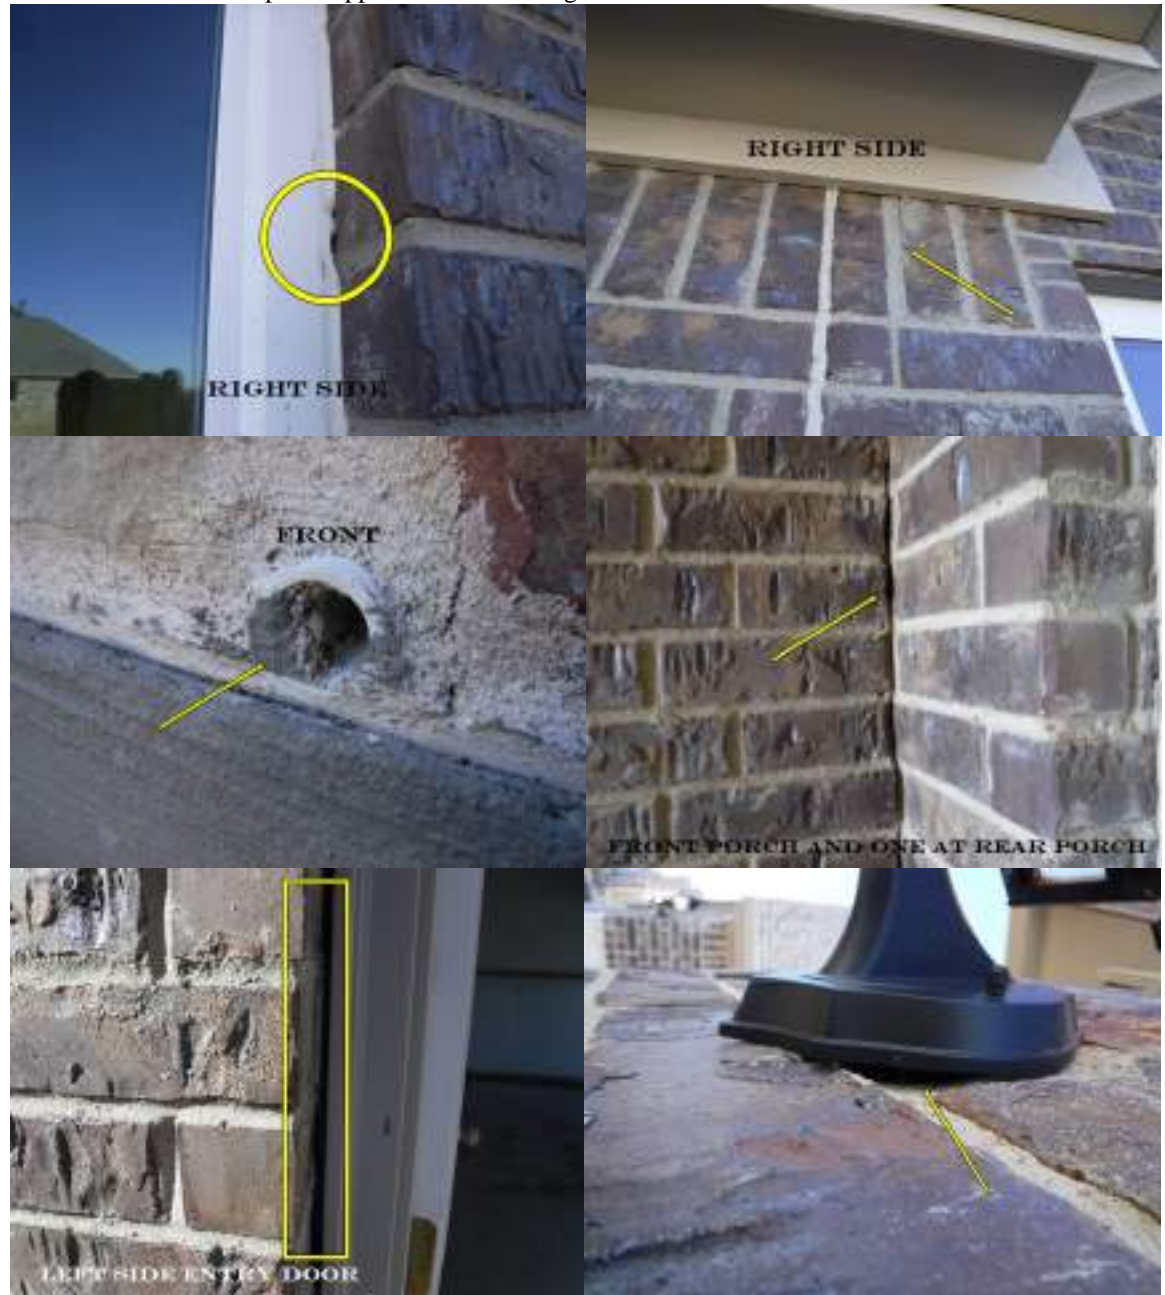
Exterior Walls & Surfaces

- Re-caulk: Some areas of the house need re-caulking due to deteriorated or missing caulking. Recommend re-examination of all windows and vertical joints between the trim and brick veneer. All openings should be sealed/caulked to prevent water intrusion and deterioration.
- It is recommended to seal all exterior light fixtures to the veneer.
- Mortar cracks were observed in the exterior veneer at some locations around the structure. Monitor and seal as necessary.
- There is mortar missing in the corners of the front and rear patio.
- Stonework at front porch appears to have damage.

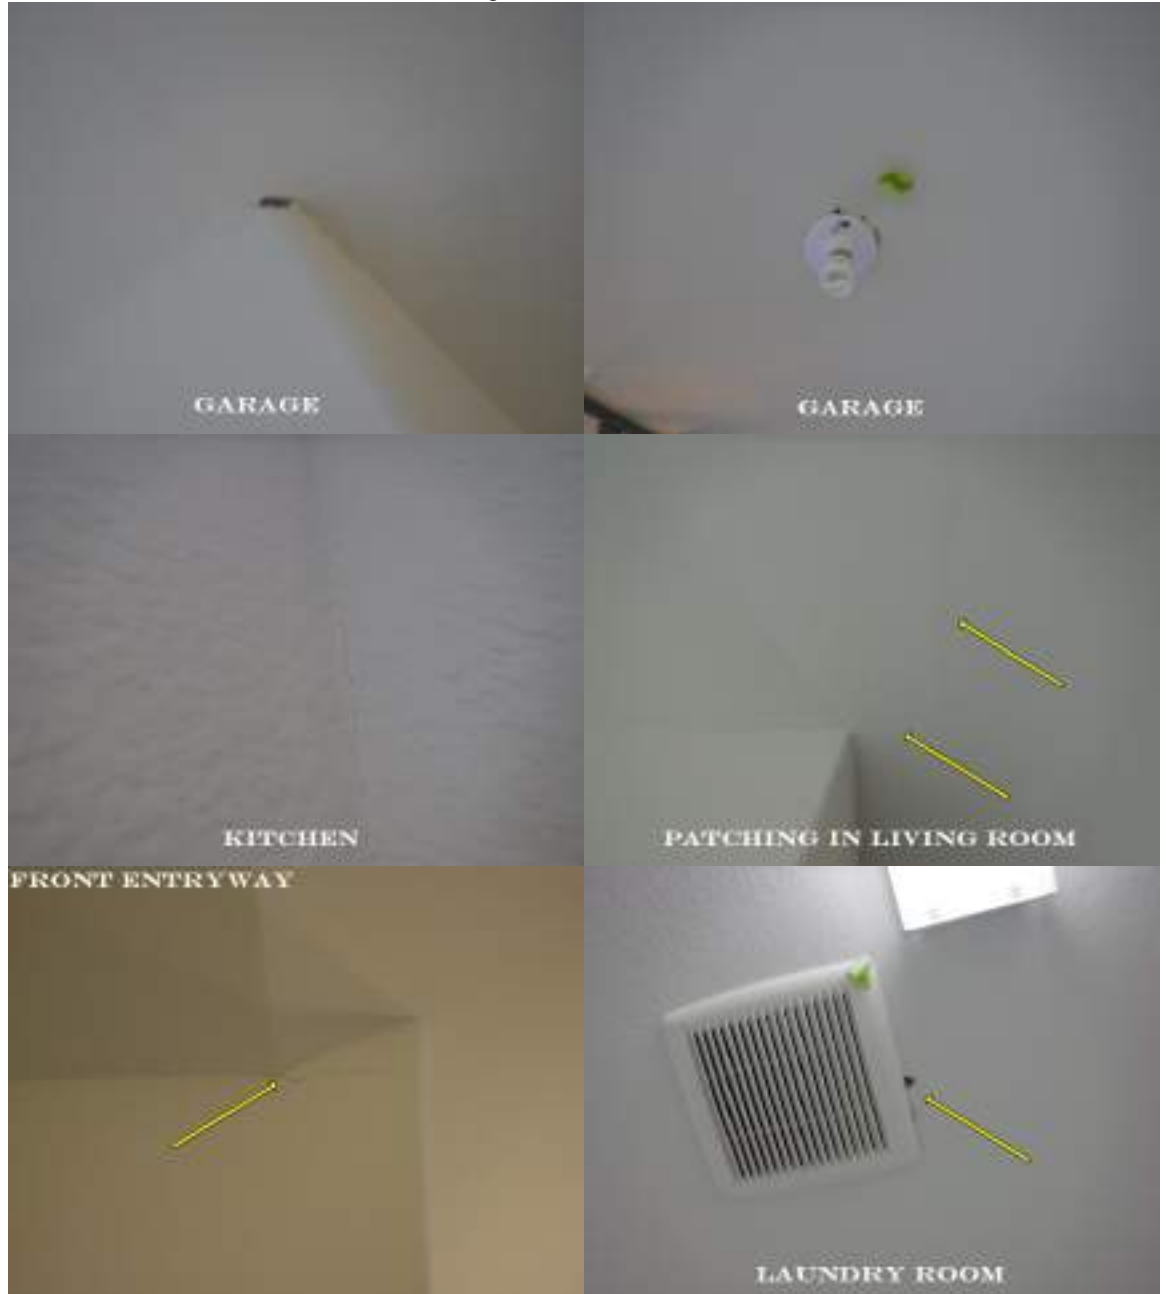
Ceilings

- Stress cracks were observed at the ceiling in various locations.

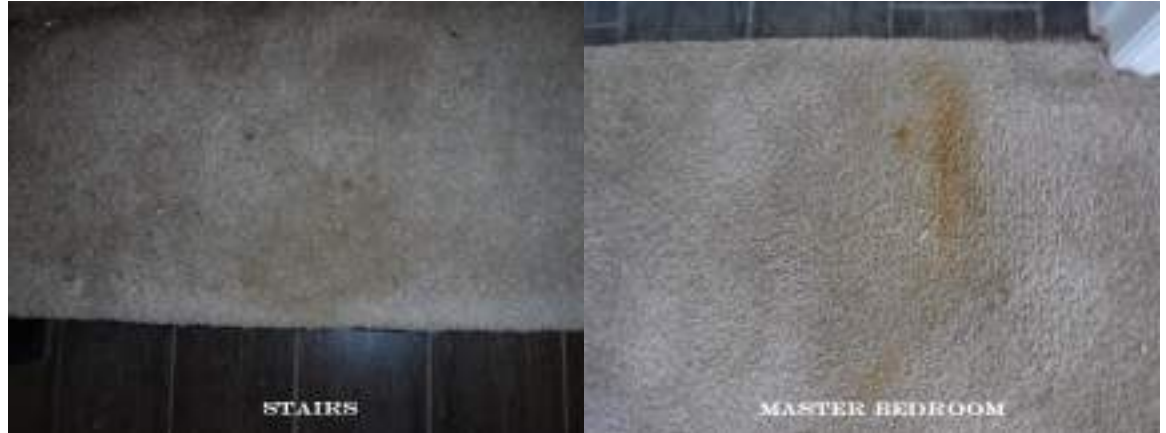
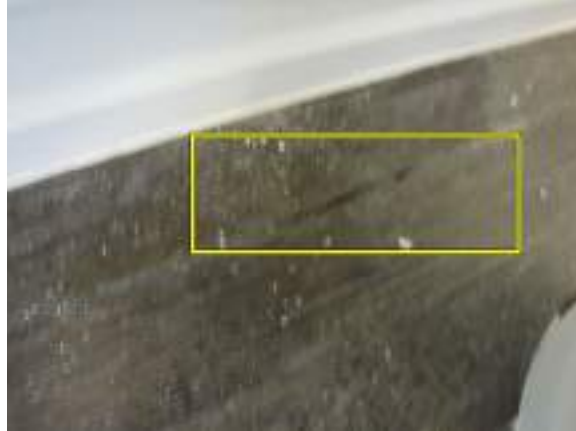
Floors

- Noted possible carpet stains at the bottom of stairs and master bedroom.
- There is missing grout in master commode area.
- Note: The floors were overly dirty from contractor traffic. This limits the visual inspection of the flooring.

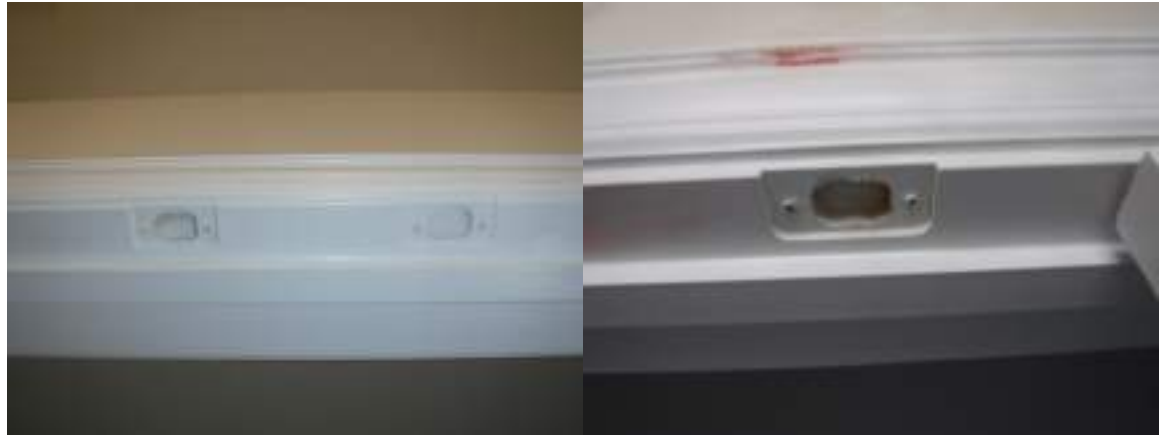
Interior Doors

- Multiple doors have damaged and/or missing catch plates for spring latches.
- The door to closet under the stairs is loose.

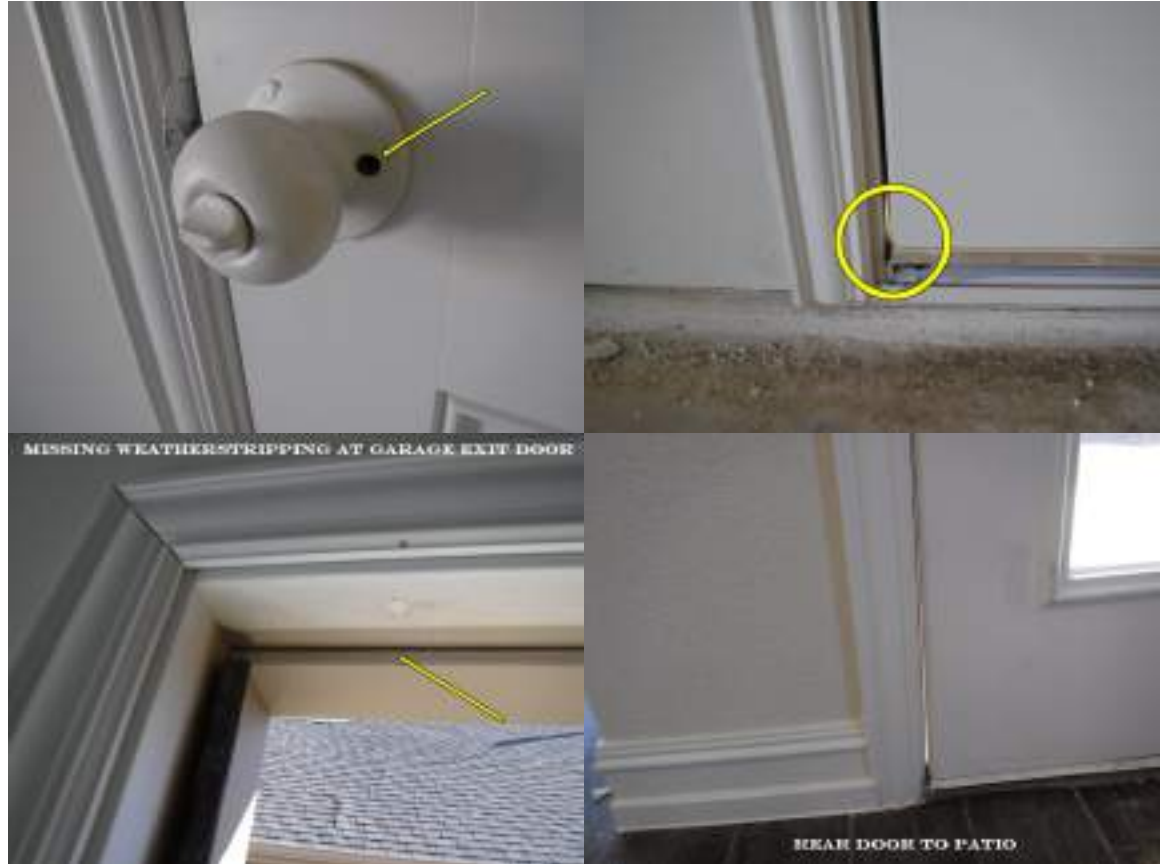
Exterior Doors

- Noted missing screw from garage left side door hardware and has been painted over.
- The door hardware is loose to the front entry door.
- There is missing weather stripping to the garage left exit door.
- The front door is difficult to open and close. Adjustments are needed to either sweep or threshold.
- Visible daylight was observed at several exterior doors throughout the house. Weather stripping improvements are needed to prevent heating /cooling loss and water / pest intrusion.

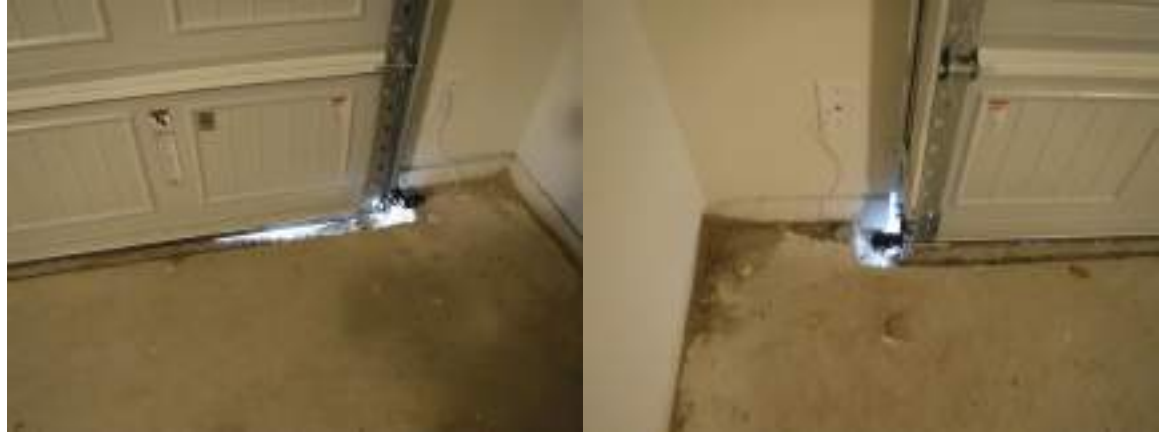
Overhead Garage Door

- The garage door is allowing visible sunlight through the right and left side of door. Adjustments are needed.
- Note: It is recommended to disable the manual lock when an operator is in place for the overhead door.

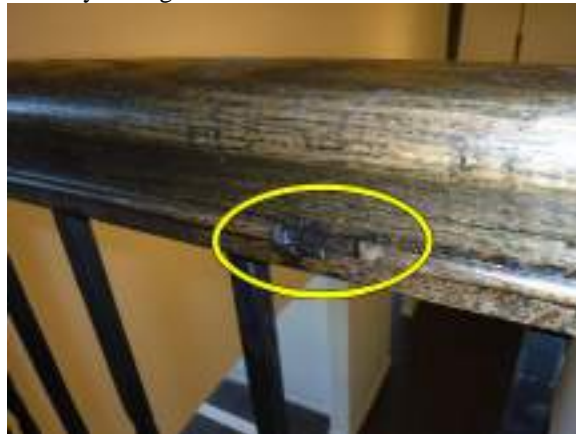
- Noted damage to the 2nd story railing.

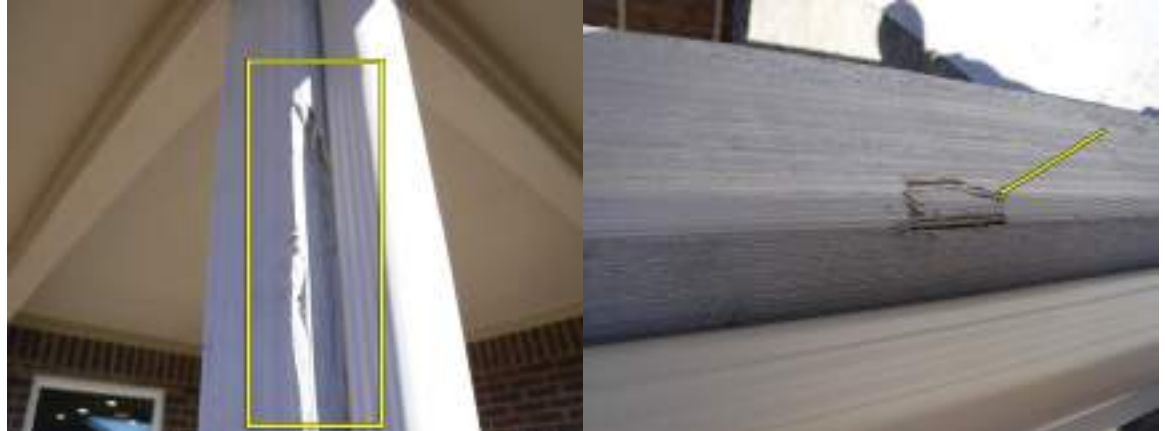
- The rear patio support post was observed to be damaged. Further evaluation is needed.

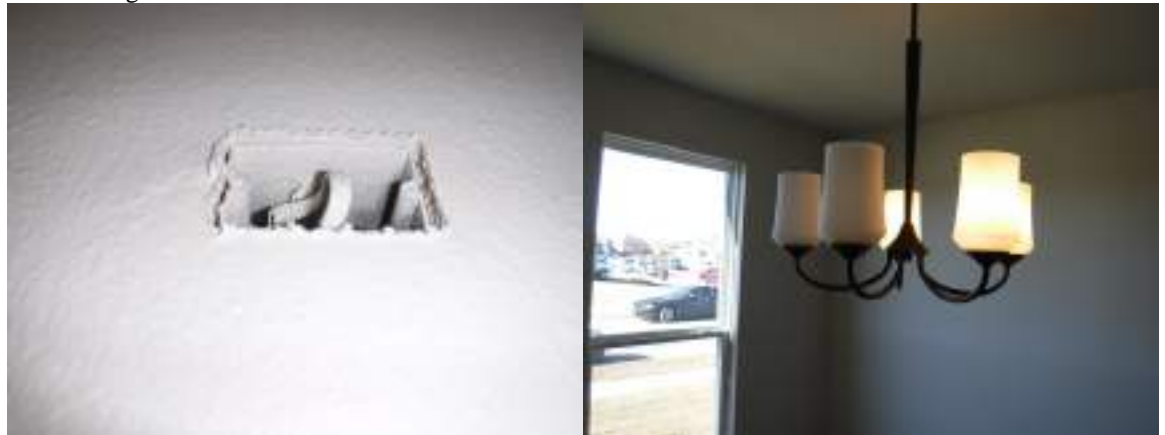
Fixtures and Distribution Wiring

- An open junction box was observed in the pantry. A junction box cover should be installed for reasons of safety.
- Noted multiple inoperative lights; if the bulbs are not blown or missing, the fixtures/circuits should be investigated.

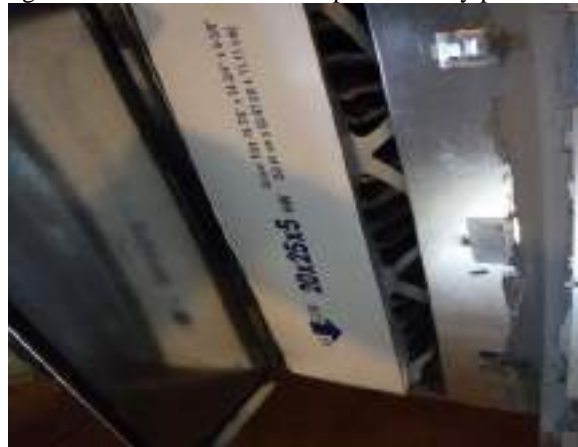
This component appears to be performing adequately at the time of this inspection. It is achieving an operation, function, or configuration consistent with accepted industry practices for its age.

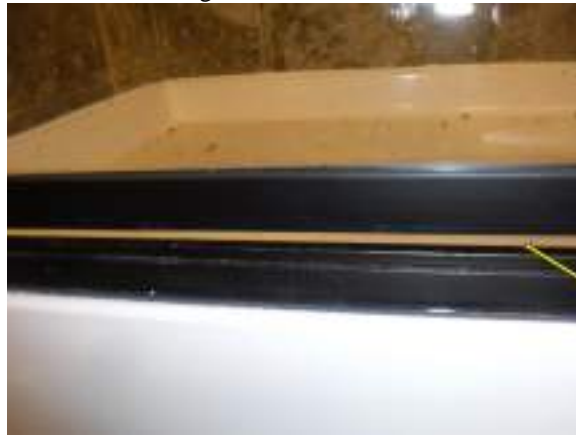
Downstairs Hall Bathroom:

- The sweep for the shower door is missing.

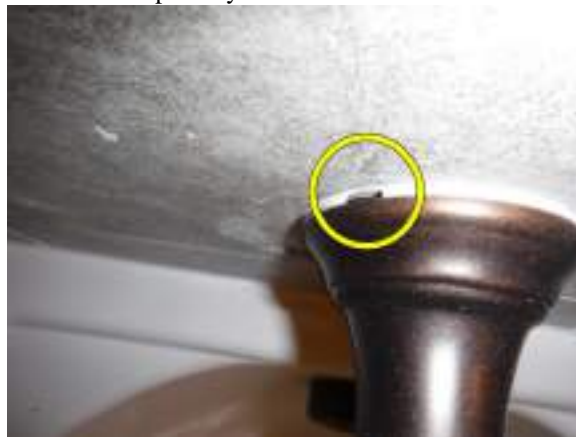
Upstairs Hall Bathroom:

- The supply hardware should be completely sealed to the bathtub enclosure.

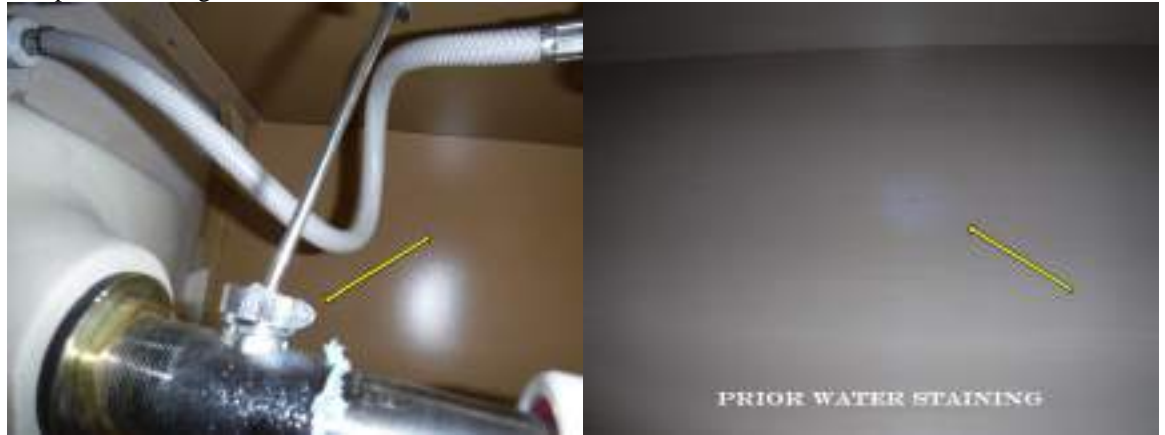
- A leak was observed at the waste plumbing under the upstairs bathroom bathroom sink.
- The plumbing is loose under most bathroom sinks. The plumbing needs to be properly secured to prevent leakage. Further evaluation is needed.

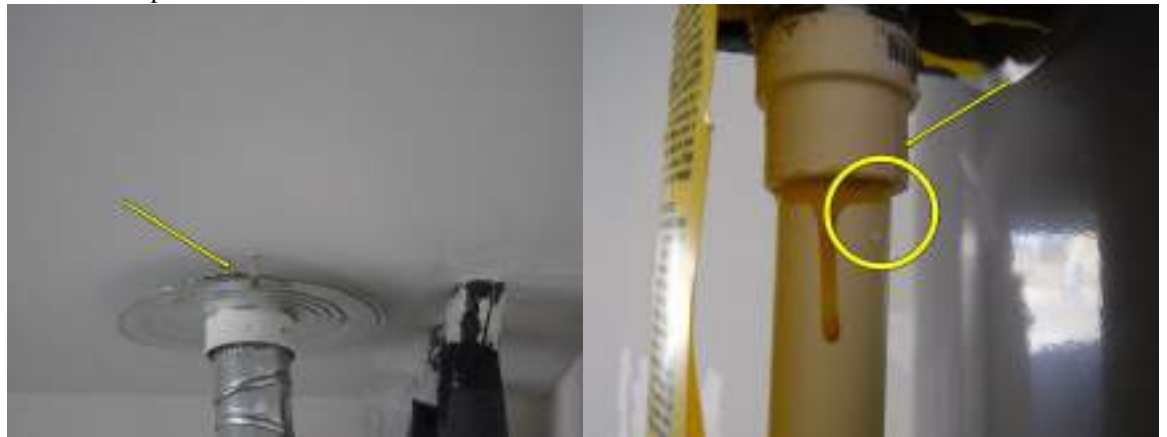
- The vent pipe collar is loose at the ceiling.
- The temperature and pressure relief (TPR) valve serving the water heater is cracked and needs repair and or replacement.

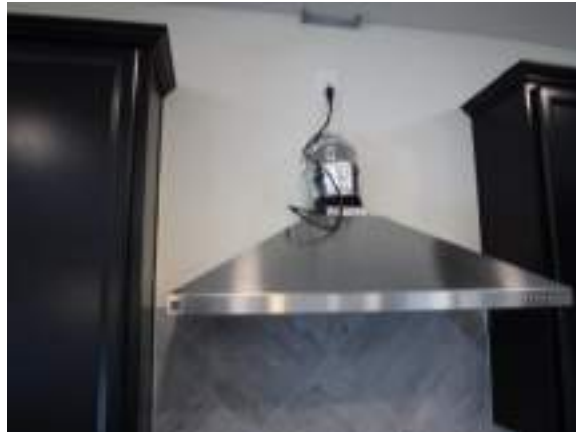
- The finish out for the range hood has not been completed.

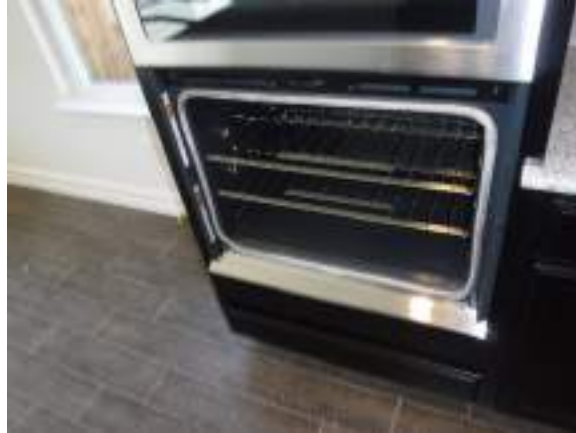
- The oven was inoperative at the time of this inspection. The power was off to the unit and the front has not been installed.

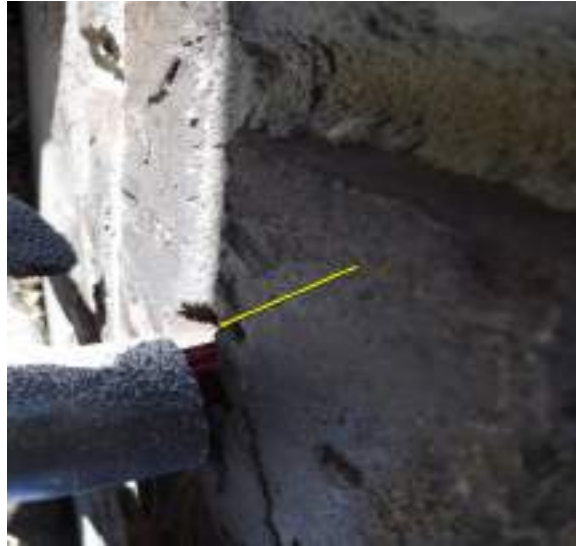
- The conduit that is protecting the sprinkler system wires by the control panel needs to be sealed to brick to prevent water intrusion.
- Due to near or below freezing temperatures the sprinkler system could not be safely inspected.
