## PROPERTY INSPECTION REPORT

**Concerning:** 54321 Earth Belowers Ln, Fort Worth , TX 76244  
(Address or Other Identification of Inspected Property)

**By:** Graham Waring, Lic #22823 02/08/2018  
(Name and License Number of Inspector) (Date)

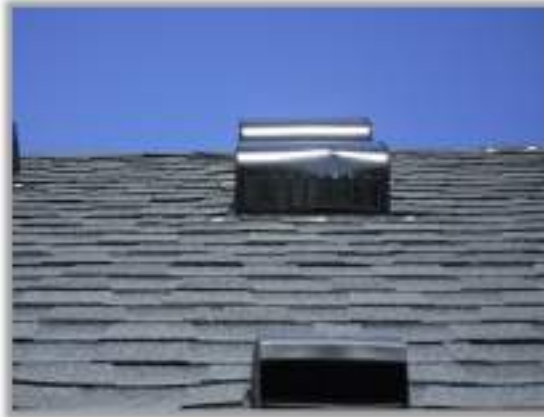
**Roof Covering**

- One or of the roof structure static vents is damaged.

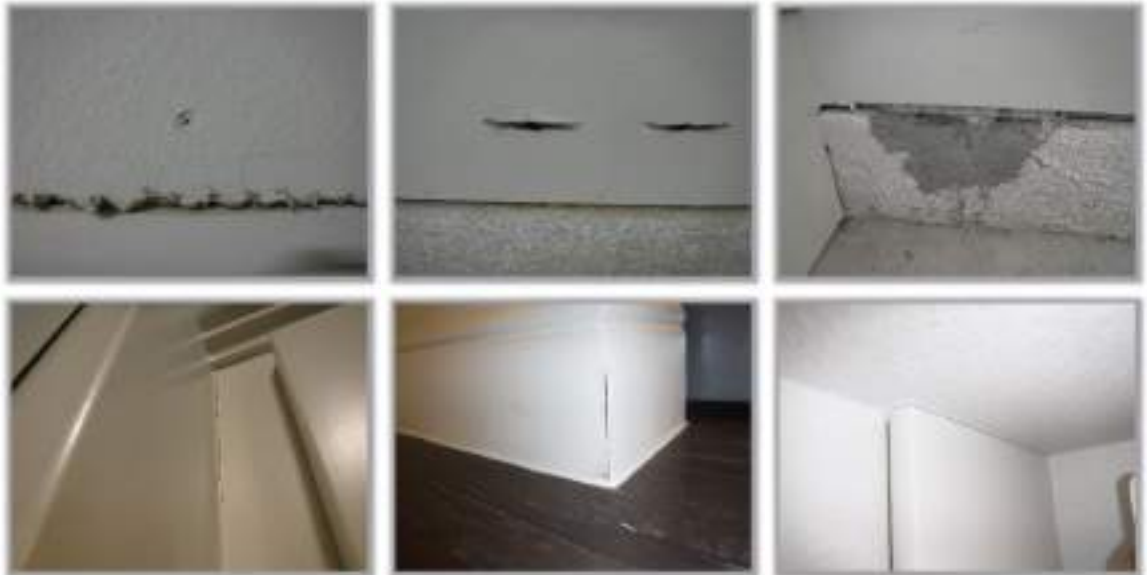
**Interior Walls & Surfaces**

- There are exposed drywall screws in the garage.
- Drywall damaged noted in the garage area.
- Evidence of prior repairs noted in the garage.
- The baseboard in downstairs bathroom is cracked and in need of grout repairs.
- Many of the seams in cabinets/shelving/trim in the home have separated. Repair as needed.

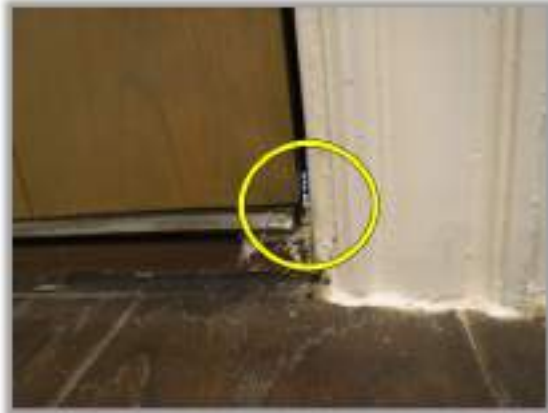
**Exterior Doors**

- The front door needs weather stripping improvement.

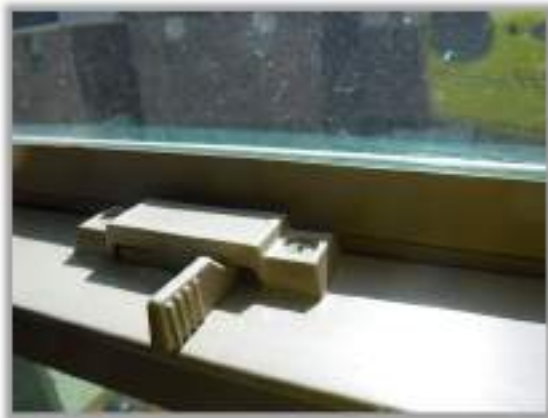
- The window lock(s) do not appear to be latching properly in the master bedroom.

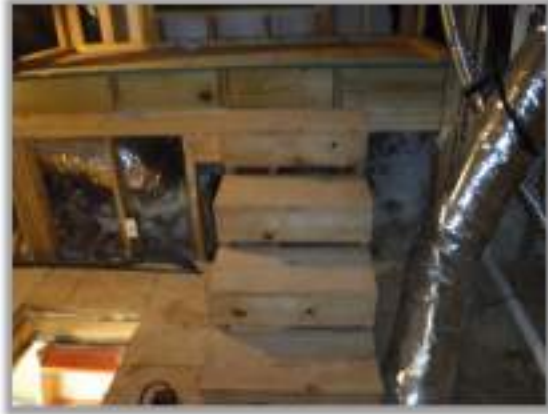
- There is no handrail in place for the stairwell. For improved safety, it is recommended that a handrail be installed.

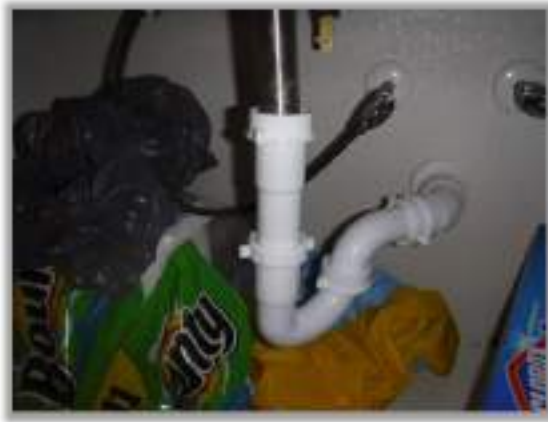
- The plumbing is loose under the master bathroom left sink. The plumbing needs to be properly secured to prevent leakage. Further evaluation is needed.
