Gypsum Plaster Floors

SPAB Regional Technical Advice Note

Anthony J Goode DipBldgCons (RICS), IHBC

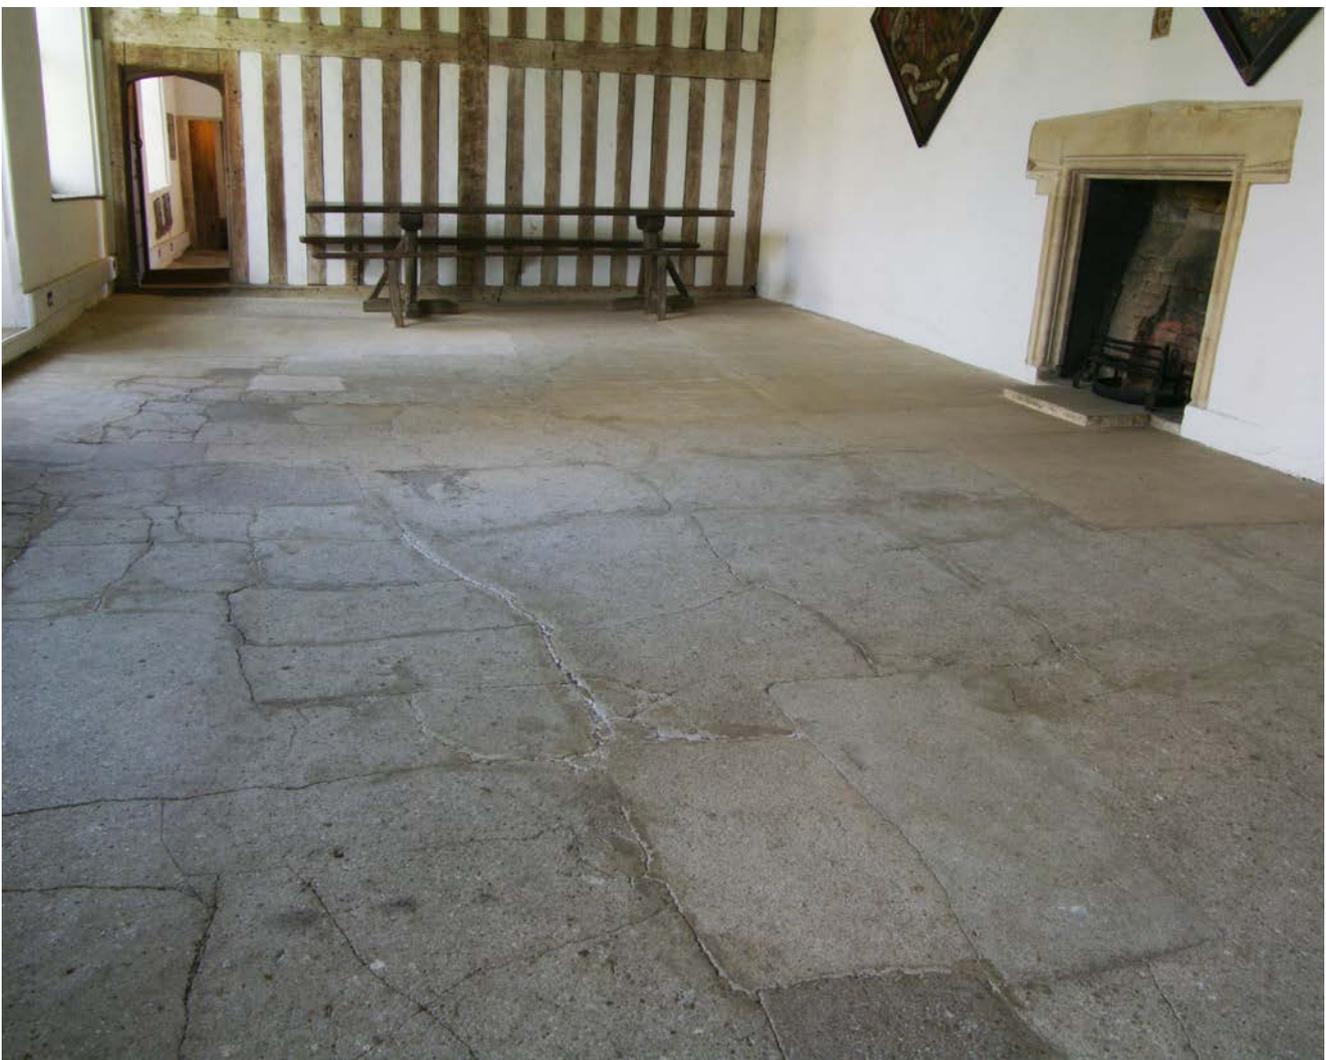
Cover image: The historic gypsum plaster floor in the Great Chamber at the Bede House, Lyddington, Rutland.

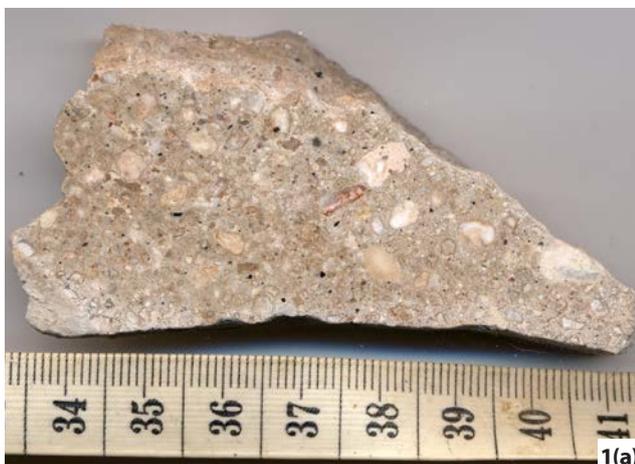
Figure 1: Samples of old gypsum plaster floors: (a) Typical colour and texture. (b) The varied composition found.

The composition of a gypsum plaster floor was determined by what materials were to hand locally (see figure 1(a)).

in part from the ash of wood or coal, to a pink-reddish hue, influenced by brick dust or fragments (see figure 1(b)). Many of the contents are visible with the naked eye or a x10 hand lens, especially after the surface is wiped with a damp sponge. These might include, for example, opaque blue/grey or near translucent particles of anhydrite, a mineral frequently found with naturally occurring gypsum. It is the varied composition of the mix that provides an important characteristic of gypsum plaster floors and helps distinguish them from concrete or cement screeds.

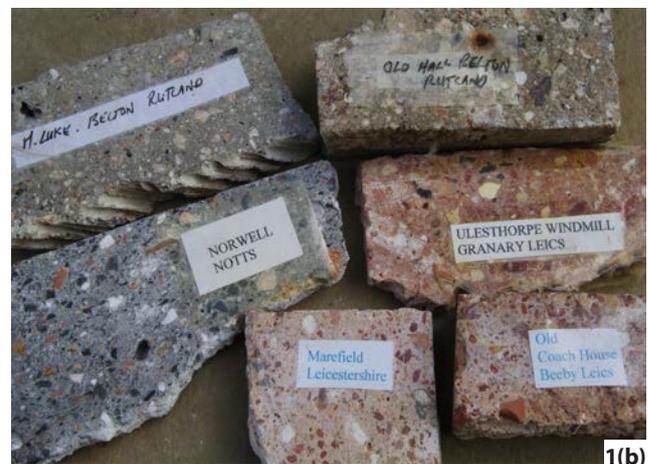
Photos: A J Goode Ltd (a) and Douglas D Kent (b)

The presence when viewed below of organic bedding material (for instance, reed or straw) can provide a further clue to the existence of a gypsum plaster floor, as does a suspected pre-20th century date (see figure 2). In addition, unlike with concrete or cement, the surface of a gypsum plaster floor is scratched easily with a sharp knife and 'rings' when gently tapped. Be mindful, however, that gypsum plaster floors may well contain some later cement repairs.

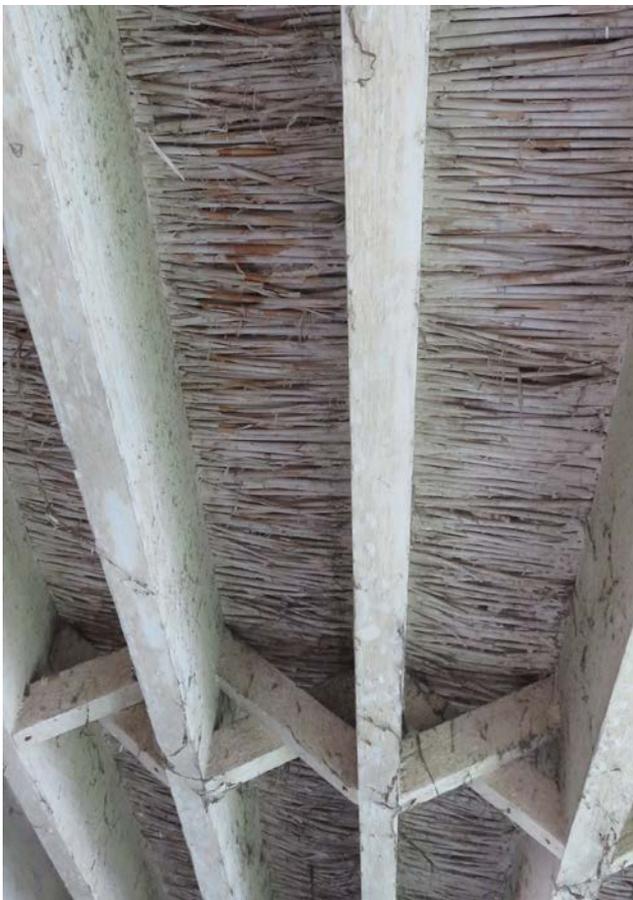
Figure 2: The presence of organic bedding material, such as reed, can indicate the existence of a gypsum plaster floor.

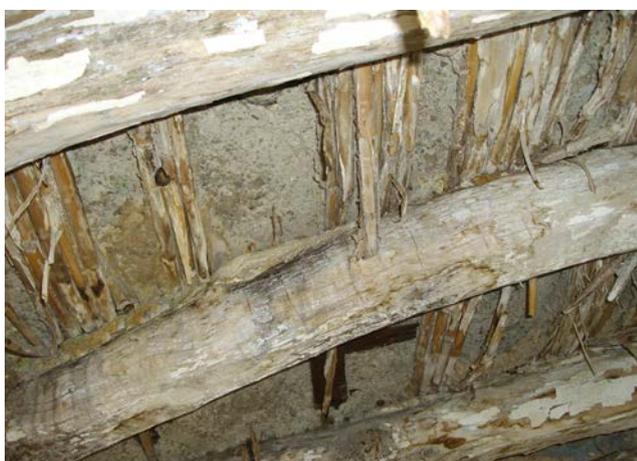
Figure 4: Cane bedding forming the underside of a historic gypsum plaster floor in Sierra, Andalucia, Spain.
Photo: Douglas D Kent

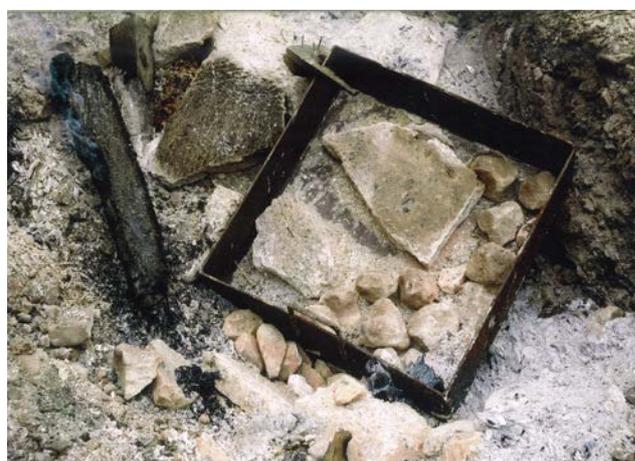
Figure 5: Trial gypsum-burning on an SPAB course.
Photo: Douglas D Kent

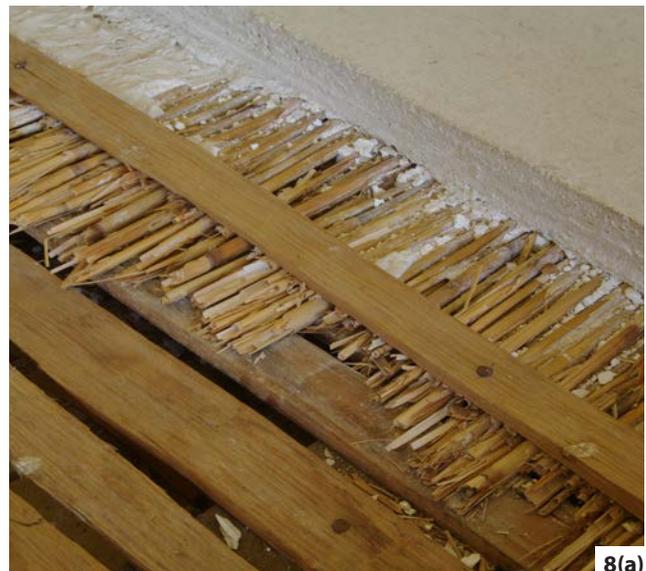
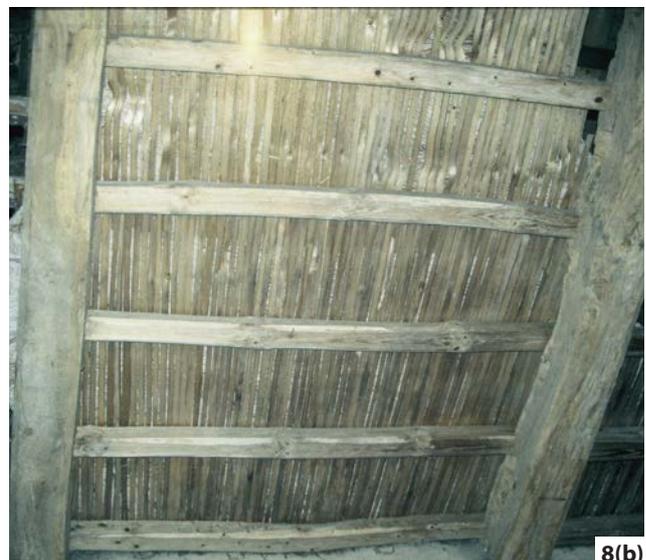
Figure 8: Organic bedding material: (a) Reed, as seen in a sample box cutaway. (b) Laths.

A variation has been noticed in high status buildings where riven hardwood laths were nailed to the joists before the bedding material was laid (particularly where hay was used). (See figure 8). In rare cases, the plaster was spread over boarding.

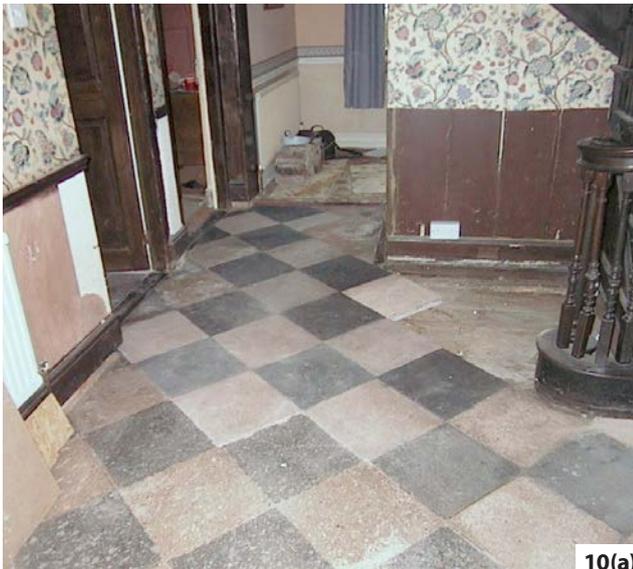
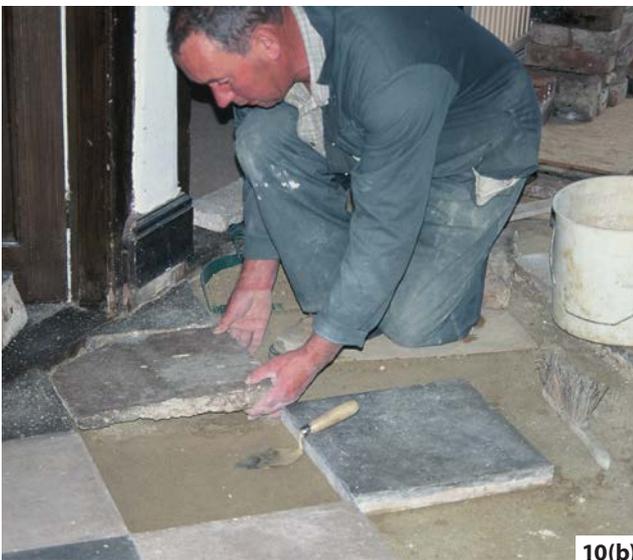
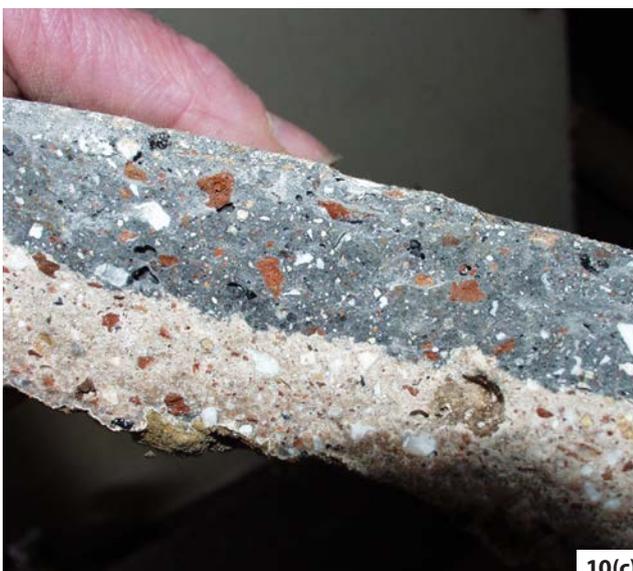
Figure 10: A historic solid gypsum plaster floor at Scraftoft, Leicestershire laid to imitate tiles: (a) General view. (b) Alternating black and white 'tiles'. (c) The two layers forming a black tile.
Photos: A J Goode Ltd

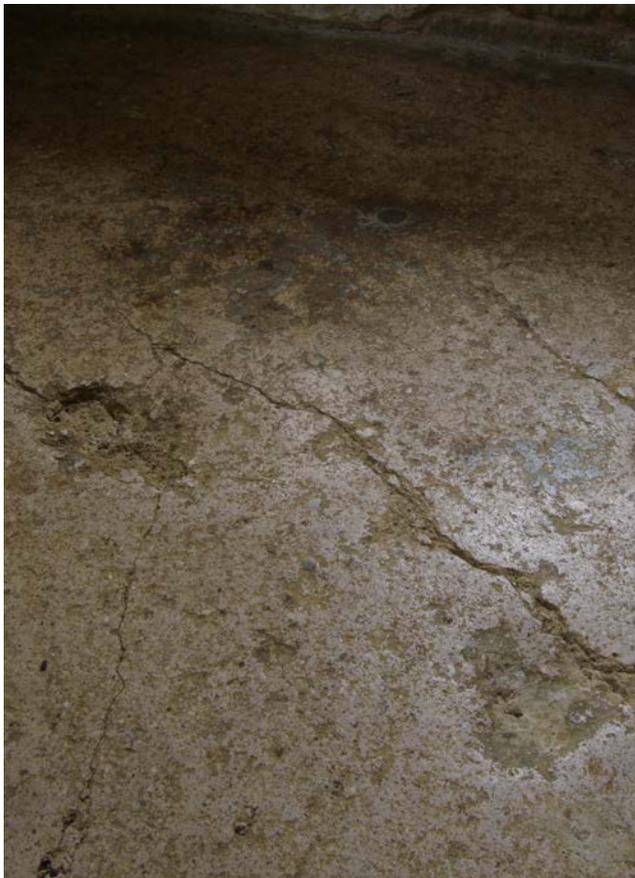
Figure 11: An old gypsum plaster floor may look beyond repair but can frequently be brought back into a sound, functioning condition. Photo: Douglas D Kent

Knowledge about the history and construction of gypsum plaster floors will assist with the diagnosis of any defects. Once the nature and cause of defects are established, an appropriate form of repair can be implemented to maintain the integrity of the floor yet retain as much of the original fabric as practicable. Many old plaster floors continue to be serviceable but over time can become heavily eroded, weakened or fail (see figure 11).

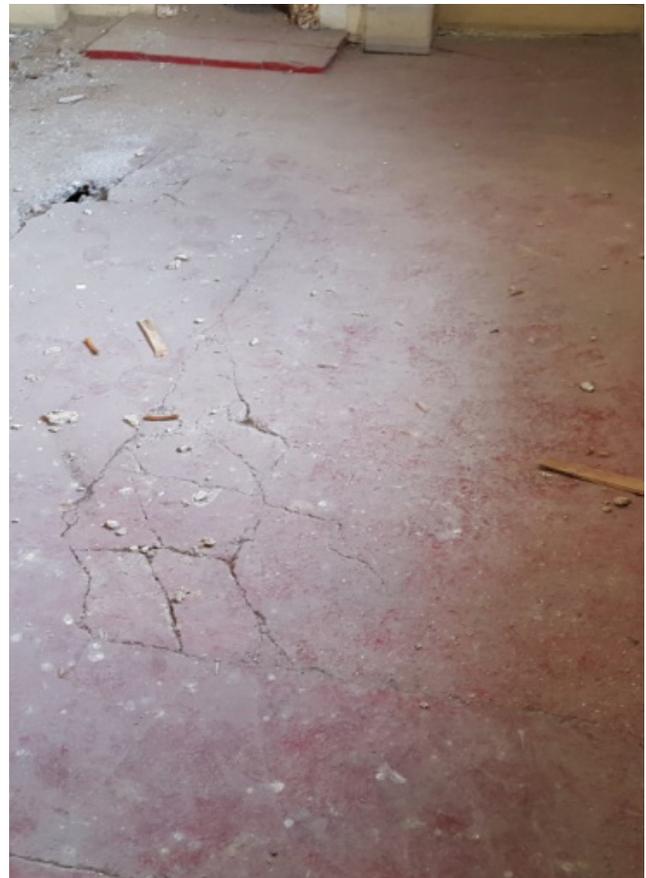
Figure 12: The nature and causes of defects should be clearly established before carrying out work involving an old gypsum plaster floor. Photo: Bonsers Restoration Ltd

Many old plaster floors are uneven and distorted but this does not necessarily indicate ongoing or recent movement causing damage that requires attention. Gypsum plaster floors can distort and crack for various reasons, leaving them more susceptible to abrasion, impact damage and, in extreme cases, collapse (see figure 12):

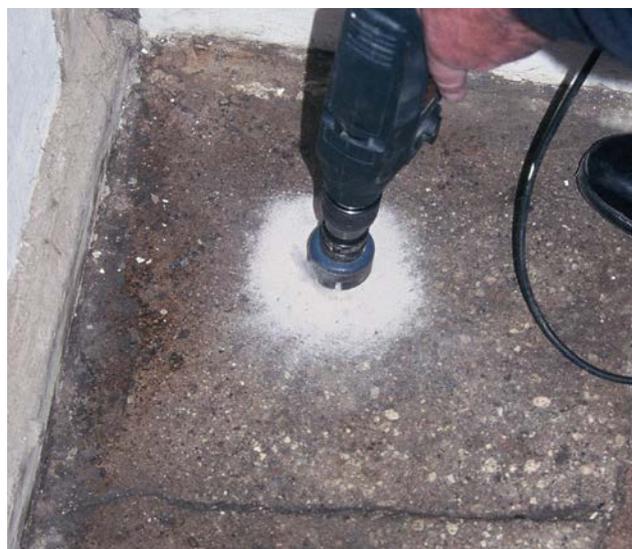
Figure 14: Drilling to remove a core sample of a gypsum plaster floor for laboratory analysis. Photo: A J Goode Ltd

ascertained by laboratory analysis (see figure 14 and section 11.1). Such analysis is normally essential, therefore, to formulate a suitable plaster mix for repairs. It is important when sampling historic plaster floors to ensure the specimen being analysed is representative of the inhomogeneous material. Take care not to inadvertently select inappropriate later work. A range of simple and sophisticated analytical techniques is available to establish the ingredients and their proportions. Be sure, however, to employ an experienced analyst who can interpret the resulting data accurately.

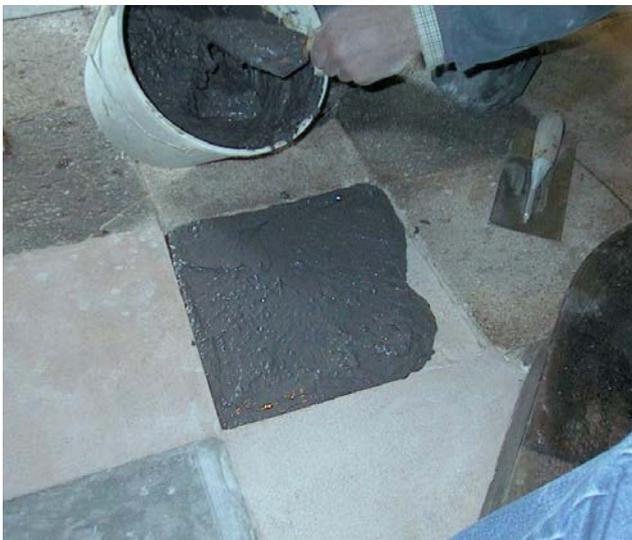
Figure 15: Materials and methods for repairs should match those of the original gypsum plaster floor as far as possible.
Photo: A J Goode Ltd

Methods and materials should be chosen to ensure that the appearance and performance of repairs correspond, as far as possible, to those of the original floor (see figure 15). A sympathetic match is important not only for aesthetic reasons but also to help ensure good durability. Cement or lime plaster should not, therefore, be used as a substitute for gypsum plaster of a suitable composition.

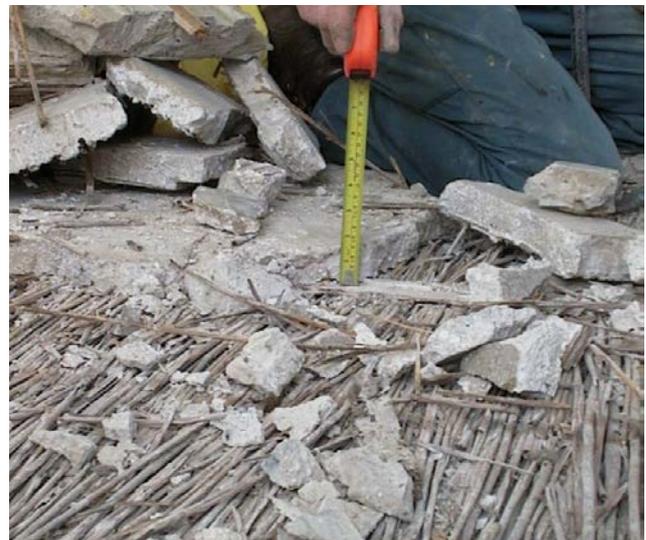
Figure 16: Old gypsum plaster that is removed should normally be retained for use as aggregate when laying replacement flooring.
Photo A J Goode Ltd

Where possible, any gypsum plaster removed from a floor should be crushed and reused as aggregate in new plaster, as was frequently done historically. This helps ensure the visible aggregate matches the old floor, particularly as the surface wears and the old particles become exposed. It is also likely to encourage crystallisation. New plaster is added to the aggregate in proportions identified by analysis. If recycled material is not available, many of

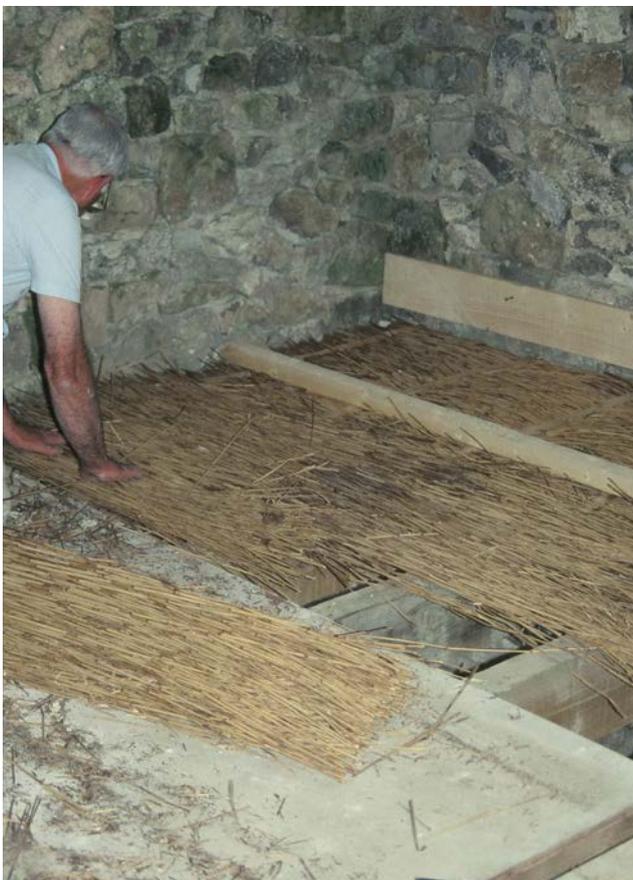
Figure 17: New reed bedding being laid.

The bedding or base of a floor may require repair or, if unavoidable, replacement before new plaster is laid (see figure 17). Repairs should normally be like-for-like in terms of methods and materials, including any used for sound deadening.

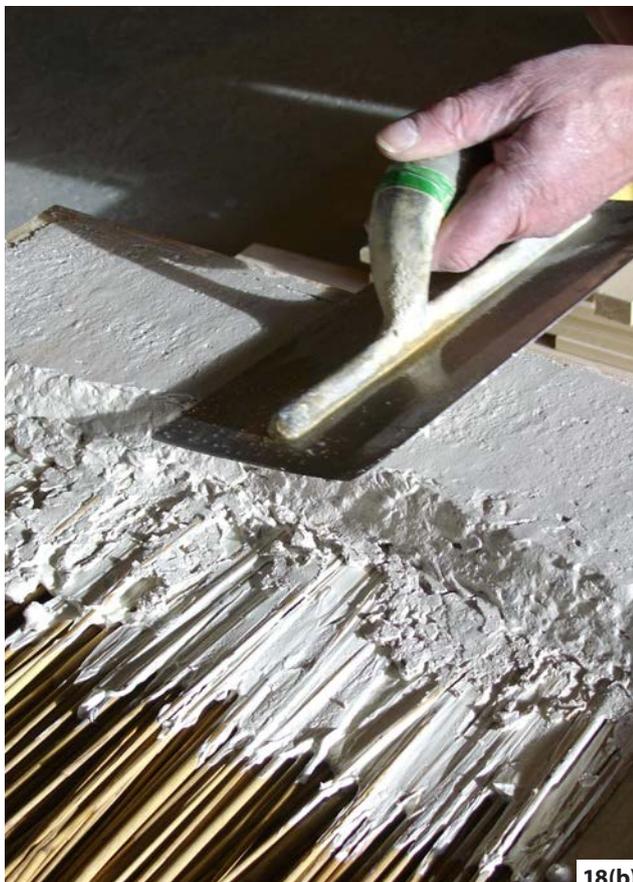
Figure 18: Bedding material being dressed with lime putty (a) over which, as in this demonstration, gypsum plaster is laid. (b) .
Photos: Douglas D Kent (a) and AJ Goode Ltd(b)

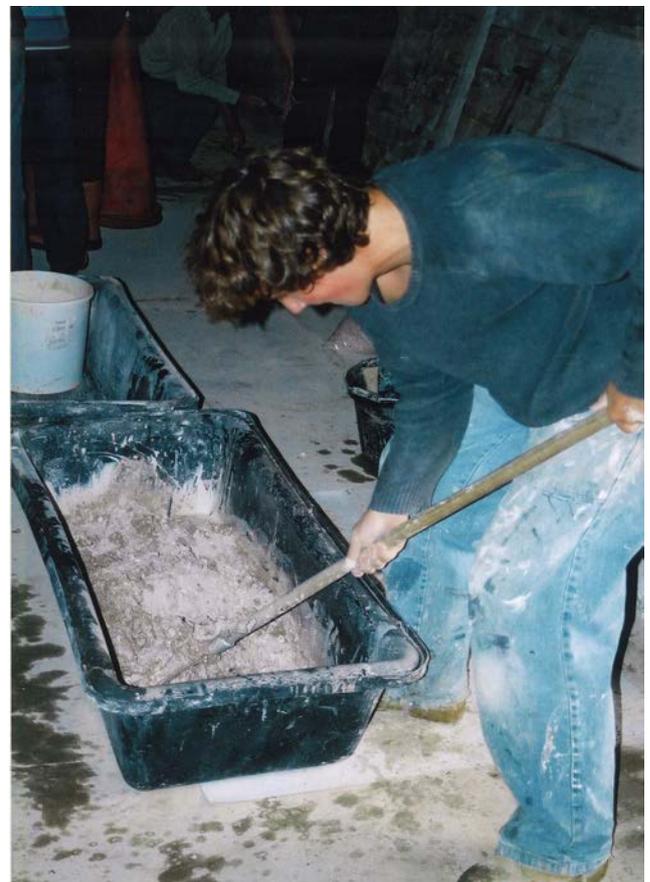
Figure 19: Mixing gypsum plaster in a plasterer's bath.
Photo: Douglas D Kent

The main issue affecting the mixing of plaster for a floor is the volume of water required (before it is added to the blended aggregates). The water content for the plaster is found in the product information sheets but more may be needed for dry aggregates. This can be

estimated by adding a measured volume of water to a known amount of dry aggregate. For example, if 1 kg of dry aggregate absorbs, say, 300 ml of water without excess, multiplying the water content to the weight of aggregates used in a mix will give the extra water needed.

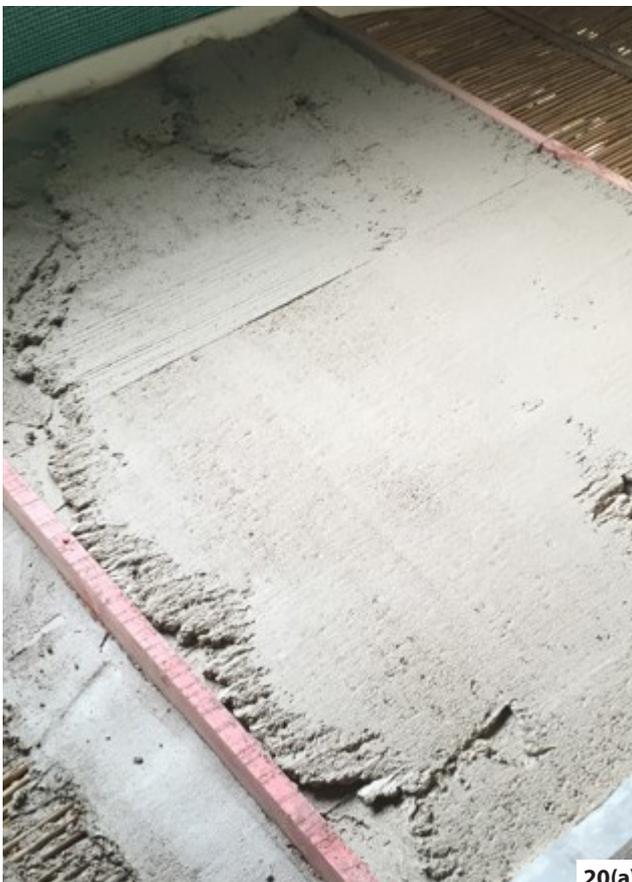
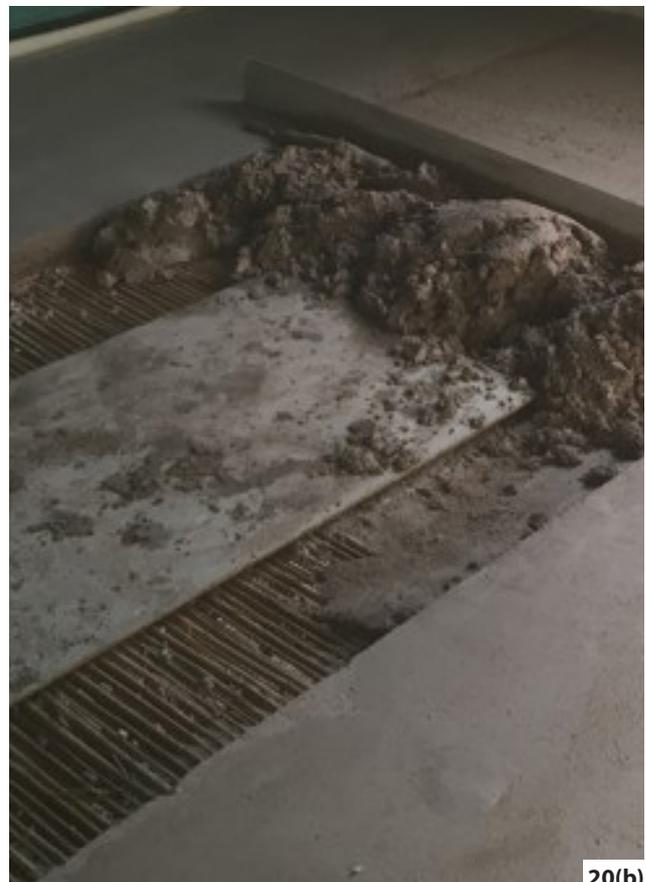
Figure 20: New gypsum plaster being laid between temporary timber battens (a) before the adjacent sections are infilled (b).

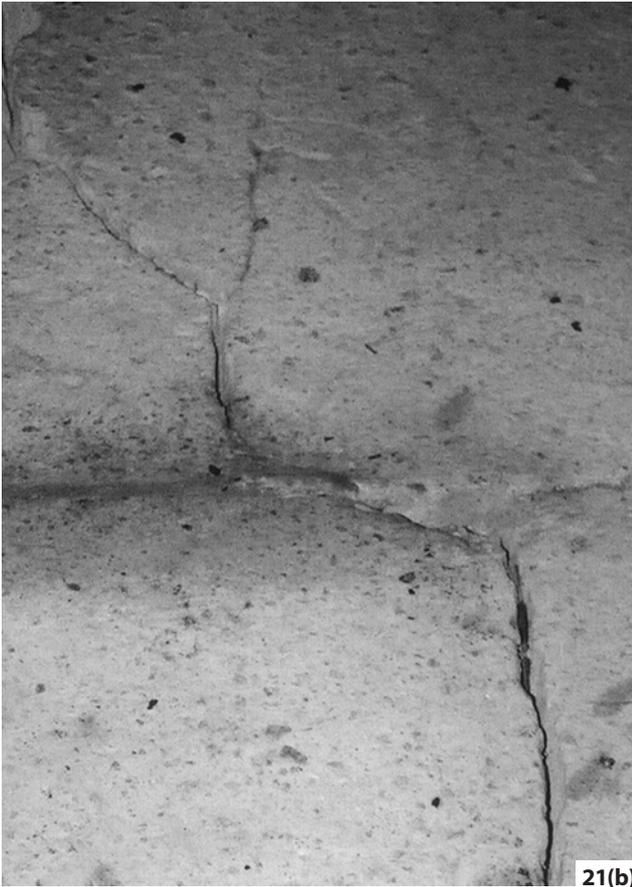
Figure 21: Cracking in gypsum plaster: (a) Raked out for repair. (b) Filled with a matching new mix.
Photos: Douglas D Kent (a) and A J Goode Ltd (b)

Holes from redundant pipe or cable runs can be filled, as can wide cracks if stable.

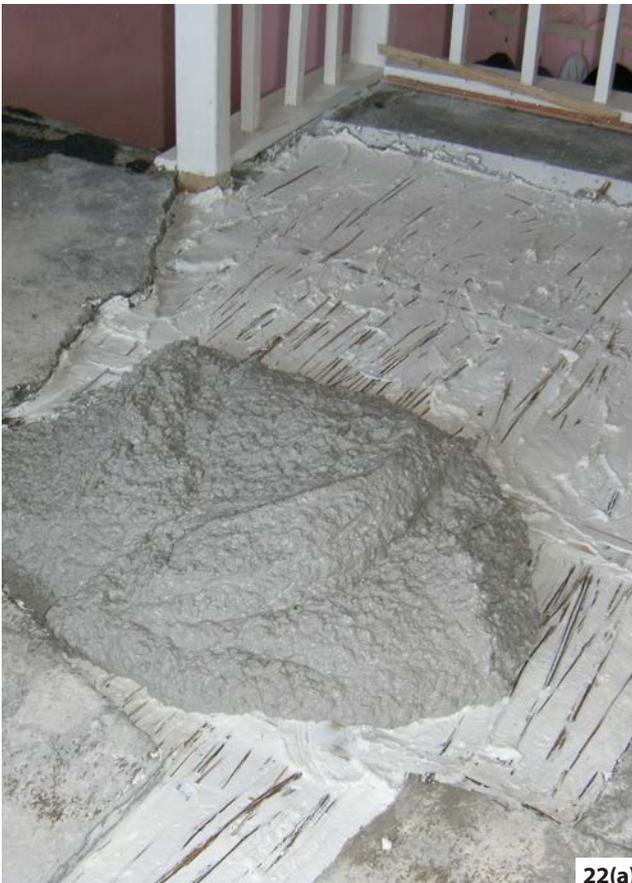
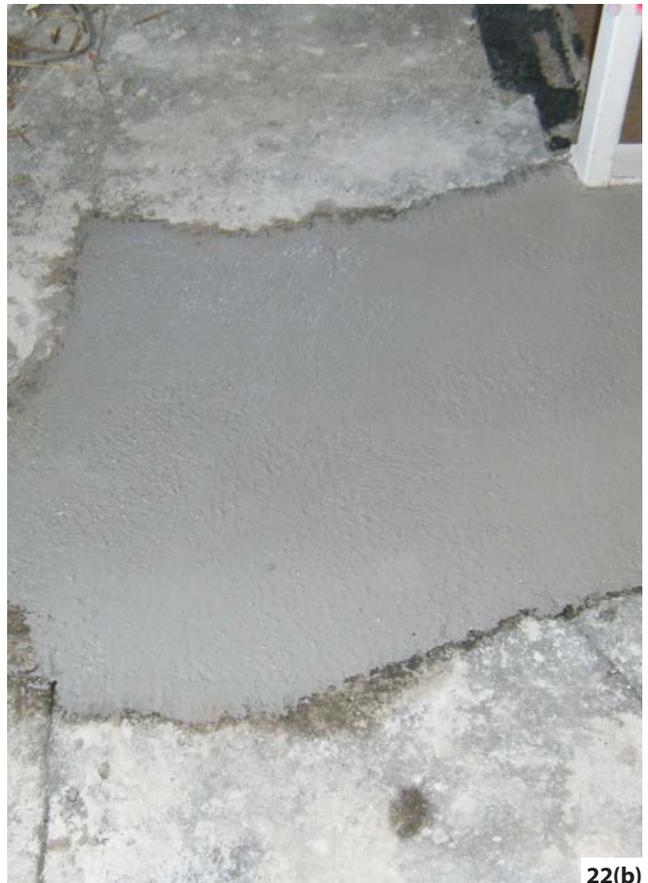
Figure 22: Patch repair: (a) New plaster being spread over a dressing of lime putty. (b) Finished level with the existing surface.
Photos: A J Goode Ltd
