PROBE

13: Charities Aid Foundation

Natural ventilation, adiabatic cooling and passive solar architecture – the makings of an environmentally sound and low energy building. But has the headquarters building for the Charities Aid Foundation lived up to its billing?

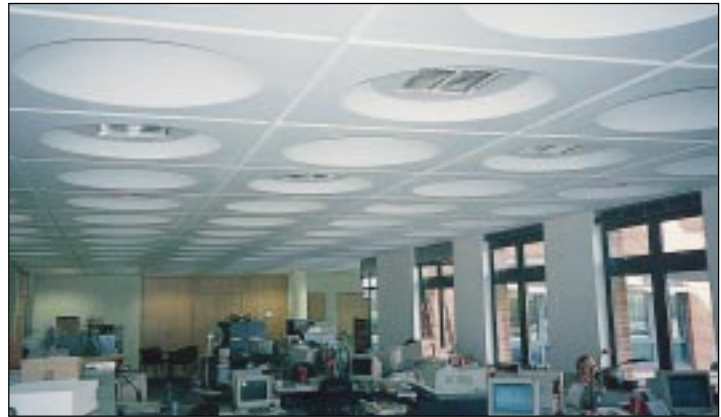
The offices at the CAF building feature an exposed concrete ceiling. Good for thermal balance but, without acoustic treatment, poor for noise control.

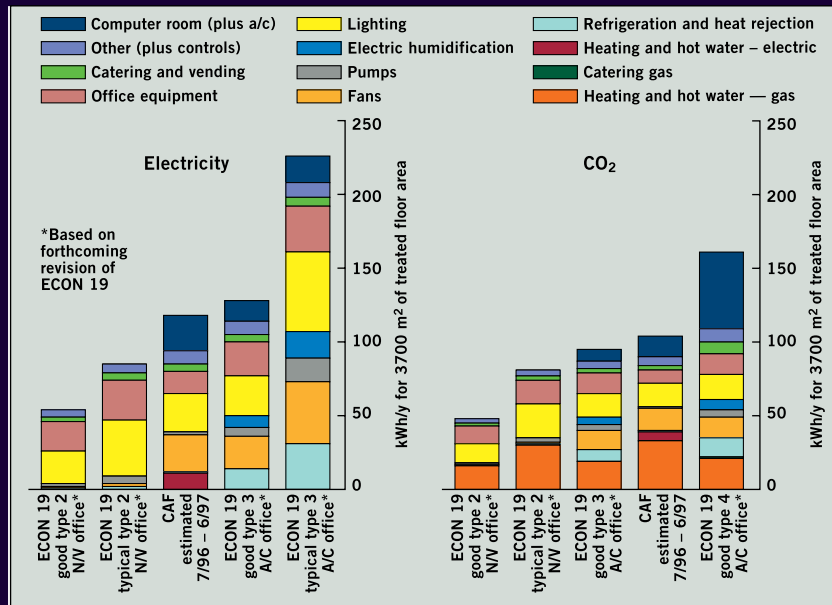
FIGURE 1: End-use energy breakdown at the Charities Aid Foundation building. Note that the conversion factors are: electricity 0.6 kg CO₂/kWh and gas 0.2 kg CO₂/kWh.

Annual electricity consumption between July 1996-June 1997 was 117kWh/m² of treated floor area, very close to the design estimate of 120kWh/m². Figure 1 shows a detailed breakdown and compares it with a range of relevant benchmarks from the forthcoming edition of *ECON Guide 19*⁴.

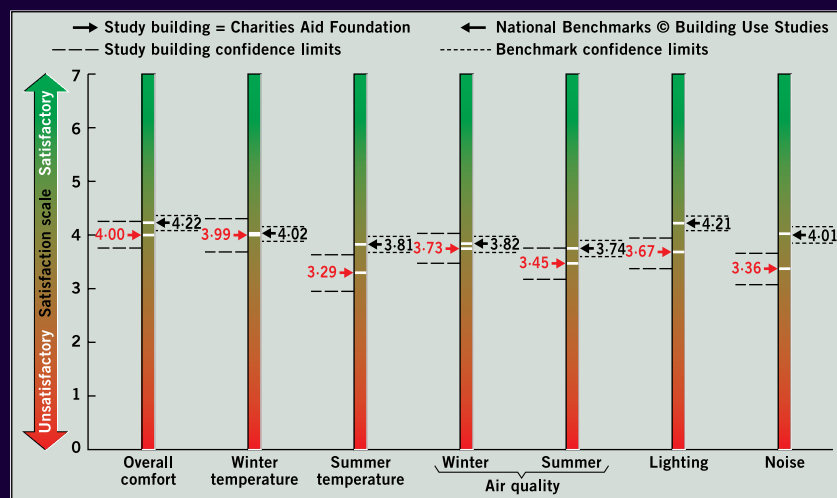
FIGURE 2: Overall satisfaction with comfort conditions at the CAF. Green scores are good, red are poor.

Summertime temperatures overall were perceived to be much hotter, less comfortable and more variable than the benchmarks (figure 2). Analysis shows thermal comfort on the first floor to be similar to the building mean, the ground floor is cooler and more comfortable and the second floor is hotter owing to the additional planar glazing and rooflights.

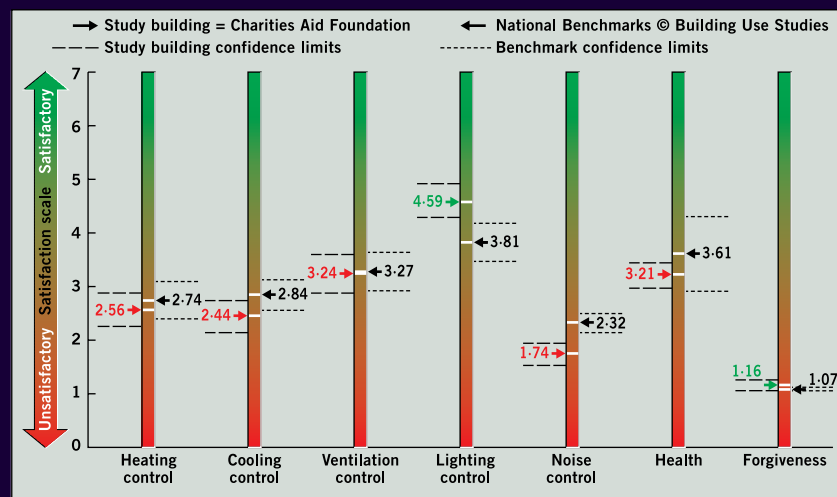
FIGURE 3: Occupant satisfaction with the CAF building's health, management and control strategies.

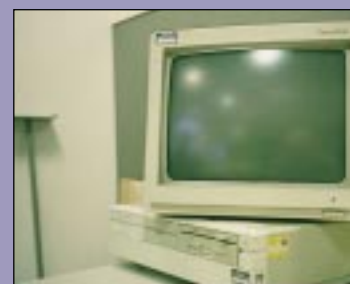
On asking why, a common reply was that the ceiling lights caused headaches. One reason for this seemed to be that the louvres had different cut-off angles in different directions, causing distracting reflections in some computer screens. Interestingly, some local problems have been resolved by rotating fittings through ninety degrees.

...the penalty has been glare problems on computer screens, and additional noise pollution from the untreated soffit.

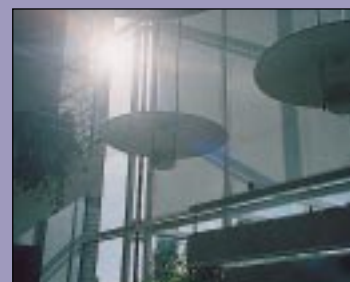
The architect warned that blinds might be necessary, but it was decided to wait and see. In practice, the sun shone onto the desk from about 14.00h, with severe consequences both for glare and thermal comfort. Motorised internal roller blinds have now been added under manual control from reception.

Sun glare into the reception area required a retrofitted sunblind.
