probe 4

Queens Building

Roland Asbridge and Robert Cohen report on how de Montfort University's Queens Building has performed since its completion. To understand the building's detailed design readers should refer to the original building analysis 'Learning curve' which appeared in the October 1993 issue of *Building Services Journal*.

The fourth article in the PROBE series revisits the Queens Building the award winning School of Engineering and Manufacture completed in 1993 for de Montfort University in Leicester. Today the building represents a benchmark in natural ventilation, daylighting and passive solar design.

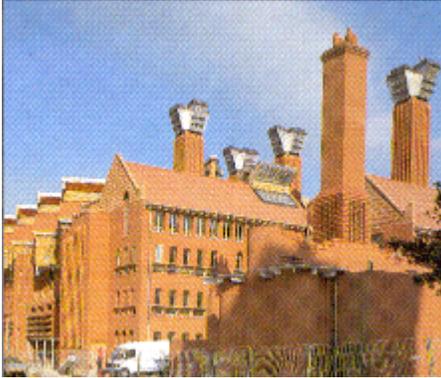
The stems on three of the main three-port control valves broke soon after completion. Because of a protracted dispute with the contractor these have only recently been replaced. However they subsequently broke once again which raises a question over their suitability for the particular application.

The major problem this caused was circulation of hot water through the heating distribution pipework during summer. Even though the pipework is well insulated, the high level routing through the third floor staff areas contributed to overheating problems. In an effort to overcome the problem the boilers have been manually isolated during the summer of 1995 and the immersion heaters in the central calorifiers used for hot water generation.

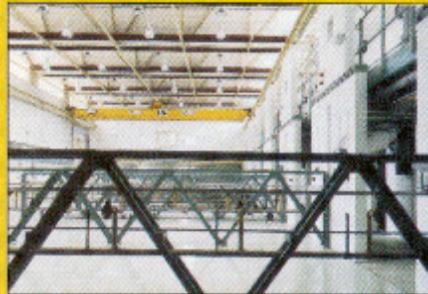
During the first winter of operation an aluminium actuator arm sheared off the opening mechanism on one of the rooflights. This may have been due to the rooflight being frozen in position, but to avoid the risk of this recurring some have been disabled until an appropriate solution has been identified.

Some of the actuators on the rooflights have been disabled until they can be made more robust.

Ventilation Ventilation opening mechanisms need to be carefully specified to ensure that they are sufficiently robust for the specific application, and that there is suitable indication for remote, out of sight operation.

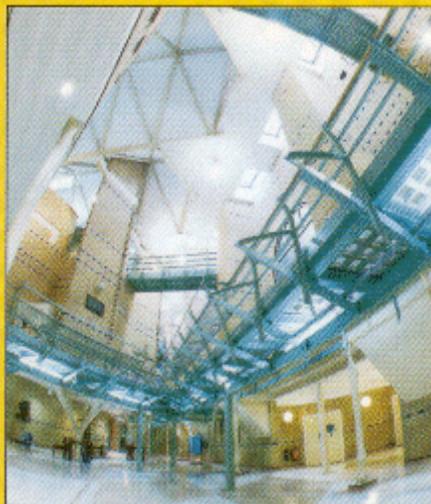
The use of high bay SON lamps is probably an efficient choice, but striking characteristics do not encourage frequent manual switching.

Lighting In the machine hall, good daylight factor is achieved without risk of glare or noise breakout, but artificial lighting is used regardless whenever heavy machinery is operating, seemingly on health and safety grounds. While the use of high bay SON lamps is probably the most efficient fitting for the application its striking characteristics do not encourage frequent manual switching.
