Chapter 7

Technical Issues and Solutions

Making New York City Parks Accessible

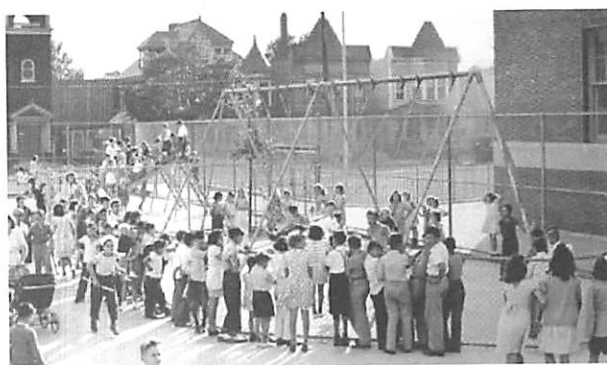
Figure 2. Moses-era standard swing set (New York City Department of Parks and Recreation, circa 1935)

Perhaps the most ubiquitous New York City park type is the playground. There are more than 950 playgrounds citywide, each requiring renovation approximately every twenty years to meet changing safety requirements and to remedy intensive wear and tear. During the tenure of Robert Moses as Parks Commissioner from 1934 to 1960, the renowned city planner, parks commissioner, and builder, the number of playgrounds swelled from 119 to 861 and could be found in every corner of the city. Moses achieved this massive development of play spaces partially through the federally subsidized Works Progress Administration, which, at its height, employed more than 80,000 landscape architects, architects, and construction staff in New York City parks.¹ These designers developed playground and park standards that established a formulaic imposition on the landscape; there were comfort station types a, b, and c, and drinking fountain types a, b, and c. Play equipment came in the parks' own form of Sears catalogue: standard slide, standard swing, and standard seesaw (Figure 2).

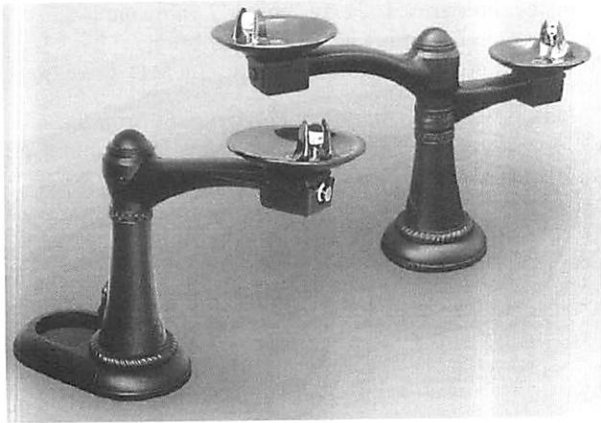
Figure 5. Accessible drinking fountains (New York City Department of Parks and Recreation, 1991)

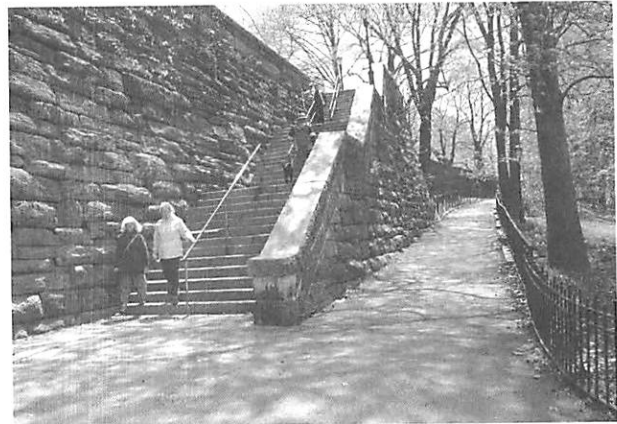
Figure 6. Olmsted steps in Riverside Park (New York City Department of Parks and Recreation, 2005)

Landmark parks that retain much of their Olmsted- and Moses-era character, such as Riverside Park, offer extreme challenges to designers and planners who seek to make these historic landscapes accessible. Margaret Bracken, landscape architect for Riverside Park, undertook its analysis to determine the most rational and practical accommodation for accessibility without disrupting the historic step ramps of the Moses era and the magnificent grand masonry steps that survive from the Olmsted design (Figure 6).

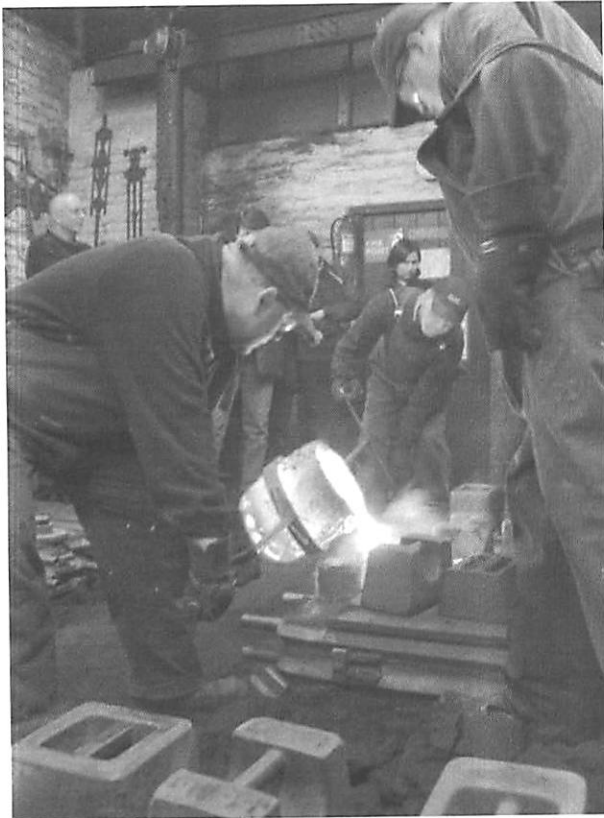
Figure 3. Casting grey iron into green sand molds at Beaverbank Foundry, Edinburgh, in 2004 (Copyright, D.S. Mitchell)

Grey iron is readily available, but sourcing high quality pattern making for architectural works is a significant problem in the United Kingdom, as is finding iron founders with the necessary skills and experience. Replacement castings should be moulded traditionally in green sand rather than

modern foundry sands—the finish is often better in skilled hands and stimulating demand will help to perpetuate the craft skill. It is good practice to ensure that any new components for an existing structure are marked with the maker's name and dated for future reference (Figure 3).

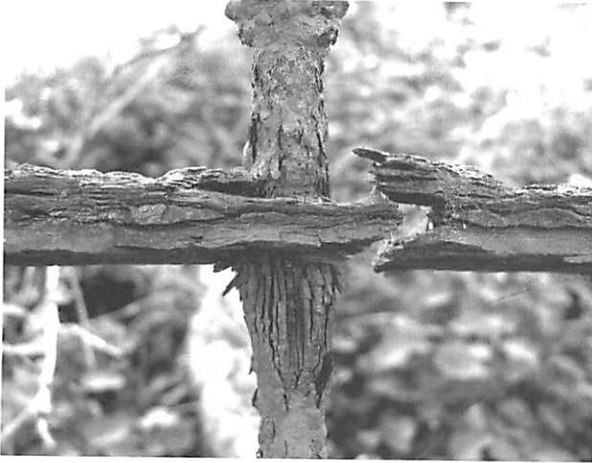
Figure 4. Conservation challenges indeed—wrought iron delamination in a marine environment, Stornoway, Western Isles (Copyright, D.S. Mitchell)

nance of structural integrity—objectives that can be diametrically opposed. Repairs are by nature intrusive to some extent, but the preservation of historic fabric should always be the primary factor. The most successful philosophy is to approach the project with a variety of repair techniques, and consider each circumstance on an individual basis (Figure 4).

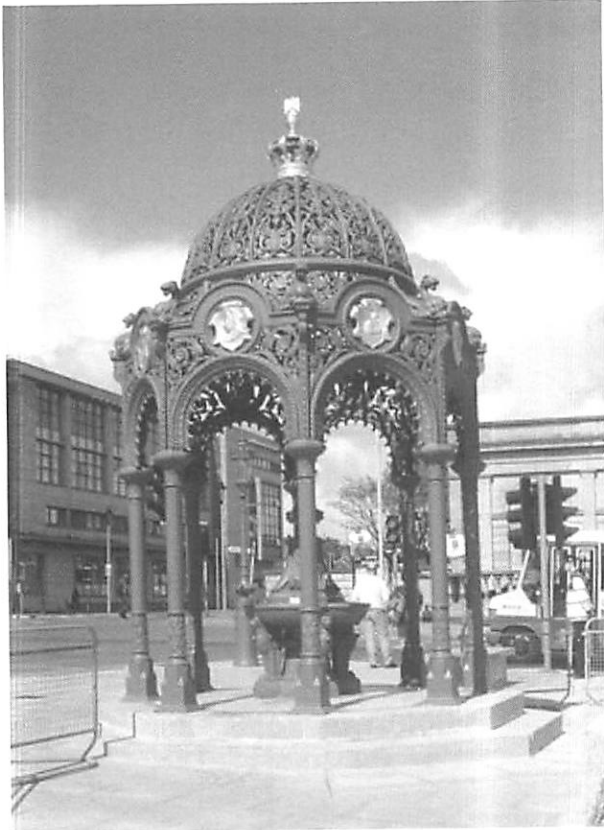
Figure 5. Dun Laoghaire Fountain Canopy, Dublin
(Heritage Engineering, Glasgow)

A fountain canopy (Figure 5) was reconstructed to a Saracen design in Dun Laoghaire, Ireland. Though the original had been largely destroyed, a

decision was made to use the materials and techniques employed on the original canopy to gain an understanding of the manufacturing process. Timber patterns were used with castings in grey iron, moulded in green sand. An original example in Glasgow served as a reference point. The project was challenging to the pattern maker and iron founder alike, but the result perhaps reflects the zenith of the historic craft.

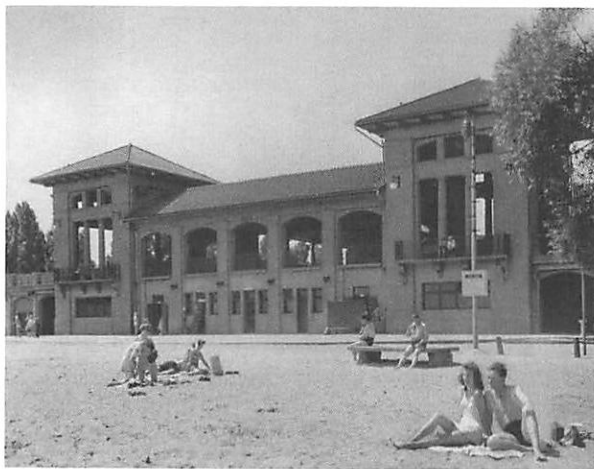
Figure 1. The lake side of the beach house probably in the 1940s (Chicago Park District, Department of Special Collections)

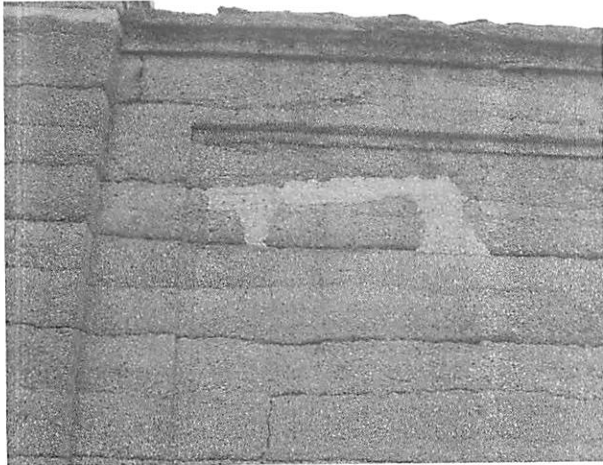
Figure 3. Wall construction of the Beach House with lift lines between concrete placements. Note the intentional inconsistency of the placement and variable aggregate exposure. (Wiss, Janney, Elstner Associates, Inc.)

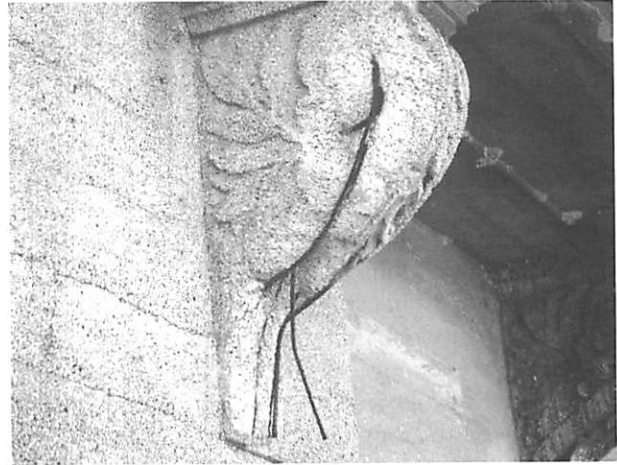
Figure 4. Severe deterioration of a concrete ornamental bracket below a balcony. The deterioration was due to corrosion of embedded reinforcing steel. (WJE)

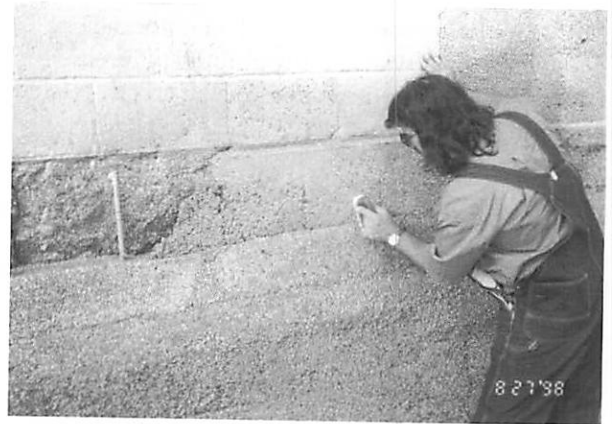
Figure 6. Craftsman placing and finishing repair concrete in a mock-up area. The craftsman developed techniques to maintain an inconsistent aggregate exposure to match the variability in the original adjacent concrete. (WJE)

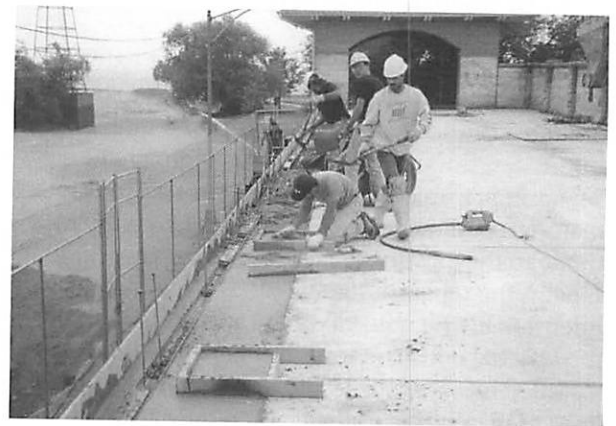
Figure 7. Placement of architectural concrete along the projecting edge of the upper terrace. The concrete was placed against formwork with a concrete retarder and then hand finished to match original concrete. (WJE)

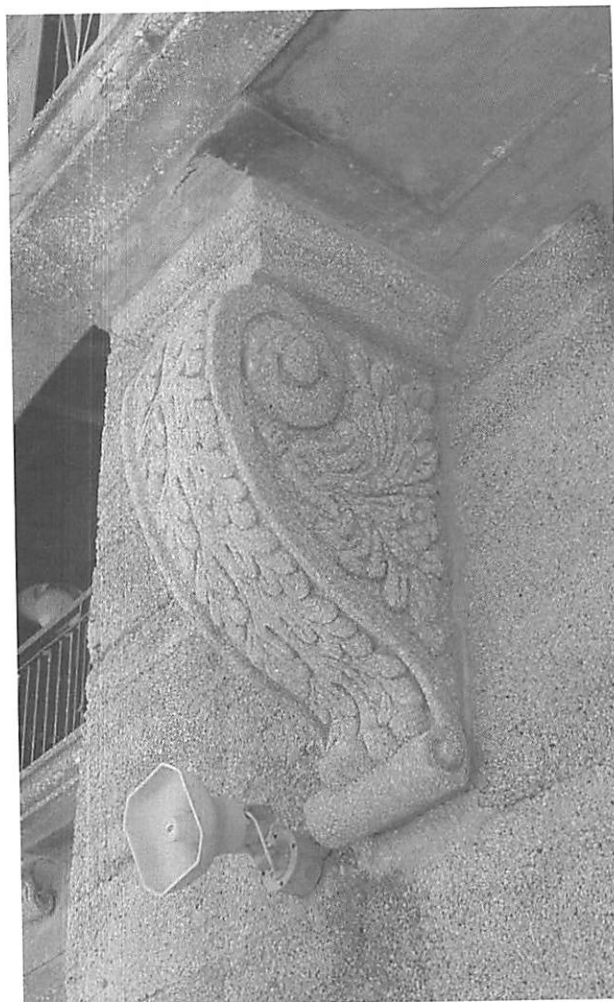
Figure 8. Replacement precast concrete bracket that was installed below the balcony (WJE)

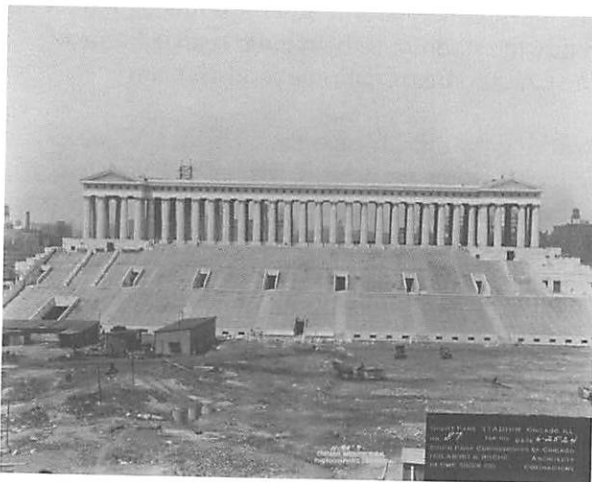
Figure 3. Completed west colonnade, 1924 (Chicago Park District Special Collections)

At a construction cost of \$13 million, the stadium was completed and dedicated in 1926 in honor of the soldiers of the First World War. Figure 3 shows the nearly completed west colonnade. Over the years the stadium has been used for myriad public events, including football, boxing, soccer, midget-car races, concerts, and other assemblies. Currently the stadium is the regular season home of the Chicago Bears national football team.

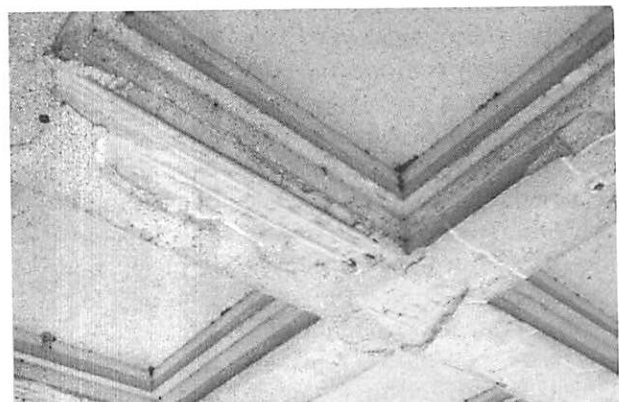
Figure 5. Typical concrete spall in coffered-ceiling beam in the colonnade. The corroded reinforcing steel was coated with epoxy paint for short-term protection. (WJE)

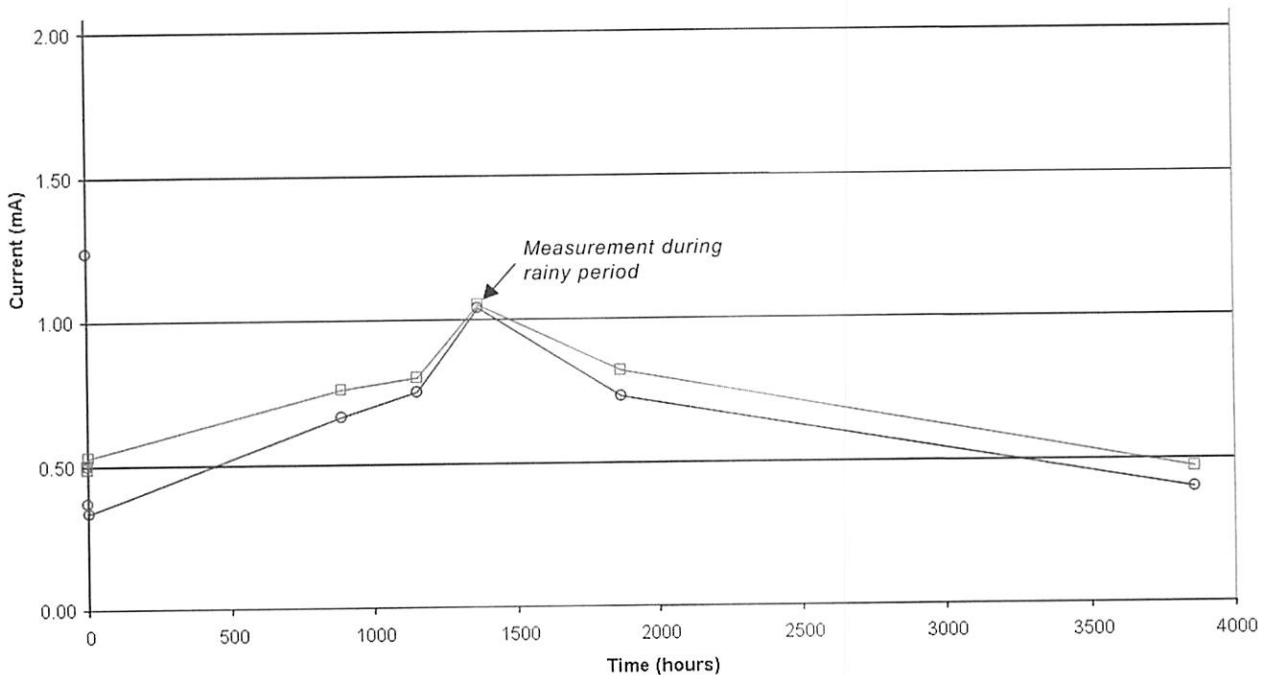
Figure 9. Change of average galvanic current output with time for two groups of zinc anodes installed in coffered ceilings (WJE)

The mean galvanic current between the zinc anodes and the adjacent reinforcing steel is shown in Figure 9. The current exhibited typical cathodic protection characteristics, that is, a large initial current output followed by a smaller current that can fluctuate with time. The measurements taken during a rainy period indicated a moderate spike in current, demonstrating that the system can deliver more current and thus greater protection with increased moisture in the concrete.

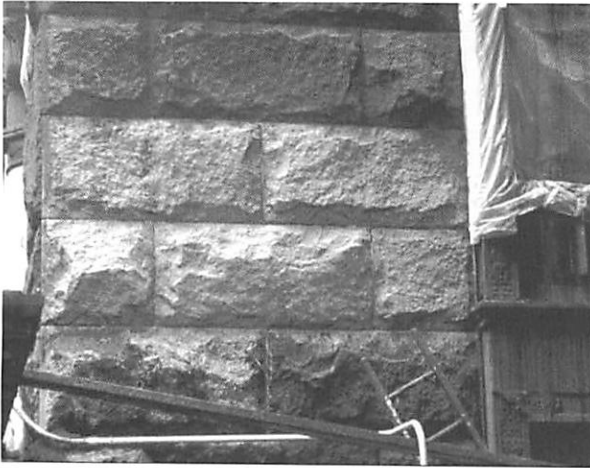
Figure 1. Successful cleaning can remove harmful deposits and enhance the appearance of historic buildings. (Wiss, Janney, Elstner Associates, Inc.)

longevity of facade materials (Figure 1), while improper cleaning can result in damage and accelerated deterioration (Figure 2).

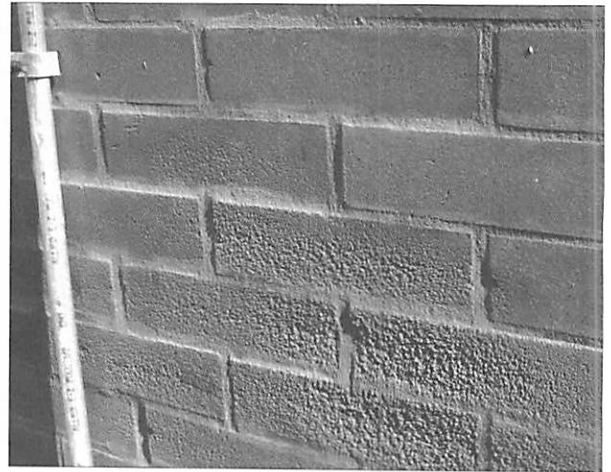
Figure 2. Inappropriate cleaning can irreparably damage building materials, such as the etching of this brick facade. (WJE)

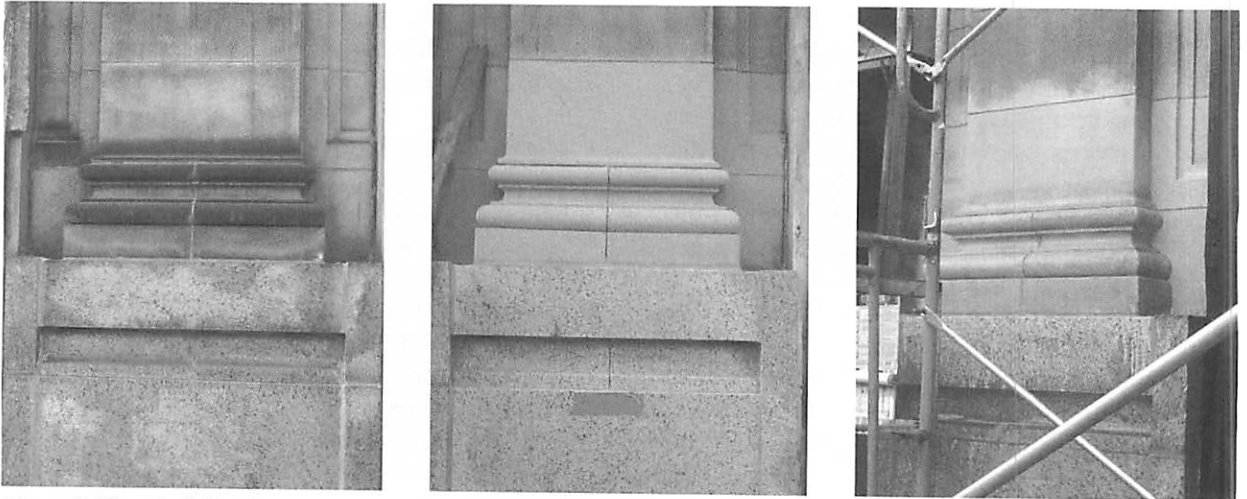
Figure 6. Chemical cleaning was used on this terra cotta and granite facade in Chicago to remove general surface dirt from water runoff and air pollution. At left, the original appearance of the facade. At center and right, field samples of two different chemical cleaning products. An examination of the sample at center with a field microscope suggested that damage to the terra cotta substrate could occur; therefore, the product used for the sample at right was selected to clean the building. (WJE)

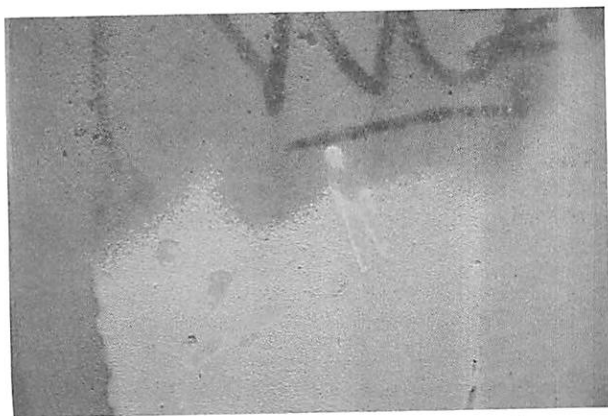
Figure 7. Use of a chemical poultice to remove graffiti. (WJE)
