Mold Clearance Inspection with Sample Analysis

CLEARANCE PASSED

Property Address:
6915 West Main Street
Belleville, Illinois 62223

Date: January 6, 2010

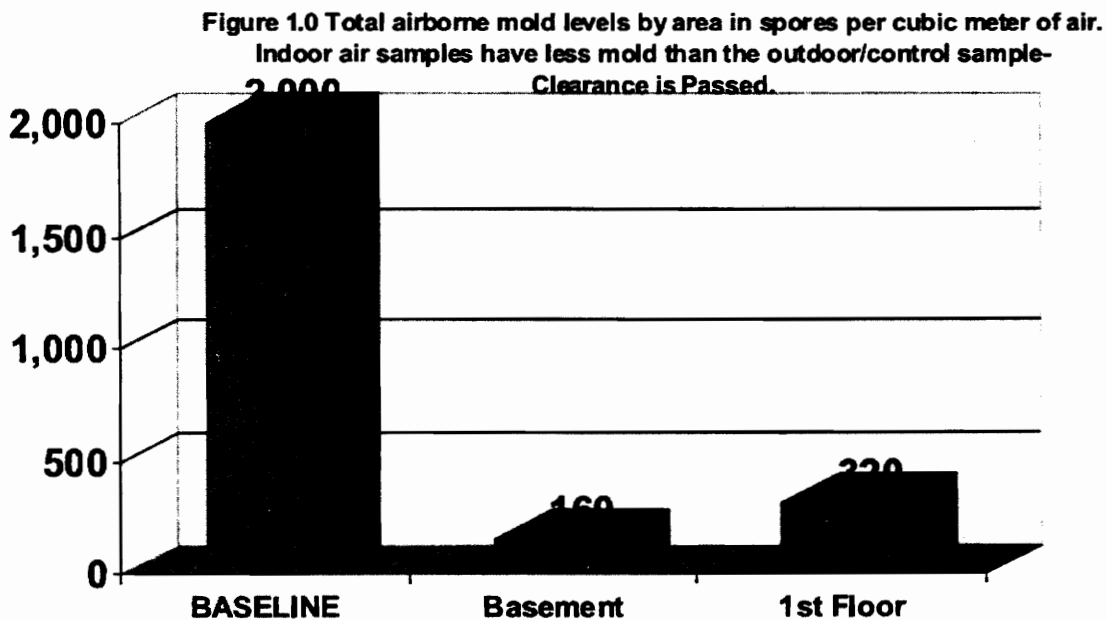
Laboratory results indicate that all samples taken have met clearance standards, total mold spores indoors less than baseline levels and no *Stachybotrys* spores in the indoor air.

See attached laboratory results.

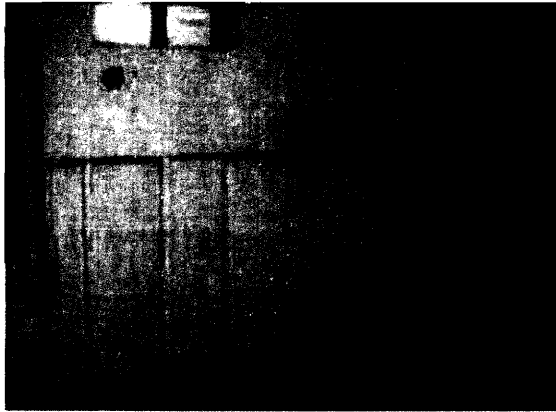
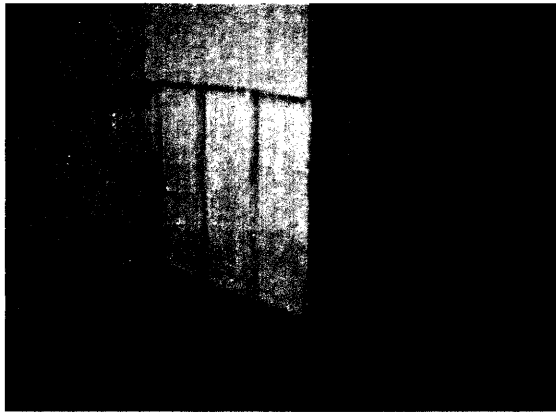
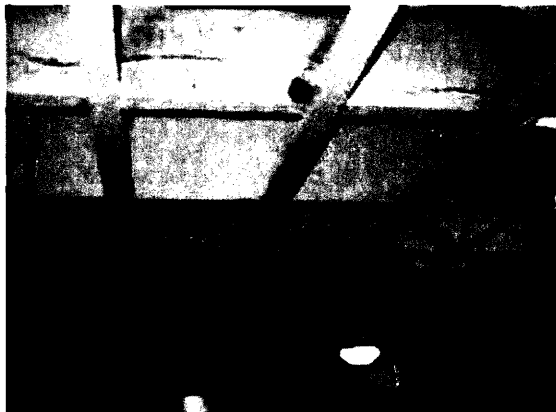
AFTER PICTURES

Upon completion of the above scope of work a clearance test was performed. This test determined whether the remediated areas of the home met clearance standards. In addition to the clearance test the on-site project manager completed a visual inspection of the building, which yielded an out come of no visible mold growths. **Results of the final testing indicated the clearance standards have been met**; the mold spore levels indoors were found to be less than the mold spore levels in the control, outdoor, sample.
