Editor: Jim Baker (Note: this is kind of roughed together, some day maybe I'll clean it up. There are are few more pictures, too, that could be added.)

INTRODUCTION

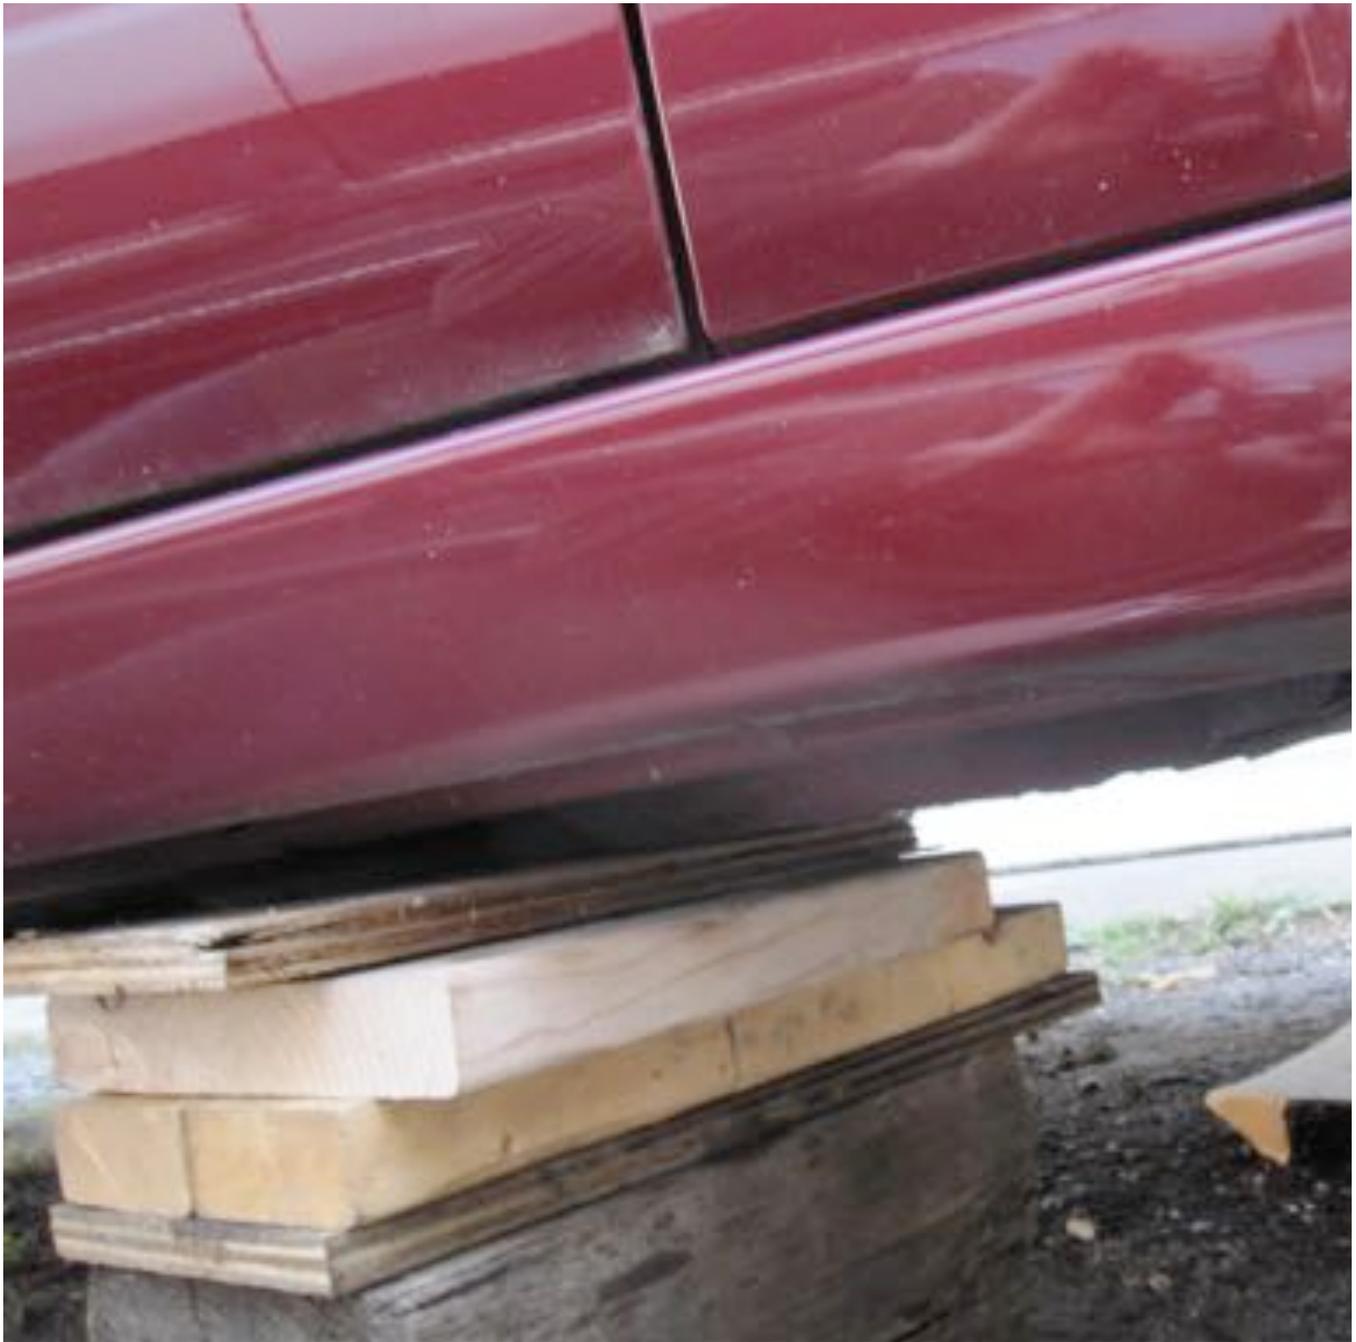
Underbody support. In lumber I trust, but not jack stands. So...

The driver's side front wheel was raised on a 3 x 6 block.

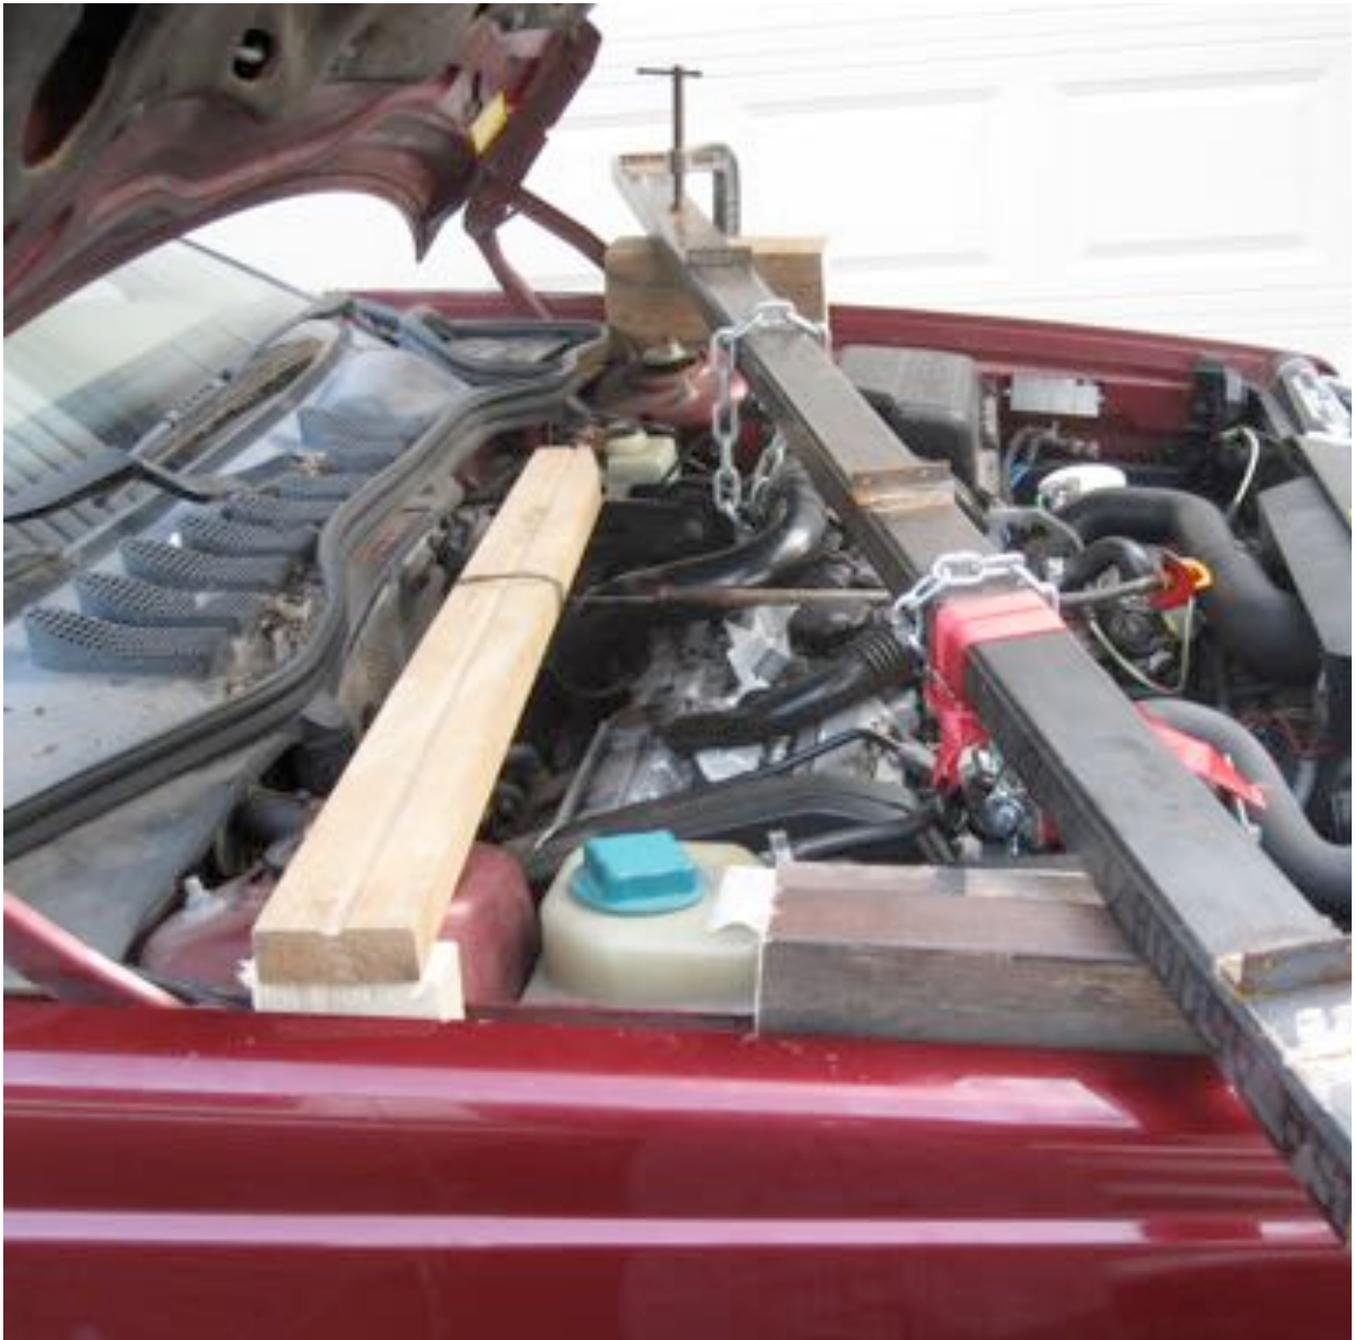
The engine needs to be raised to remove the motor mount under the crank pulley. I suspended to keep the underside workspace clear. A friend loaned me the box tubing.

Before you begin, disconnect the upper torque mount (firewall to engine bracket). Do not jack the engine before disconnecting this support.

The 2 x 4 supports are screwed together with 3 3" wood screws. The wire around the maple stick holds up the steering rack. NOTE: to suspend the engine, after unbolting the motor mount under the crank pulley, you need to jack the front of the engine from below an inch or so before securing it from above. The lengths of chain, bolts and washers are from an Ace Hardware. The extra red nylon strap taken from a ratchet tie-down is for good measure.

A friend had the box tubing which was perfect for this task.

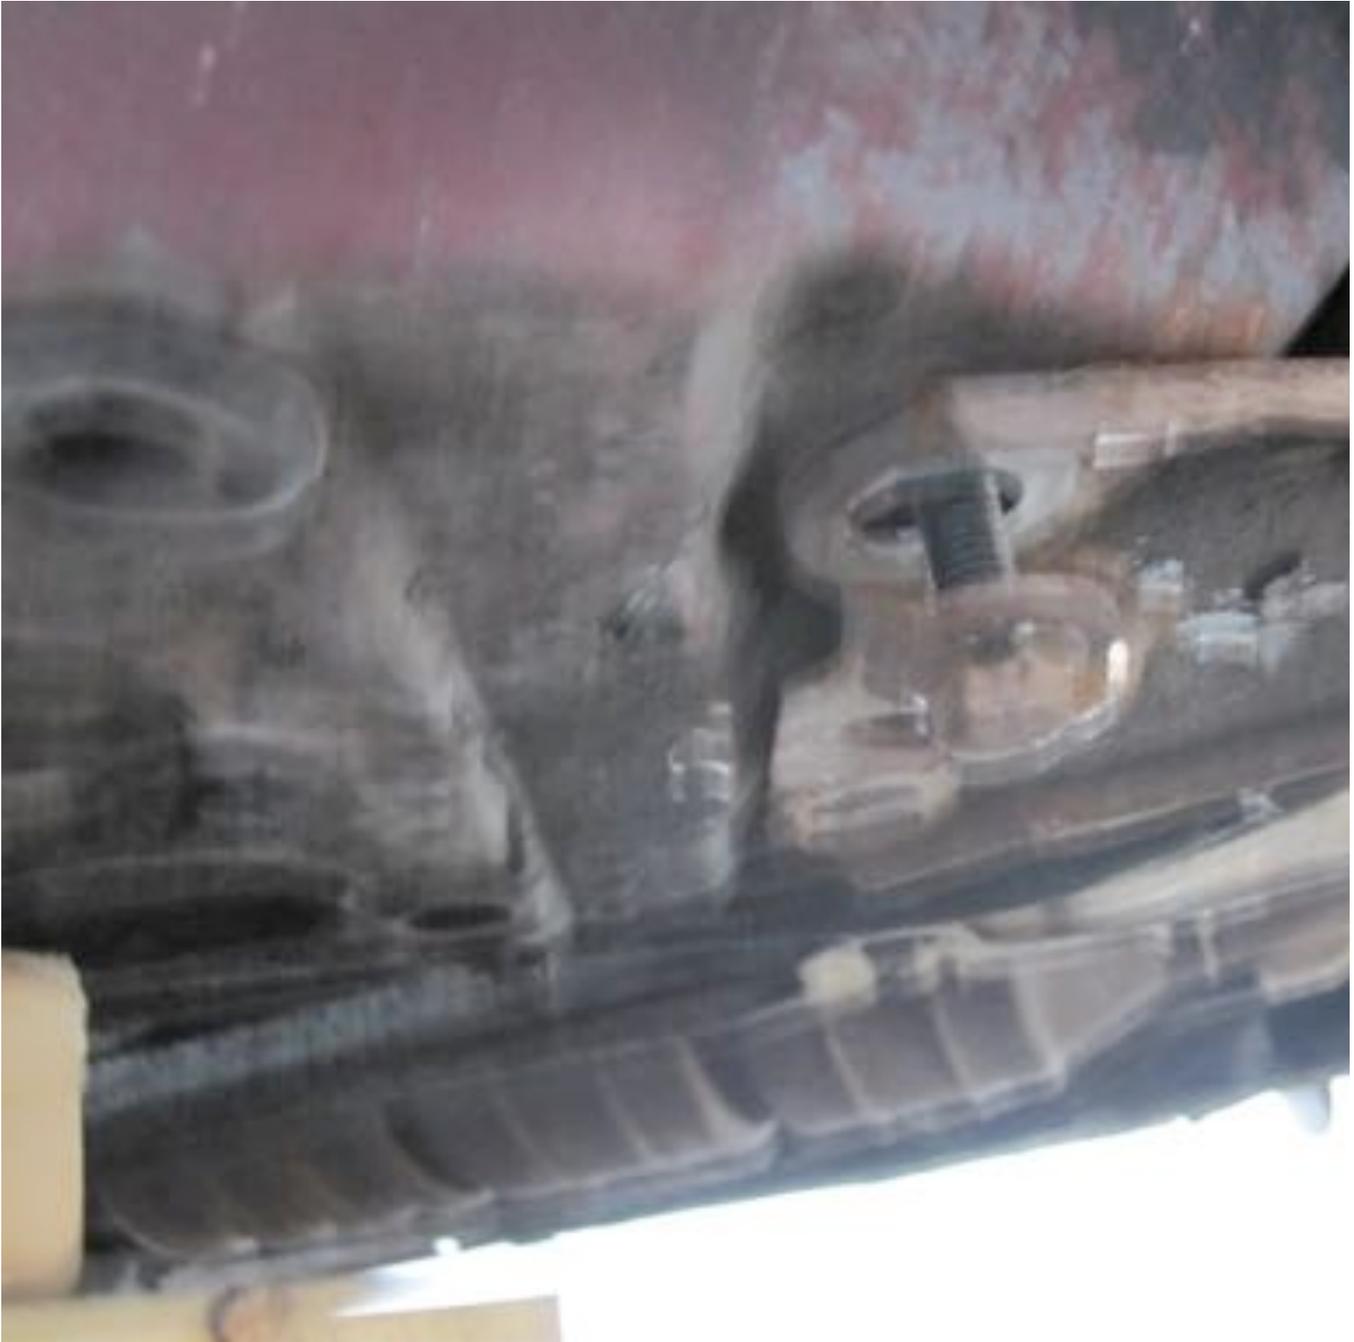
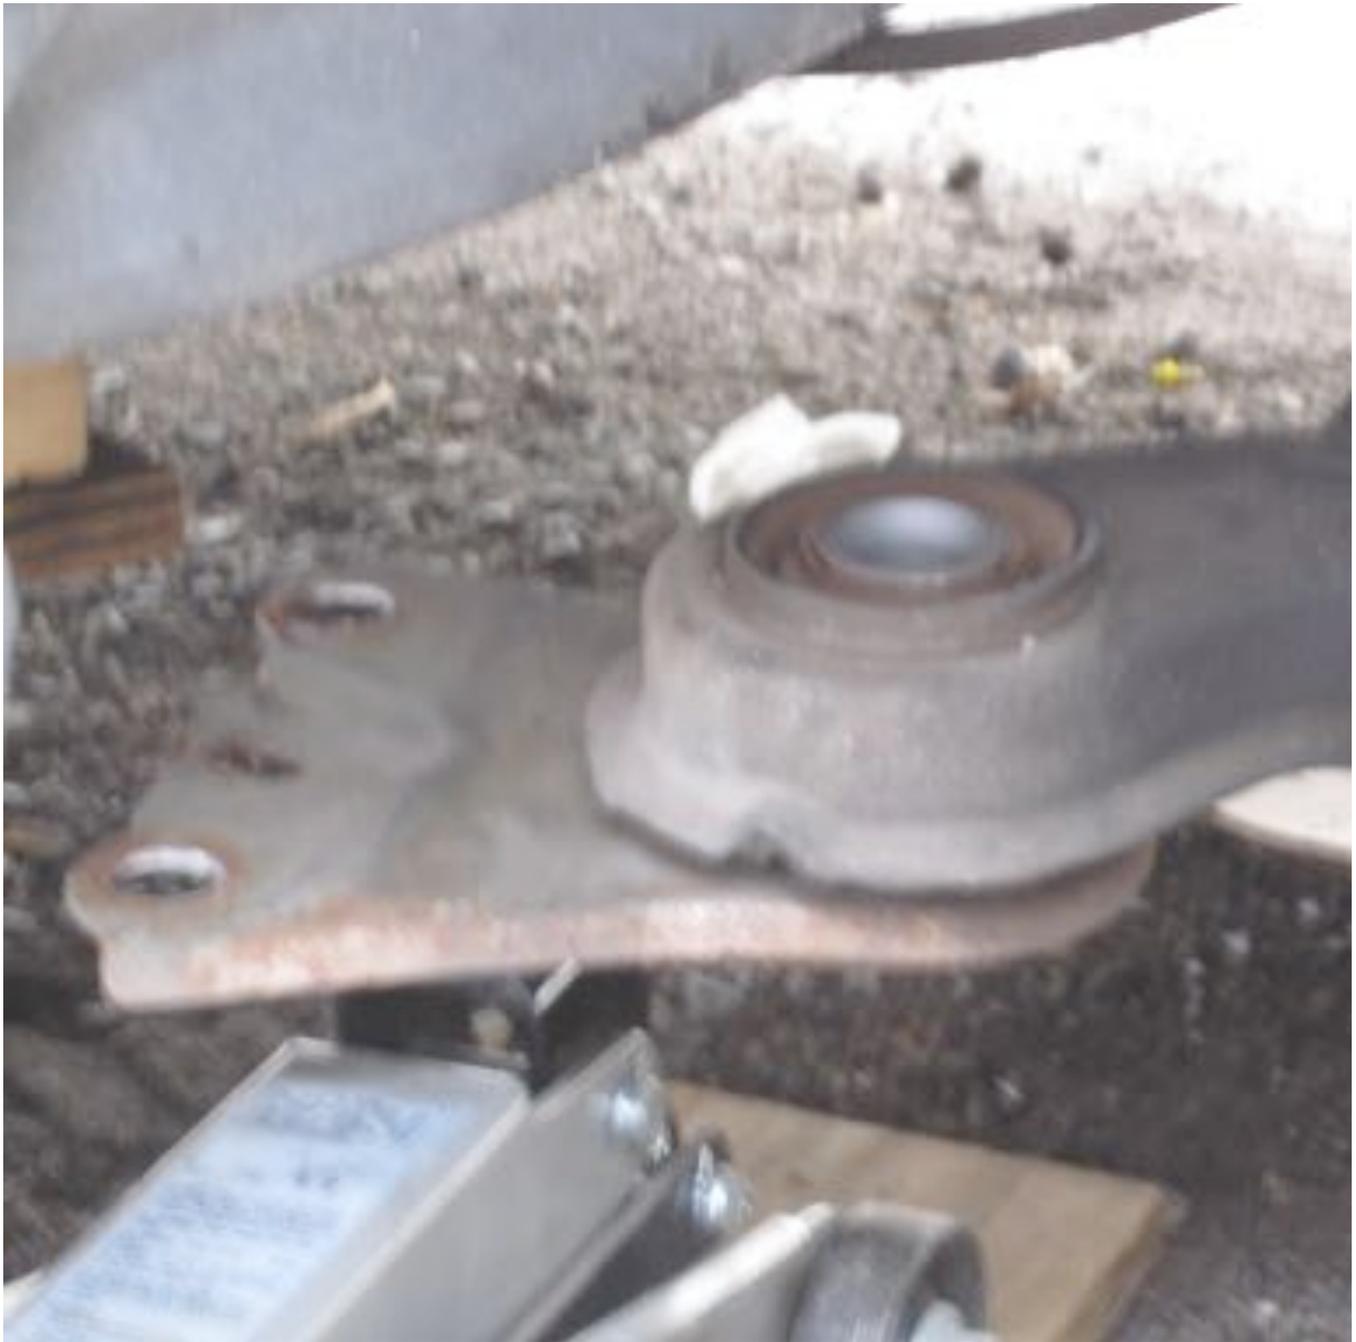
Place a floor jack under the passenger side subframe and remove the bolts from the bracket shown below. Also remove the large center bolt from the front right (p.s.) corner of the subframe. If you have the Harbor Freight's electric impact wrench it will make short work of all these bolts.

NOTE: The large center bolts will have red thread lock on them. It's a good idea to put a wire wheel on your bench grinder and clean the stuff off the bolts' threads as well as possible.

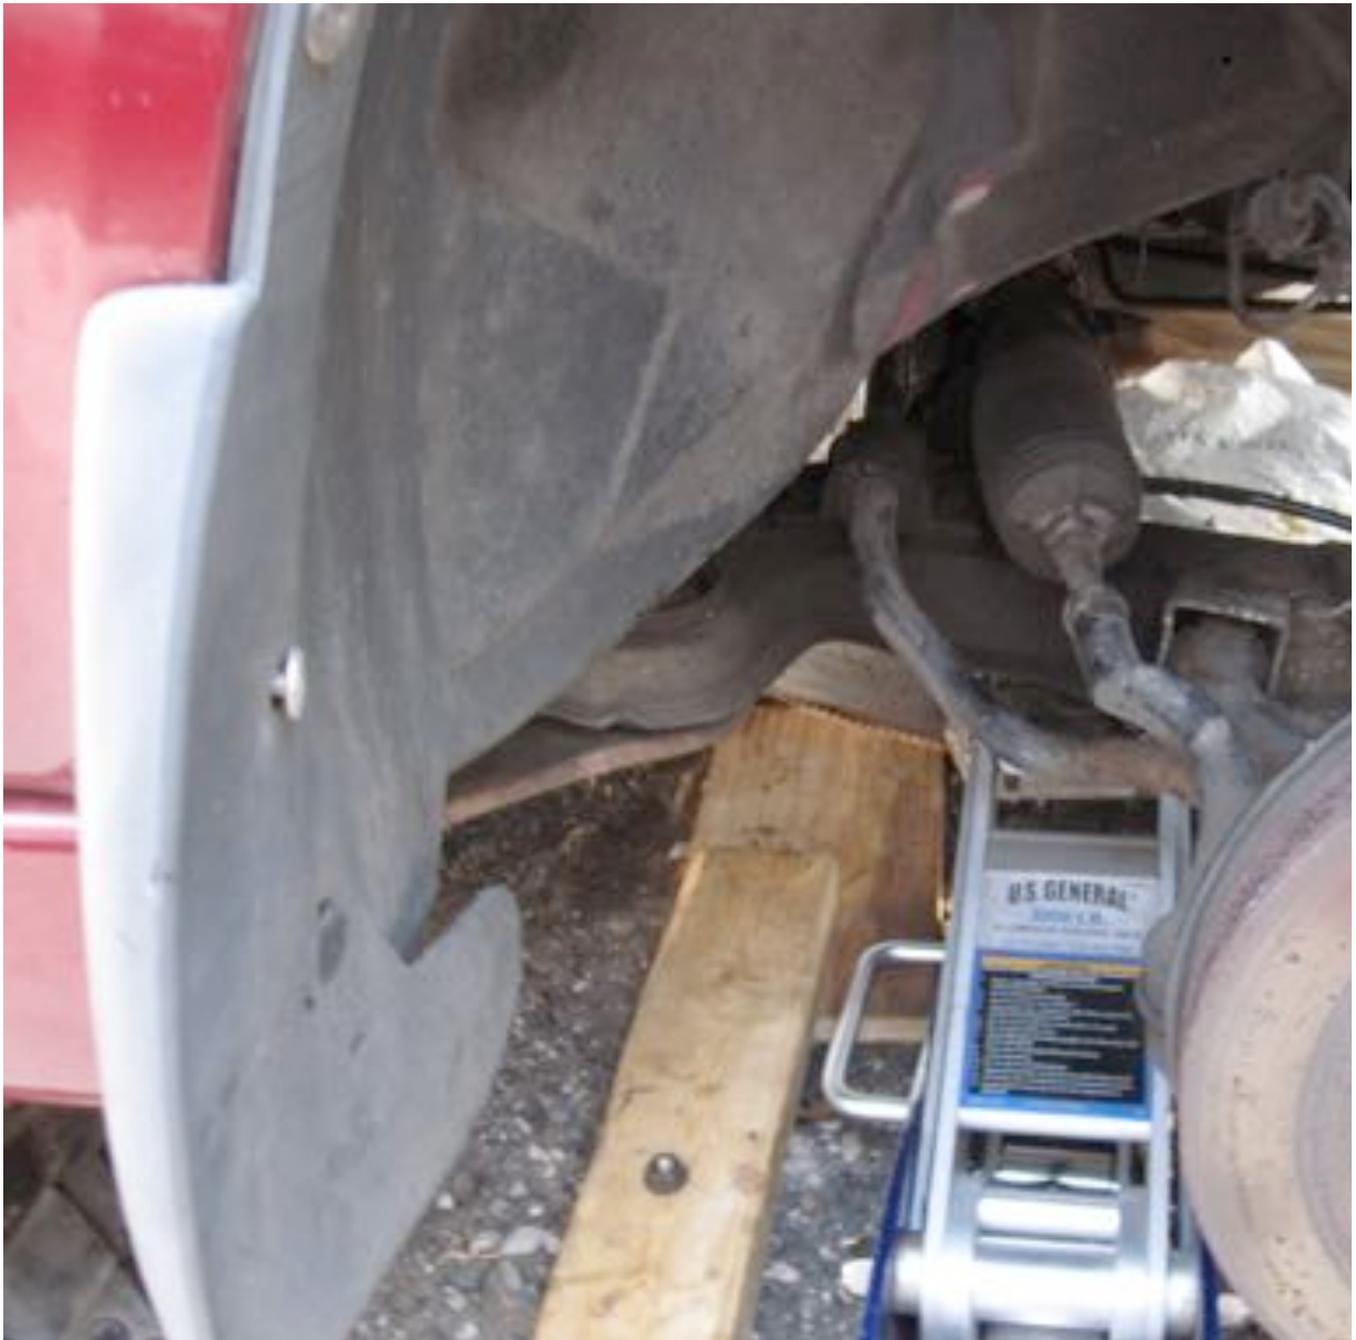
Below, the pan is removed. You can see the subframe where the front engine mount sits and at the top that mount's upper bracket. If I do this again, I'll remove that bracket to get a little more clearance, though the subframe would still need to be lowered.

Also, note the bagged oil cooler manifold (t-stat?). The two Torx bolts were pretty tight. Make sure you use the right size bit. Due to a little corrosion, I first used the next smaller size. It didn't feel right, so tapped in the correct size and had no problem breaking them loose. The mating face of this manifold (and its mating face on the pan) should be cleaned up carefully. The rectangular O-ring looked fine and hadn't been leaking, so I reused it even though I had a new one. It hasn't leaked.

Not visible is a line (an old boot lace) that I used to pull the manifold forward and tie it off out of harm's way.

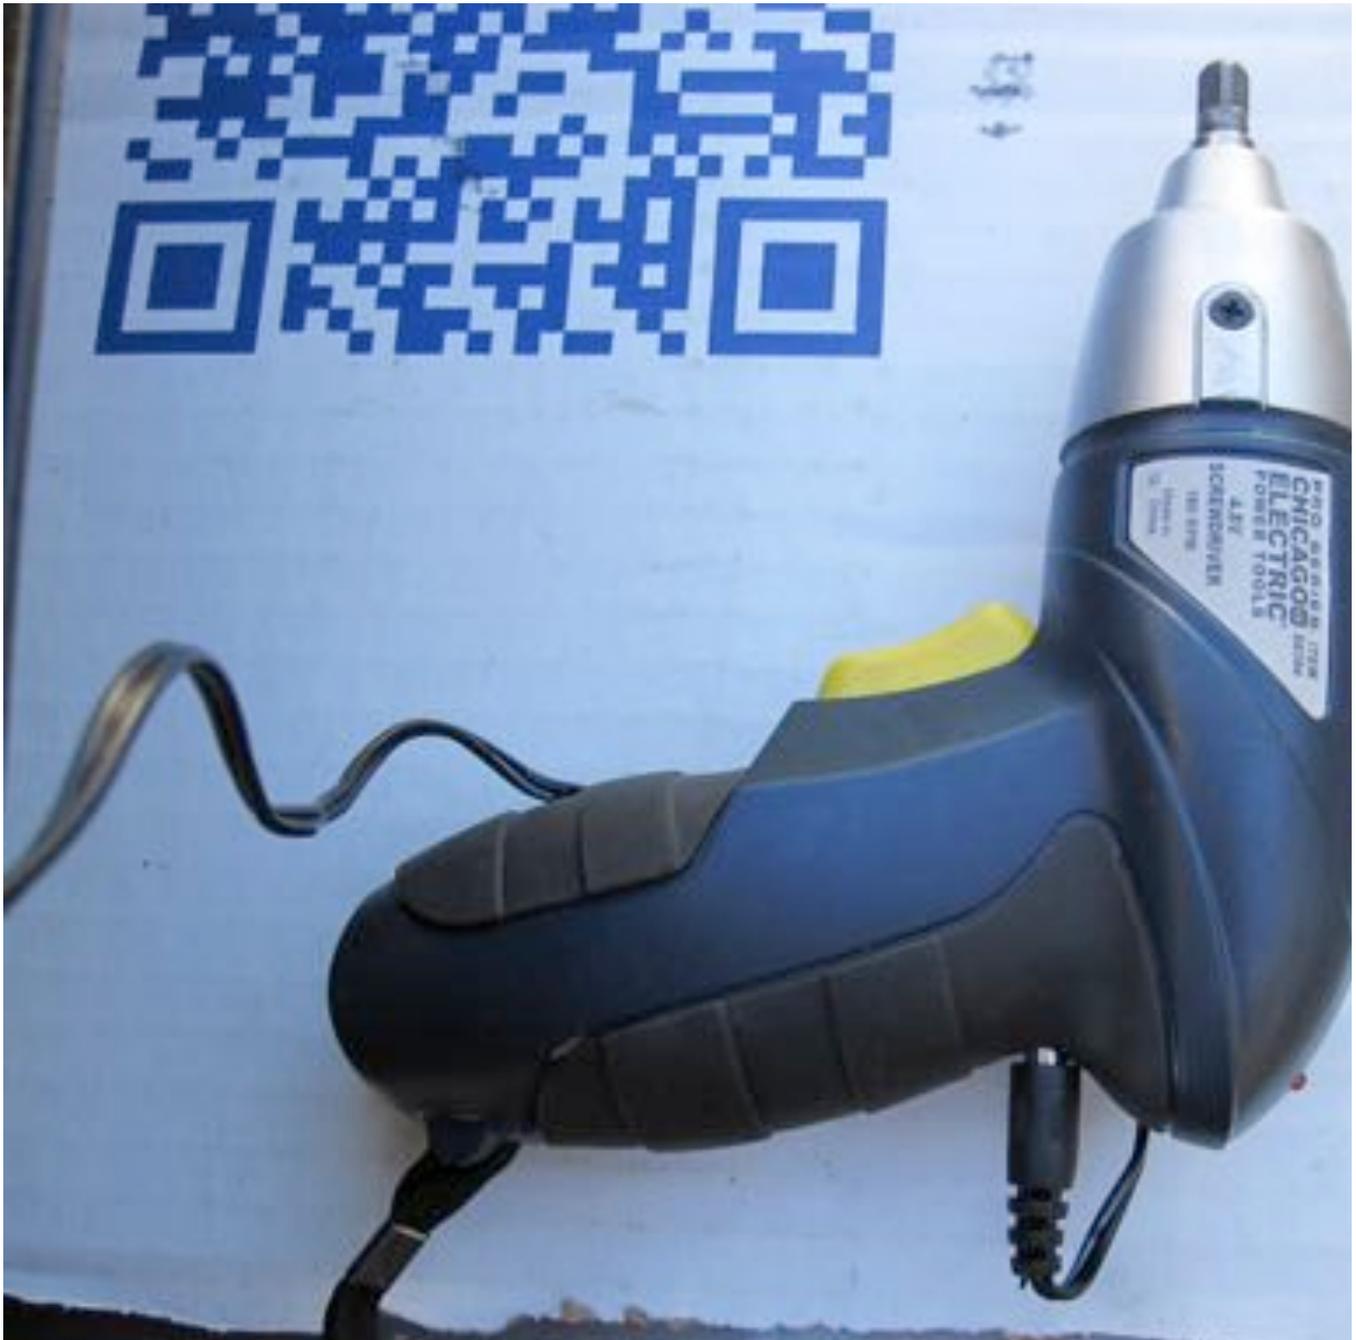
This rechargeable driver came in very handy for removing the pan bolts once they were cracked loose with a ratchet. I used a 4" extension with a deep socket and spun them right out. As others have noted, be aware that the pan bolts on either side of the engine are all short. Bolts on the front and back of the pan are different lengths.

ALSO: the longer front and back bolts will have some thread sealant or locker on them. CLEAN that stuff off with your wire wheel before reinstalling them. It will also be helpful to pick up a tap the size of the pan bolts next time you're at the hardware store (Menards has them) and clean out any holes where the sealant or locker was used. You'll thank me for that tip.

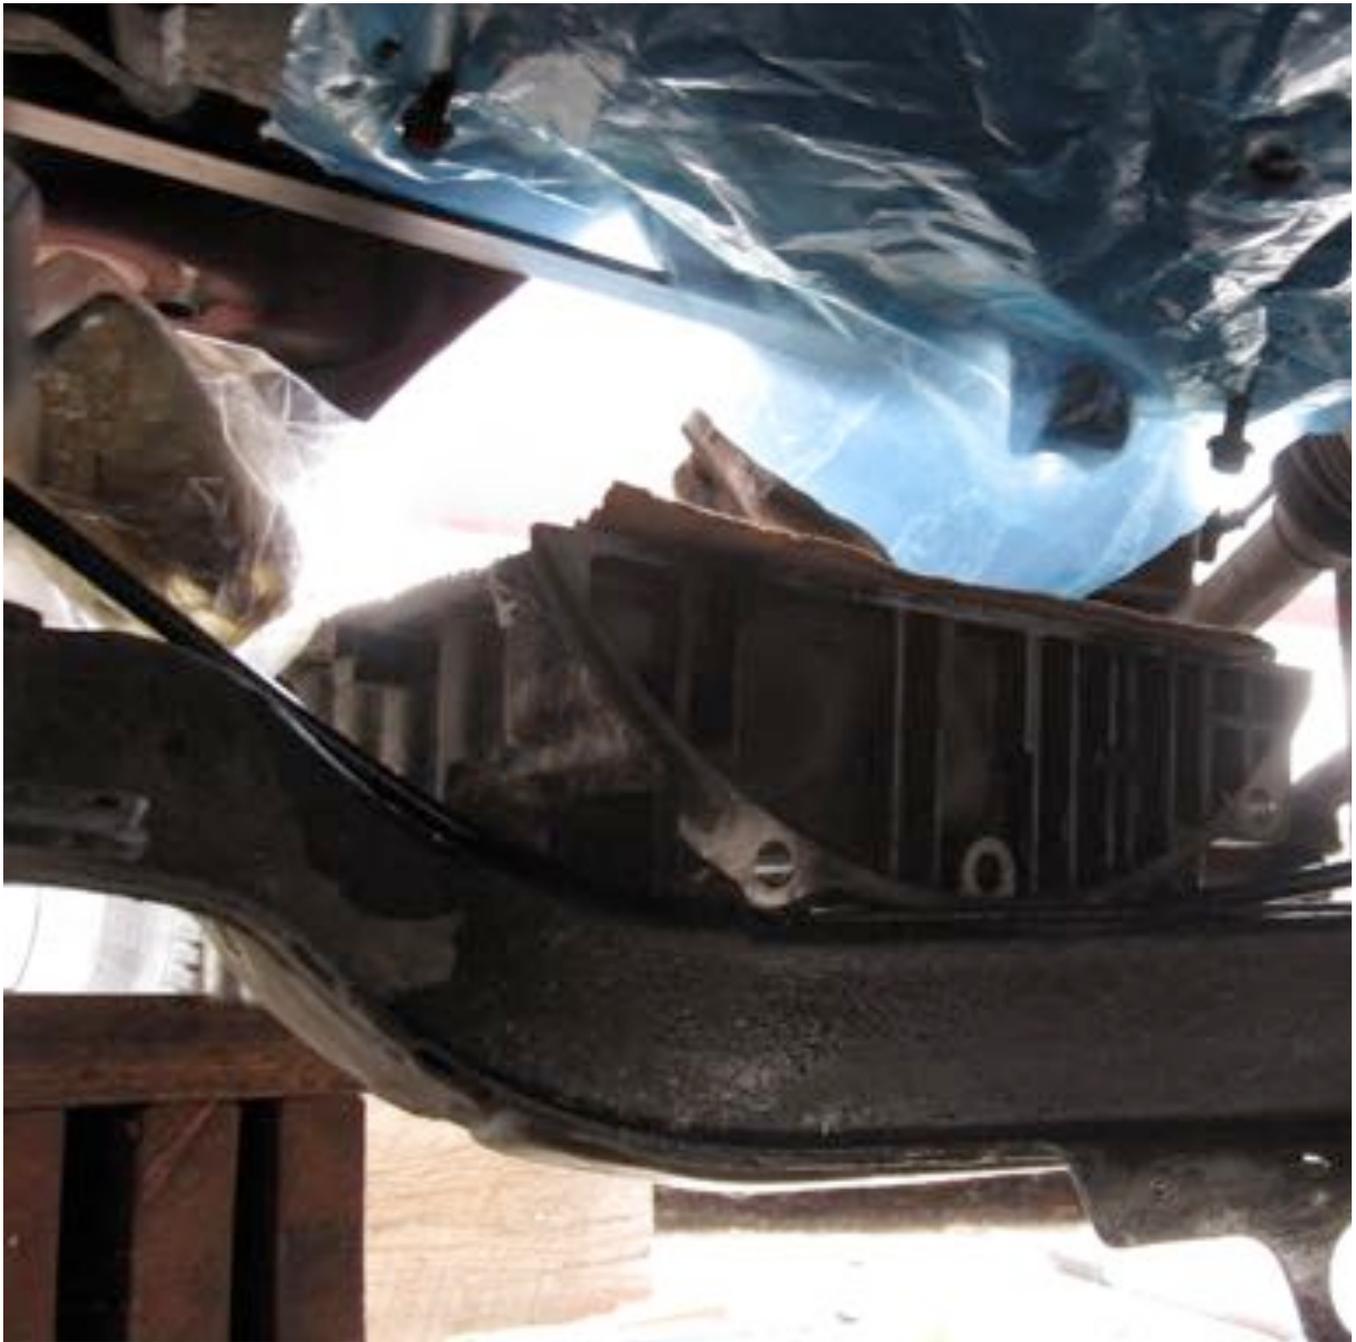
Below, you can see the pan being removed above the dropped subframe. NOT SHOWN is that you will need to remove the oil pickup tube that snakes down through a round hole in the horizontal baffle that's about midway down in the pan. That tube needs to be unbolted before you can maneuver the pan out. There are two screws that hold a saddle bracket to the engine bottom.

Technique: sitting on something while straddling the passenger side wheel hub, left hand reaches in with small breaker bar or ratchet and breaks them loose. The pan will need to be supported from beneath while this is done. So a four handed task. The front of the pan will sit on the subframe, so you have enough room to get a hand in there.

Also, note the blue plastic. As soon as I got the pan out and mopped out any pooling oil, I flipped it over onto some scrap plastic sheeting and roughly cut a rectangle to fit over the bottom of the engine. Then I forced 6 screws through the plastic to hold it up. This kept dust out of the engine and oil out of my face.

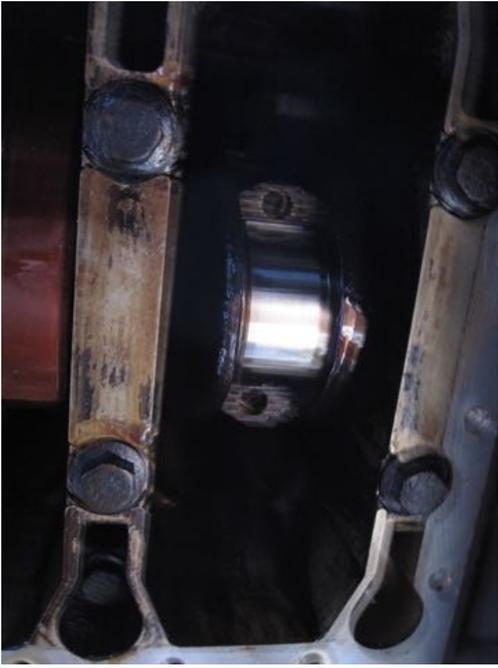
I couldn't see any metal-to-metal contact, so I decided to pull the rod bearing caps to inspect for abnormal wear. If there had been any, or marring of the crankshaft, I'd have stopped there and just put it back together. The picture below is of journal #1. The journal is mirror smooth; the others were, too. and the bearing inserts were in excellent condition.

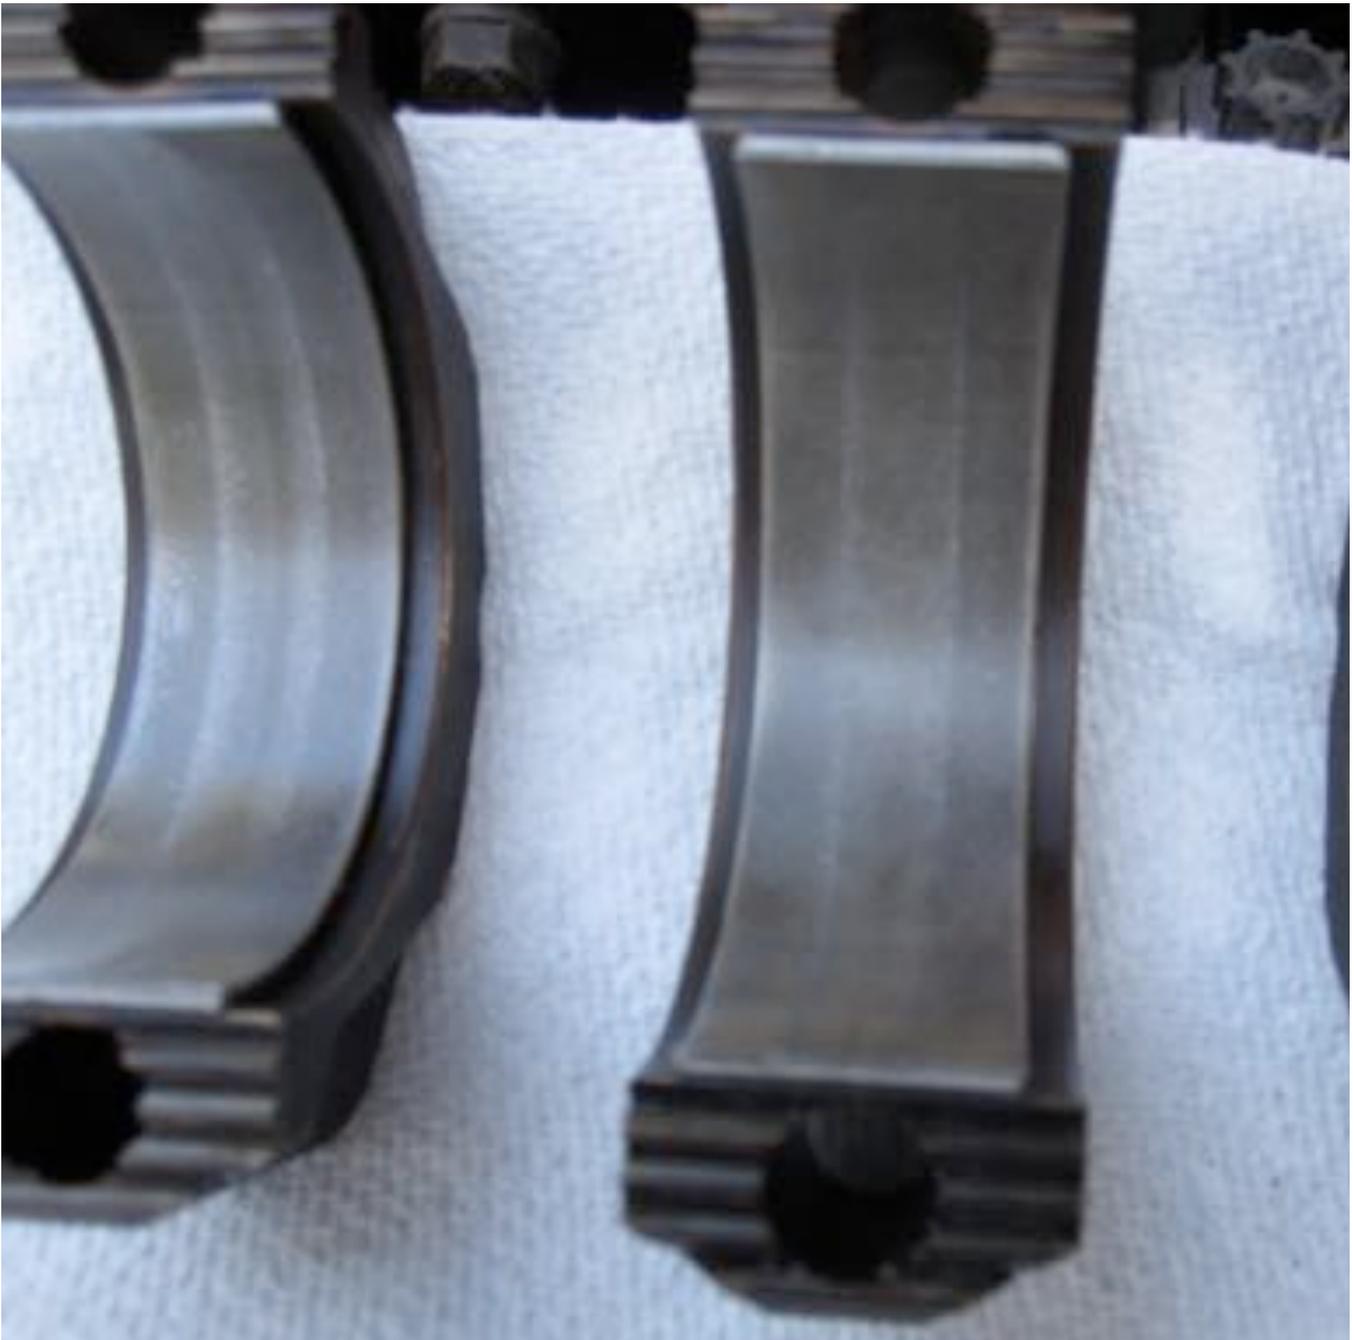
The others are likewise.

I took those around to 3 engine rebuilders in Minneapolis and all gave the same opinion: virtually no wear; certainly nothing abnormal. One said, "heck, those look like new". You can find pictures of worn bearings online. They usually have some copper/bronze showing.

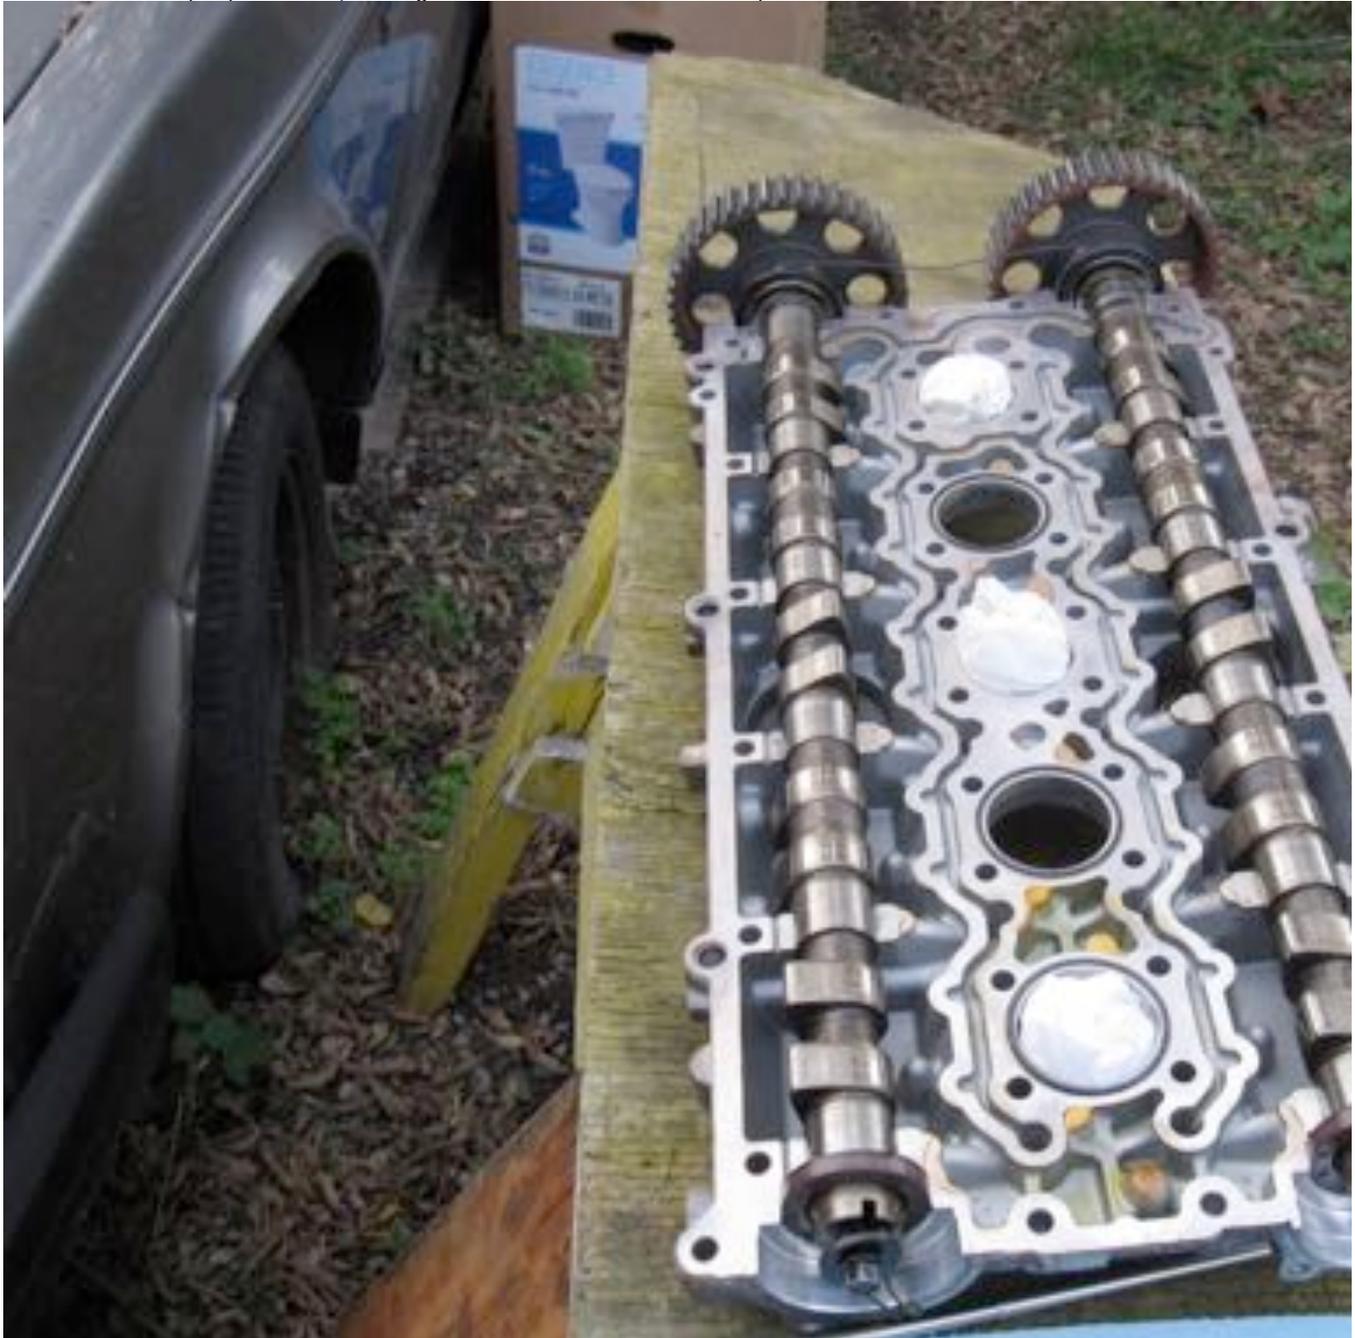
Picture of cleaned up cap with cams, showing how the cams are wired into the cap.

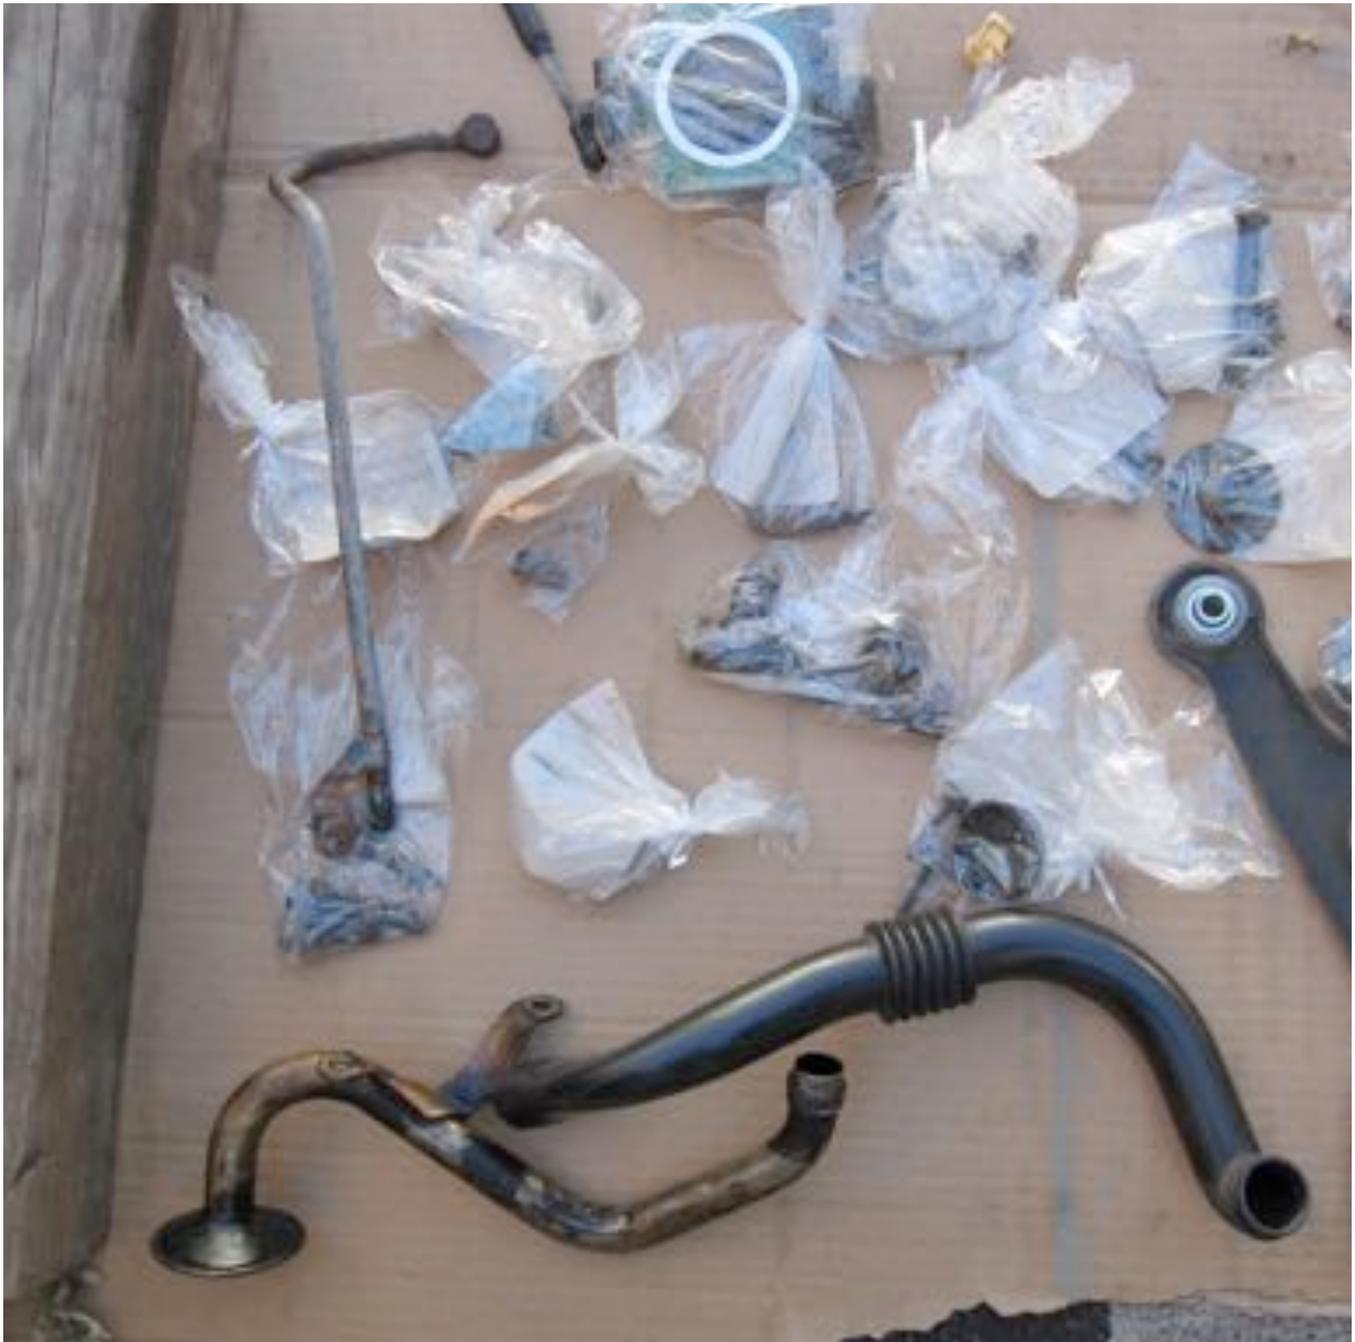
The torque link bracket is from another project. Lower left, is the oil pump pickup tube.

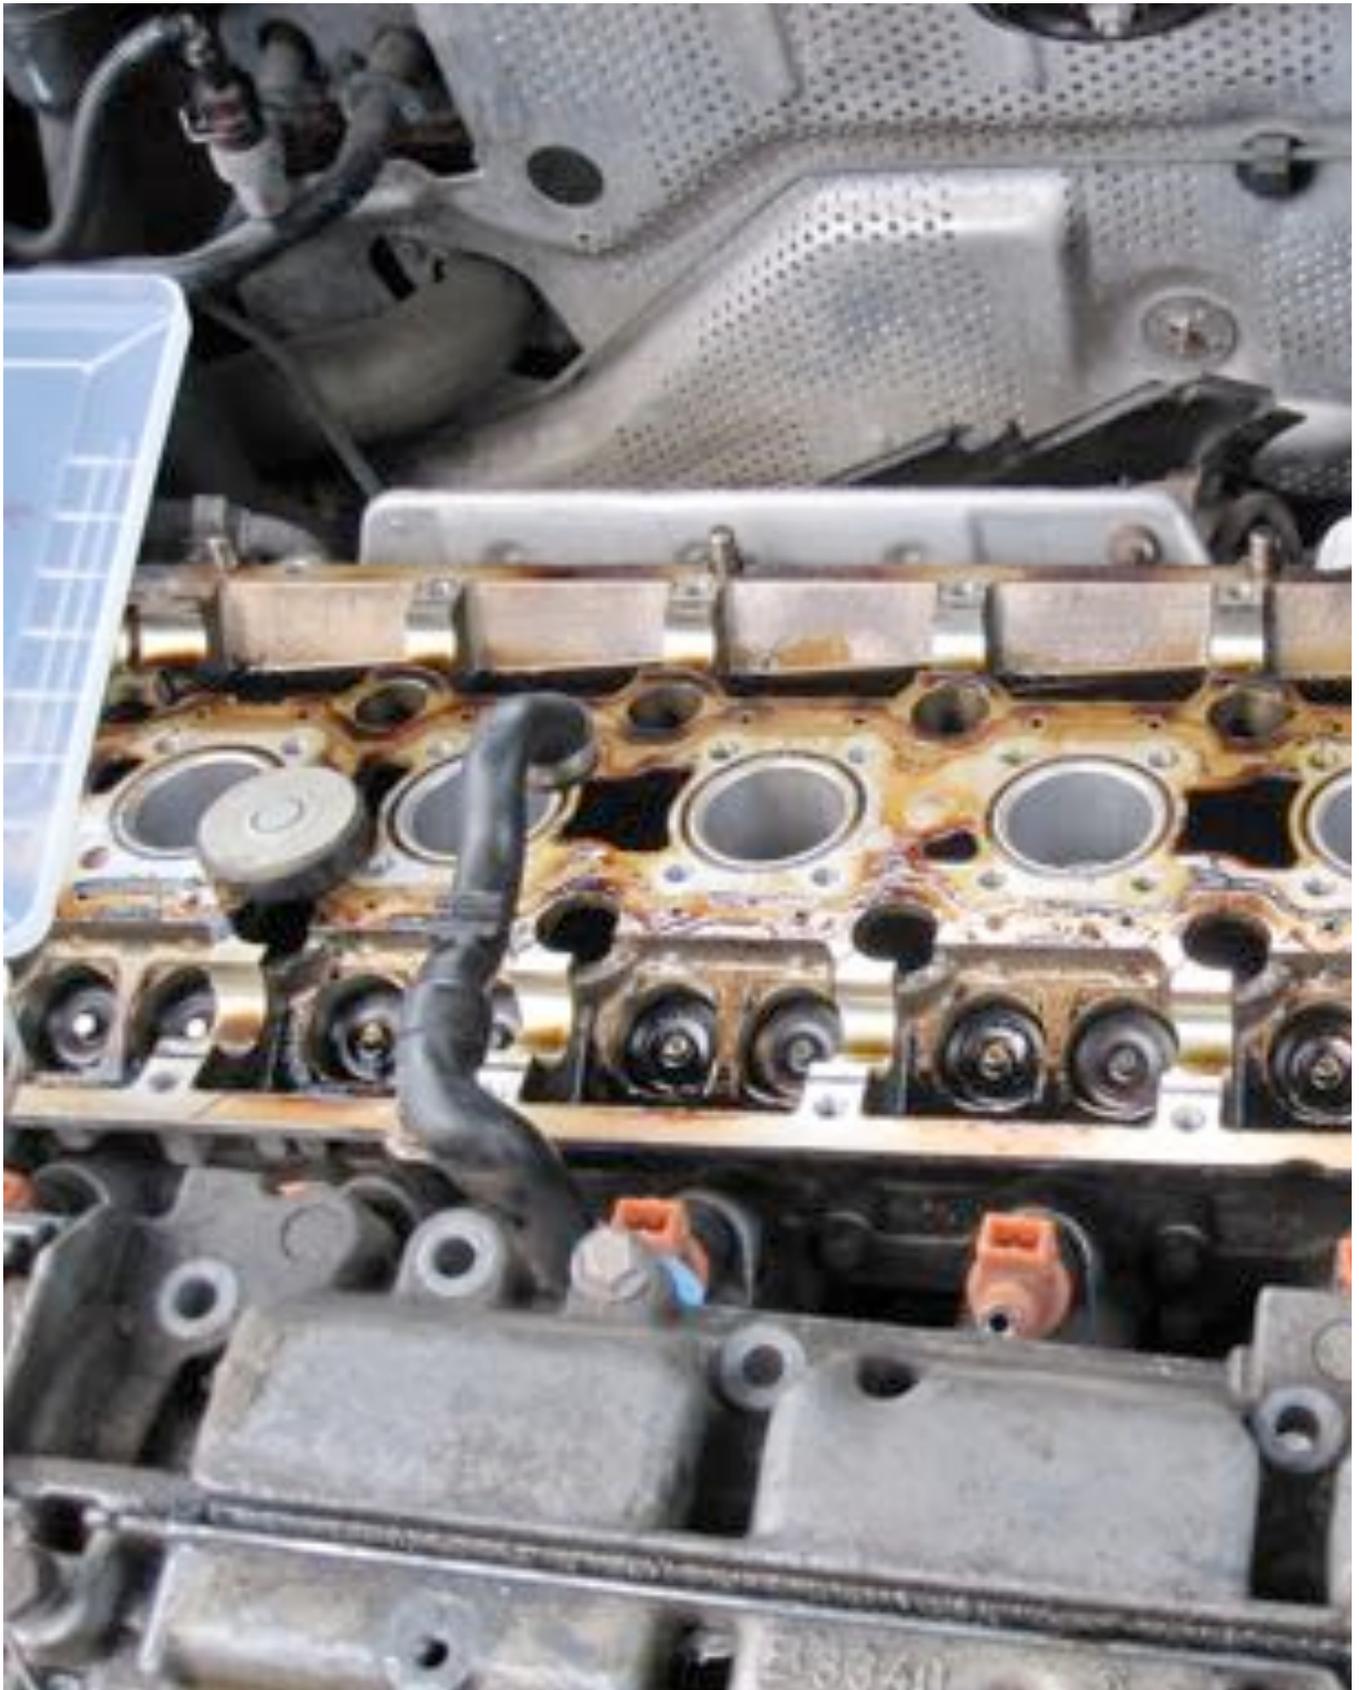
The head before cleaning up. Some of the residue can be cleaned off with degreaser and since you have the pan off, there's no need to worry about drain-down, though you don't want grimy solution to get down inside. Stuffing the drain holes with a ball of paper towel is helpful. Most of it, though, is baked on sealant. The razor blade technique described in the oil pan cleanup picture (below) works best on this surface.
