Editor: Jim Baker (Note: this is kind of roughed together, some day maybe I'll clean it up. There are are few more pictures, too, that could be added.)

INTRODUCTION

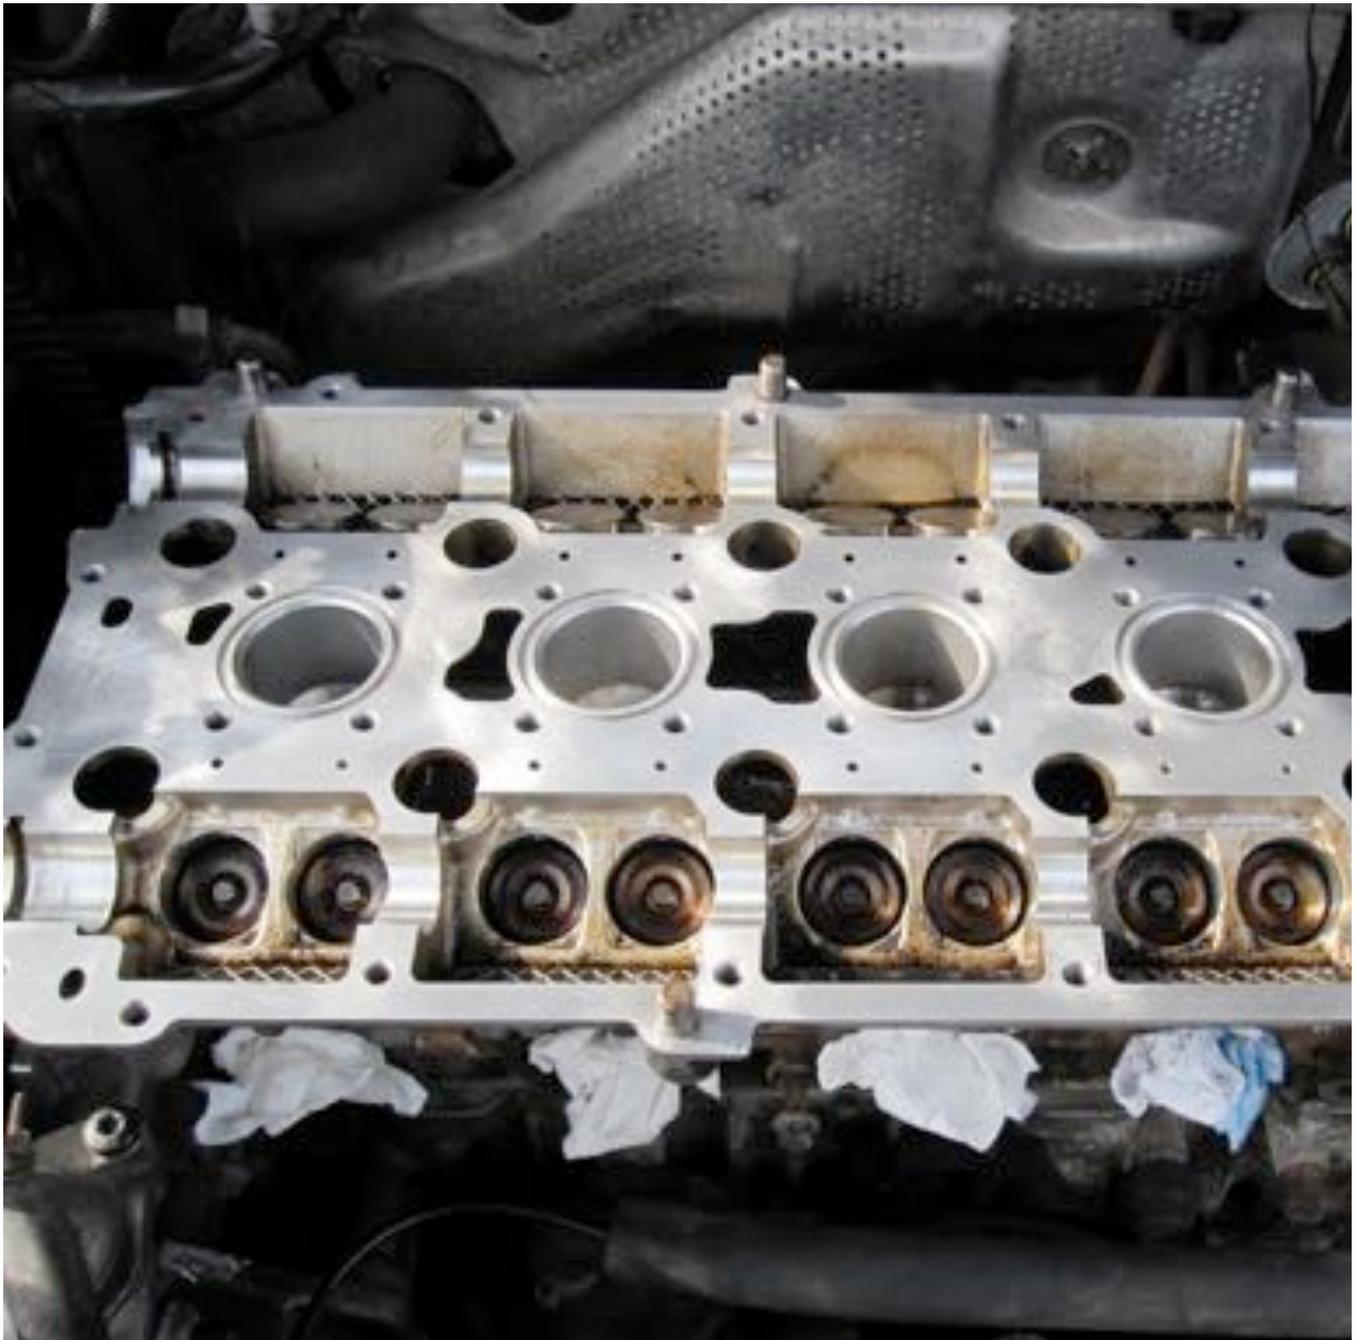
Head after cleaning up:

Most instructions I've read counsel against using any kind of abrasive scrubber on this mirror smooth surface. I finish the cleanup with a very light scrub using 90% alcohol to remove any greasy or oily residue for reassembling, then wipe it down with clean towel. It actually goes quite quickly.

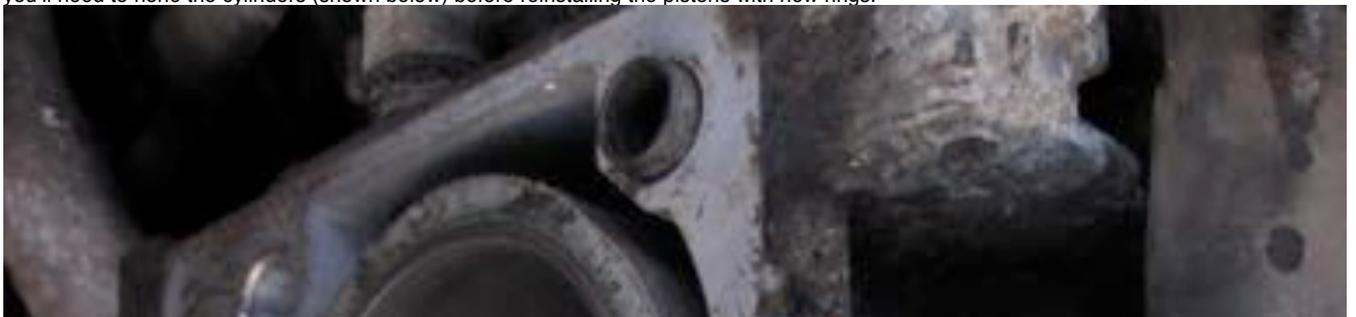
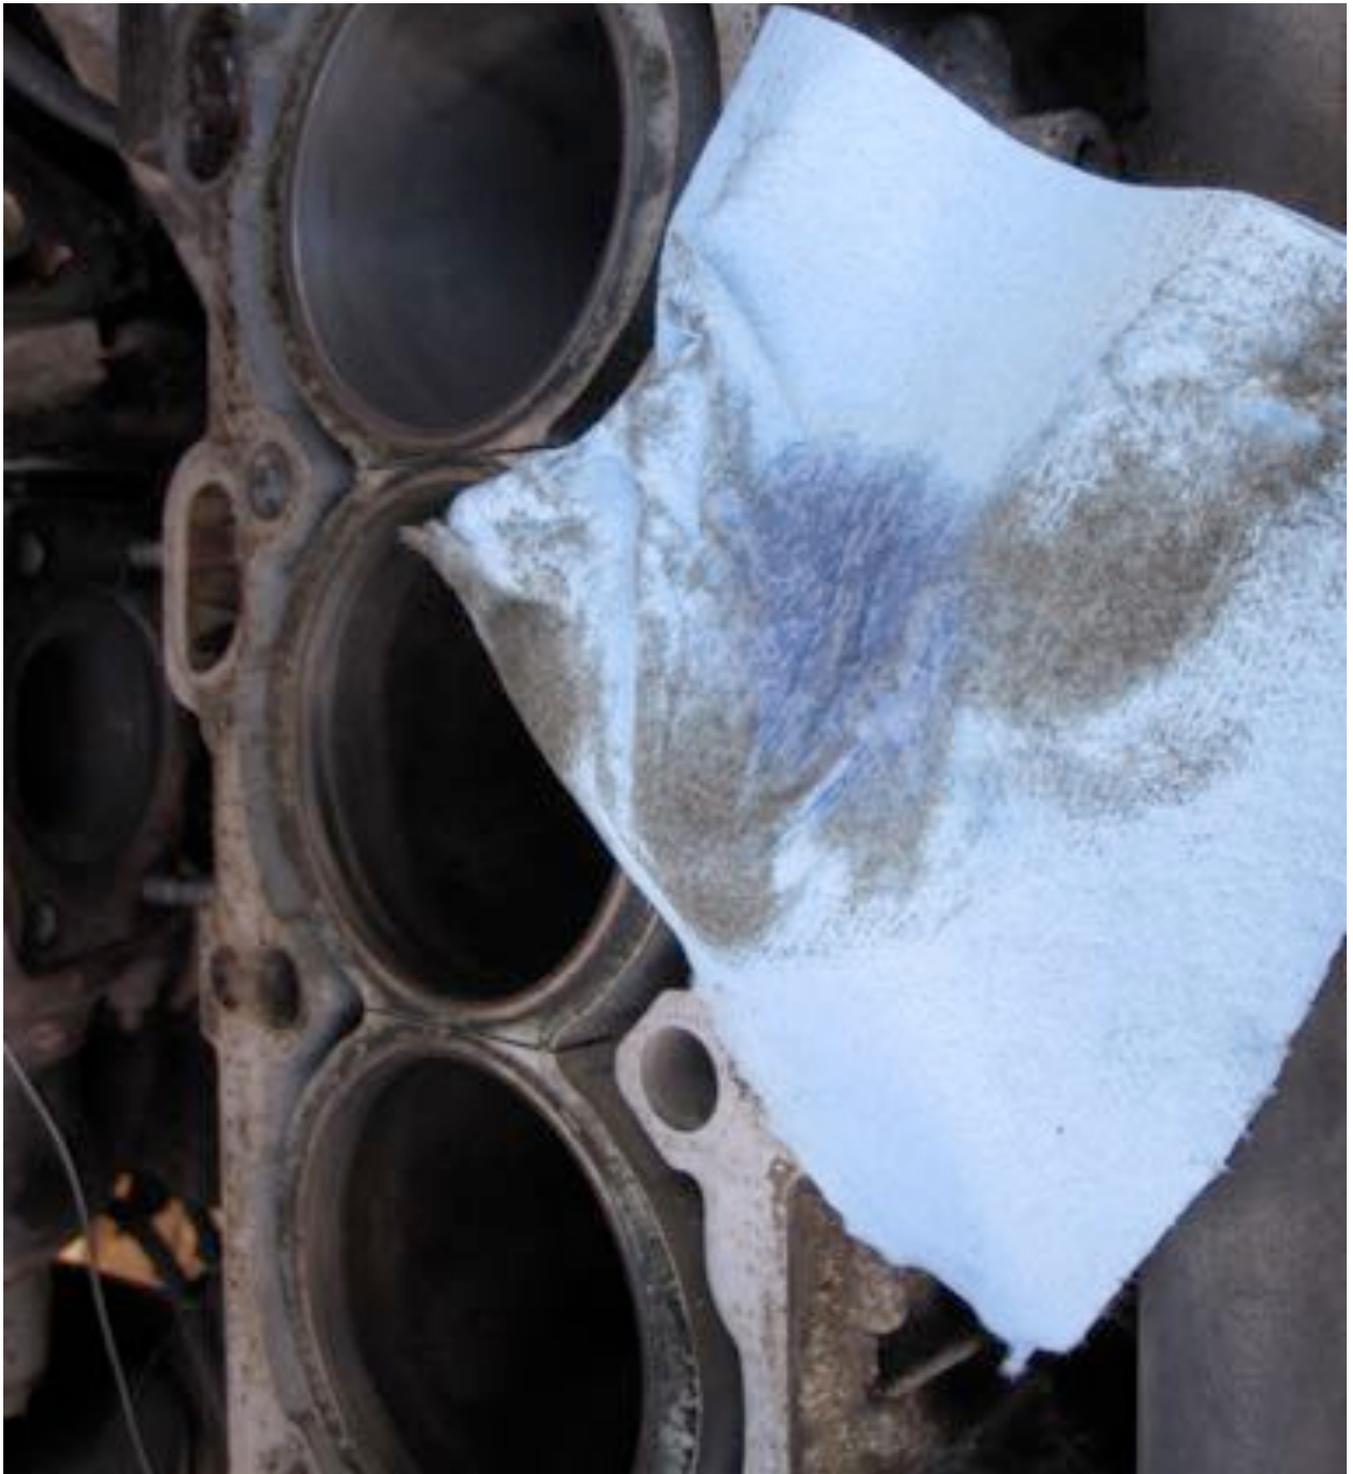
Cleaning up the cylinders. I packed some shop towels in the bottom of the cylinders over the crankshaft journals to protect from the cleanup mess. I used degreaser and a lot of towels to remove as much of the build-up of baked in carbon deposits as I could. This is important, because you'll need to hone the cylinders (shown below) before reinstalling the pistons with new rings.

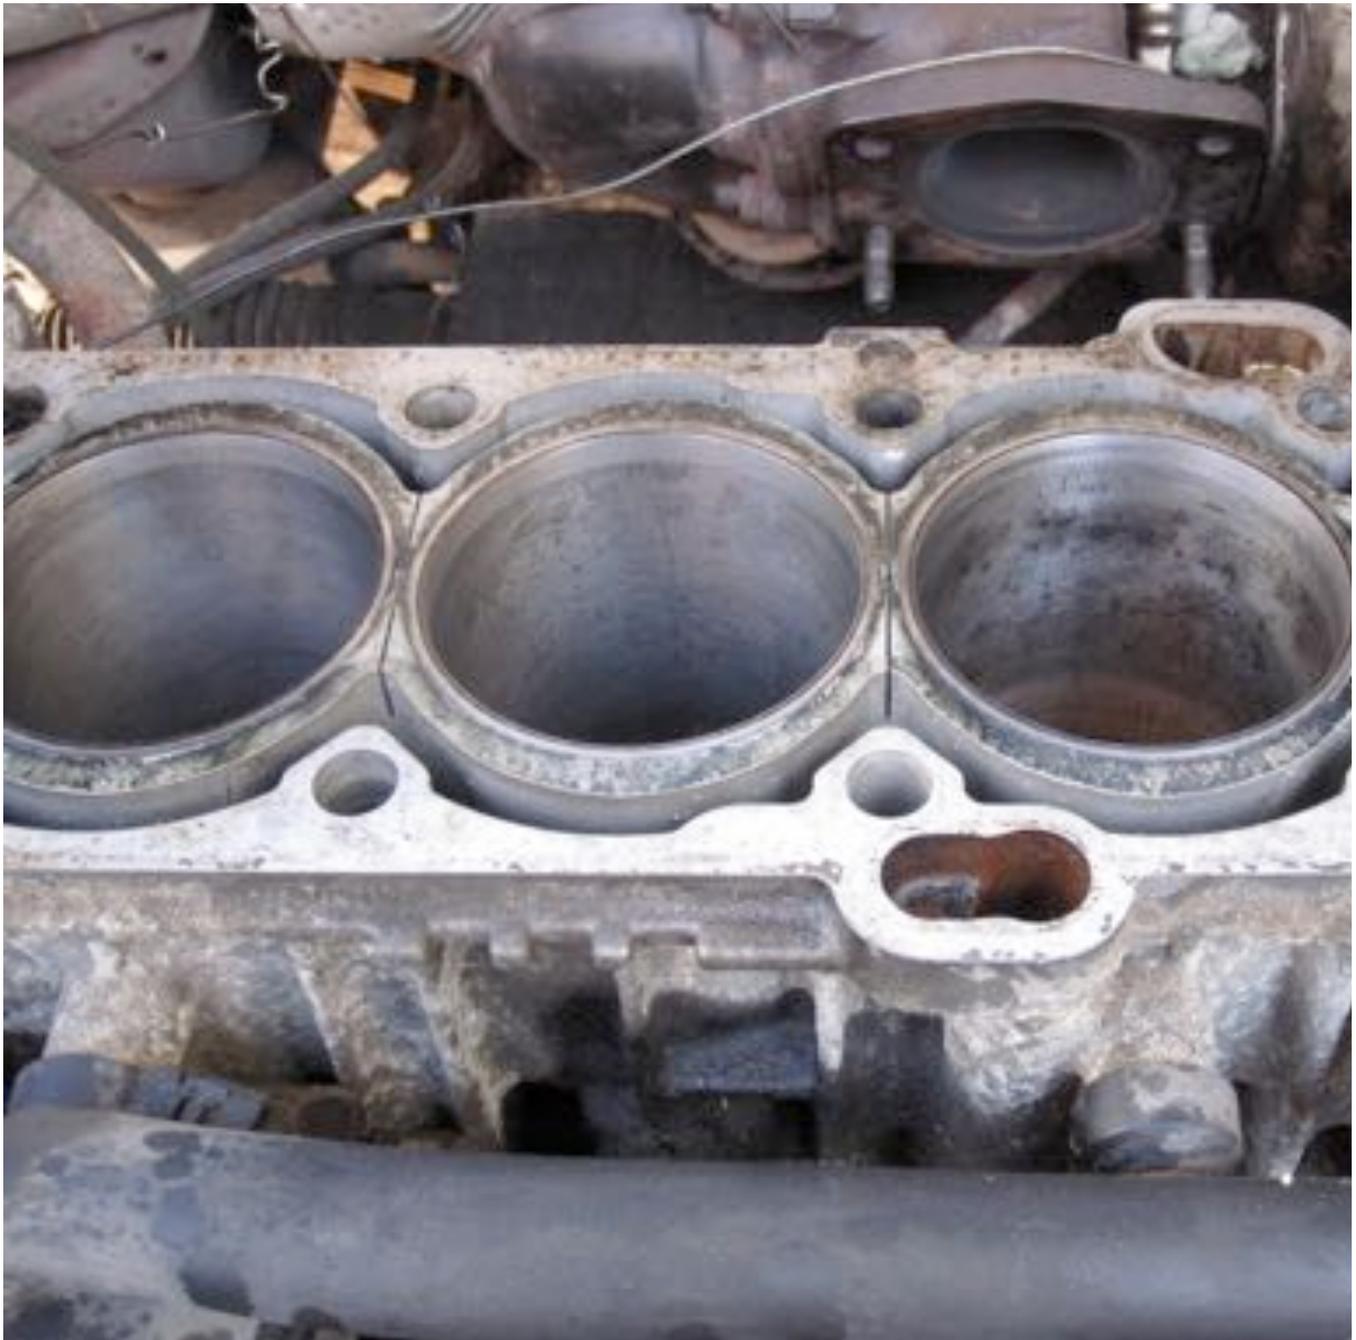
Cylinders are pretty clean.

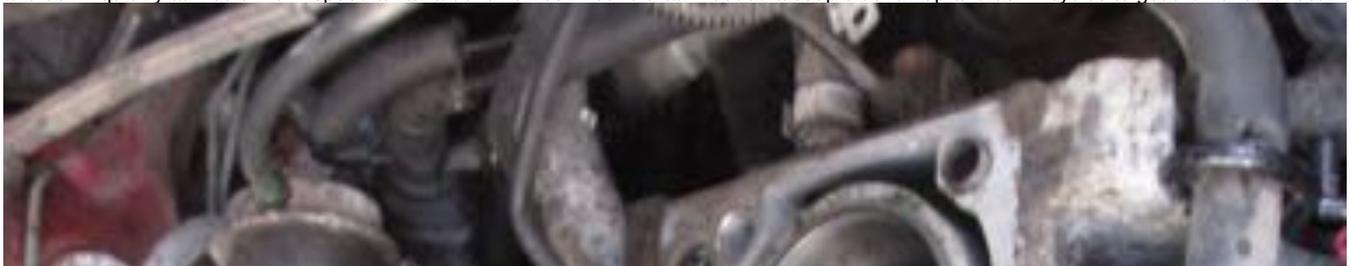
As I mentioned, the cylinders need to be honed before installing the pistons with new rings. This doesn't actually put a mirror finish on the cylinders, but roughens them slightly. The earlier style hone was called a glaze buster and used several vertical honing stones. The new method called "ball honing" creates a crosshatch sort of scratching in their surfaces (barely visible). This both busts the glaze and the crosshatch helps to "chafe in" the new rings, so that the metal parts mate well. The rebuilder who cleaned up my pistons (they literally looked like new) and installed the new rings, loaned me a ball hone. It worked pretty well and isn't hard to use. The loaner was pretty well used. I was told to run it up and down quickly at medium drill speed a half a dozen times. I found that I needed a couple dozen up and down cycles to get the honed effect.

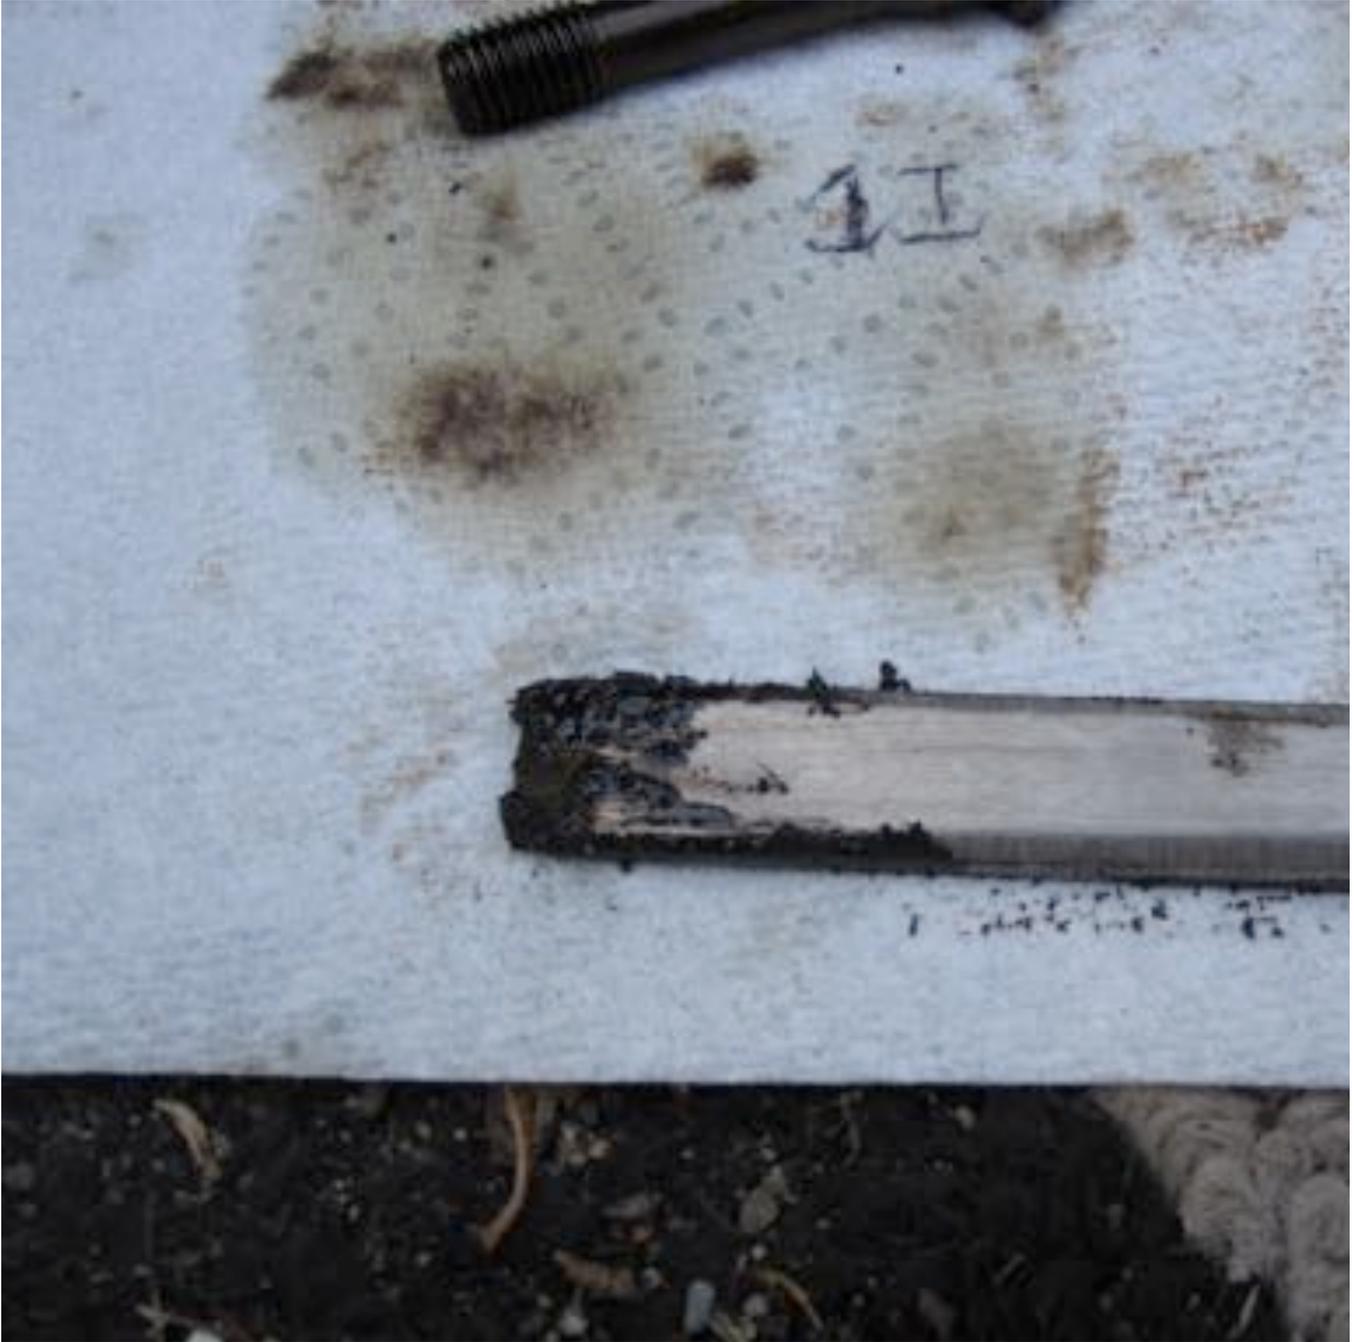
This is a good time to clean out the head bolt holes. Some of mine were gritty and grimy, indicating a little oil leakage past the head gasket, over time. There wasn't anything visible from the outside, though.

I squirted some degreaser into the holes and ran a clean head bolt into the hole with a drill/socket. Up and down each time wiping off the bolt. When the holes looked free of grime, I wicked them out with some giant pipe cleaner type wicks I found at the dollar store. Lacking those, I'm not

sure how I would have cleaned out all the solvent. They worked well.

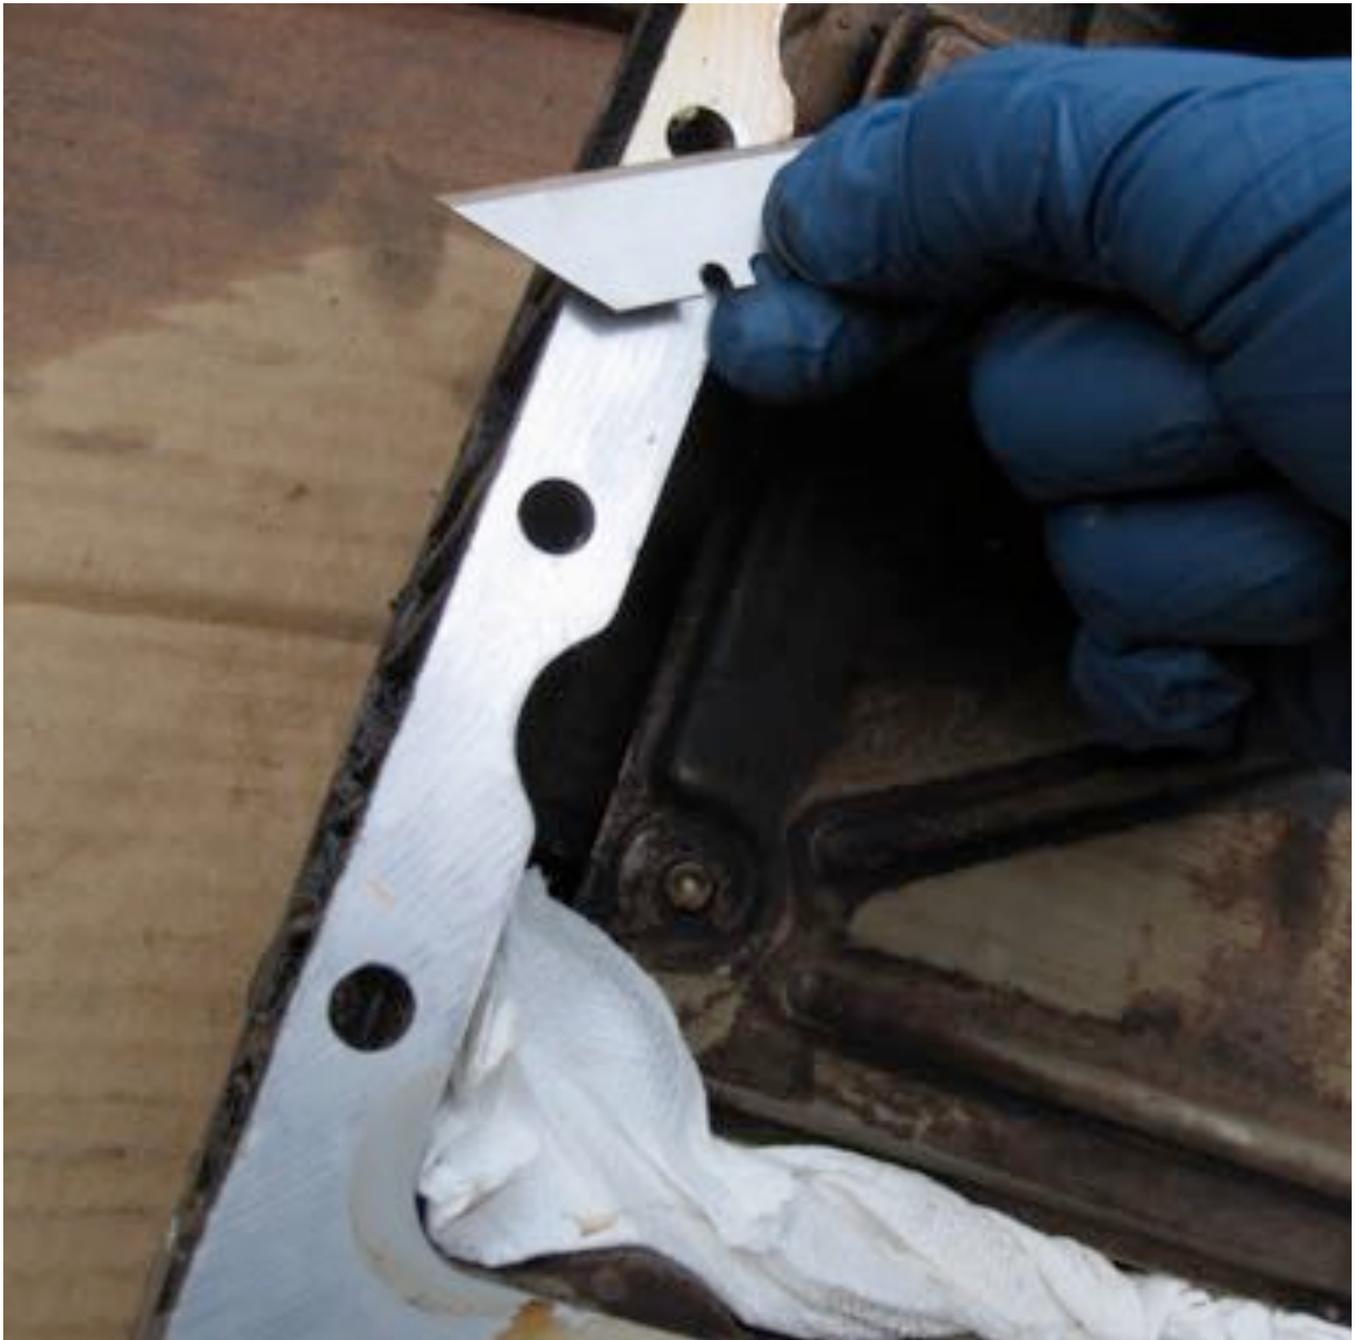
I read somewhere in an o-ring tutorial, that "I just use a razor blade" to clean up the mating surfaces where anaerobic sealant is used. What I found to work really well was a fresh sharp utility knife blade. Notice the beveled edge. Using a new blade, they have enough of a bevel that you can feel it when it's flat on the shaving surface. The idea is to ride the blade flat on its bevel and just maybe a degree sharper. The blade's steel is sturdy enough that you can control it exactly at the angle the provides the best cut without gouging the workpiece. I also used this on my camshaft cap, top of the head, bottom of the head and top of the block—as well as the bottom of the block that mates with the oil pan. I seem to recall that doing the whole pan flange, working carefully, took about 45 minutes. The lines you can see where the flange has been cleaned are from the factory milling machine not the utility blade.

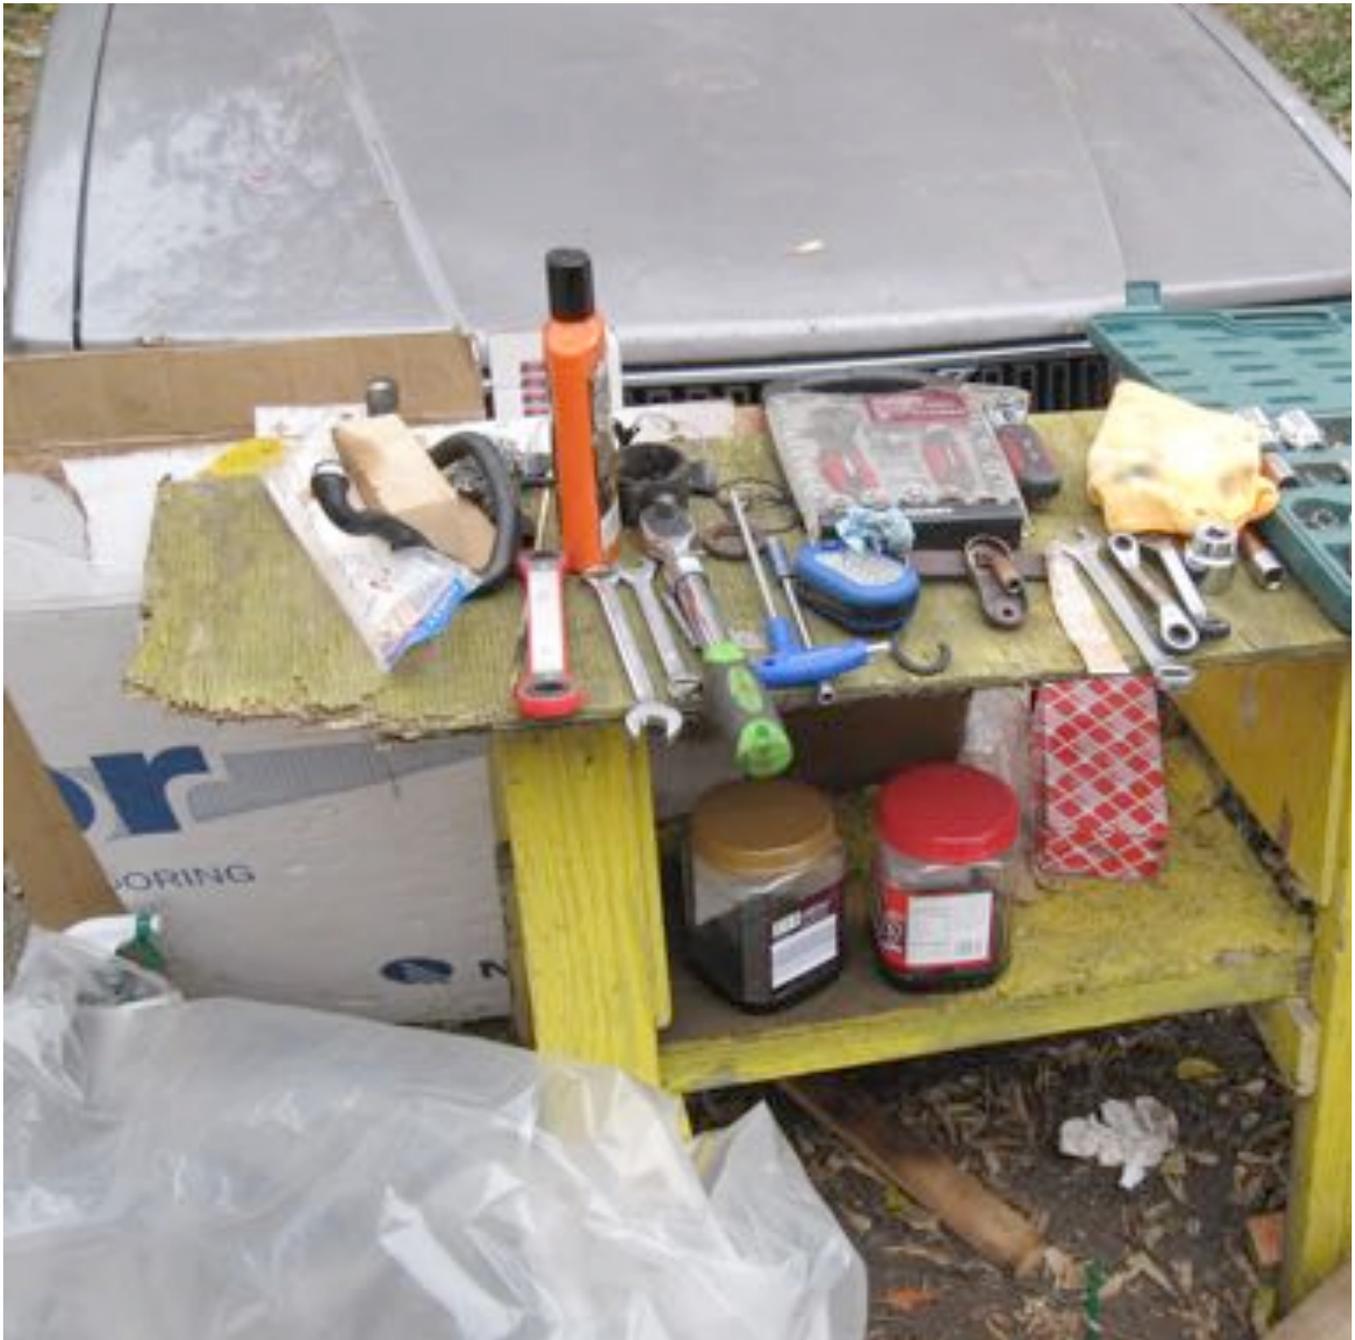
I mostly used what's on the bench but you need some torx sockets, including the internal torx to pull connecting rod bolts. Most of my tools are from Harbor Freight.

The connecting rod bolts, by the way, are the stretch type, but for steel; they are "elastic". They're 50 mm long underside of head to shank tip. A Volvo spec sheet counsels "do not reuse them if they are 55 mm or longer. I checked with the rebuilders; they reuse them without problems, and I did, too. I think I still have the Volvo torque spec document on my hard drive somewhere. If anybody needs it let me know. I Googled and found it. Don't lose any rod bolts, the cost around \$30.00 *each* from Volvo.

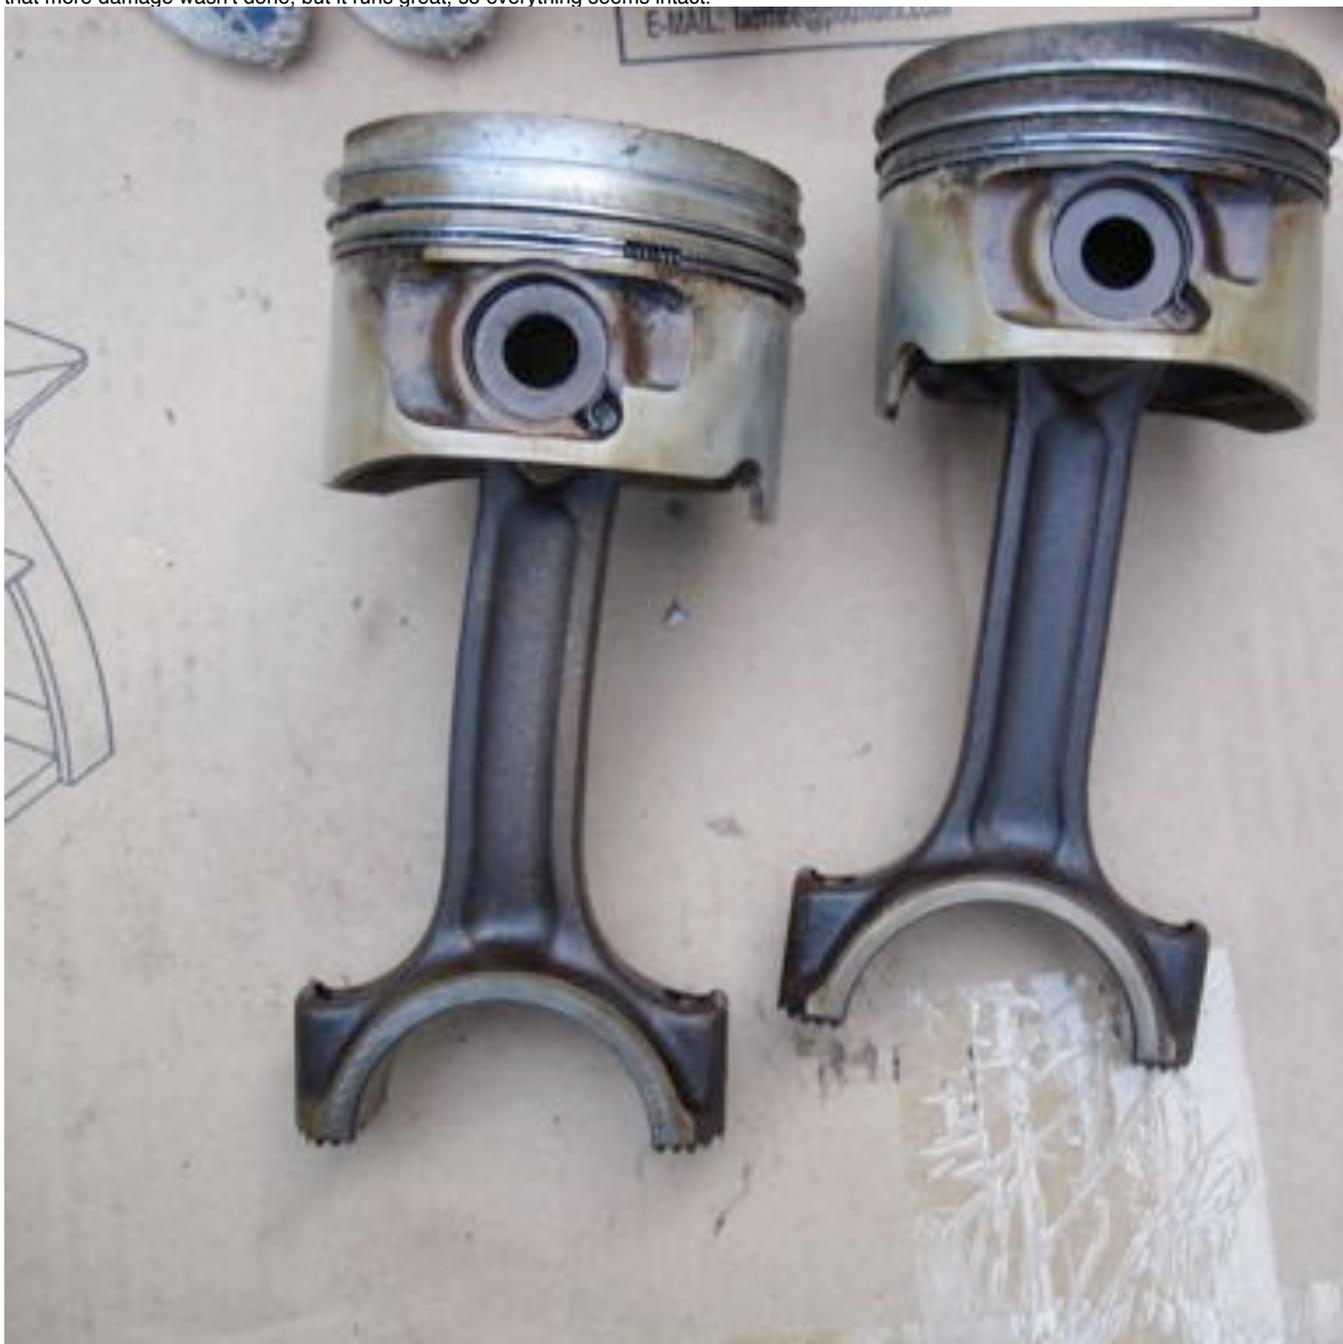
I was quite amazed that I couldn't see any metal-to-metal contact in the engine. And looking up from the bottom, I was looking along the side of the rod so the curvature didn't stand out. In a proper engine, parts run extremely close to one another. The crankshaft counter-balance just barely misses the bottom of the piston skirt when all is normal. Put a slight curvature in the rod and it shortens the length just enough for the counterbalance to strike the bottom of the piston skirt. These pistons are made of a very tough, resilient not brittle composite of some sort, so there were no cracks in the casting, just some chafing marks at the contact point. A local rebuilder had a used rod he sold to me for \$30.00. So how did the rod get bent? Previous owner's daughter ran into a deep puddle and water came into the cylinder #1. Bam. Dead stop. Amazing that more damage wasn't done, but it runs great, so everything seems intact.

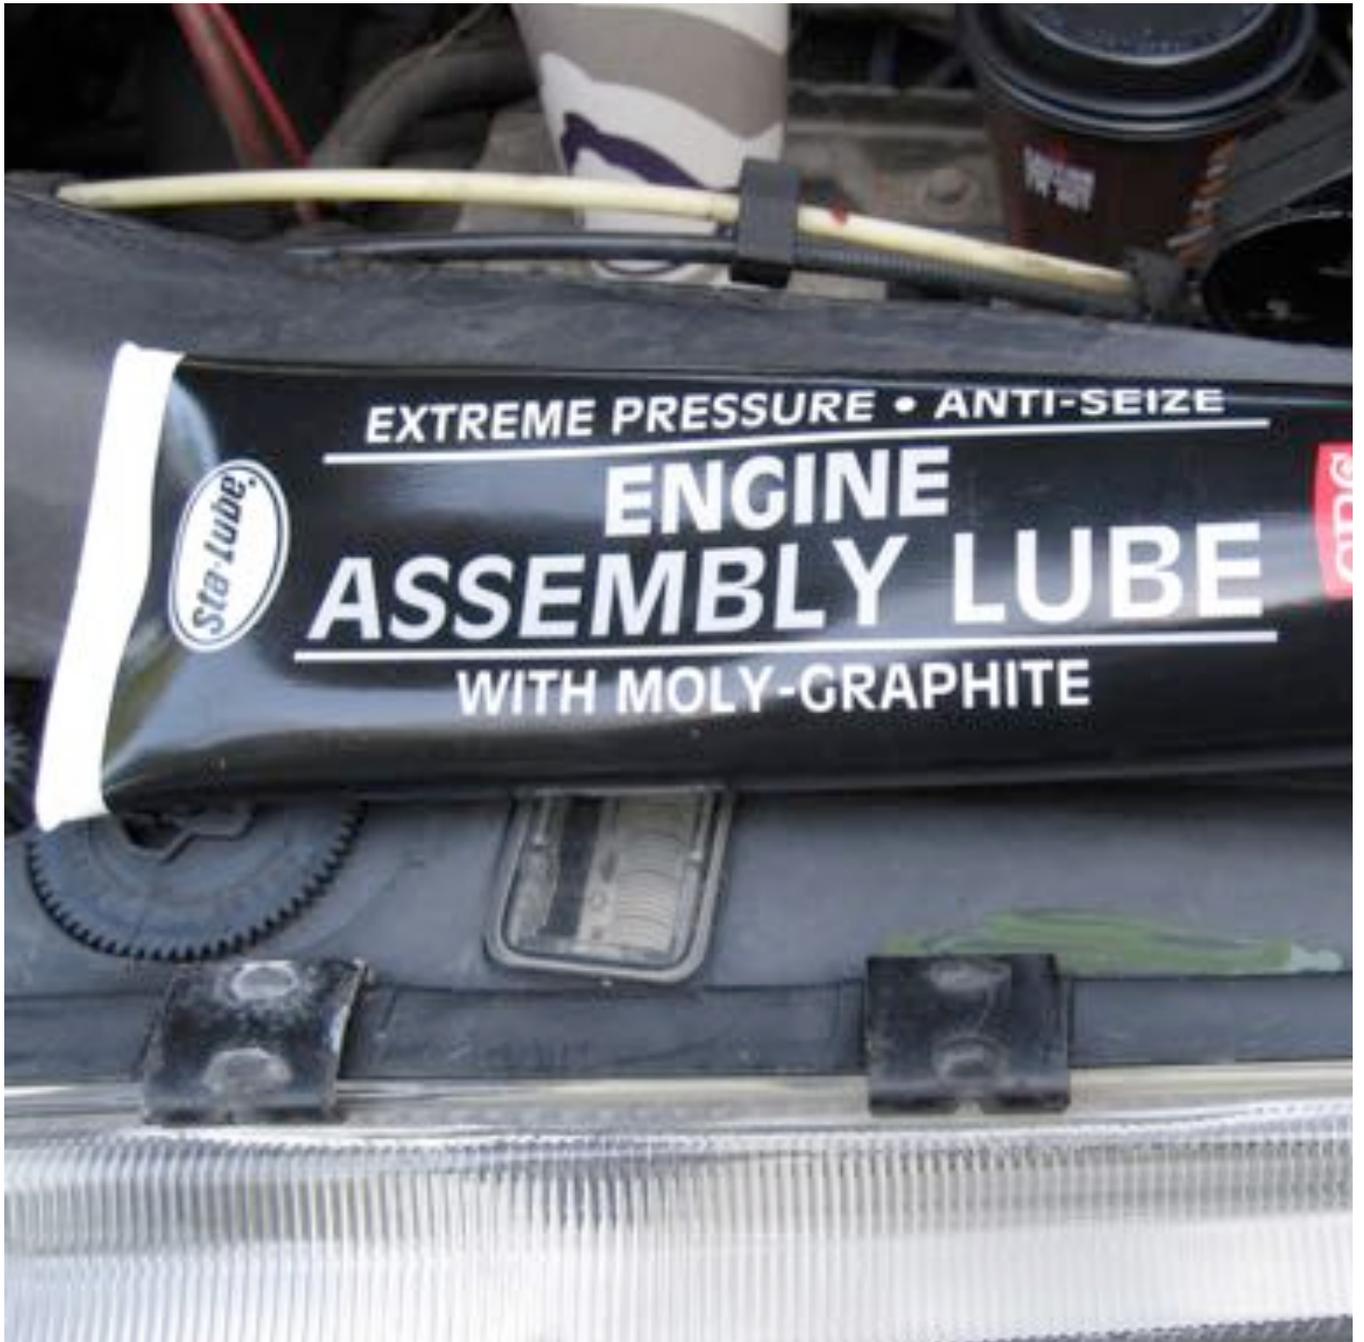
Assembly lube.

Absolutely, put a dab of assembly lube on metal to metal contact parts *except the piston rings and cylinders*. Oil jets will take care of the cylinder walls.
