Technical Journal

Anti-Tamper device , communication lost

REF NO: TJ 27910	ISSUING DEPARTMENT: Technical Service	CAR MARKET: United States and Canada		
PARTNER: 3 US 7510 Volvo Cars North America		ISSUE DATE:		
FUNC GROUP: 2610	FUNC DESC: Radiator and connections	YEAR 2015	MONTH 02	DAY 25
Page 1 of 12

Title	Radiator anti tamper device	Page	1 (9)
Action	Replacement	Operation number:	98546-2

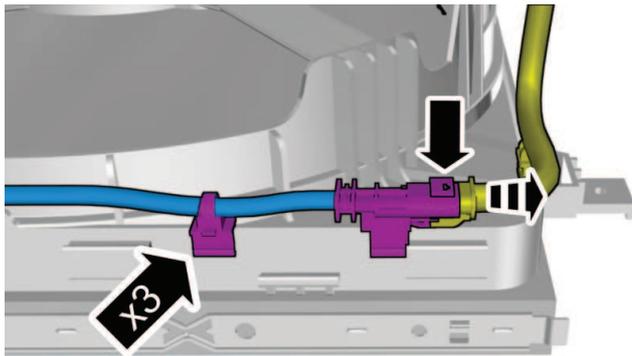
Disconnect the connector.
Loosen the clips.

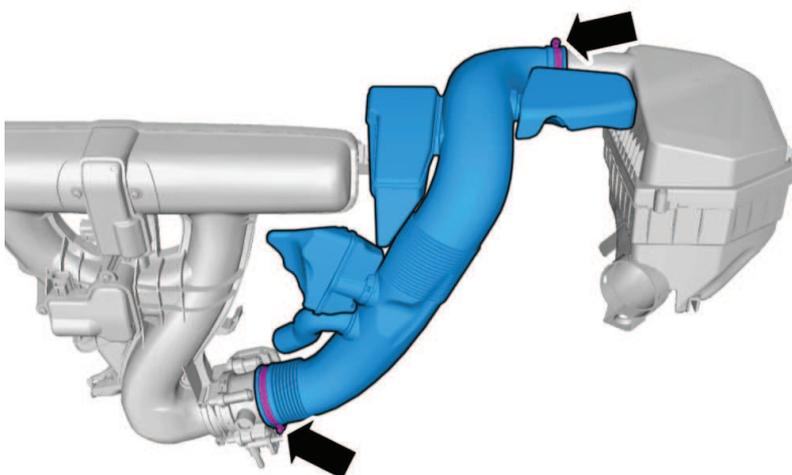
Loosen the hose clamps.
Remove the marked part.

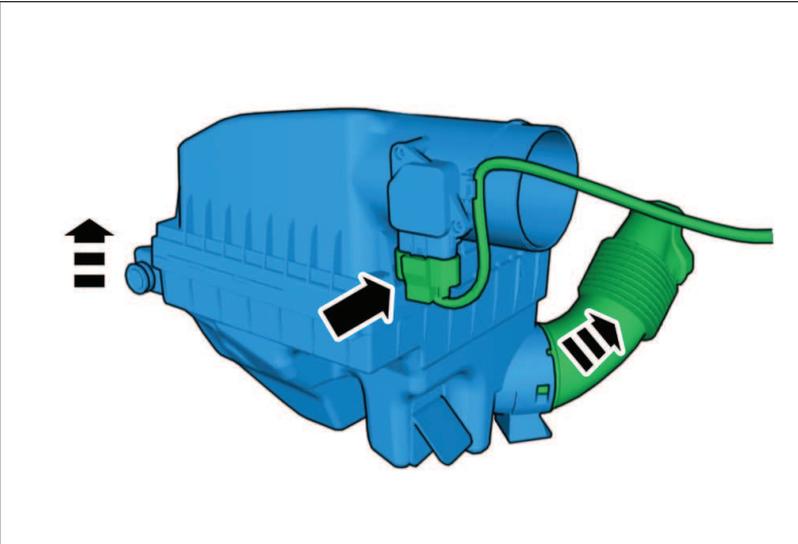
Disconnect the connector.
Undo the hose from the connection.
Remove the marked part.

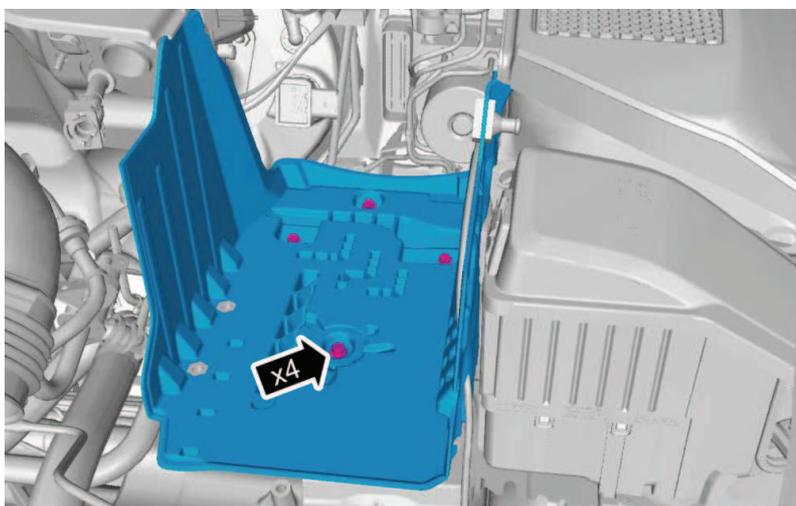
Remove the screws.
Remove the marked part.

Torque:
M6 , 10 Nm

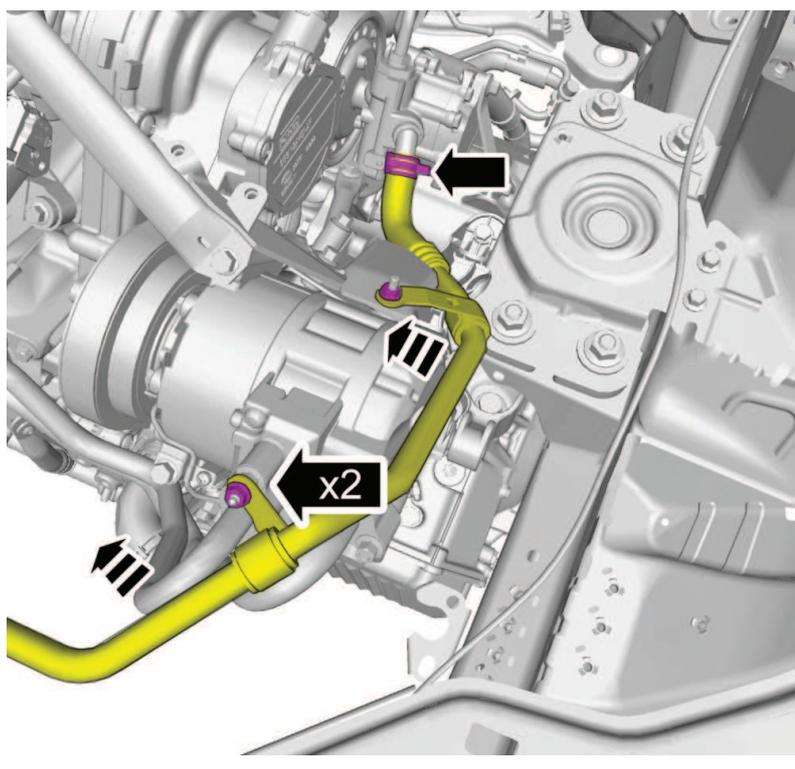
Remove the nuts.

M6 , 10 Nm

Use: Power steering fluid , 30741424

Fold marked part to one side.

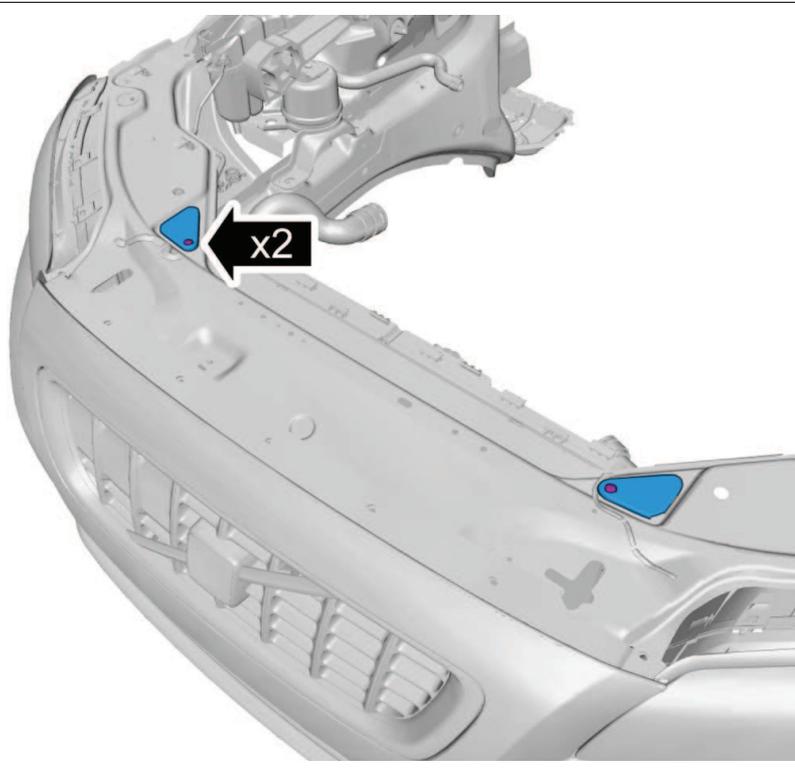
Remove the screws.

M5 , 5 Nm

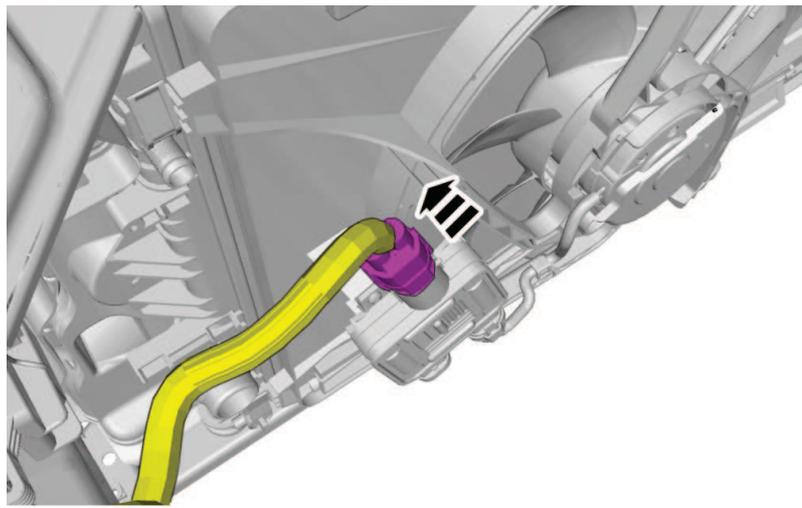
Disconnect the connector.

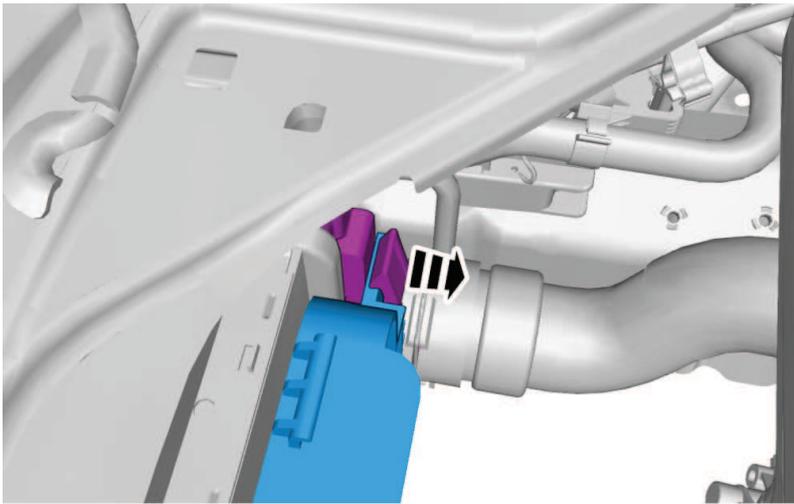
Release the catch.
On both sides.

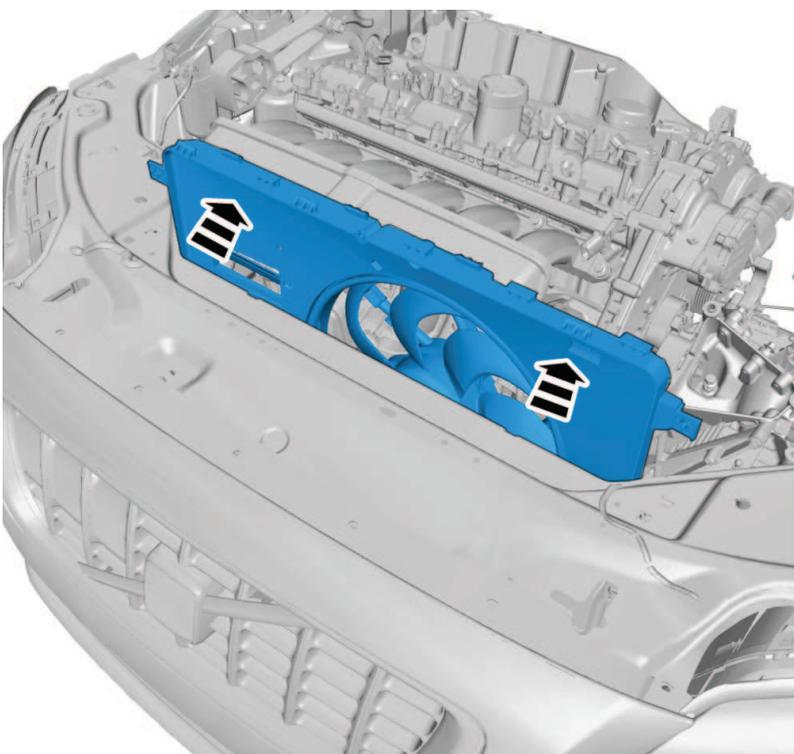
Hint: It may be necessary to twist or turn the component.

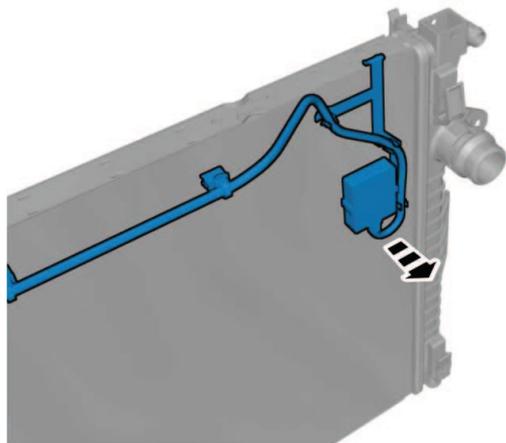
Use: Pipe wrench

Remove the marked part.

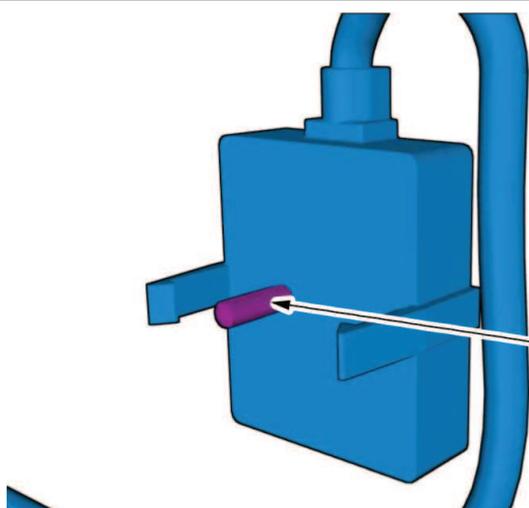
Caution! Apply the adhesive carefully as illustrated.

Use: Rapid bonding adhesive-allround , 1161624

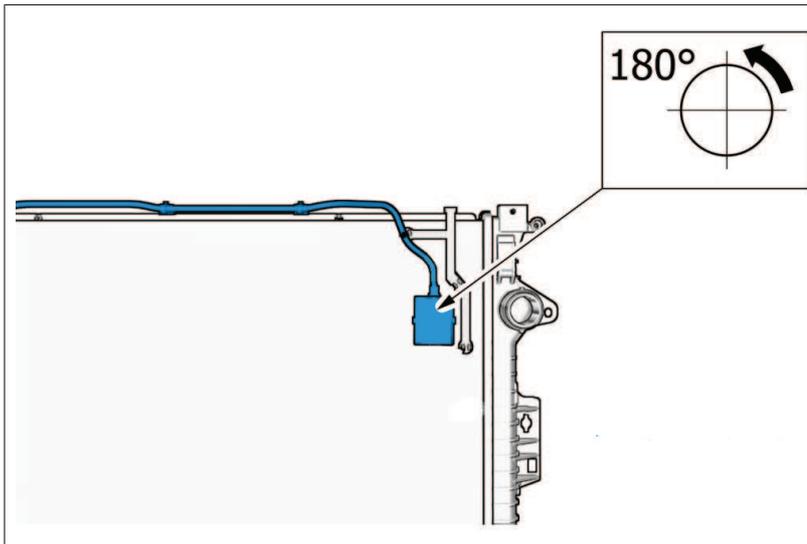
Caution! Make sure to place the component as the graphic shows.

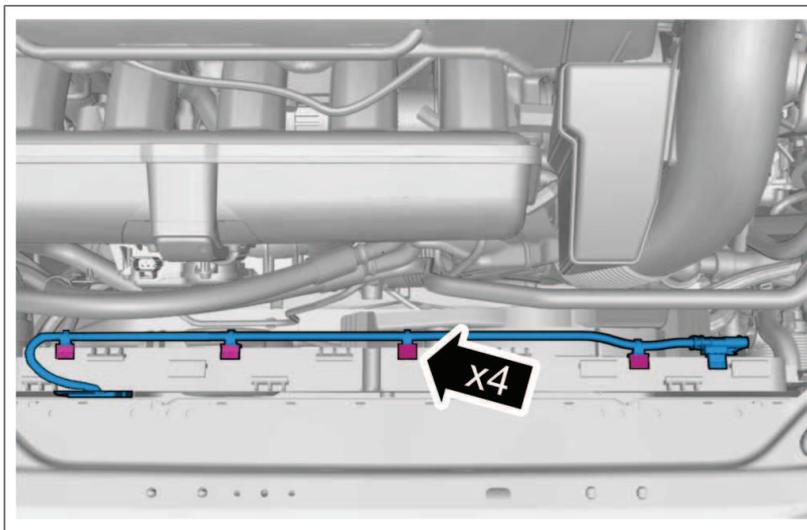
Install the clip(s).
