Measure. Plan. Optimise.

The key to maximum productivity

Iron Ore scrubber screens offer a unique solution for washing and improving the quality of Iron Ore and other minerals.

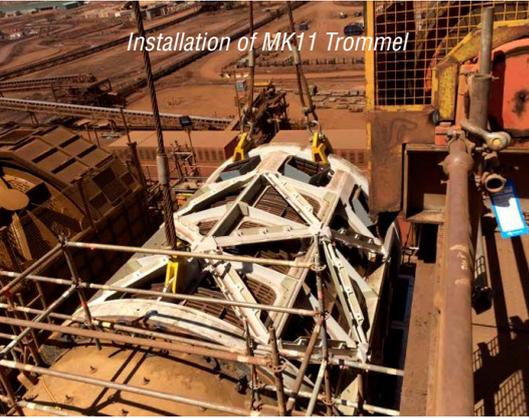
Installation of MK11 Trommel

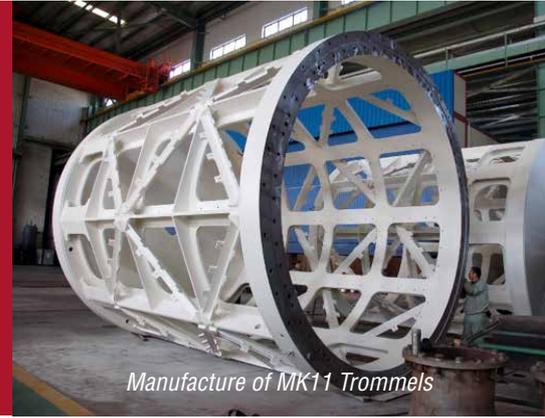
Manufacture of MK11 Trommels

During prolongation works McLanahan worked on designs for not only eliminating fatigue loadings but to actually increase throughput and screening capacity of the trommel screen section.

- Increase in open aperture of 50% to provide better screening and water drainage
- Structural members relocated outside shell to increase available shell area for apertures
- Single size screen plates to enable easier change-out and simplified stock holding
- Oversize discharge ports re-aligned to minimise wear on exit
- Increased protection on structural members.

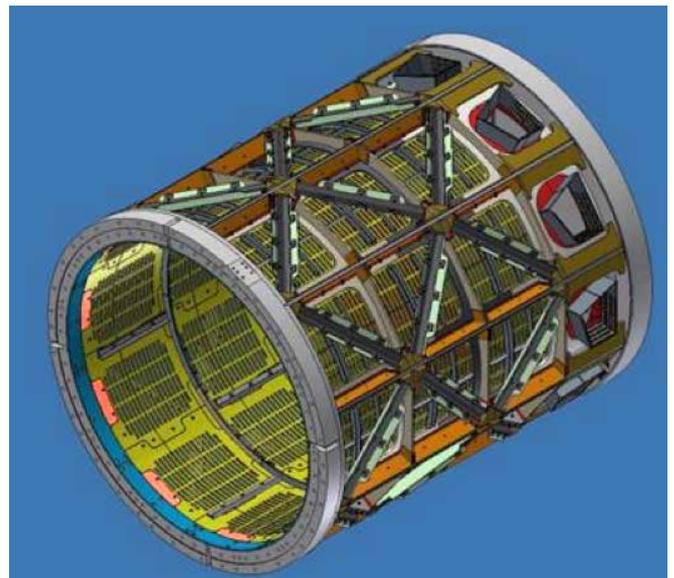
Model of Redesigned Trommel Sections

McLanahan Corporation and the plant operator continue to collaborate and operate under the same principle of measure, plan, optimise, which continues to drive performance improvements across the plant. Improvements to the feed, drive and discharge segments, have been designed and installed, and performance, wear and fatigue continue to be measured.
