**1995 Technical Review**  
**Summary**  
*by Rawia Fadel*

## **Reconstruction of Hafsia Quarter II**

**Medina of Tunis, Tunisia**  
**1296.TUN**

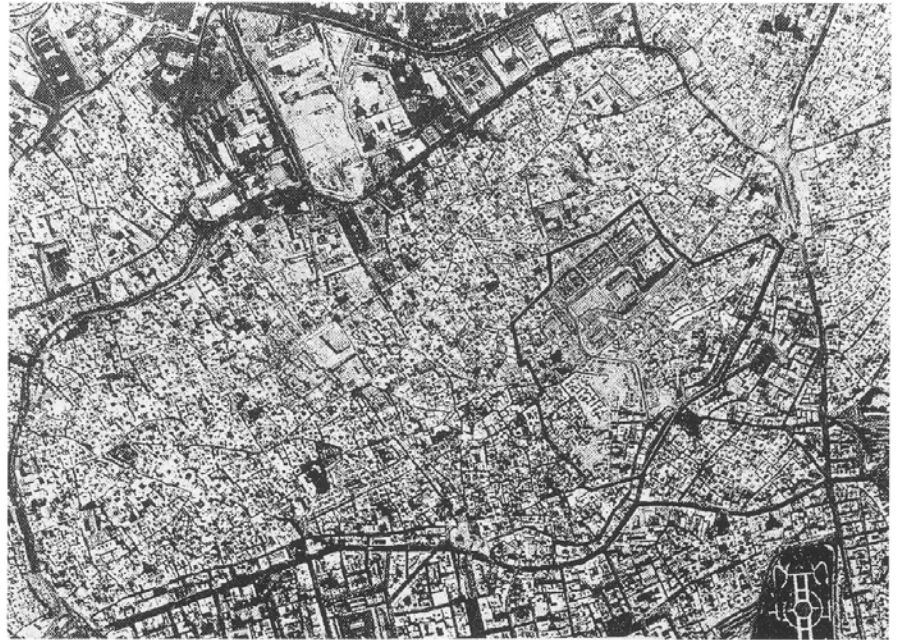
*Aerial view of  
Medina with the  
Hafsia quarter  
emphasised*

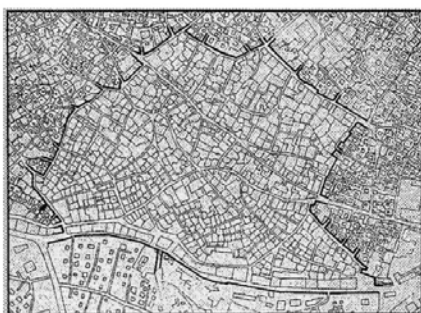
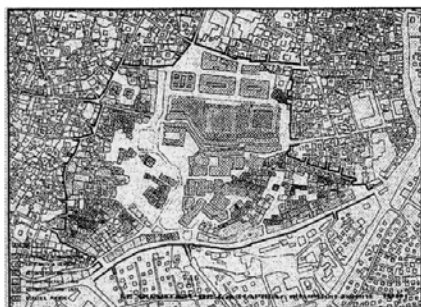
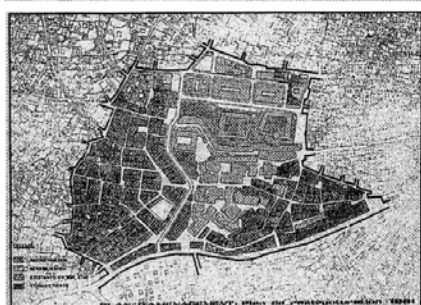
*Plans of the Medina before 1933(top), during 1980 (middle), and following the 1981 reconstruction (below)*
