Rehabilitation of Mullah Mahmood Mosque

Sang Tarashi, Shur Bazaar Kabul, Kabul Old City  
Kabul, Afghanistan

DRAWINGS OF MULLAH MAHMOOD HISTORIC MOSQUE

# Mullah Mahmood Historic Mosque

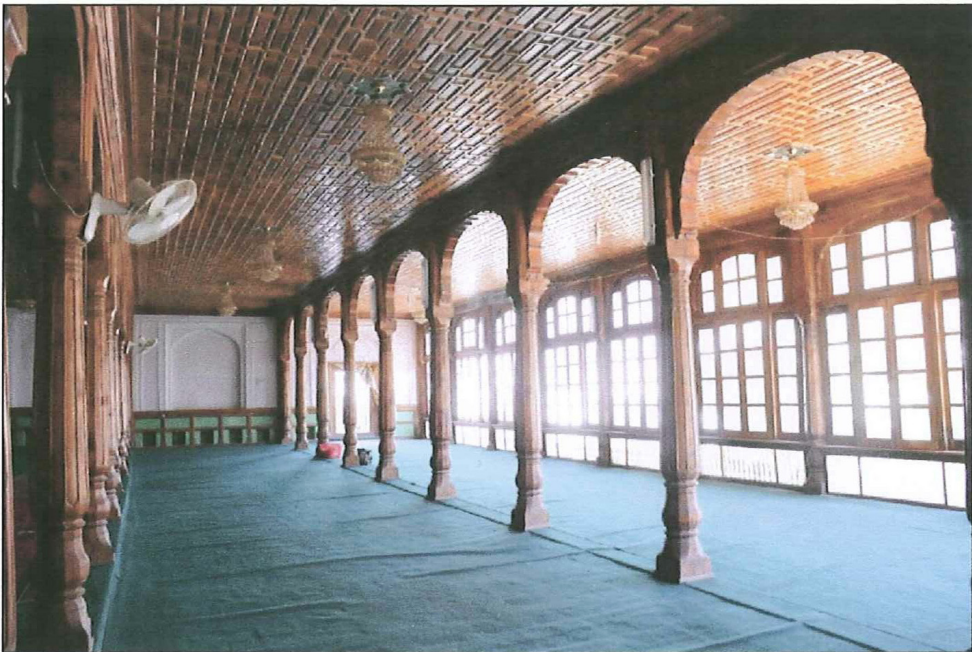
Photo 1: An internal view of Mosque after rehabilitation

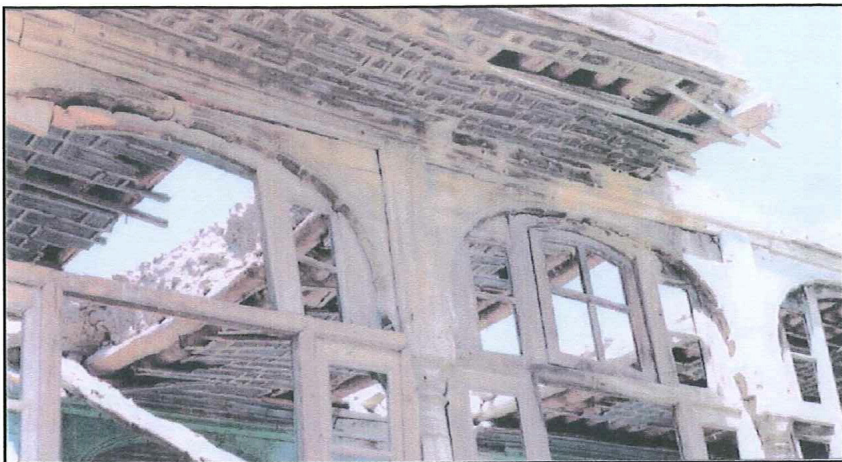
File	Description	Photographer	Date
B-1	The condition of the upper floor before reconstruction	Abdul Rahim Khurram	Nov. 2003
B-2	Southern wall of the building upper floor. The lower floor wall is hidden under piles of soil and debris.	Abdul Rahim Khurram	Nov. 2003
B-3	The single piece of carved wood remaining from the destroyed main gate	Abdul Rahim Khurram	Nov. 2003
B-4	The fallen roof destroyed by missile explosion	Abdul Rahim Khurram	Nov. 2003
B-5	South Eastern view showing the status of the building and the boundary wall.	Abdul Rahim Khurram	Nov. 2003
B-6	Upper floor ceiling with broken wood beams	Abdul Rahim Khurram	Nov. 2003
B-7	The northern door of the upper floor opened to the road. Later we found the actual foundation stonework of the boundary wall 2.60 meters to the roadside and reconstructed the boundary wall in its original location so that about 62 square meters stolen land of the mosque was regained. The door now opens inside the mosque compound.	Abdul Rahim Khurram	Nov. 2003

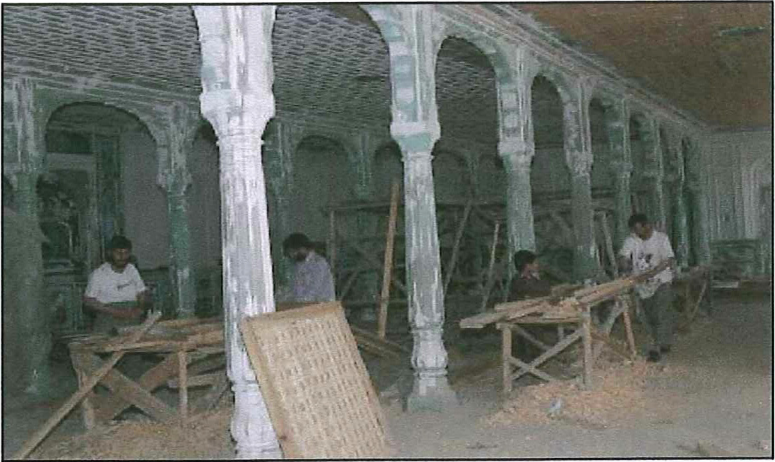
File	Description	Photographer	Date
D-1	Construction of the wooden doors, windows and decorative ceiling cover of the first floor by a team of professional carpenters	Abdul Rahim Khurram	May 2004
D-2	Construction of the wood joist network and ceiling cover of the ground floor ceiling in progress	Abdul Rahim Khurram	Feb. 2004
D-3	The furnace of the underground heating system after plastering and firebrick flooring of the opening	Abdul Rahim Khurram	Oct. 2004
D-4	Construction of the ablution area; plumbing, plastering and flooring in progress	Abdul Rahim Khurram	Nov. 2004
D-5	The roof of the building is removed so that the destroyed and rotten wood beams, ring beams and lentils could be replaced	Abdul Rahim Khurram	Dec. 2003
D-6	The heap of soil removed from the top of the roof before dismantling	Abdul Rahim Khurram	Dec. 2003
D-7	Plastering the Eastern boundary wall reconstructed with firebricks and mortar of lime and sand in progress	Abdul Rahim Khurram	June 2004

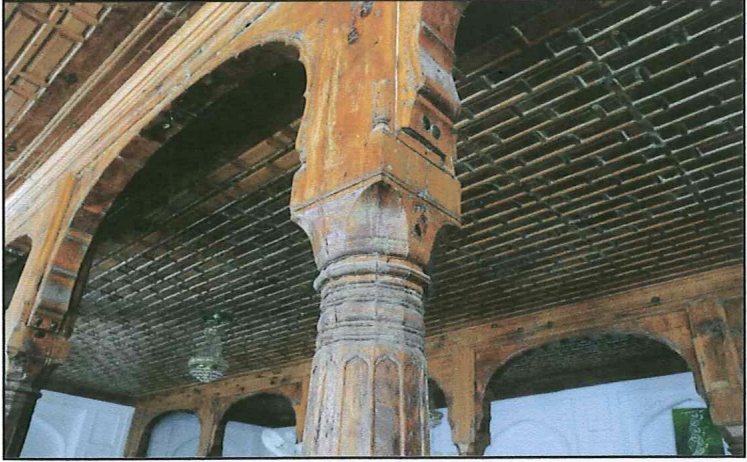
File	Description	Photographer	Date
A-1	The wooden arch, columns and ceiling after reconstruction	Casey Johnson	Oct. 2009
A-2	A view of the Mehrab (alcove) of the mosque after repairs, plastering and painting	Casey Johnson	Oct. 2009
A-3	Upper floor of the mosque ready for use	Casey Johnson	Oct. 2009
A-4	Column top and the windows after reconstruction	Casey Johnson	Oct. 2009
A-5	A view of the Eastern façade of the building. The stairs leading to the Southern door of the first floor could be seen	Casey Johnson	Oct. 2009
A-6	Roadside view of the gate and the building	Casey Johnson	Oct. 2009
A-7	The main gate, ablution area, the lawn and the water point seen from inside the courtyard	Casey Johnson	Oct. 2009
