Restoration of Chittoor Palace

Sheet No.1

Ernakulam Kochi, India

Programme

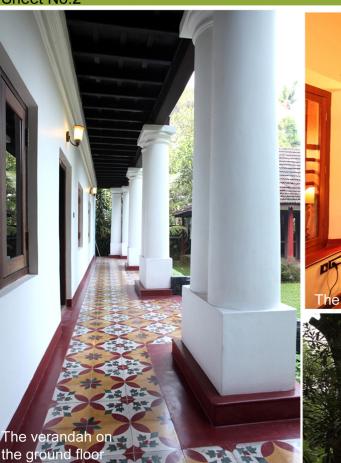
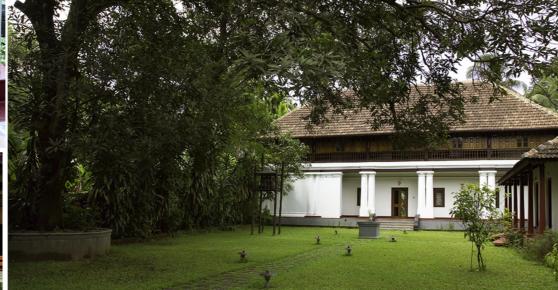
Sheet No:2 3769.IND

The flooring was done up with athangudi tiles with polished red oxide borders and skirting.

The toilets were redone to accommodate functional use and hygiene. The electrical, plumbing and air conditioning systems were introduced without tampering the building.

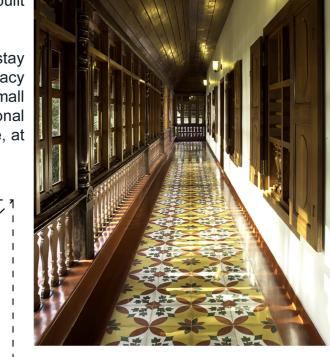
The enchanting corridor on the first floor

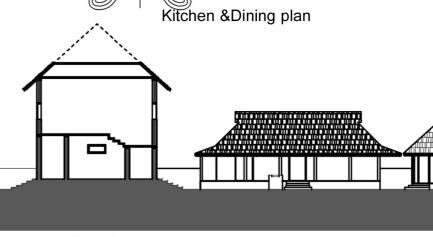
View of palace from the padipura
