## **Djenné**

*Djenné, Mali*

## **I. Introduction**

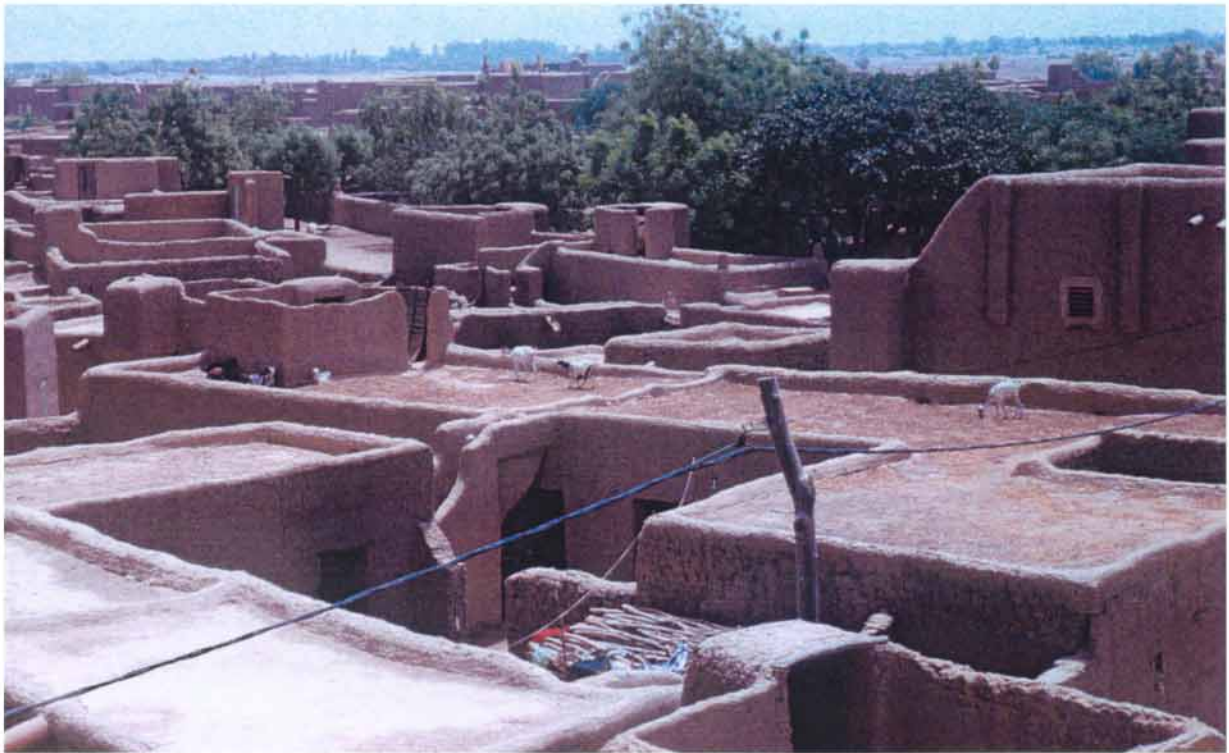
*Above: General view over the flat mud roofs and courtyards of private residences.*

*Below: There are three distinct house types in Djenné: Moroccan, Toucouleur, and Modern. A Modern style house is seen here; water drainage pipes project from the main elevation.*

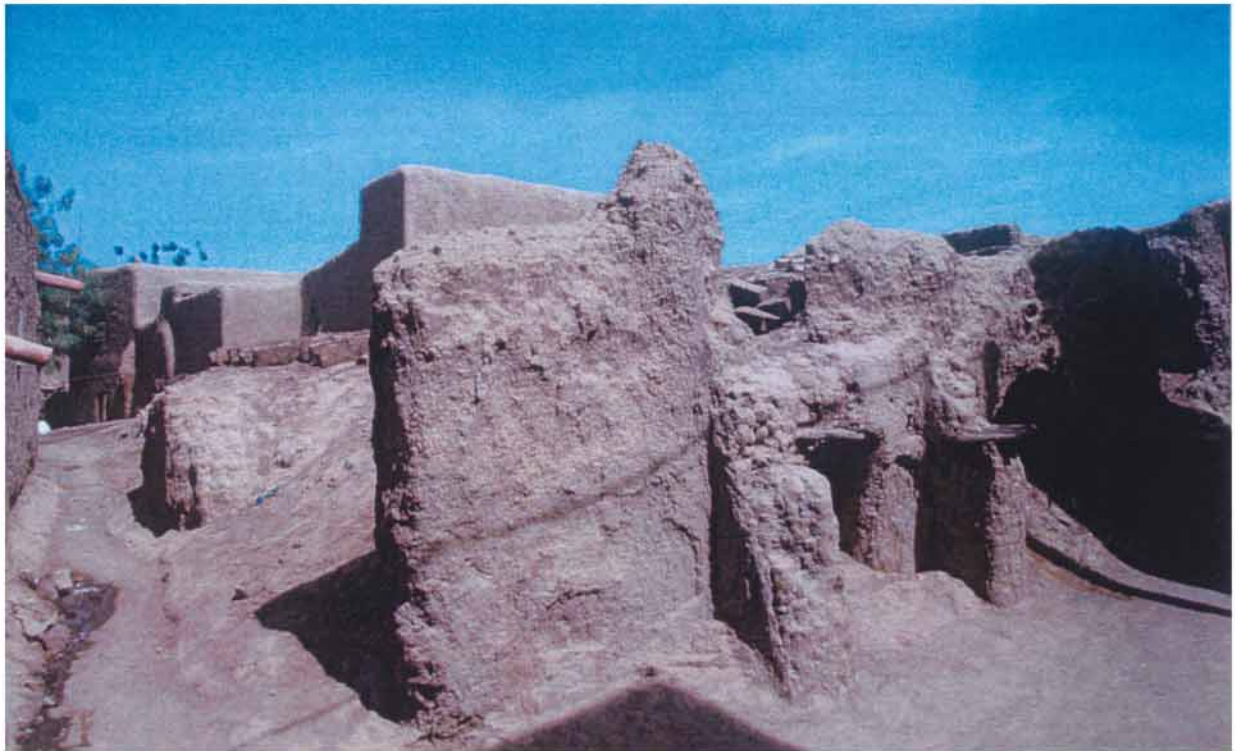
*Above: A badly deteriorating house in need of reconstruction.*

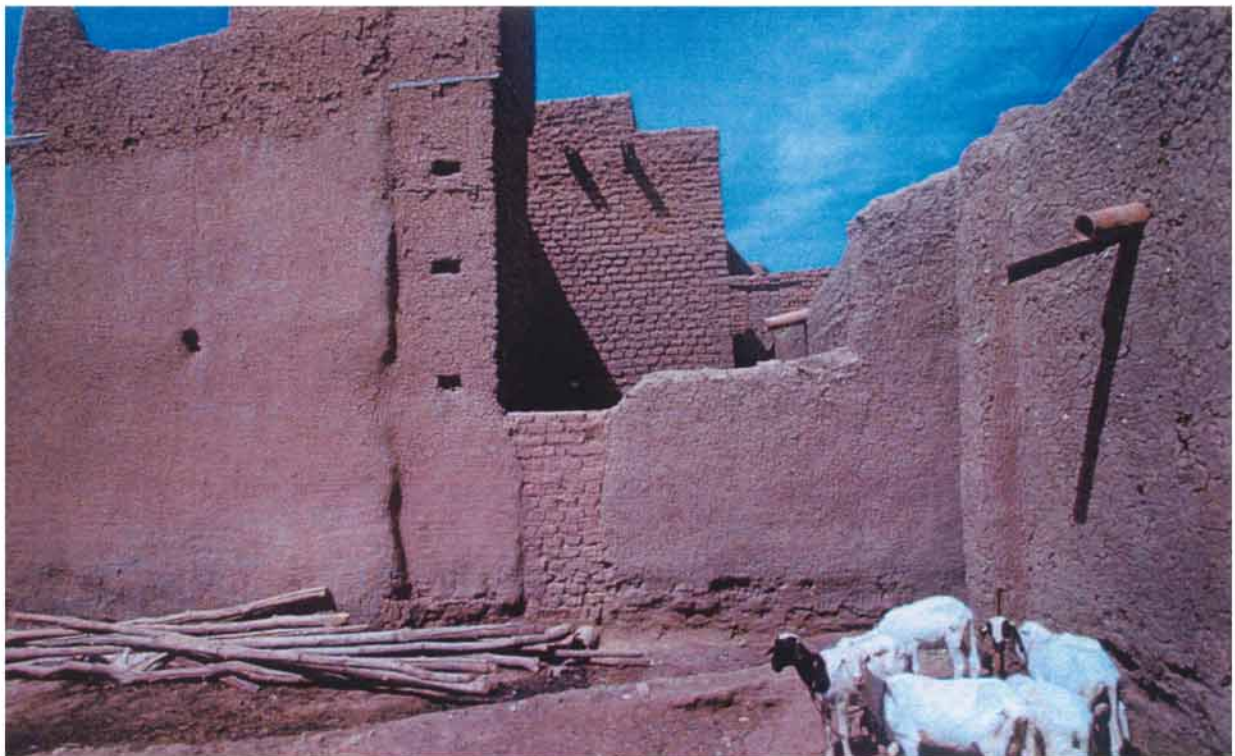
*Below: Mud brick surfaces are rendered in smooth mud plaster. Wood is necessary for the structure of floors and roofs, doors and windows, and toron - palm tree trunks protruding from the elevation of taller buildings which serve as scaffolding.*

Wood is necessary for the construction of floors, ceilings and roofs, doors and windows, and also for *toron*, bundles of palm-tree trunks that jut some 60 centimetres from the elevations of taller buildings and which serve simultaneously as decoration and as scaffolding for the periodic rendering of the walls. Otherwise, the singularity of the city and of its buildings results from the plastic quality offered by mud, combining structural elements such as pillars and pilasters with the decorative opportunities they offer, so that pinnacles, parapets and *toron* create natural details.

All the bearing elements in the buildings are made of mud (*banco*) blocks: foundations, walls, pillars and pilasters. Roofs, ceilings and floors are constructed of wooden joists that are crossed with branches and then covered with fine mud. The foundations are about 100 centimetres deep and 80 centimetres wide; walls are reinforced with pilasters and wooden beams (*domba*) intermittently laid over the courses.

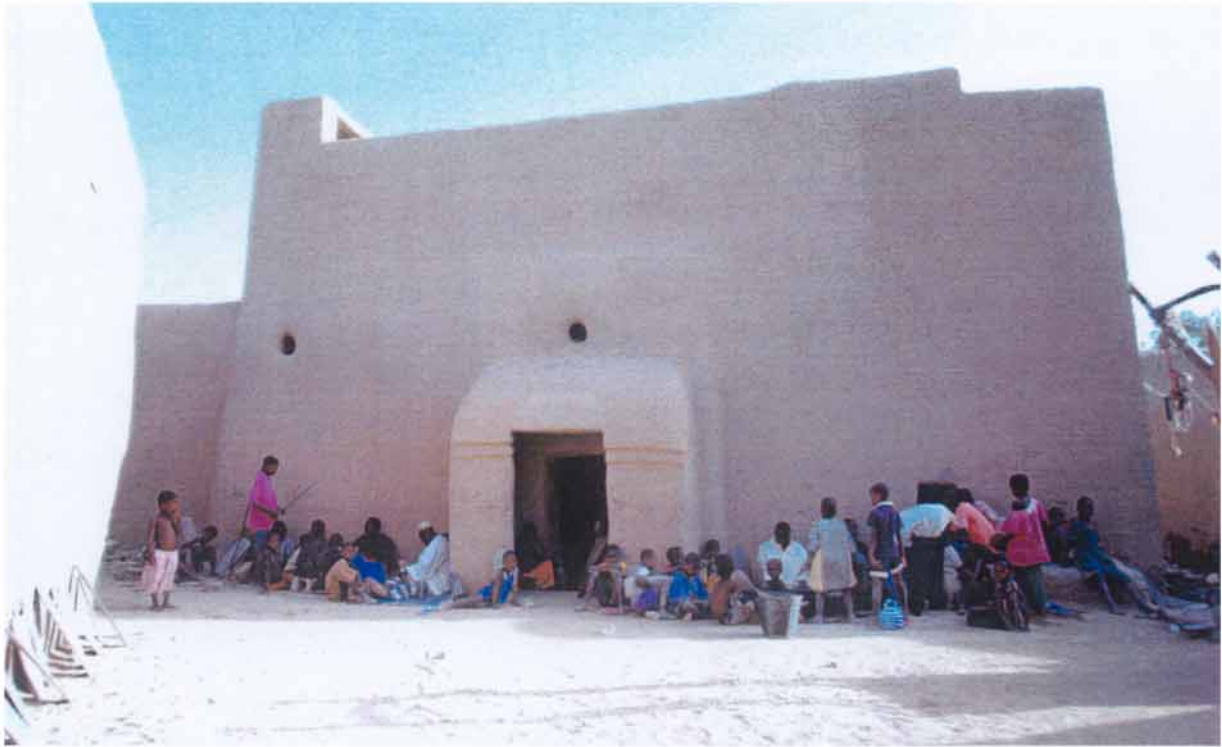
*Above: Students gather in front of a recently rendered two-storey school. Minimal openings on the façade help keep the building interiors cool.*

*Below: Students leave their writing tablets against the wall of a one room schoolhouse.*

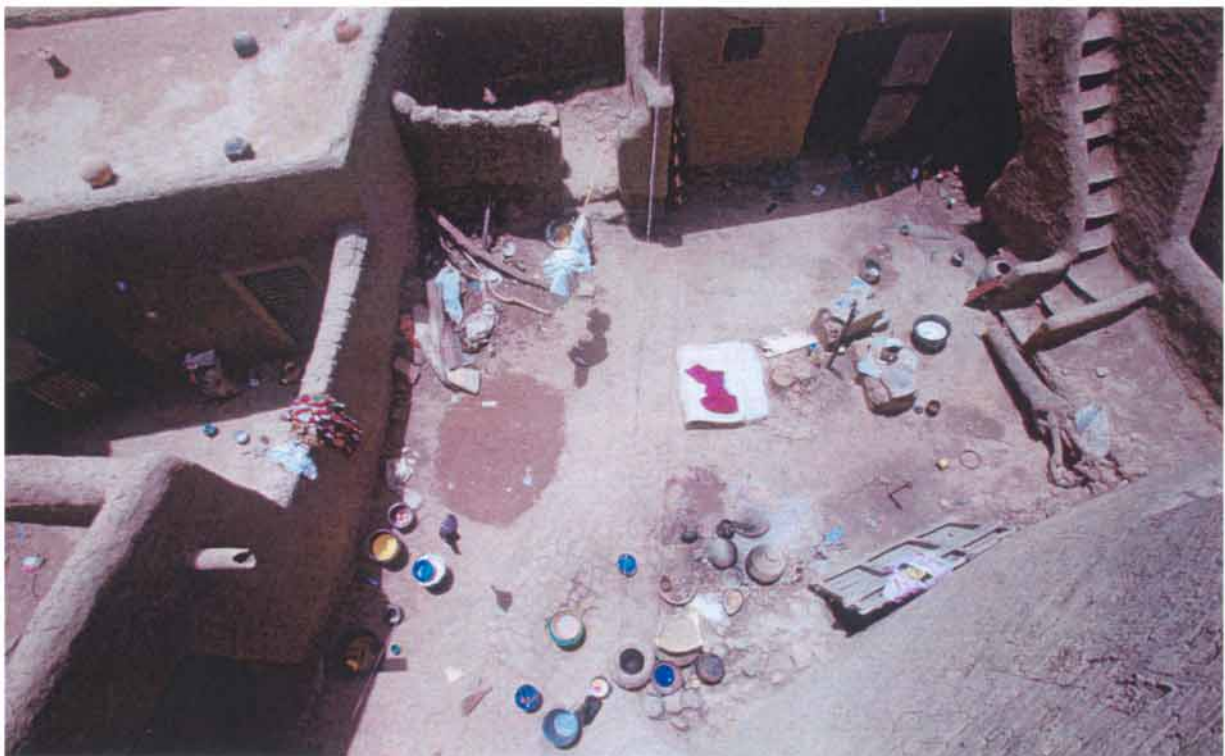
*Above: The Moroccan style identifies this house as one of two-storeys containing an interior courtyard and belonging to an important family.*

*Below: View into a private courtyard of a residence.*

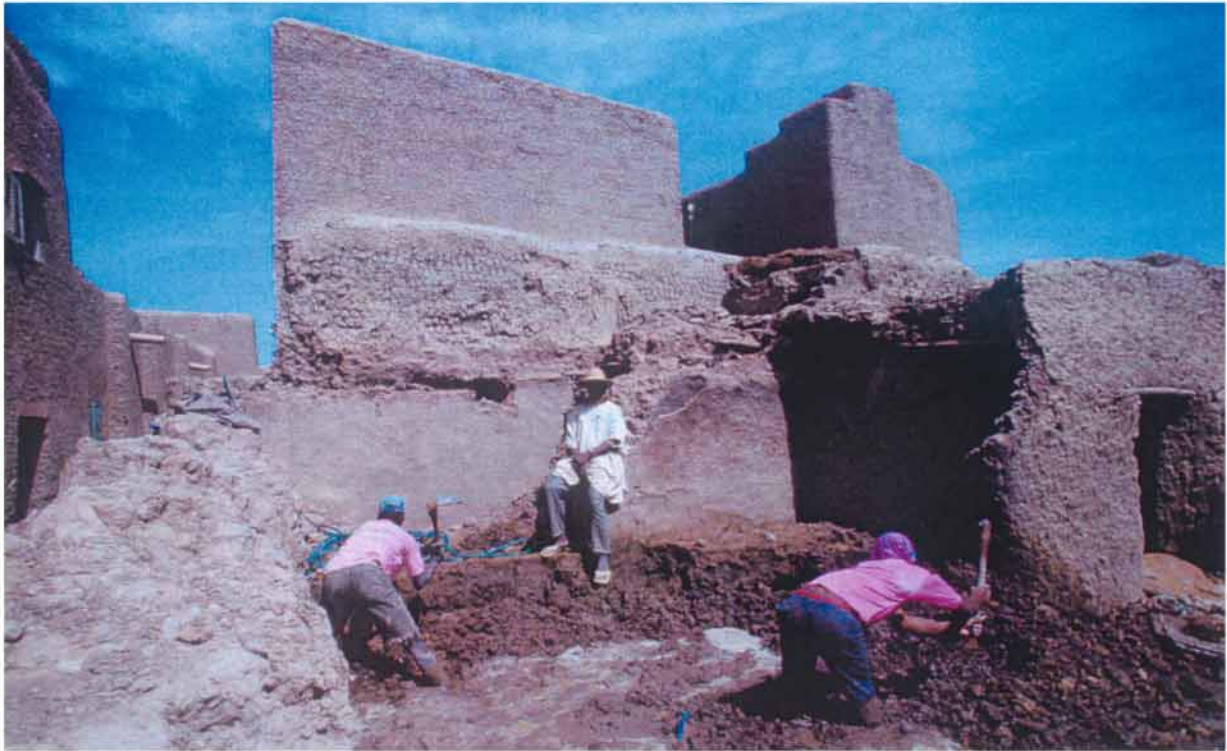
*Above: Workmen mixing mud or banco dug from the floor bed of a site to be constructed. The mud will eventually be mixed with rice or barley straw before being shaped into bricks.*

The earth used for blocks, mortar and rendering may come from the site or from nearby (earth from collapsed buildings is also used) but it is selected according to its ultimate use. Earth from pits excavated in the flood beds is also used, and complete production sites are often found here, with mud pits for the blocks, blocks already shaped, and pits for the 'fermented earth' used for rendering. Rice or barley straw is mixed with the mud for the blocks in a proportion described as 'for one cart of earth, thirty bags of straw', a bag being the size of a 100-kilogram rice bag. The mortar should be about 3 centimetres thick for the horizontal joints and 2 centimetres thick for the vertical.

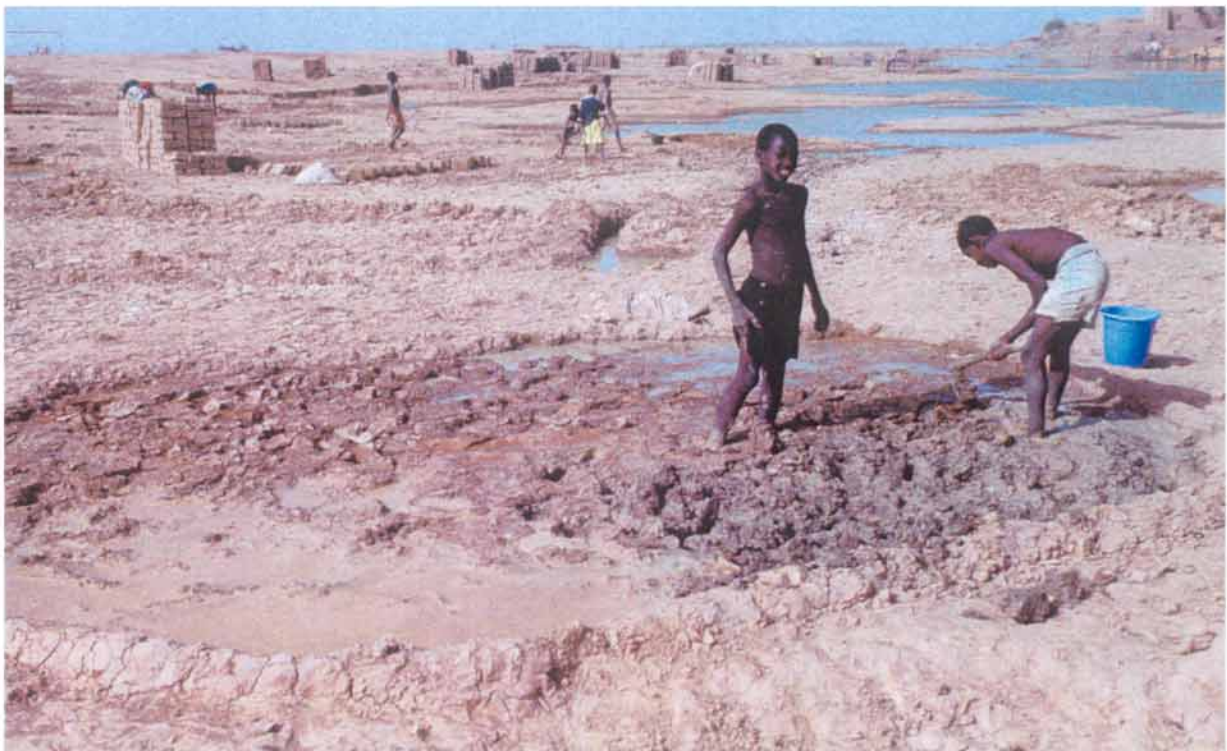
*Below: A mud brick production site.*

There are two types of mud blocks. The older kind, now no longer used except for specific restoration work, are called *Djenné ferey* and consist of roughly cylindrical pieces, moulded by hand, which explains the tapered appearance of the oldest houses and the softer modelling of their pilasters and decorative elements. From the 1930s, however, it became common to shape the mud in rectangular wooden forms, producing blocks of about 20 x 10 x 40 centimetres (*toubabo ferey*, the white men's bricks). This gives the houses a more angular and less tapered form, although it is likely that mud rendering and weathering will see them develop the soft contours of the original buildings.

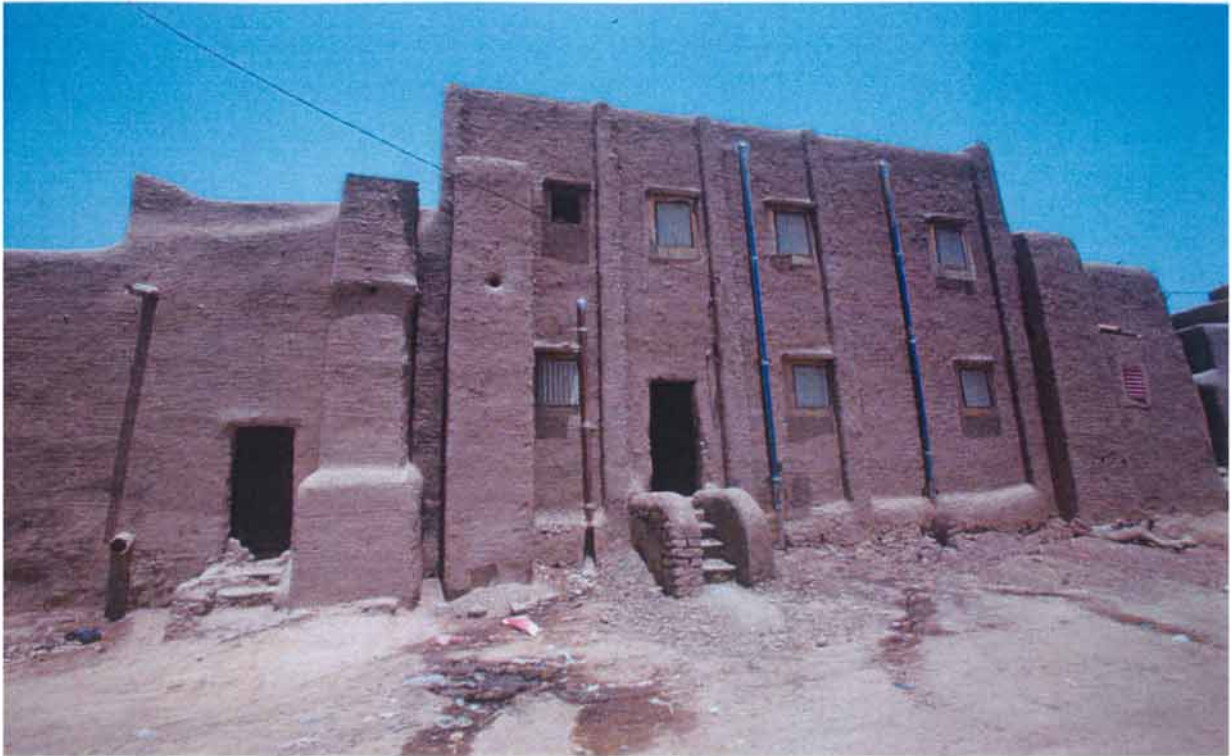
*Above: The Moroccan style identifies this house as one of two-storeys containing an interior courtyard and belonging to an important family.*

*Below: View into a private courtyard of a residence.*
