Darb al-Ahmar Monuments

CAIRO, EGYPT

The conservation projects of the Aga Khan Trust for Culture (AKTC) in Darb al-Ahmar started with two minarets in the vicinity of Azhar Park, that of Umm al-Sultan Shaaban Mosque (1368–69) and that of Khayrbek Mosque (1502–20). Both minarets had lost their upper parts as a result of the devastating 1884 earthquake. Collapses and reconstructions of minarets were not unknown to the history of Cairo. Despite attempts to reconstruct them in 1941, the minarets of Umm al-Sultan Shaaban and of Khayrbek mosques waited until 2003 to recover their integrity, when AKTC, on the basis of historic documentation, started with the Supreme Council of Antiquities in Egypt not only to restore them to their original shape but also to restore and revive the skills and the craftsmanship of artisans whose crafts were, and still are, in danger of being lost.

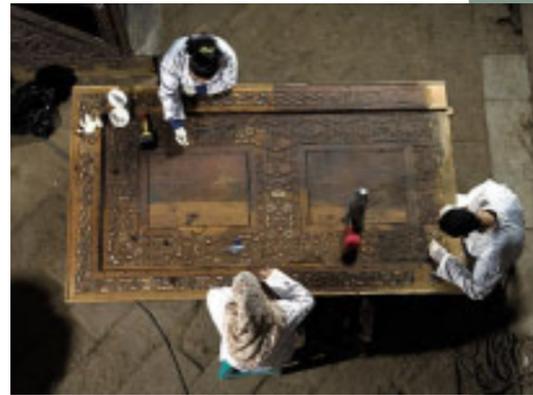
Conservators clean a wooden frame from the mausoleum of Aslam Mosque.

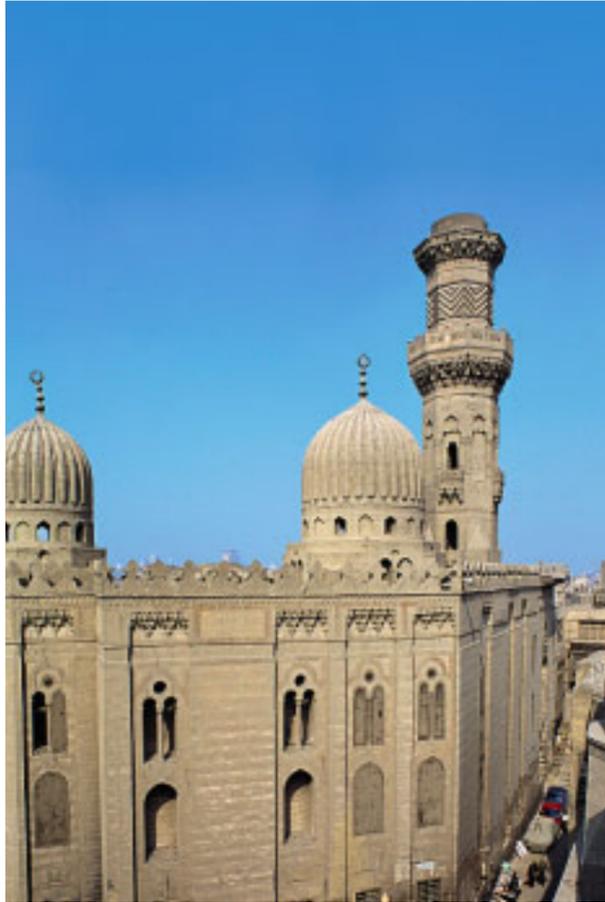
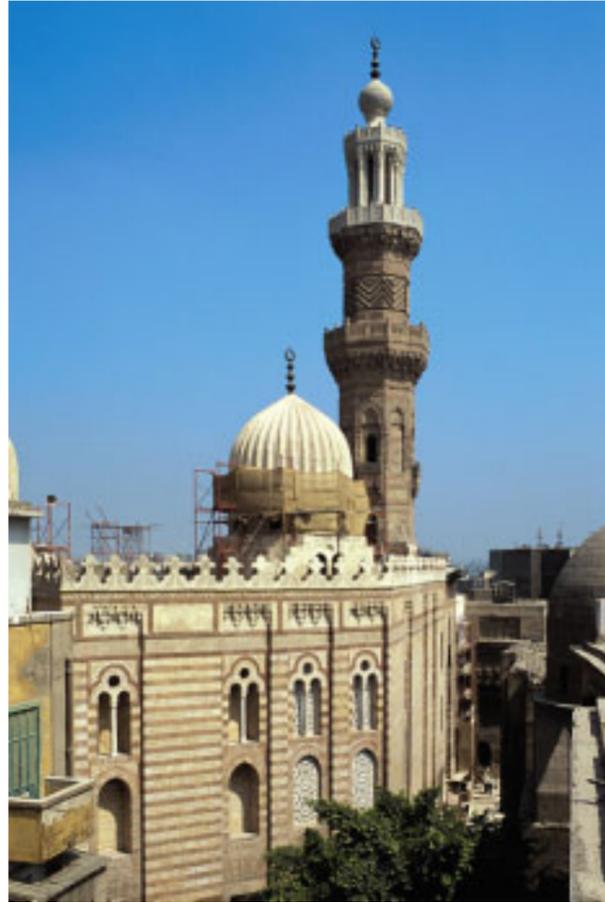
The 14th-century Umm al-Sultan Shaaban Mosque was restored by the Historic Cities Programme. The minaret had lost its upper part as a result of the devastating 1884 earthquake. It was returned to its original shape on the basis of historic documentation.

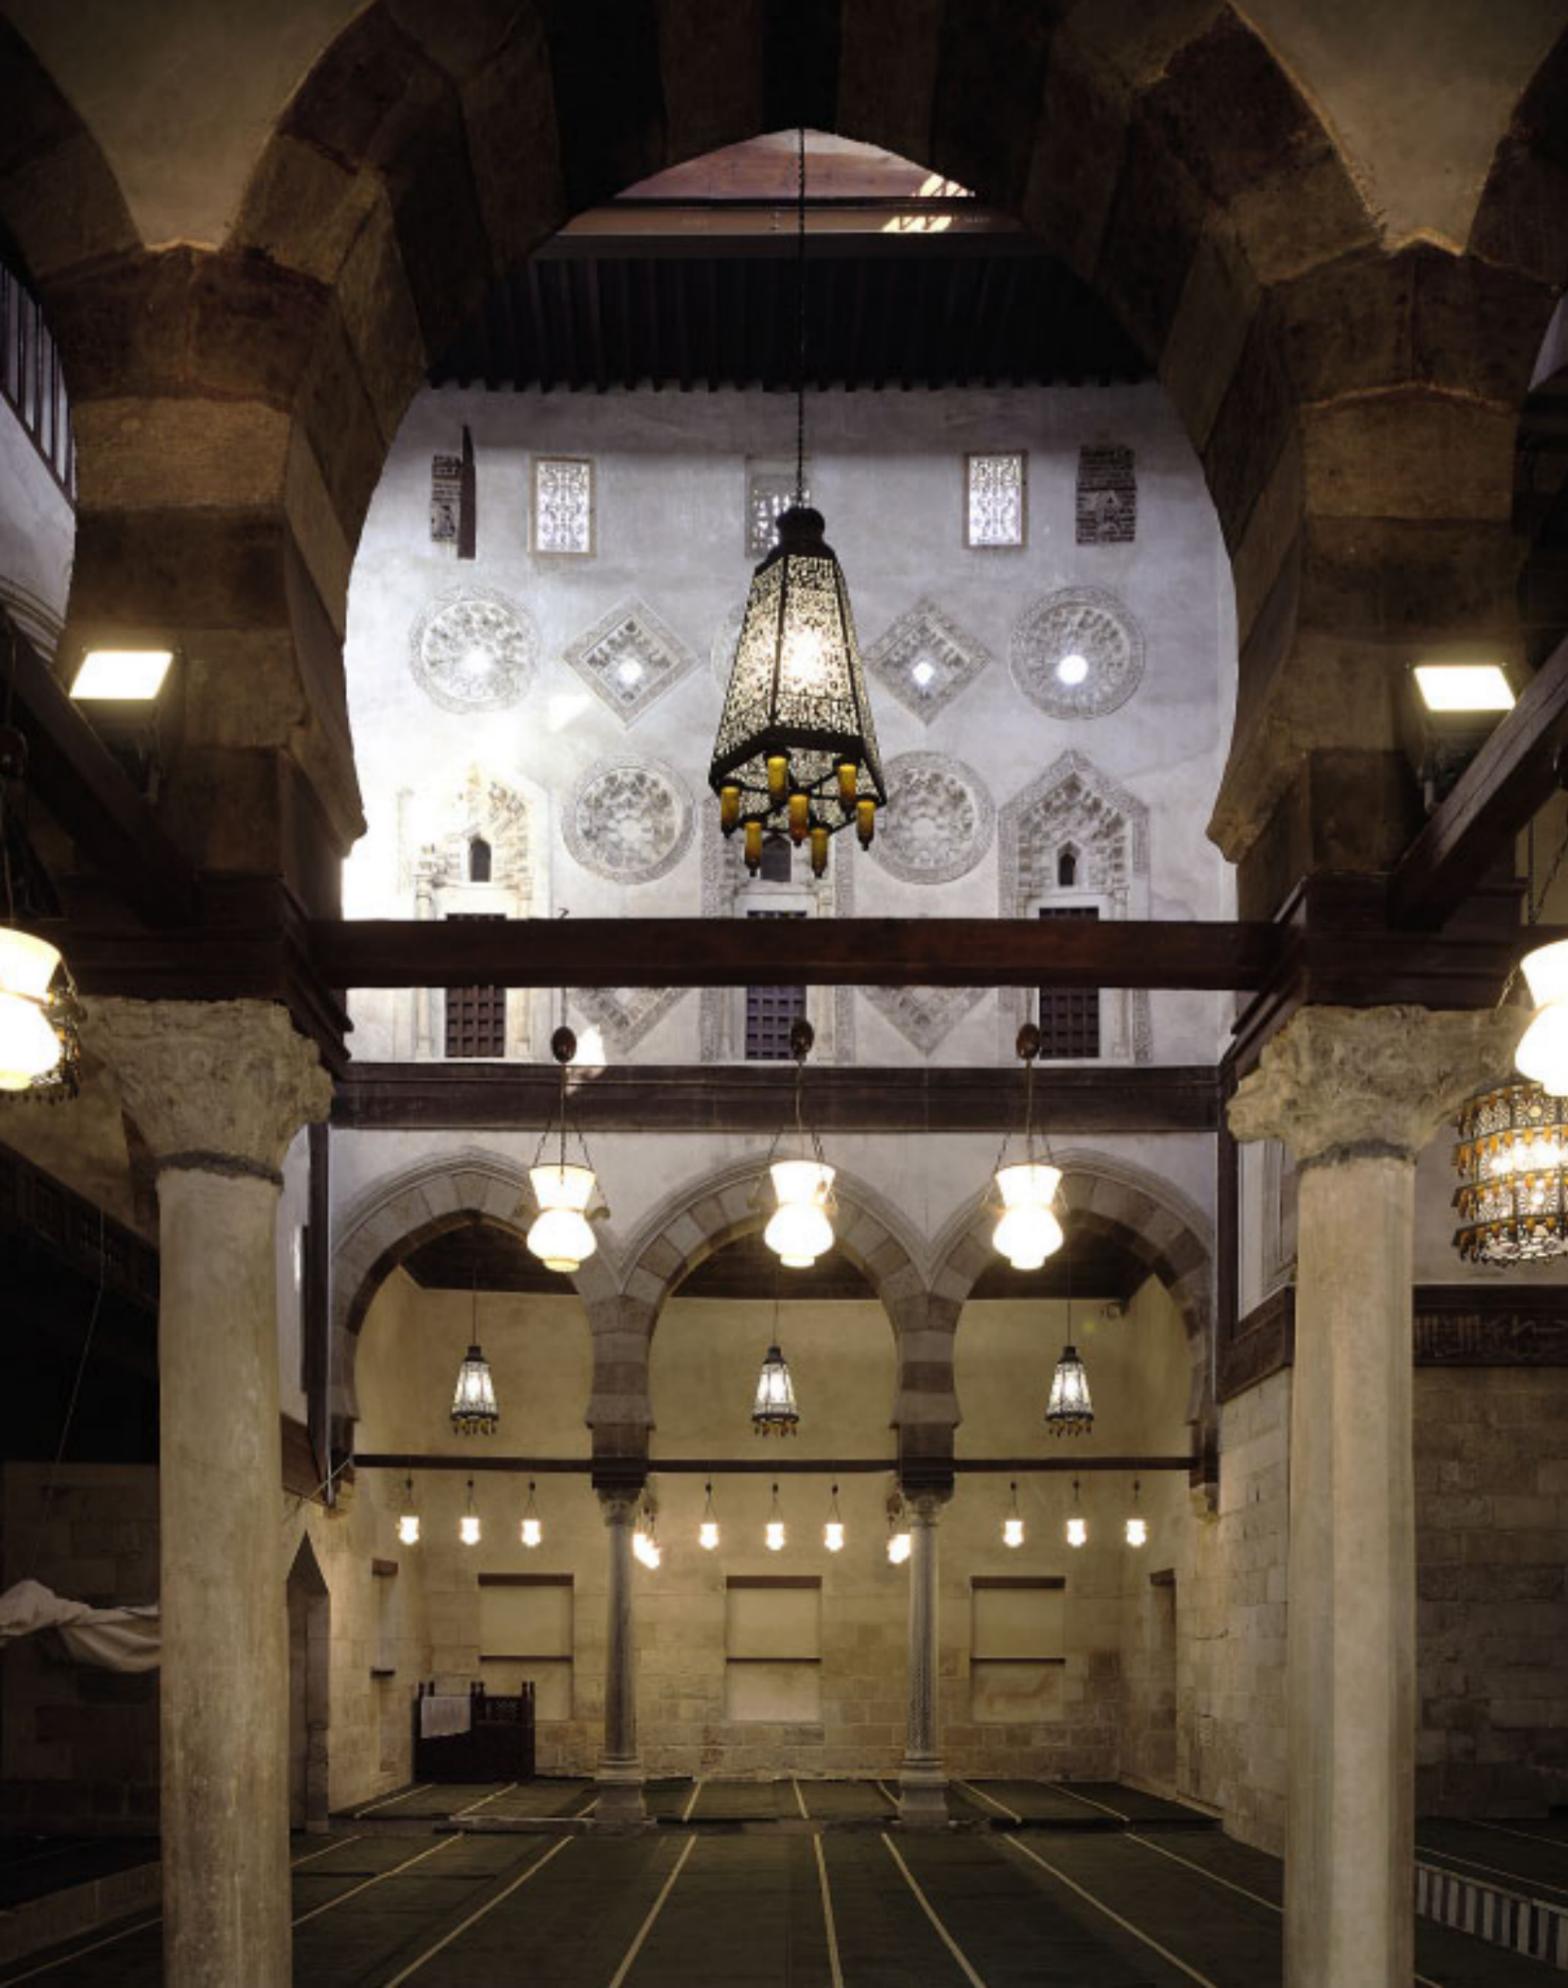
Below, a view of the interior of Aqsunqur Mosque (known as the Blue Mosque) during restoration in 2009.
