T B M M
NATIONAL
PALACES

Palace Parks Programme, Istanbul, Turkey

Assessment

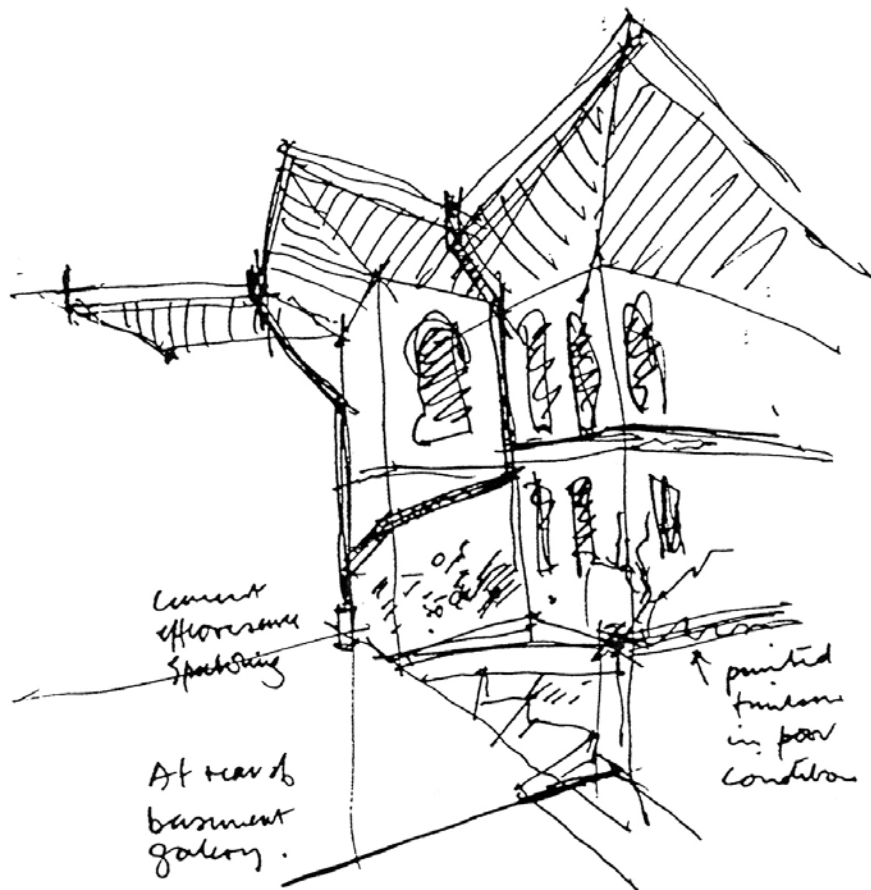
There is also on the exterior walls much efflorescence and blowing of the painted surface which appears to cover a portland cement render, which in itself may not be beneficial to the health of Aynali Kavak. There are cracks associated with the corners of the building and with many of the window openings at the levels of the main floor and the basement. In addition to the water damaged painted timber, there are some timber elements which are in poor condition with flaking paint, and which may not have been properly primed or given an undercoat. Thus the timber structure, along with the lead roofs and the painted interiors, requires a complete and detailed survey, the result of which must be carefully considered before any work starts. Unfortunately, this goes against the present practice of the NPT where time rather than the long term well being of the buildings appears to be of the essence. Certainly in view of the conservation needs of this building it cannot have been the wisest of actions when in 1986 four posts were removed from the basement having been put in by the military to prop up the basement ceiling, which is also

AYNALI KAVAK : DAMAGE CAUSED
BY RISING DAMP.

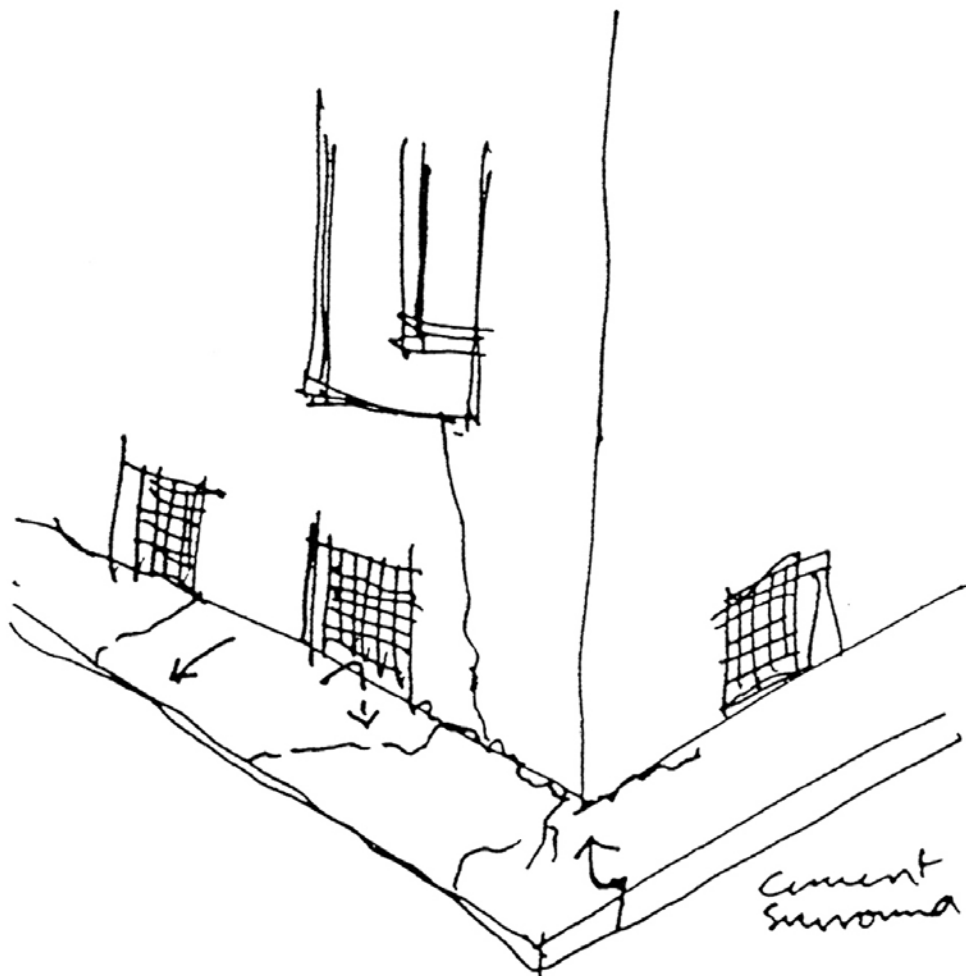
One further cause of problems related to dampness are the cement margins running around the foot of the walls, for they are not laid to a fall that would shed water away from the walls, but

AYNALI KAVAK: CEMENT SURROUND

rather they are either flat and so allow puddles of rain water to form, or they actually slope towards the wall forcing water to drain away at the junctions where the margins and walls meet.

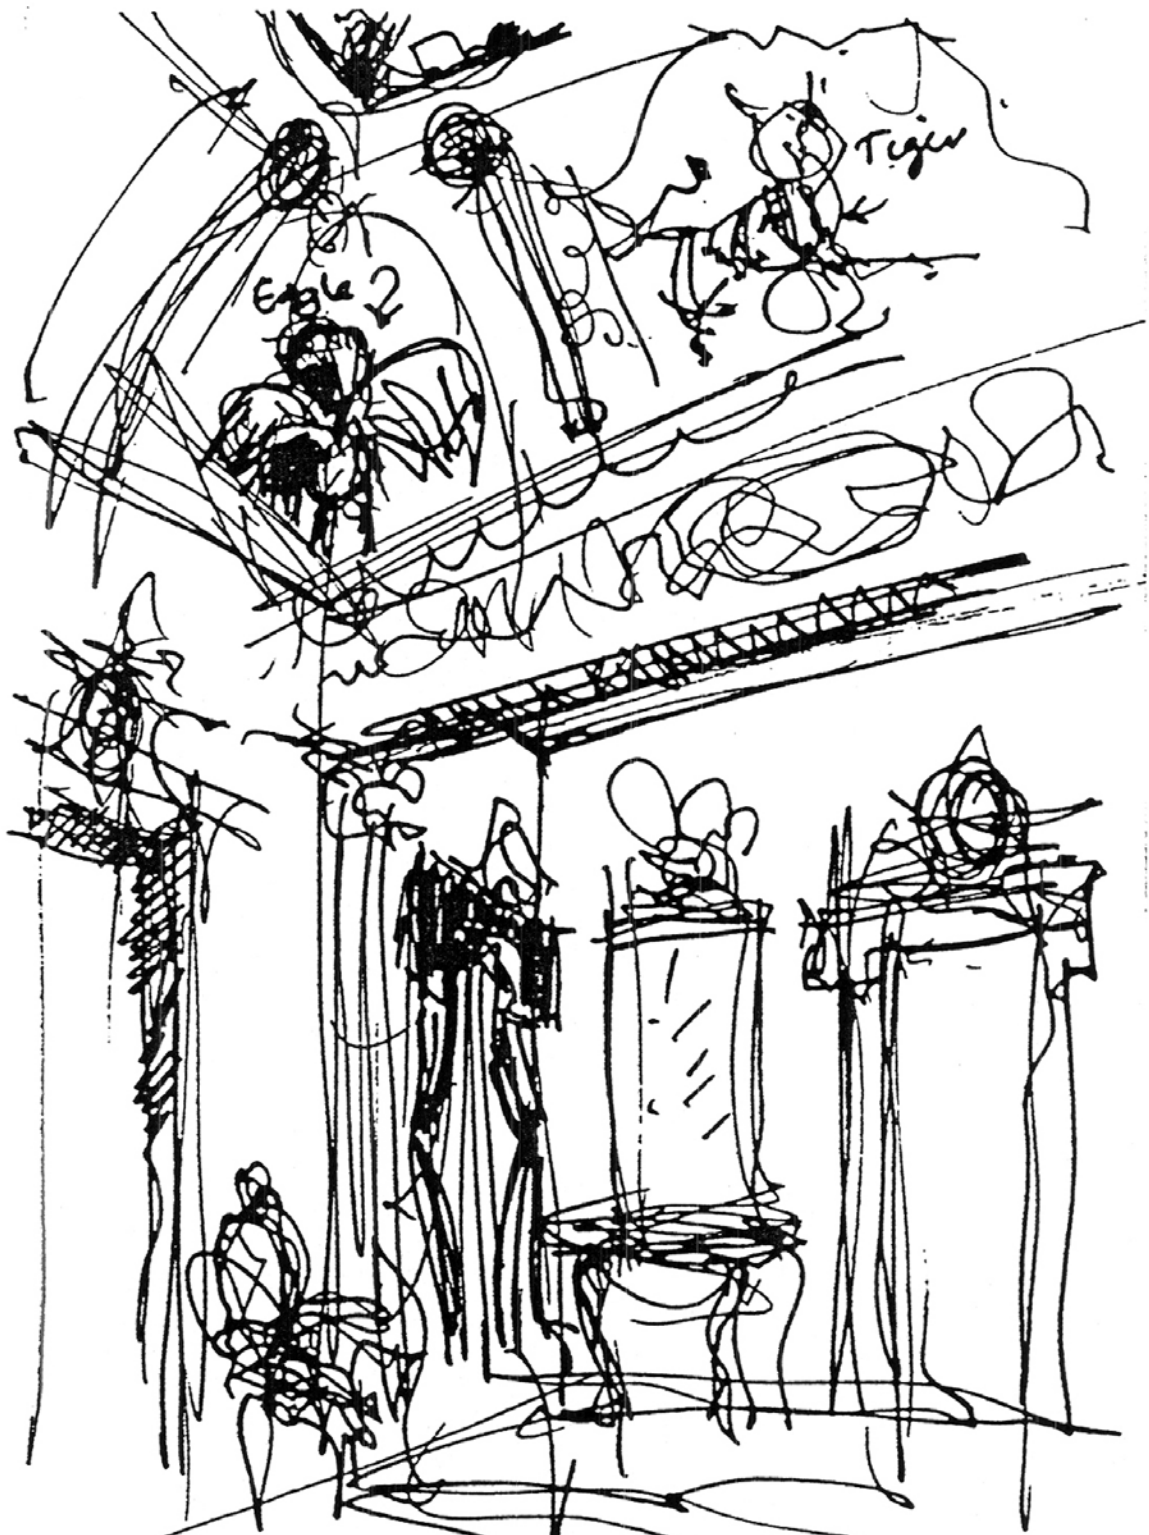
The glass pavilion which looks two ways - on to the public street and into the Aviary Gardens - has undergone maintenance. The decorated glass panes were removed whilst the metal structure was reprimed and painted, and then they were returned to their former positions. Presently there is little of interest in here other than a gilt mirror gilded under the direction of the Conservation Centre at St Servalao, Venice. In the central pavilion of the main palace building the actual structure of the two vaulted ground floor rooms in which valuable objects are exhibited has changed little despite there being a new marble floor and timber

DOLMABAHCE
 THE 'WILD ANIMAL' ROOM FROM WHICH
 THE SULTAN COULD VIEW THE STREET
 OUTSIDE THE PALACE.

mouldings to protect some of the arrises and even display cases. Surprisingly the display cases do not all together destroy the general feel of the vaulted rooms. However, they do give rise to another concern: that of the condition of precious objects. These cases have no humidity or temperature controls, and as the heating of the Palace is turned on and off at the beginning and end of the working day, some of the less stable objects might deteriorate in time. It is sometimes preferable to leave objects in store where the temperature and humidity are reasonably constant.

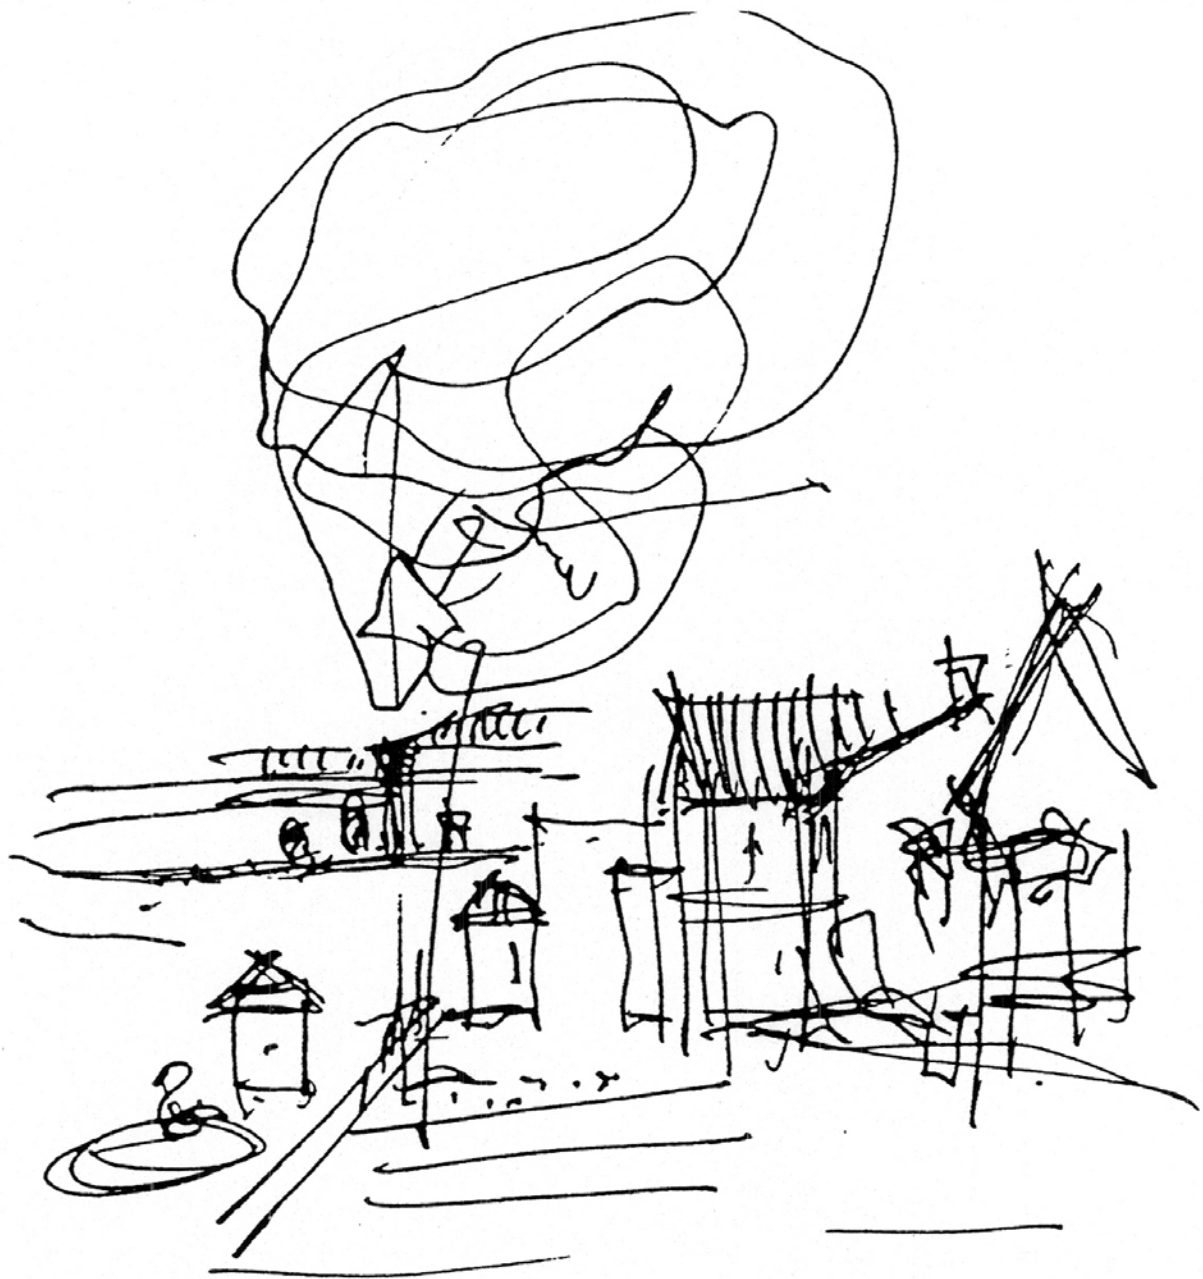
DOĞMABALICE : THE EARTHQUAKE HOUSES .

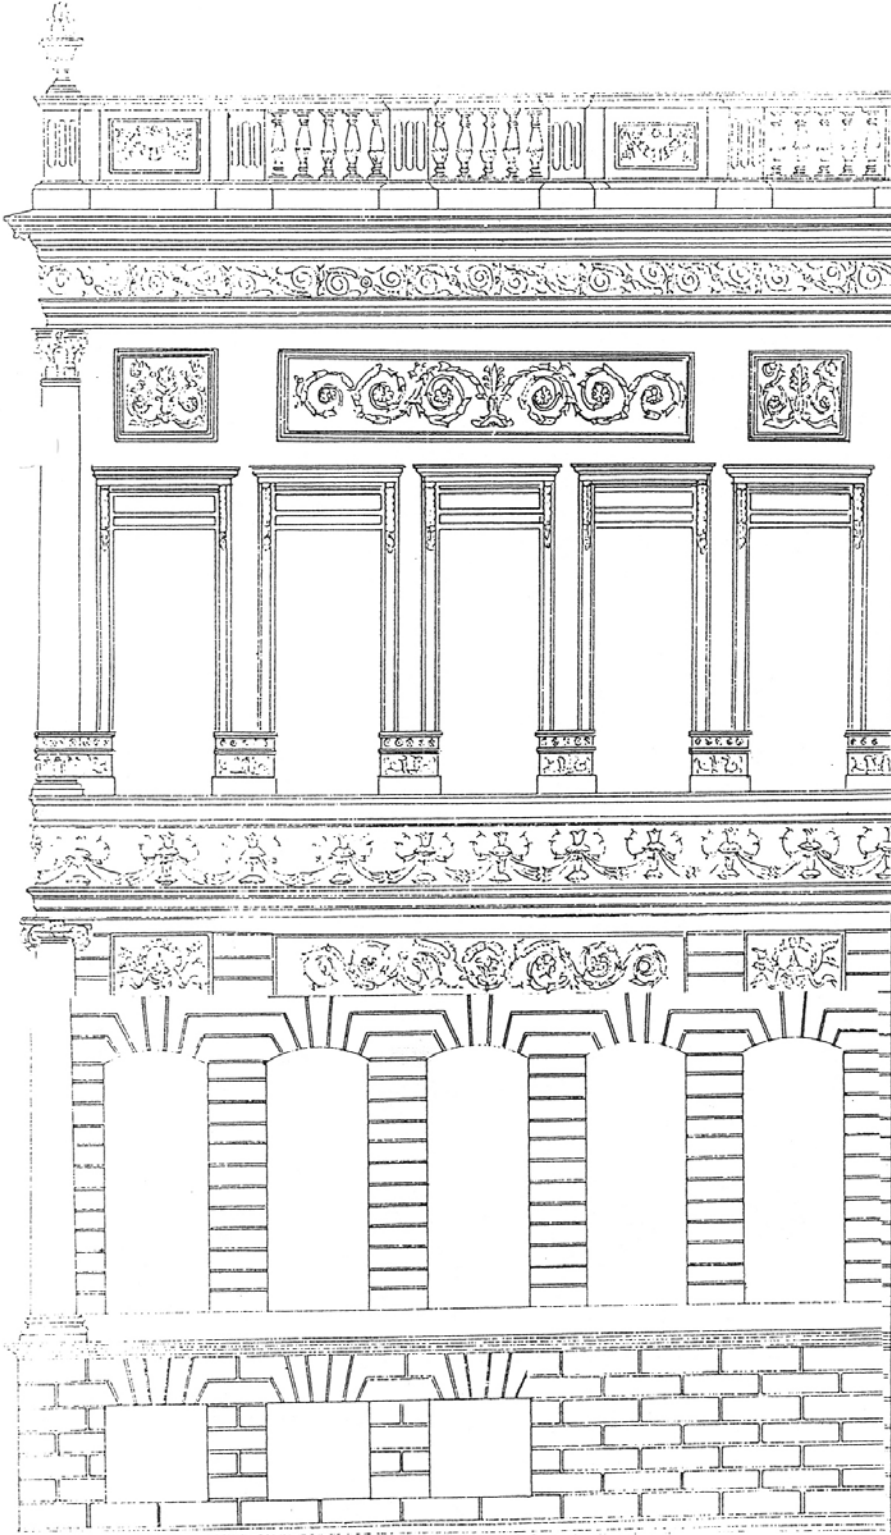
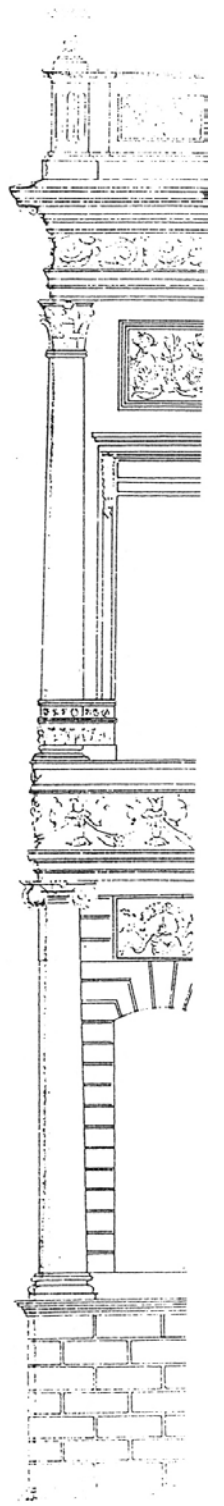
DOLMABAHÇE SARAYI
NUSUSİ DAİRE YAN CEPHELERİ Çizim 1/50

Finally, at the north east corner of the block containing the apartments of the Crown Prince, the stone work is being repaired and cleaned up. Two drawings relating to this work were seen (see appended material), and both were of the type of drawing required when presenting a proposal to some committee rather than the type needed on site for use by the architect or masons. The explanation could be that this is what they actually are, since the replacement or not of a particular stone is decided in consultation with architects from the University of Istanbul and the University of Mimar Sinan. Both Universities have collaborated with the NPT, and it was with students from Mimar Sinan that the palace was resurveyed to bring up to date the architectural drawings which are in the archives.

An idea of the work can be gained from photographs (see D52-54), and although more stones seem to have been replaced than the 'presentation' drawings suggest, this is not the most worrying

aspect of the works, for it may have been imperative to remove the stones for the continued wellbeing of the rest. However, the original soft limestone came from quarries that are now worked out, and so a substitute has had to be found. The original stones are being replaced by a precast stone ". . . which is stronger and which also helps to separate the old and new stones clearly" to quote from written answers provided by the NPT. Unfortunately this is the reverse of good conservation practice. Just as silk should not be mended using a cotton thread which is stronger than silk, so soft stones should be mended neither with a harder stone or stone substitute, nor with a hard portland cement. At Dolmabahce the result will be that the original limestone blocks will continue to erode naturally, except for those stones adjacent to the precast units. Here the erosive processes will be accelerated and in a way not intended by the unhappy phrasing of the quotation. The precast stones will definitely try to separate the old and new stones clearly. One final comment: the original stones, whether decorated or not, are being cleaned up using a clawed chisel, that is one with teeth. Consequently the old and new stones are being given the same texture, a texture that is alien to the original finely chiselled finish.

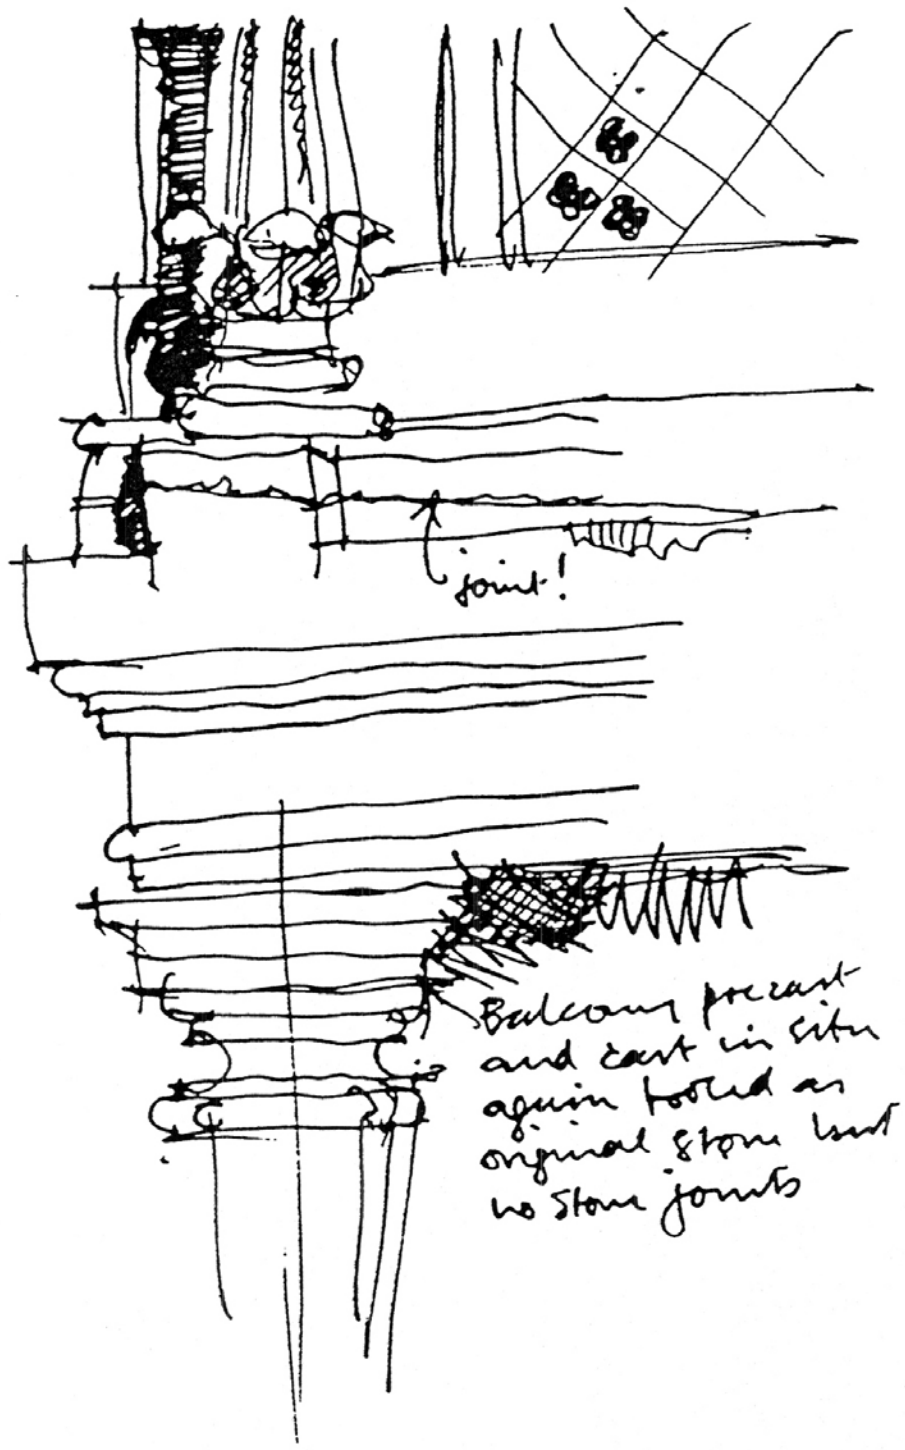
Although the restoration of the Ceremonial House was not the responsibility of the NPT, there are a number of observations. The first is that it has been over restored: the patina which grows with a building's age has been removed (compare photographs I 1 and I 34). Also there is little left of the original decorative masonry. It has been replaced by precast or cast in situ units. For example, the pillars supporting the end terraces are now in one piece. The originals were not, but had horizontal joints. Similarly the balustrades were cast as single units and the pierced quatrefoil decorative panels appear heavier than the originals (photographs I 1-4 and I 34-39). Here as in Dolmabahce it is extremely unfortunate that a strong precast stone has been used because of the harmful effect it will have on the original softer stone. There is also an aesthetic side to this. Precast units formed in moulds cannot compete with the depth and clarity that can be obtained in natural stone. To prove this, simply compare the old and the new conch shells on top of the external cornices (photographs I 1-3).

IHLAMUR: DETAIL OF END
TERRACE AT CEREMONIAL HOUSE

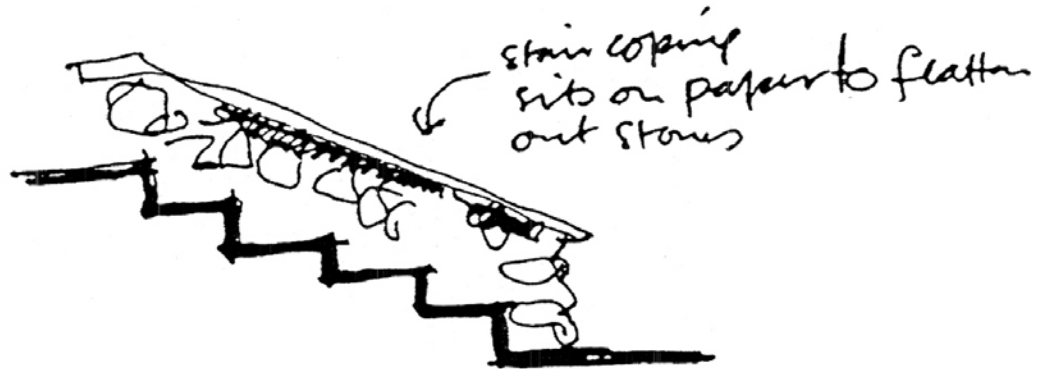
Ikhamur External Stairs

By far the greatest contribution made by the NPT to Ihlamur has been the cleaning up of its gardens, the clearing out of the ponds once they had been rediscovered, and the laying out of broad paths sympathetically surfaced in stone setts. But there were times when supervision of the works could have been better, for example on a stone wall flanking one of the external stairs the precast stone coping sits on paper cement bags, crushed and pushed in between the tops of the stone so that there was a flat surface on which to lay the mortar and the coping stones. The advantages of this building contractors' trick are that it takes less time and less material; the disadvantages to a client is that it falls far short of the good job he expected and paid for.

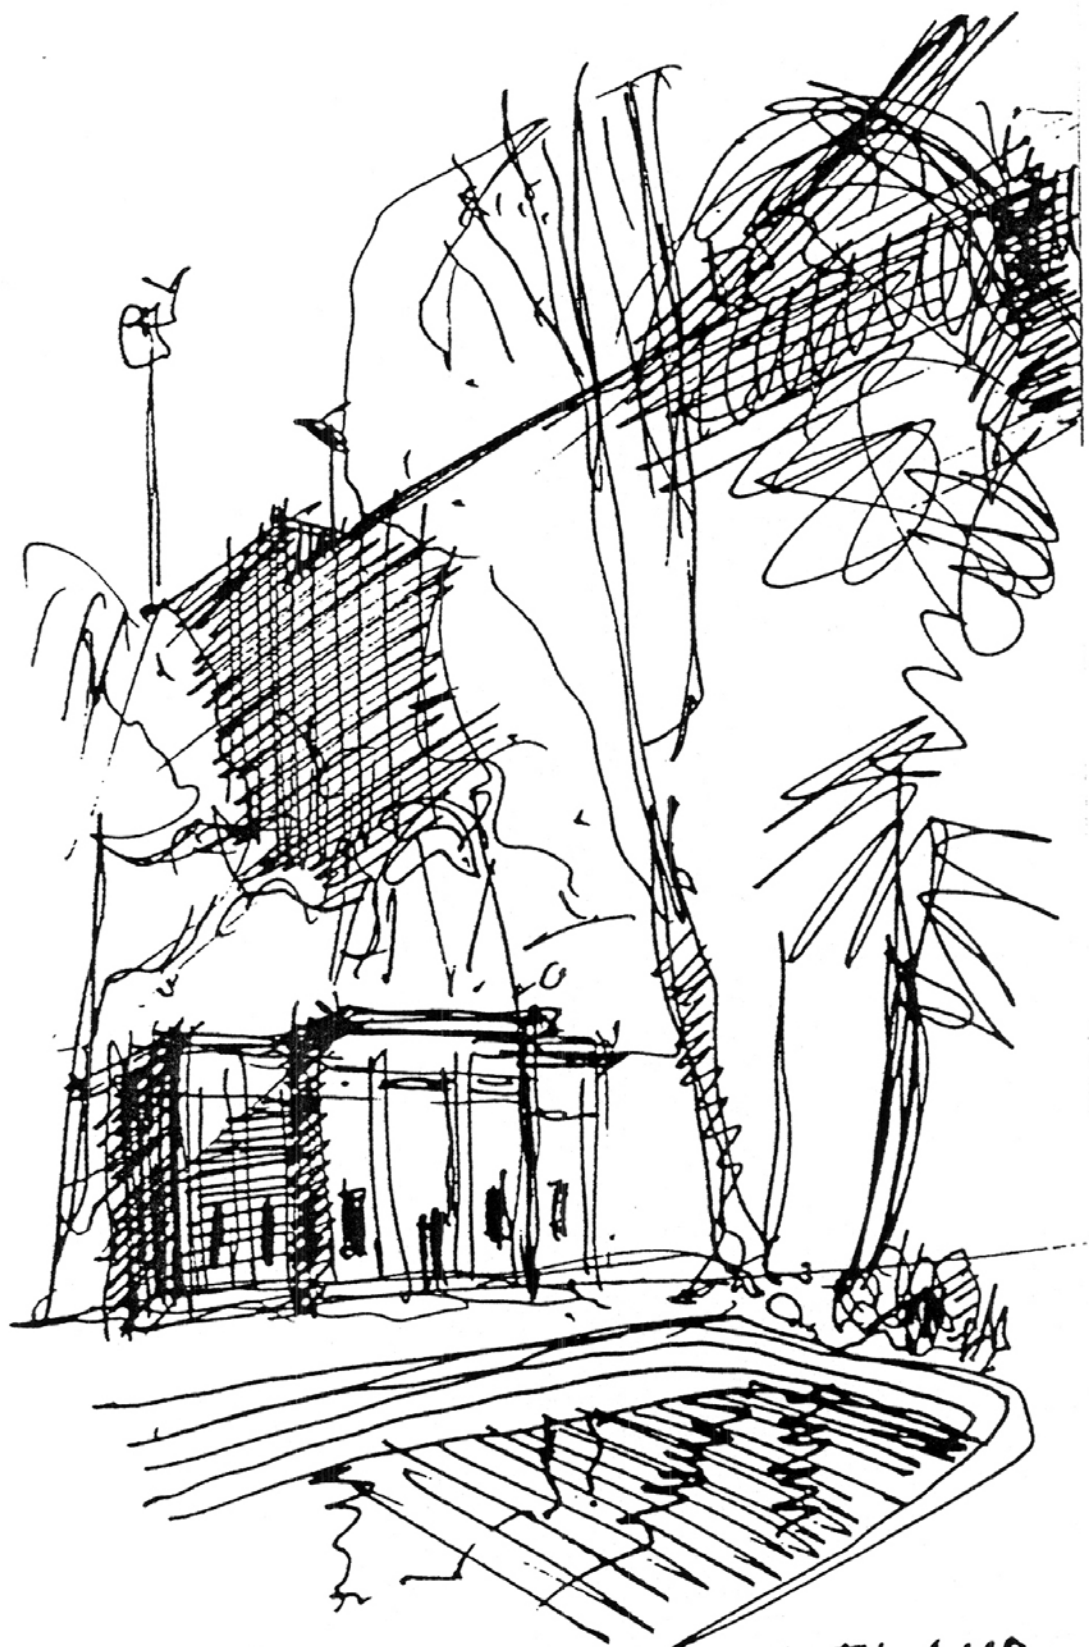
BEYLERBEYI: TWO MARBLE PAVILION AND
BRIDGE

entering the building through the flat roof which has lost its marble surface and through one of the outside walls which is also a retaining wall for the next terrace: the results are damaged wallfinishes, moulds and rotting floor boards. These must be tackled immediately and the ingress of water halted. Afterwards the walls must be left to dry out fully before reapplying the special finishes. Unfortunately it was remarked that they would all be all right again within a few weeks.

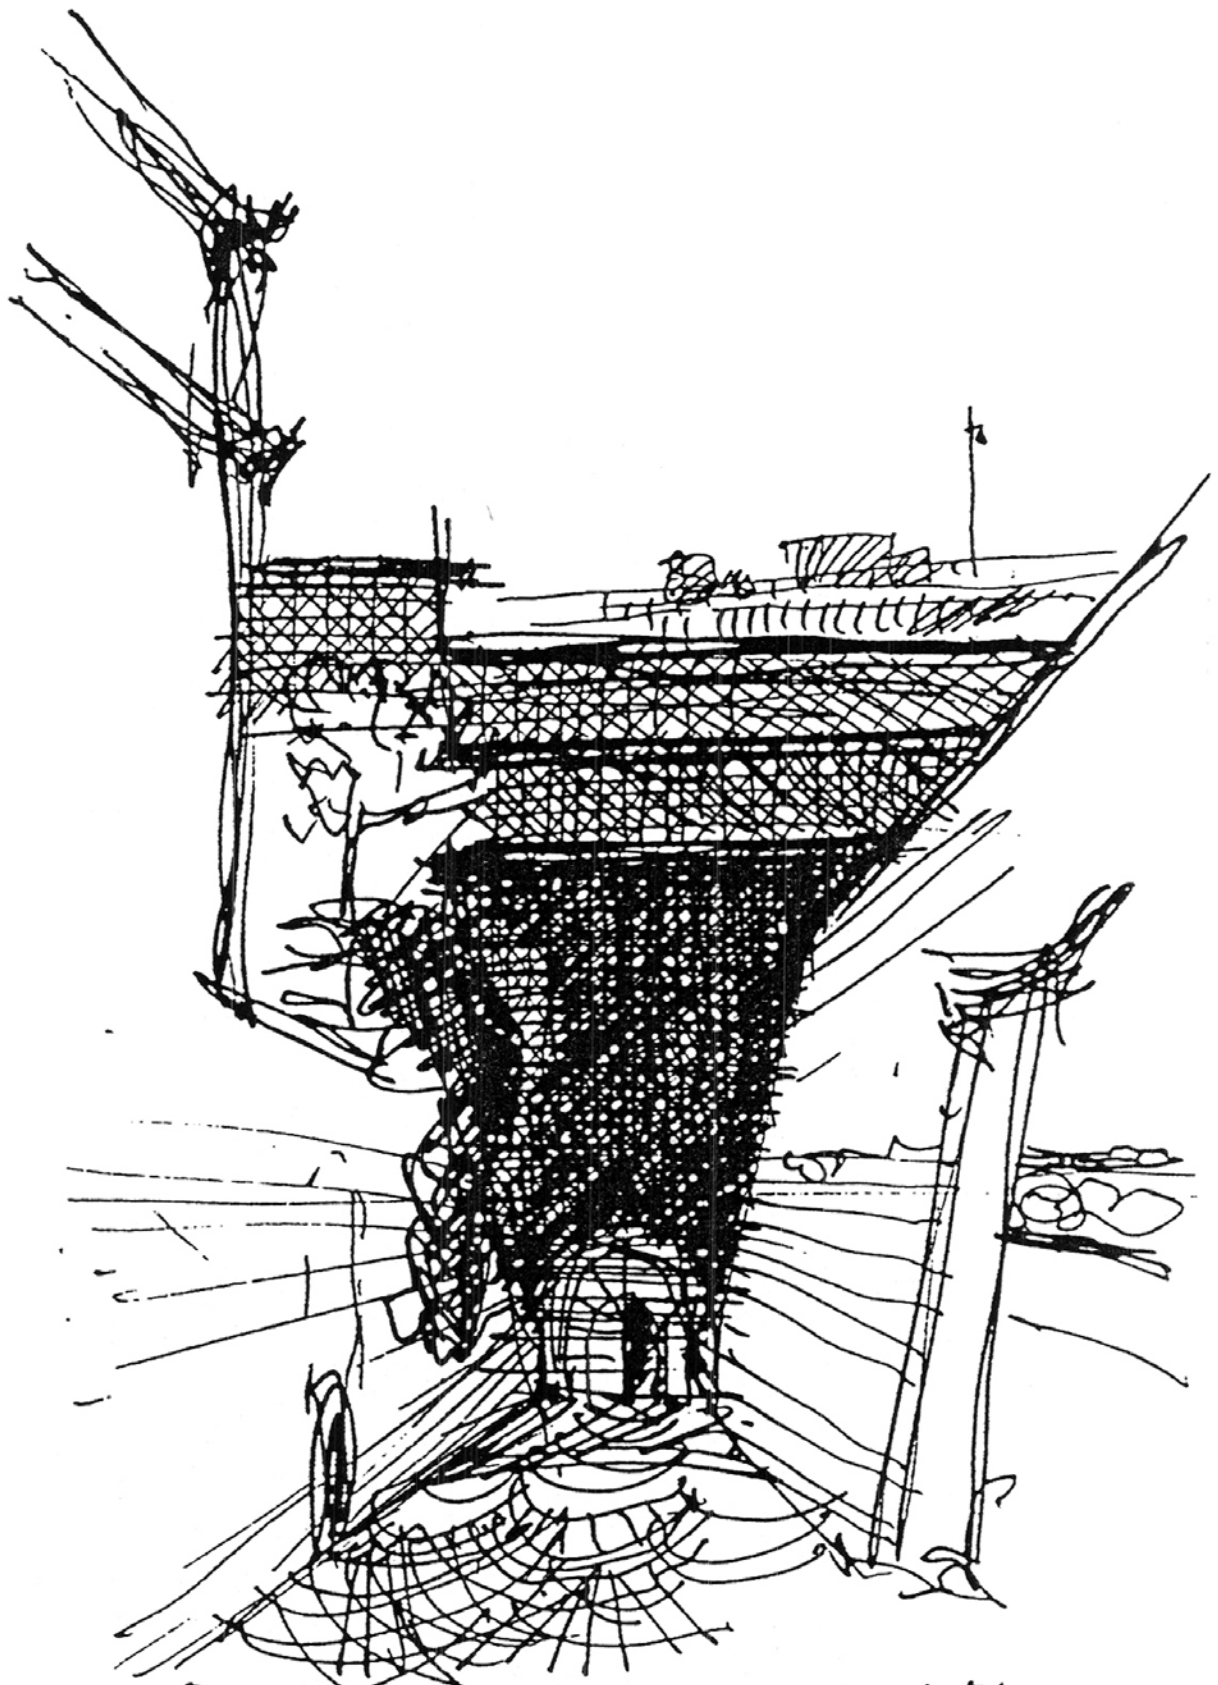
Now surfaced in stone setts forming radiating patterns, the ramped street leading down to the mouth of the Tunnel is flanked by high stone walls to left and right. The right one has a battered face suggesting strength. In front and closing the view are three battered walls painted a deep red. They rise one upon the other with dramatic effect. Unfortunately it is spoilt by cement pointing applied to the flanking walls before the NPT took responsibility. (Photographs B1-5). Even though the pointing completely obscures the three layers of tiles occurring every meter or so up the walls, it adds insult to the injury it is doing by having an impression of these layers of tiles marked out in the cement. The stained glass door and the matching window at the far end of the Tunnel may not be to everyone's taste, but there is no mistaking the fact that they are modern additions and not substitutes for earlier doors because there were never doors to the Tunnel (photograph B29). Inside the Tunnel the new floor with its strong design of white squares infilled and bordered by black stone setts is simple and attractive. The walls and piers of the Tunnel continue the three layers of tiles seen outside, and these same soft tiles are used in the vaults and transverse arches. Here is the one discordant note in an otherwise

BEYLERBEYİ: ENTRY TO THE TUNNEL.
WITH EUROPE-ASIA BRIDGE

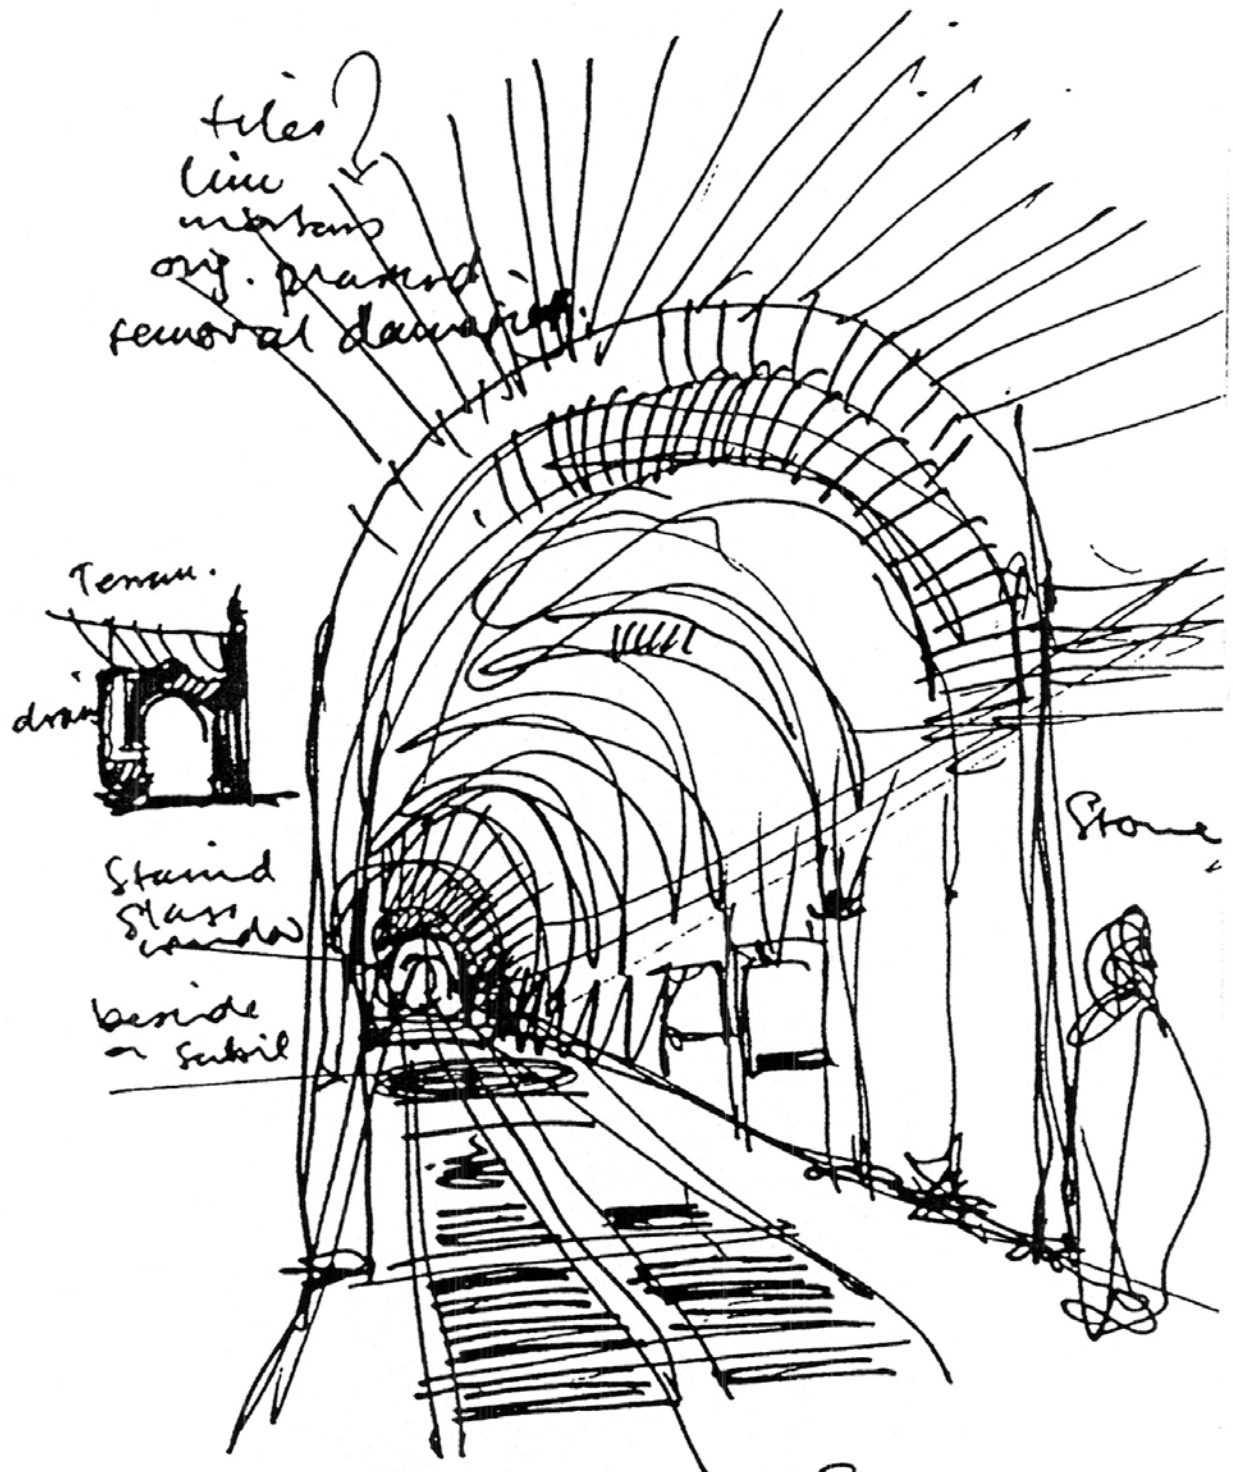
Corroded iron & doors at far end .

successful restoration: the previous plasters were roughly hacked off these soft tiles and this has caused considerable damage to them (photographs B26-28). Not only this, but the vault is permanently wet and will continue to be so notwithstanding any new damp proofing to its plastered upper surface. At present there are the telltale signs of accumulating salts covering the vault tiles with the result that little by little bits of the tiles are being forced off. The solution to this should be to replaster the vault and arches to provide a sacrificial surface which can be renewed again and again, since an historic surface cannot be renewed. Also this solution might provide an appearance nearer to the original.

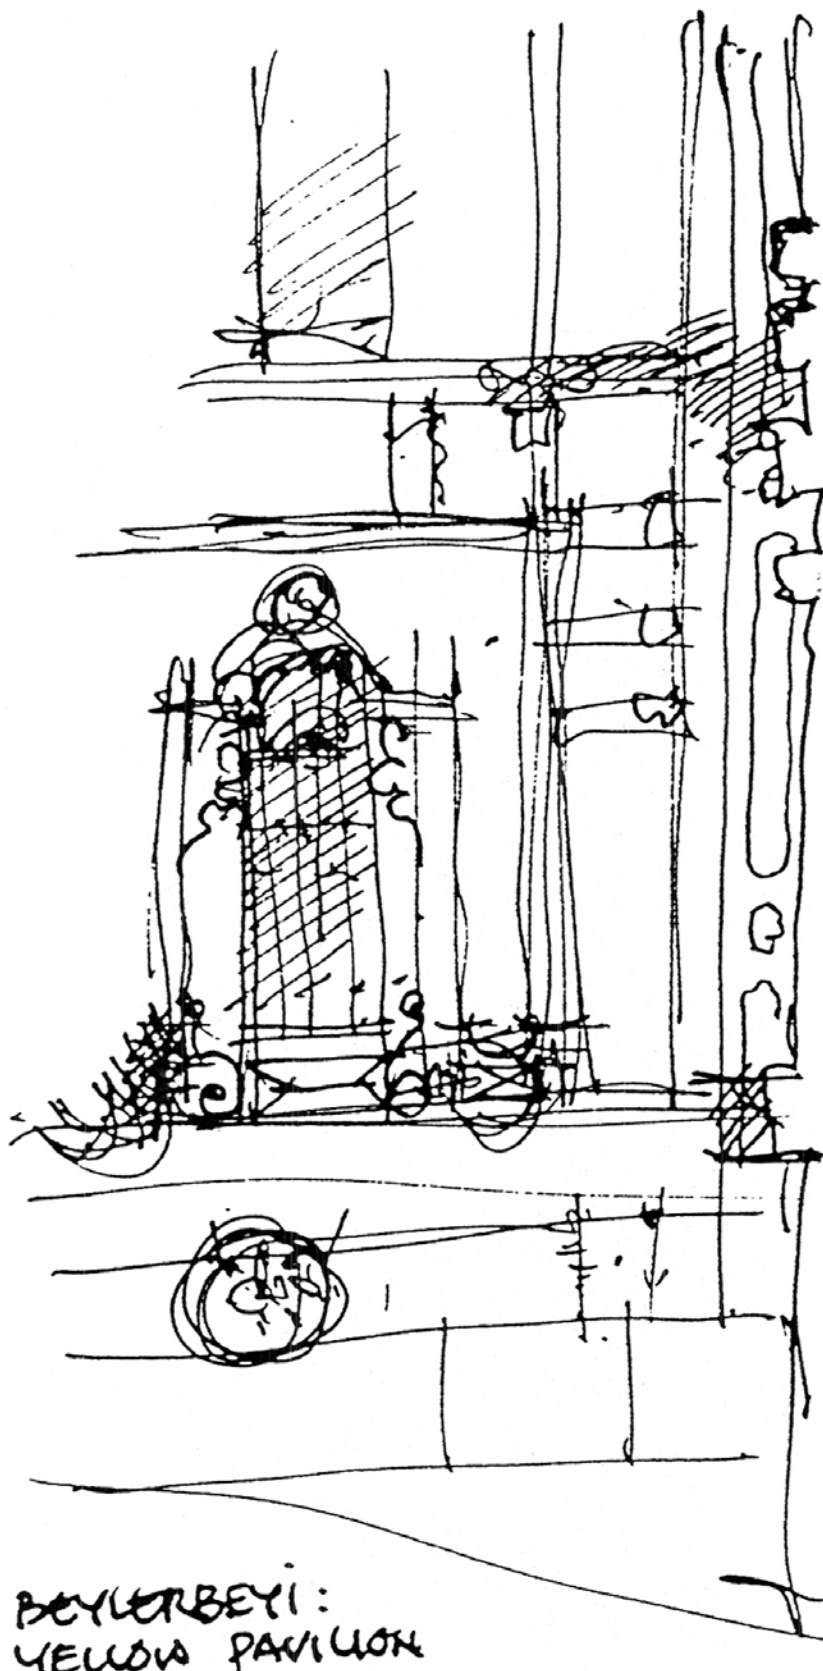
It is regrettable that the present work is a bad restoration following after a poorer one of the 1950s or 60s. Ironically the poorer restoration, has done less damage to the historic fabric than has the well funded restoration of the 1980s. The reason is that in the earlier restoration where the original brackets were replaced, it was done with hollow cement brackets reinforced by chicken wire and just stuck to the wall with cement. They only require to be hit firmly with a mason's hammer for them to fall away and without causing much damage to the original masonry. Another advantage was that being cement they were easily recognised by its characteristic grey green colour and from the roundness of their arrises caused by the moulds in which the brackets were made.

Contrast this and the present works where all but half a dozen of the original stone brackets and all of the cement brackets are being replaced with solid precast artificial stone units. In order to fix these units to the facades the original stonework is

BEYLERBEYI:
YELLOW PAVILION

Three other masonry operations are in progress and are being done in parallel with the cutting back necessary for the brackets. The first of these operations is the hacking off of unsound stone surfaces. Notwithstanding a recognition of this soft stone's propensity to deteriorate the masons were hacking off a greater area than many have been necessary, or at least this is the conclusion arrived at after listening to the true or dull sounds produced by hitting the stones with a two kilogram hammer.

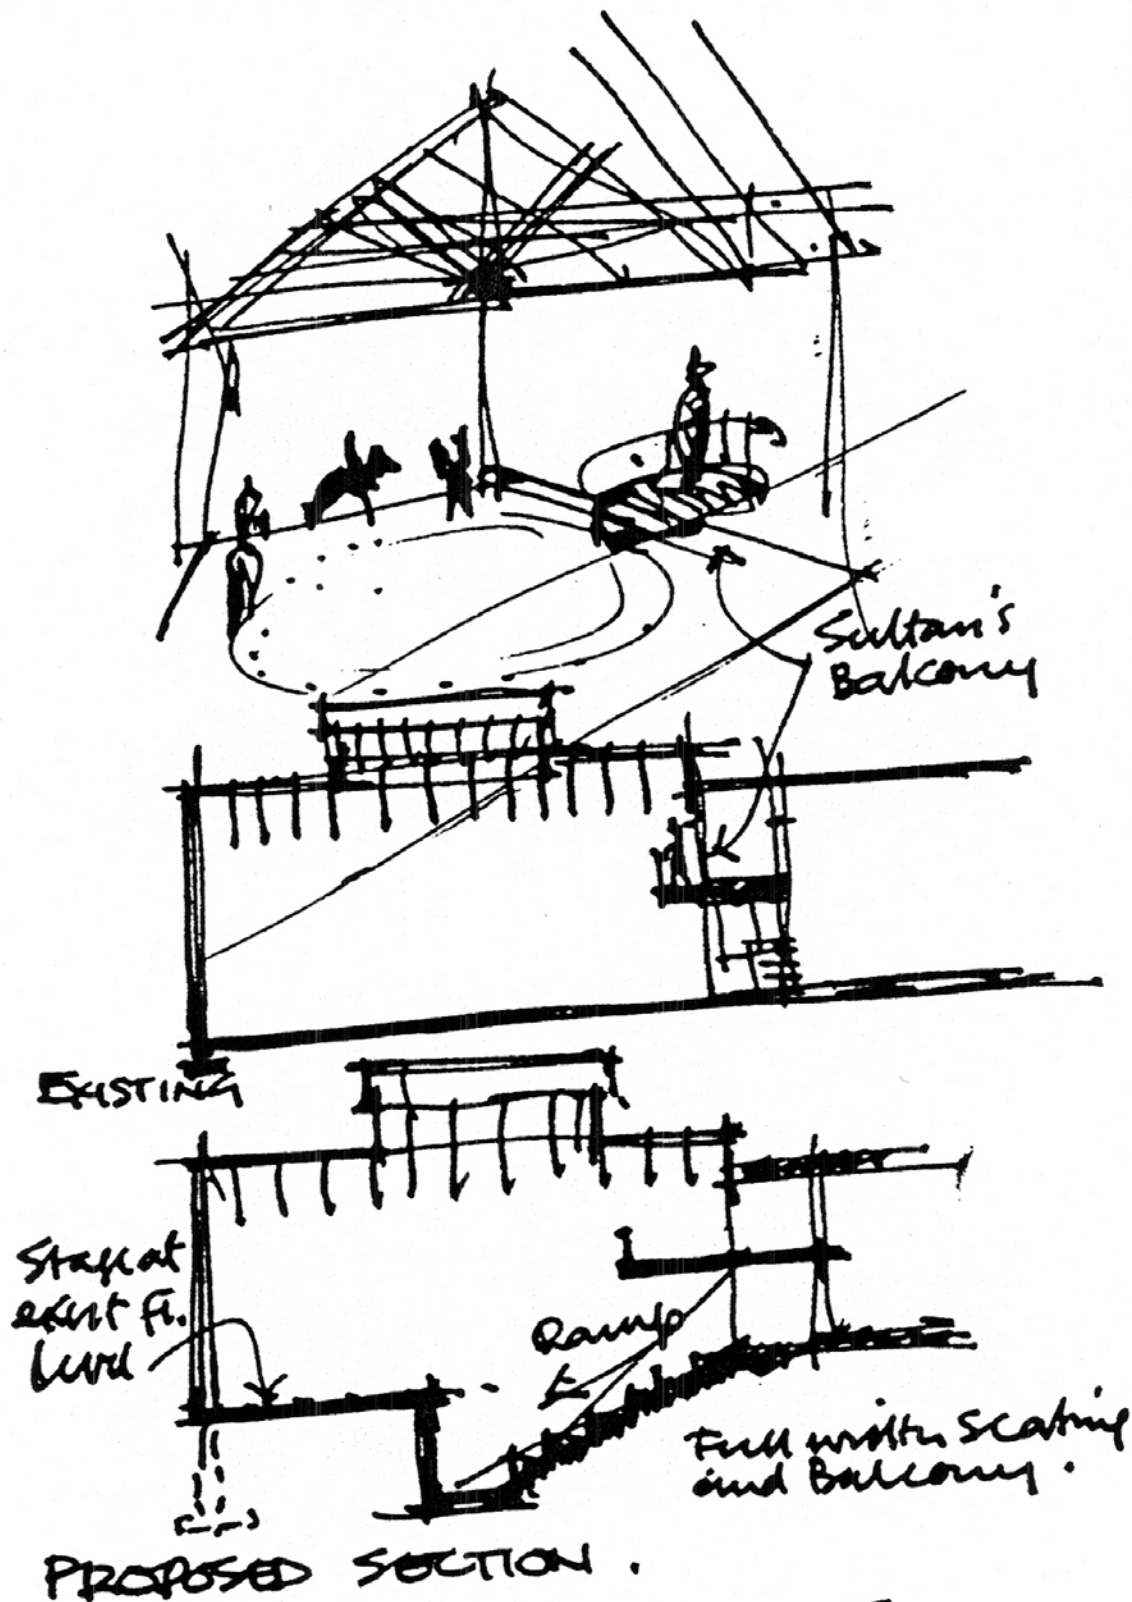
YILDIZ: RIDING ARENA TO THEATRE

there is standing water half a metre down from the existing floor level which is also about the level of the existing foundations to the walls. Once the problem of the water can be overcome, the excavations will resume. The level of the proposed stage will remain at the existing floor level.

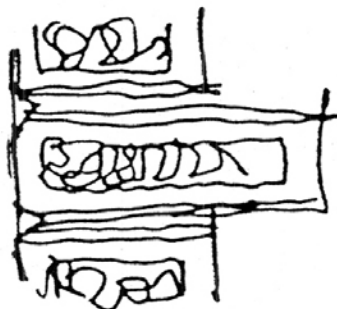
Rusticated quoins
1st red
2nd yellow
3rd black

Staying with old renders and their under-valued contribution to this building, at the north west corner where the quoins have drafted margins and centres with an applied rough finish, the evidence is that they were first red, then yellow and finally black. Therefore it is possible that originally the building had pink walls and red quoins. Unfortunately, such details may have been noticed by the labourers but not noted by the architects and engineers. There were no drawings in the site office that even attempted to record such details.

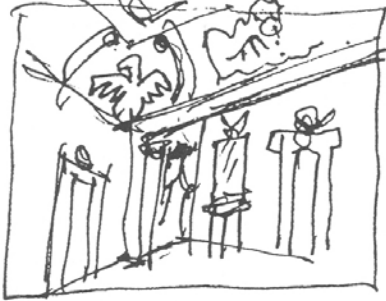
Is SULTAN'S ROOM & STAIRS

2. Sultan's room with wild birds and animals - show condition

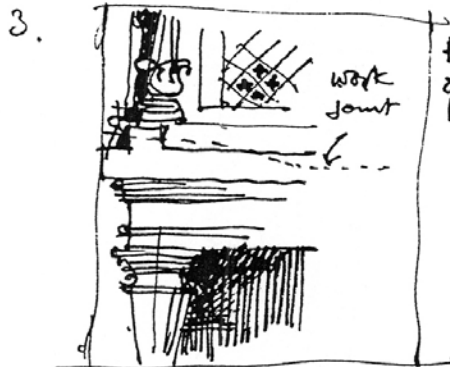
Precast slabs
columns and
balcony.
