1992 Technical Review Summary  
by *Tanvir Hasan*

## National Palaces Conservation

Istanbul, Turkey

0930.TUR

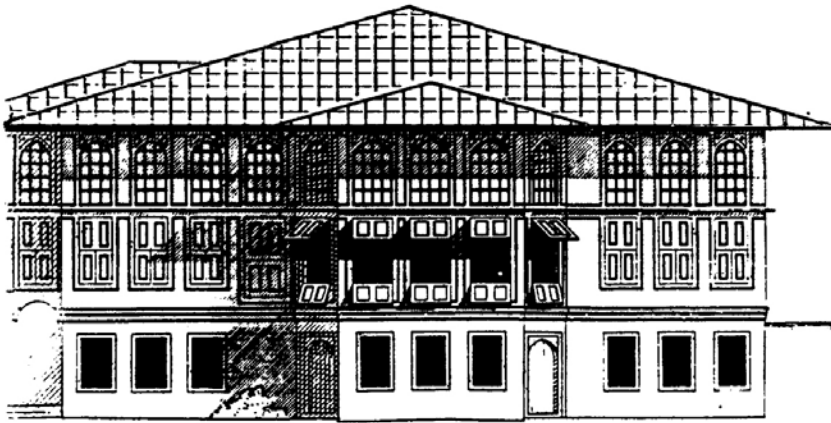
**TERSANE SARAYI, HASBAHÇE  
KASRI 1795 (AYNALI KAVAK  
KÖŞKÜ).**

Yanda, plan ve bahçe cephesinin restitüsyonu. Sağda köşkün çeşitli dış görünüşleri.
