CAR WRECKS CLE SEMINAR

September 8 2016
Austin, TX

**“Fighting Photos with Photos:”
Using Exemplars from the National Automotive
Sampling System (NASS) to Mitigate the Effect of
Low Damage Impact Case Photos**

Jack Leifer, PhD, PE (TX License No. F-11946)
Associate Professor of Engineering Science
Trinity University
One Trinity Place
San Antonio, TX, 78212
Jack.leifer@trinity.edu

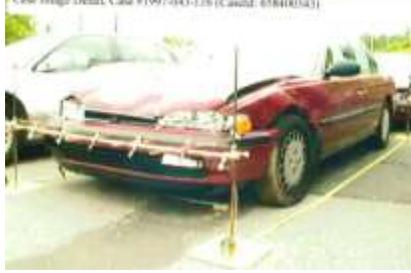
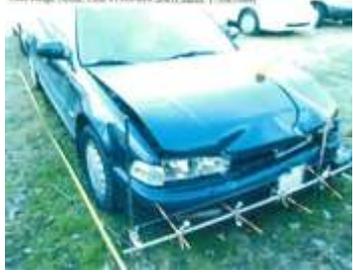
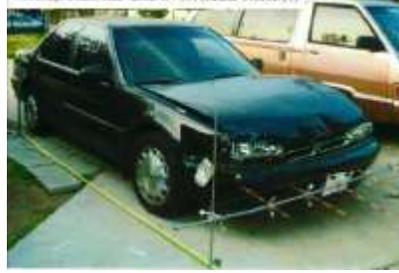
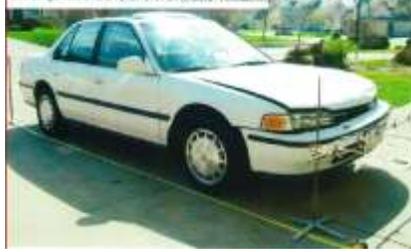
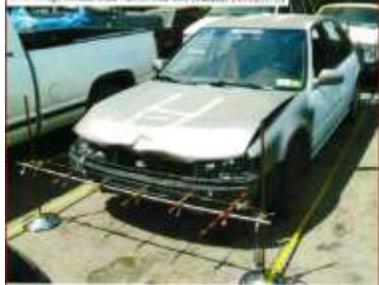
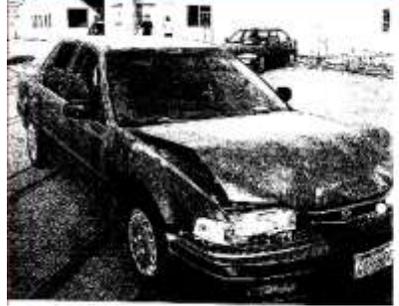
<p>Case Image Detail, Case #2002-079-004 (CaseId: 71306479)</p>
<p>1990, U = 12311 J; $\Delta v = -13$ mph Case 1997-043-116</p>	<p>1991, U = 12604 J; $\Delta v = -11$ mph Case 1999-049-206</p>	<p>1991, U = 10631 J; $\Delta v = -10$ mph Case 2002-079-004</p>

<p>1993, U = 10764 J; $\Delta v = -6$ mph Case 2005-074-054</p>	<p>1993, U = 13316 J; $\Delta v = -10$ mph Case 2003-002-050</p>	<p>1990, U = ? J; $\Delta v = -?$ (Actual vehicle, from Fig. 1)</p>
<p>Fig. 6: Five exemplar 1990-1993 Honda Accord vehicles, plus the subject Honda Accord (lower right). Note the similar visible damage and similar measured values for dissipated energy (U) for each of the exemplars.</p>

Over the five years I've used the NASS database, I have not found an easy way to automate the exemplar search method. While more popular vehicle models (like the 1990 – 1993 Honda Accord and 1998 – 2008 Ford Ranger vehicles discussed herein) may each return hundreds of potential exemplars, only few instances of other vehicles (e.g. Infiniti Q45 Series 2002 – 2006) may be contained in the NASS database. (For such cases, I look for either corporate twins, or vehicles of similar size, weight and bumper design.) Regardless, for front-to-back collisions, I try to find exemplars with damage that has the following characteristics: (1) primarily longitudinal velocity components; (2) measurement posts present in the photos; (3) point of contact on bumper, with little-to-no evidence of over-ride. Exemplars from the NASS database with damage similar to the 1990 Honda Accord shown in Fig. 1 are contained in Fig. 6; exemplars from the NASS database with damage similar to the 2003 Ford Ranger (series 1998 – 2008) shown in the same figure are contained in Fig. 7.

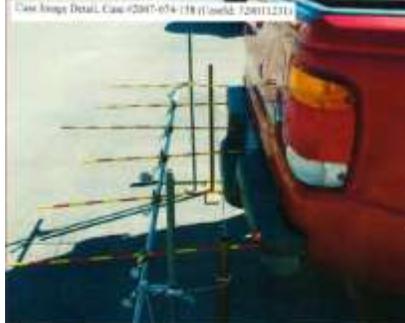
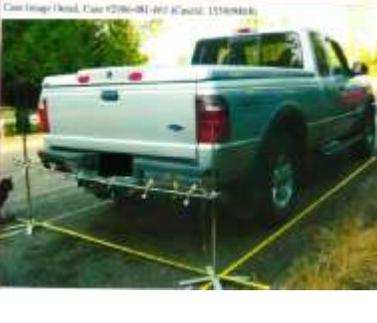
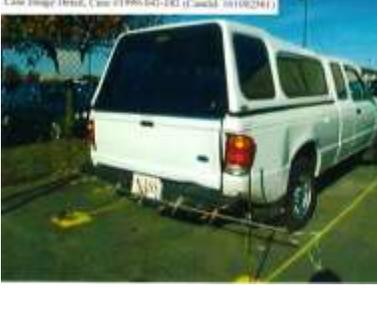
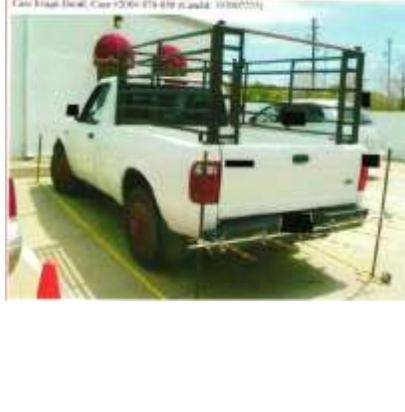
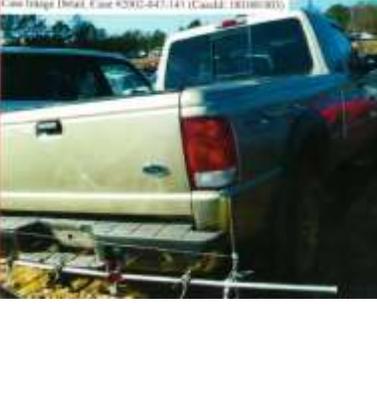
<p>1998, U = 9897 J; Δv = 7 mph Case 2007-074-158</p>	<p>2002, U = 13217 J; Δv = 9 mph Case 2006-081-061</p>	<p>1999, U = 12225 J; Δv = 9 mph Case 1999-043-183</p>

<p>2002, U = 9845 J; Δv = 8 mph Case 2004-076-050</p>	<p>2000, U = 12313 J; Δv = 9 mph Case 2002-047-141</p>	<p>1990, U = ? J; Δv = ? (Actual vehicle, from Fig. 1)</p>
<p>Fig. 7: Five exemplar 1998-2008 Ford Ranger vehicles, plus the subject Ford Ranger (lower right). Note the similar visible damage and similar measured values for dissipated energy (U) for each of the exemplars.</p>
