# Inspection Report

**Property Address:**  
6 Laurel Circle  
Peterborough

**Paul Galvin Residential Home Inspections**

<b>Date:</b> 2020-08-13	<b>Time:</b>	<b>Report ID:</b>
<b>Property:</b> 6 Laurel Circle Peterborough	<b>Customer:</b> Kristine Laufer	<b>Real Estate Professional:</b> Kristine Laufer C21

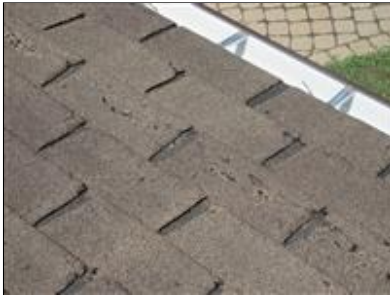
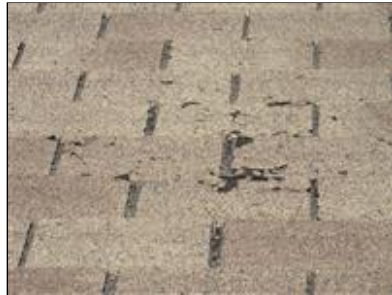
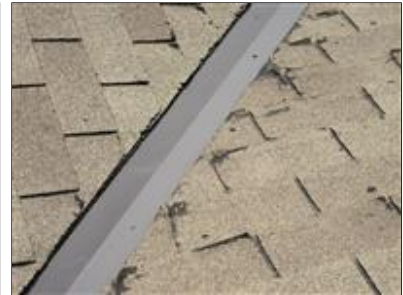
1.0 Picture 1

The entire roof surface is asphalt shingles. The shingles are showing signs of wear especially on the front and screened porch. I would recommend replacing the shingles within the next year.

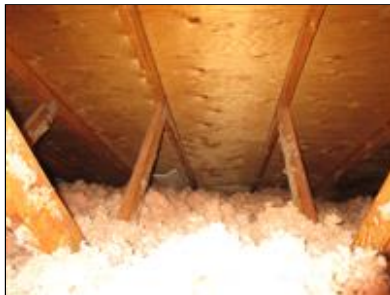
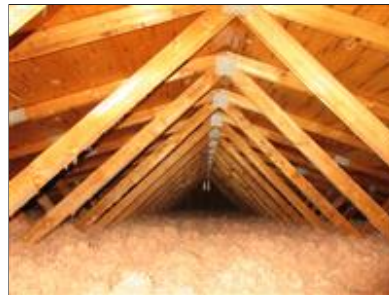
4.0 Picture 1

The attic contains a combination of fiberglass batt and blown in fiberglass insulation. This insulation appears to be well placed and installed in more than adequate amounts.

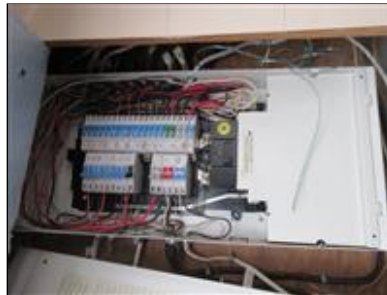
5.2 Picture 1

The main electrical panel was inspected and found to be installed properly and wired correctly. All of the proper sized breakers were present.

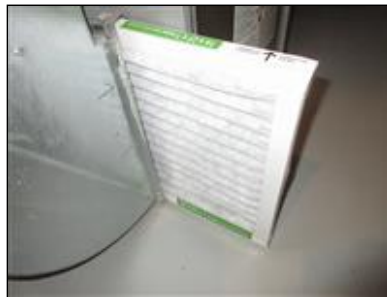
6.0 Picture 1

- (1) The furnace was tested and inspected and found to be installed properly and working well. All the necessary safety features were present.
- (2) The furnace filter should be changed on a regular basis.

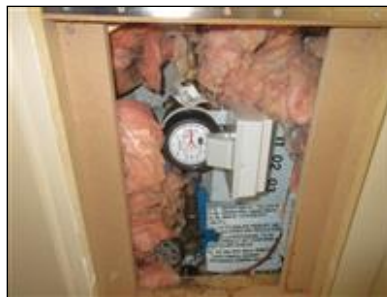
7.4 Picture 1

Front wall of basement.

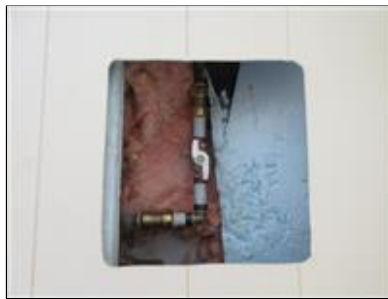
7.12 Picture 1

The outside taps should be shut off and drained before winter.

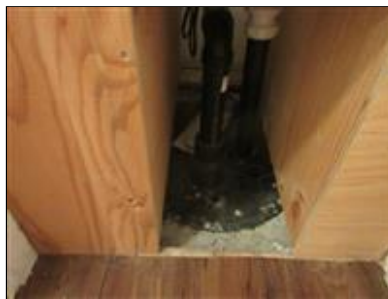
7.13 Picture 1

The sump pump should be tested on a regular basis to ensure its proper operation.

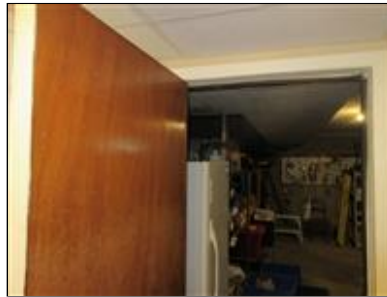
8.5 Picture 1

Technically there should be a self-closing device on the door from the garage to the house.
