# Inspection Report

11832 Cascade Dr  
Delta BC V4E 3C2

**Brighton Home Inspections**

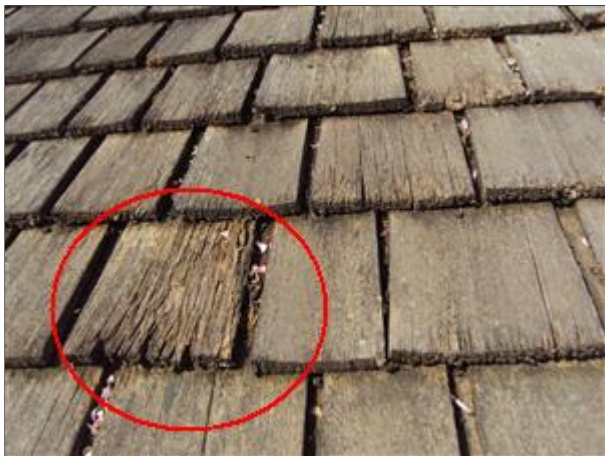
1.0 The cedar shingle roof is coming to the end of its useful life and budgeting for a new one would be prudent. This roof may last for the next 1-3 years if repairs are continued and the roof is maintained.

1.0 Picture 1 Shingle Deterioration

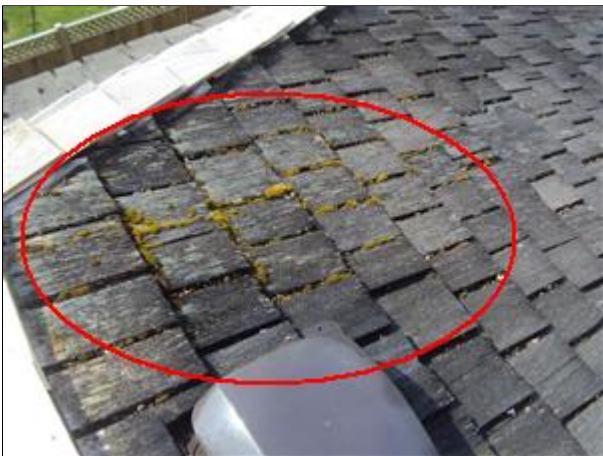
1.0 Picture 2 Moss Growth

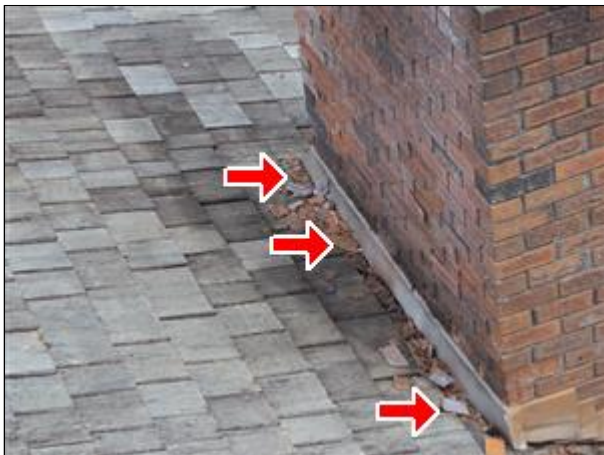
1.2 Portions of the brick chimney are beginning to flake away. This is a combination of poor quality brick and excessive heat. I would recommend having the chimney cleaned as this is potentially a fire hazard and removing any foreign matter that has formed on the exterior of the chimney.

1.2 Picture 1 Brick Debris Chimney

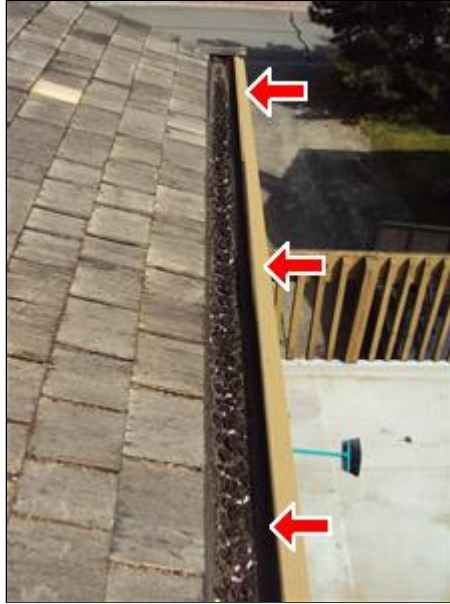
1.3 Cleaning out the gutters would be considered regular maintenance and should be done twice a year or on an as needed basis.

1.3 Picture 1 Clean Gutters

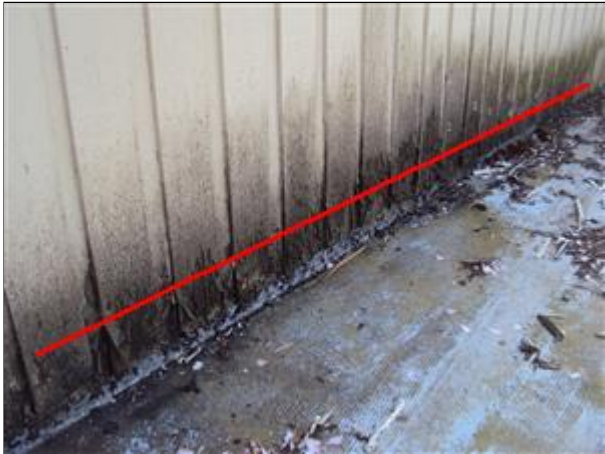
2.0 The siding around the upstairs balcony is in poor condition and should be replaced as soon as possible. Generally speaking I found the siding of the home in fair condition with the exception of the balcony area.

2.0 Picture 1 Deteriorating Siding

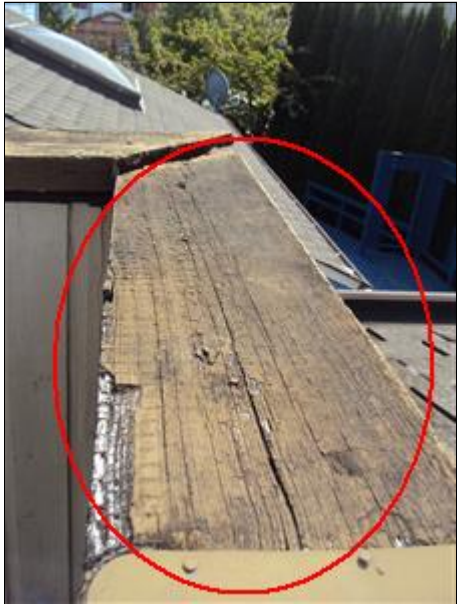
2.0 Picture 2 Deteriorting Trim

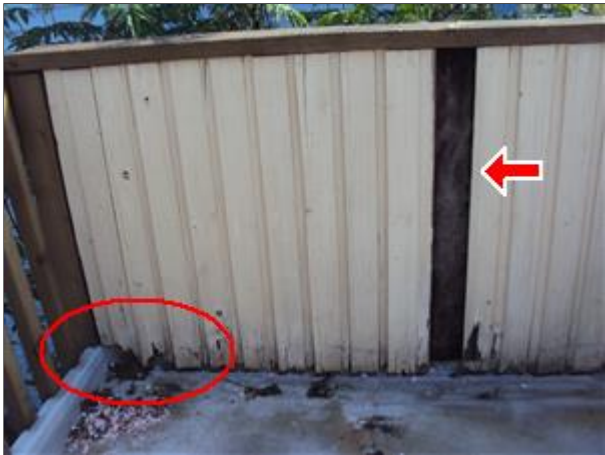
2.0 Picture 3 Missing/Deteriorating Siding

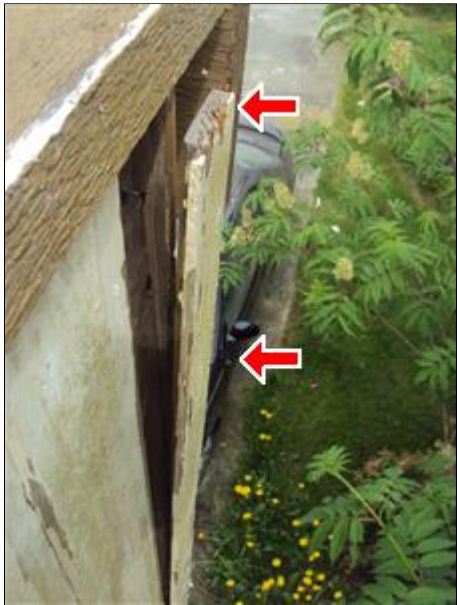
2.0 Picture 4 Loose Siding

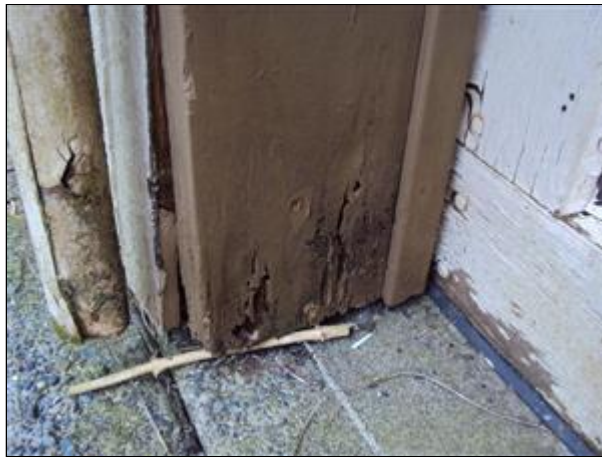
2.0 Picture 5 Deterioration Trim

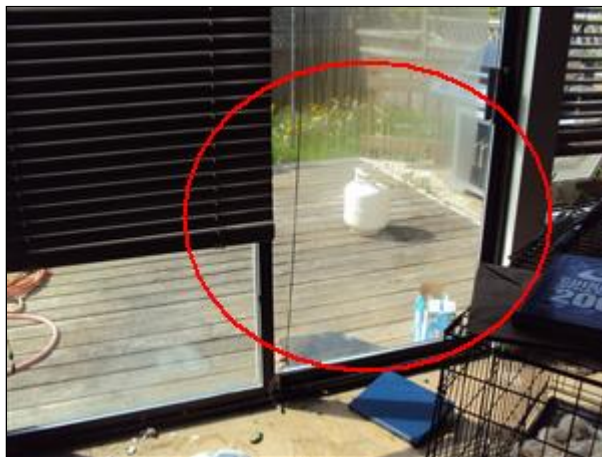
**2.1** (1) I was unable to operate the sliding door as the locking mechanism was jammed. This is a minor repair.

2.1 Picture 1 Sliding Door

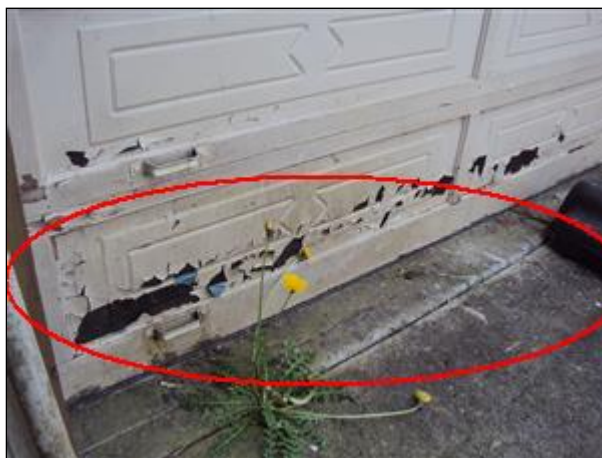
(2) The paint on the garage door is delaminating and should be repainted to protect the surface from further damage. This would be considered regular maintenance.

2.1 Picture 2 Garage Door

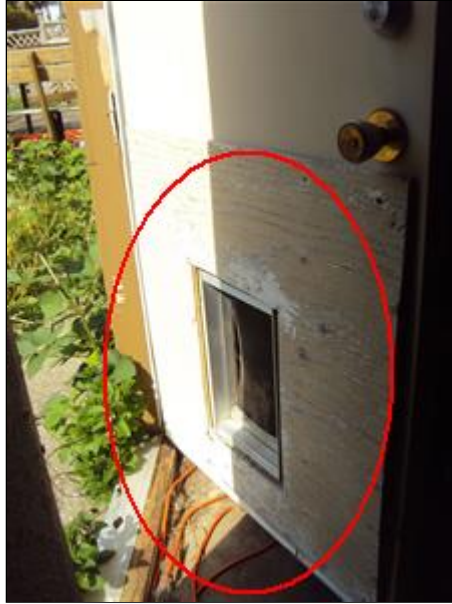
(3) This garage door is beginning to deteriorate around the pet entrance. I recommend replacing this door.

2.1 Picture 3 Deteriorating Door

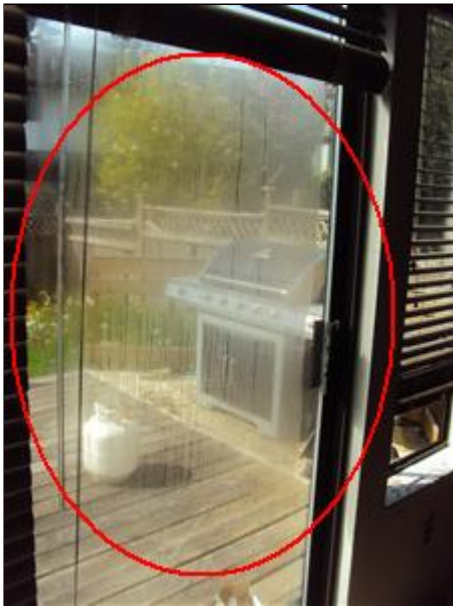
**2.2** The seal on the sliding door has failed. For the most part a failed seal has little effect on the insulation value of the window/door but presents a less than desirable cosmetic effect. The estimated cost to replace/repair windows is approximately \$55.00 per sq ft.

2.2 Picture 1 Failed Sliding Door Seal

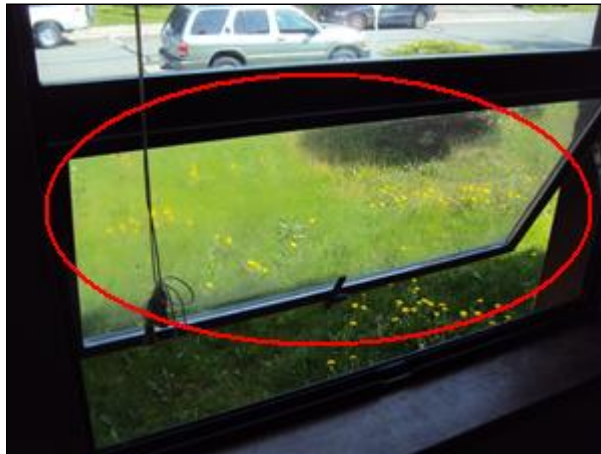
2.2 Picture 2 Failed Window Seal

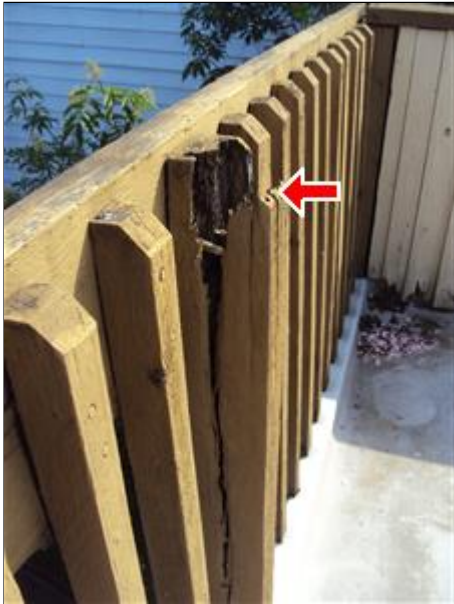
2.3 Picture 1 Rotting Support Post

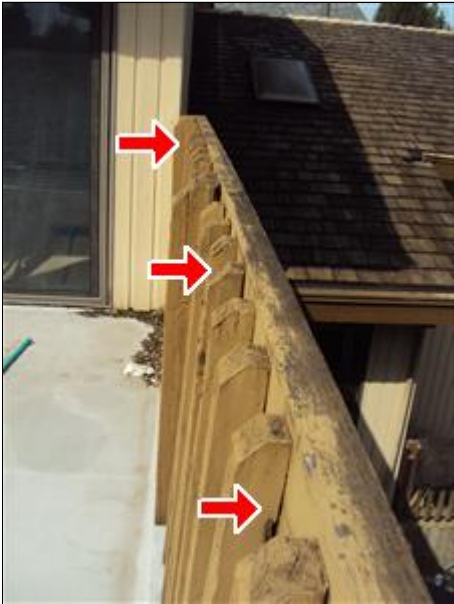
2.3 Picture 2 Loose Railing

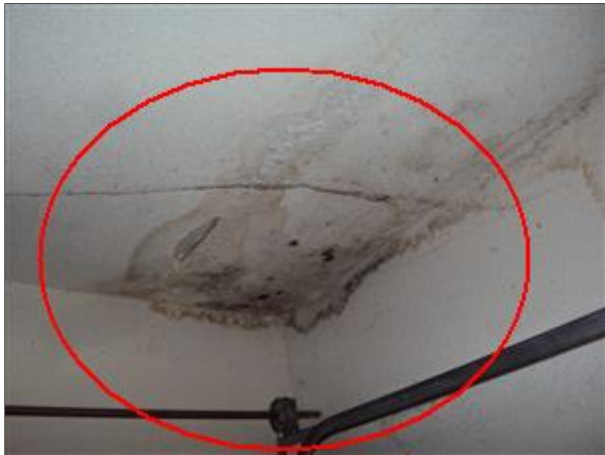
2.3 (1) The garage ceiling has been subjected to water ingress coming from the balcony above. I was unable to identify the exact location of the water ingress but suggest further investigation to identify the exact source.

2.3 Picture 3 Water Ingress Garage

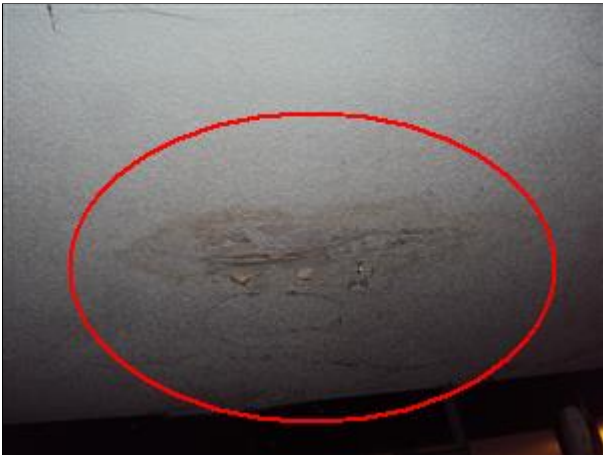
2.3 Picture 4 Water Ingress Garage

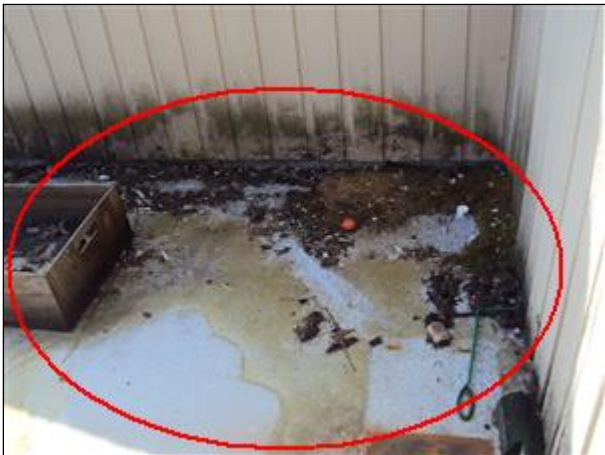
2.3 Picture 5 Balcony Deterioration

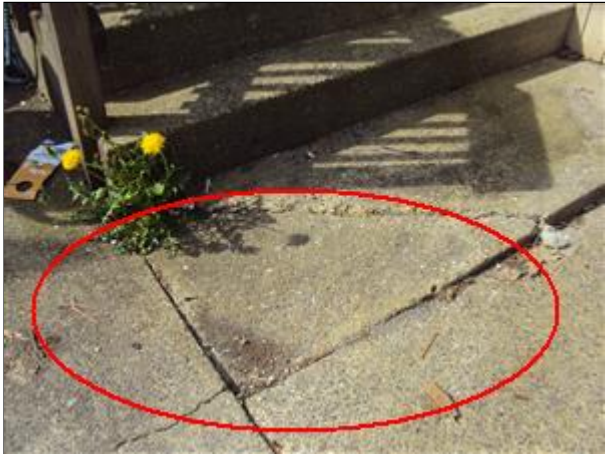
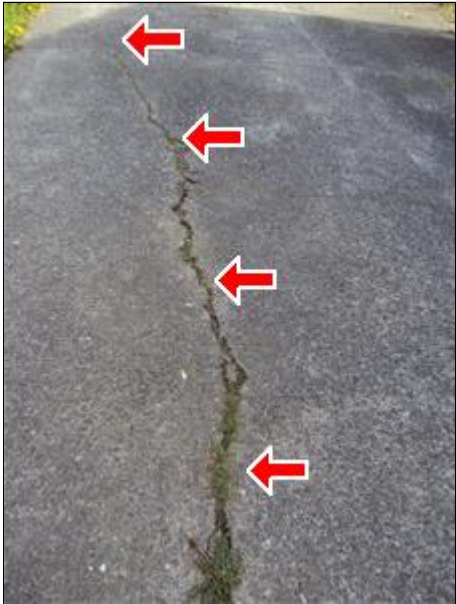
(2) Unfortunately settlement cracks are very common in large concrete structures. These cracks usually appear in the first

2.3 Picture 6 Settlement Crack

2.3 Picture 7 Settlement Crack

few years after construction. In the unlikely event of the cracks becoming wider I recommend applying a concrete epoxy to fill the cracks and minimize the damage.

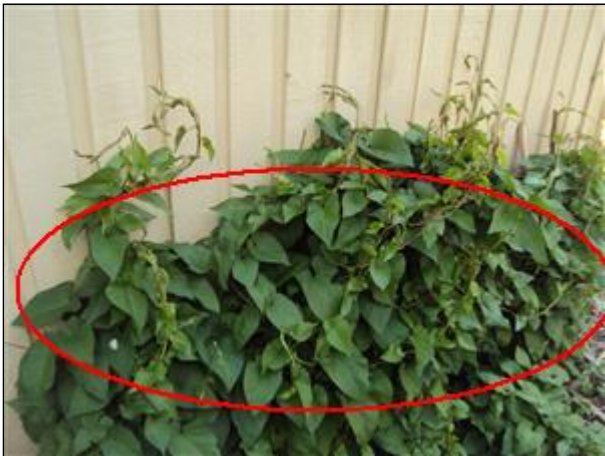
**2.4** (1) Anytime vegetation has an opportunity to grow against siding premature deterioration will take place. This will also provide an opportunity for pests or insects to enter the home. I recommend removing any vegetation that is within close proximity of the home.

2.4 Picture 1 Remove Vegetation

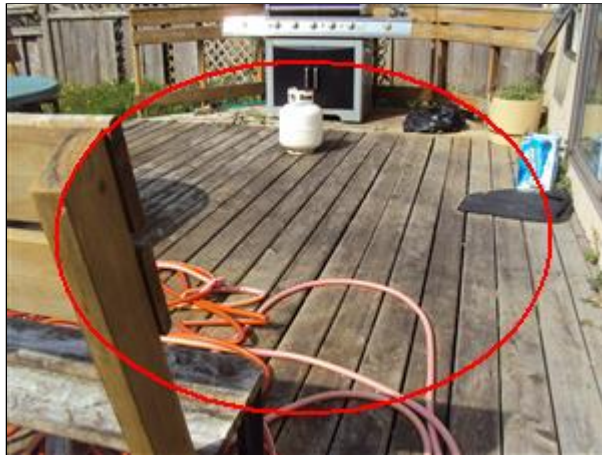
(2) The rear deck is in need of being stained and repaired. There are several loose boards and further deterioration will take place is not corrected. This would be considered regular maintenance.

2.4 Picture 2 Repair & Stain Deck

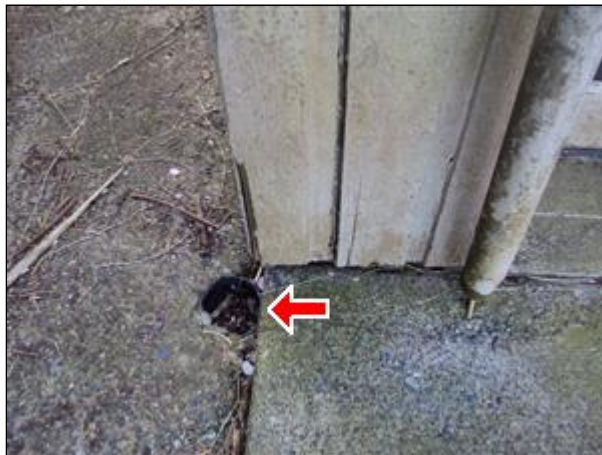
(3) The perimeter drains are full of debris and are no longer functioning.

2.4 Picture 3 Failed Perimeter Drain

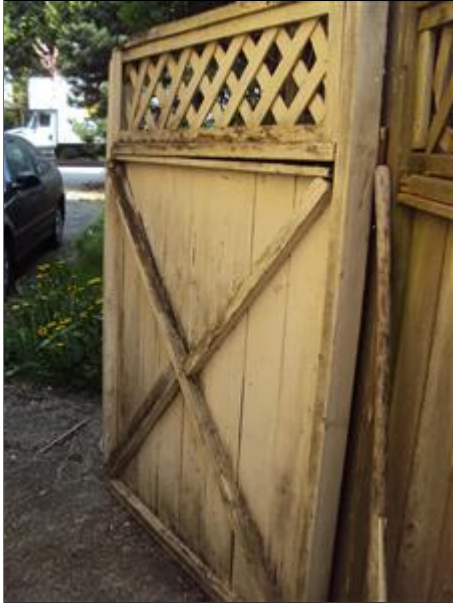
**2.6** The fence and gate around the home have either collapsed or are starting to fail. I would recommend replacing these items before complete failure.

2.6 Picture 1 Non Operational Gate

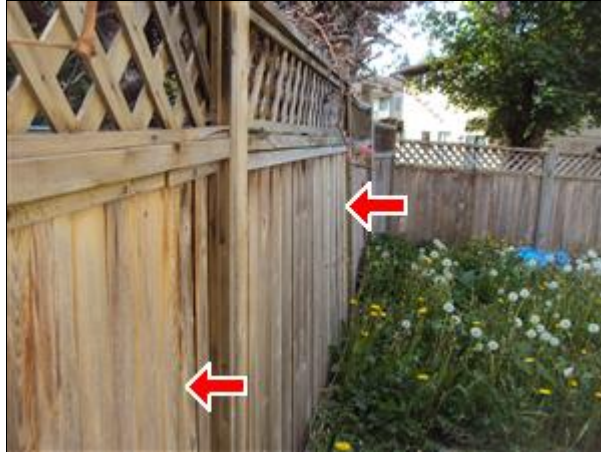
2.6 Picture 2 Perimeter Fencing

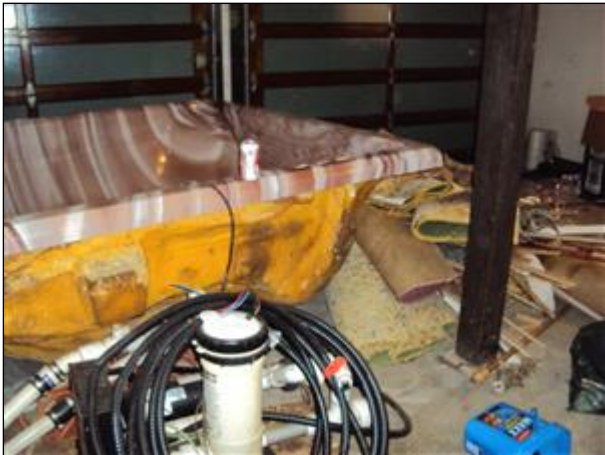
- 3.0 Please see section 2.3 of this report.
- 3.1 Please see section 2.3 of this report.
- 3.2 I was unable to inspect the garage floor due to excessive clutter.

3.2 Picture 1 Excessive Clutter

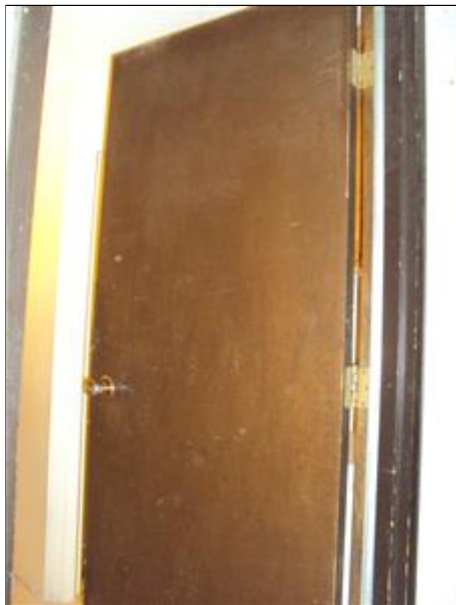
**3.4** The occupant door from the garage to the home should be on a self closing mechanism and properly sealed to prevent the possibility of carbon monoxide from entering the home. This is a minor but important safety issue.

3.4 Picture 1 Garage Door

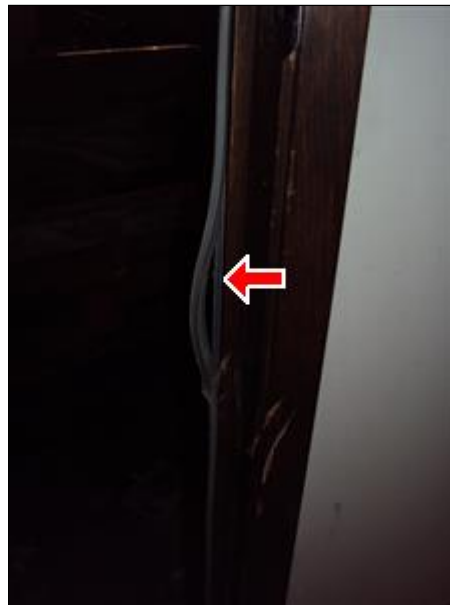
3.4 Picture 2 Failed Door Seal

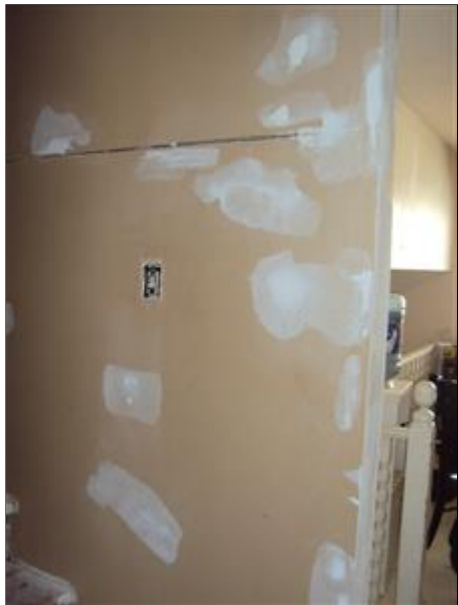
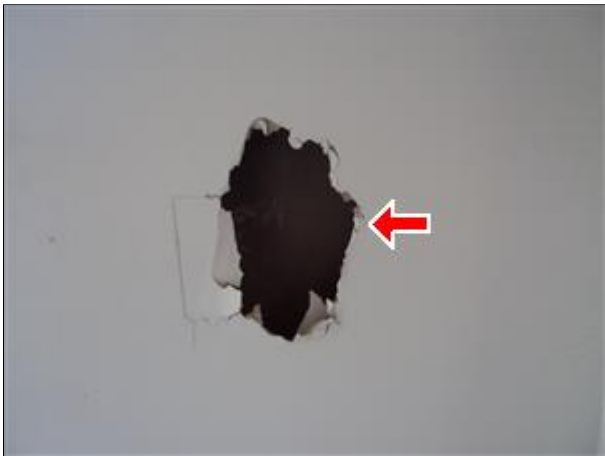
- 4.0 The interior of the home is in the midst of replacement/repair and cosmetic repairs are required throughout.
- 4.1 (1) The interior of the home is in the midst of replacement/repair and cosmetic repairs are required throughout.

4.1 Picture 1 Interior Walls

4.1 Picture 2 Interior Walls

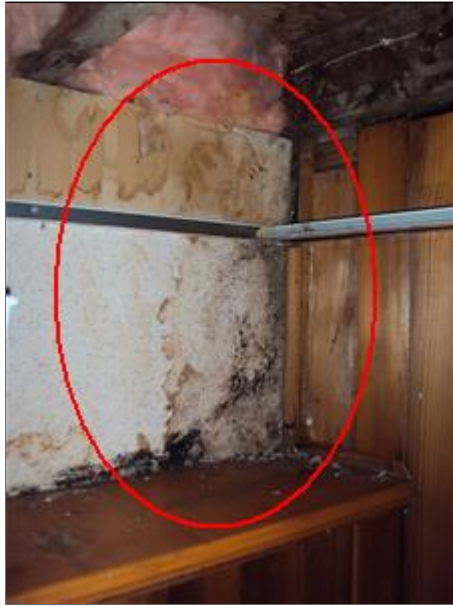
(2) Downstairs in the basement is evidence of water ingress. I suspect this is related to the failure of the perimeter drain and, during a heavy rain, water enters into the home. I recommend having the perimeter drains assessed and repaired as necessary.

4.1 Picture 3 Water Ingress

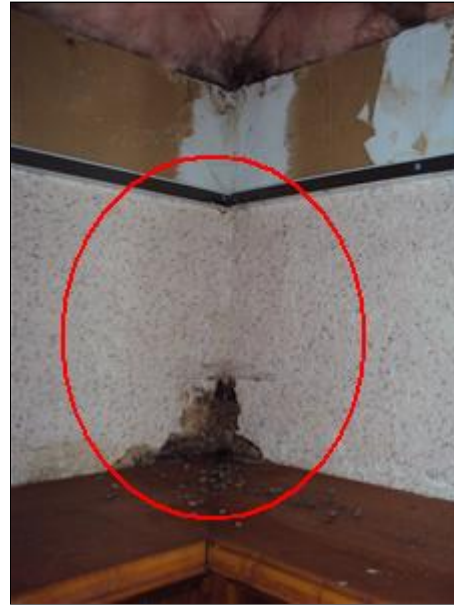
4.1 Picture 4 Water Ingress

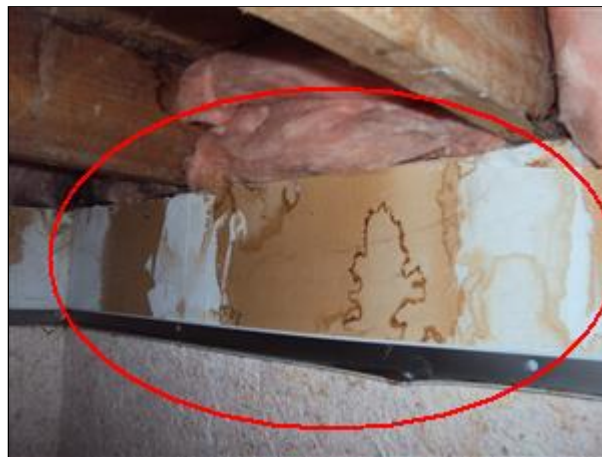
4.1 Picture 5 Water Staining

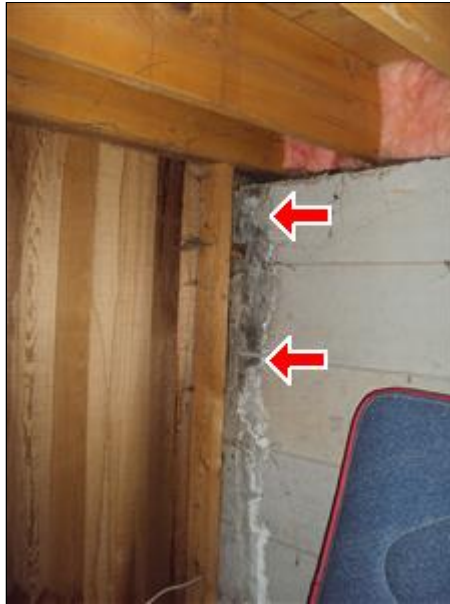
(3) Efflorescence is when moisture pushes the natural salts and minerals from brick, stone, concrete, and mortar. I was unable to identify a fracture in the wall where moisture was entering the home or whether it was purely the direct result of hydrostatic pressure. I suspect this is related to the failure of the perimeter drain as this area is not far from the water ingress mentioned earlier in this report.

4.1 Picture 6 Efflorescence

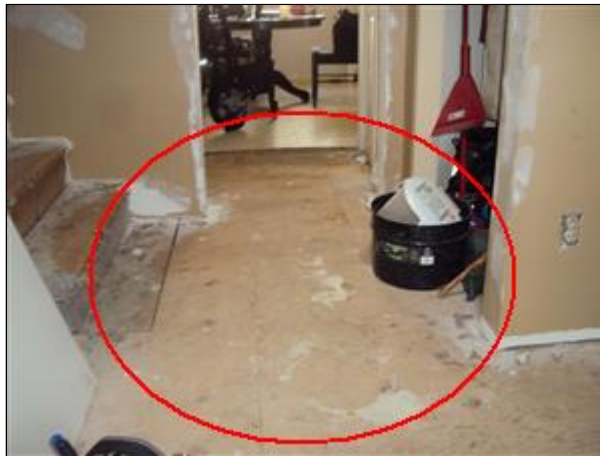
**4.2** (1) The interior of the home is in the midst of replacement/repair and cosmetic repairs are required throughout.

4.2 Picture 1 Interior Flooring

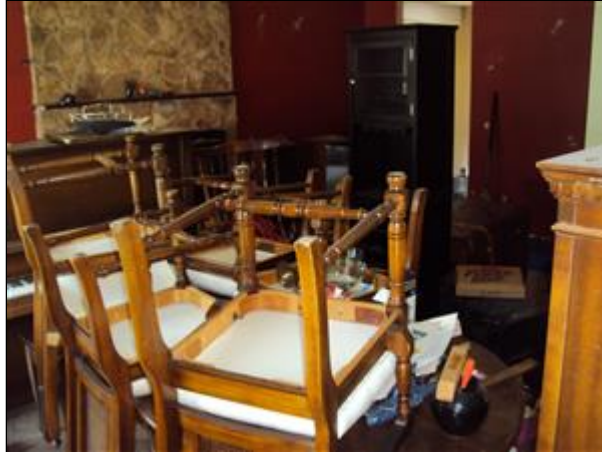
(2) I was unable to inspect all portions of the floor due to excessive clutter.

4.2 Picture 2 Excessive Clutter

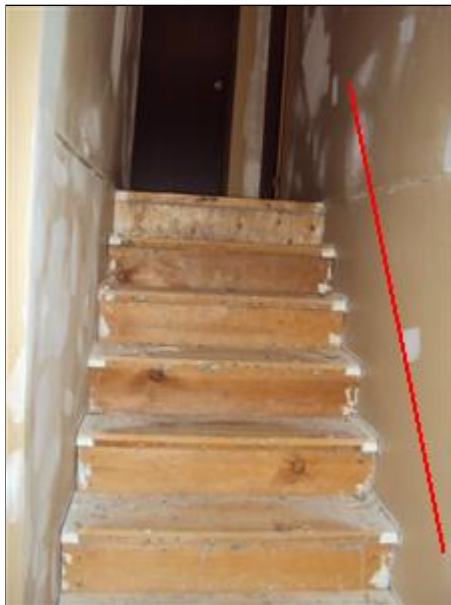
**4.3** Staircases that exceed three or more steps should have a handrail. The handrails are missing on these staircases.

4.3 Picture 1 Missing Handrail

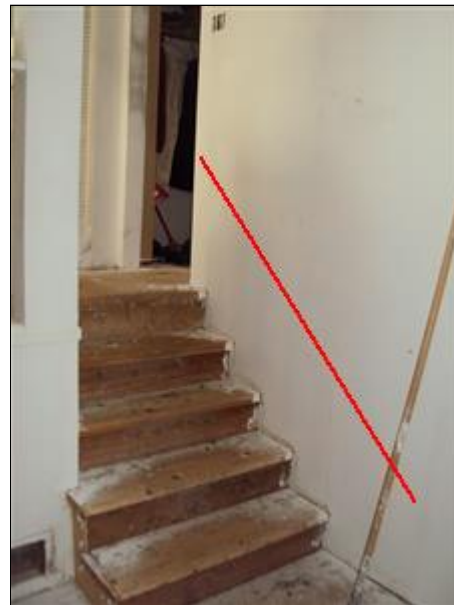
4.3 Picture 2 Missing Handrail

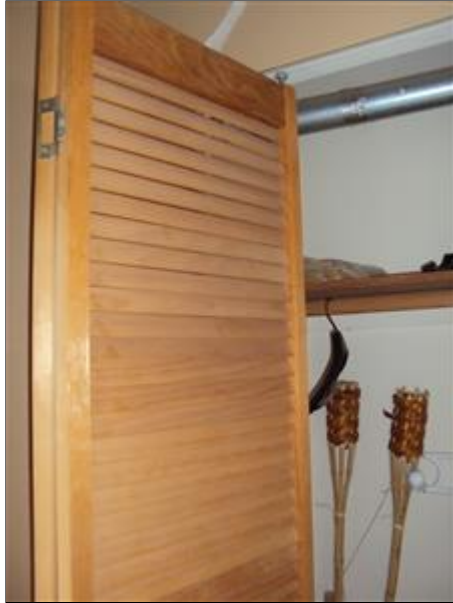
4.5 (1) There are several doors throughout the home that are in need of either repair or replacement.

4.5 Picture 1 Non Operational Door

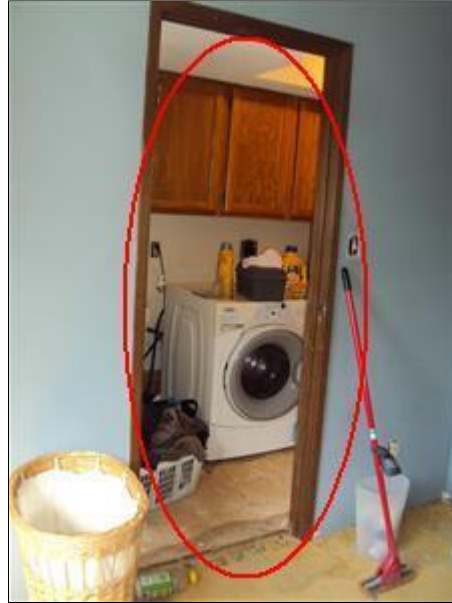
4.5 Picture 2 Missing Door

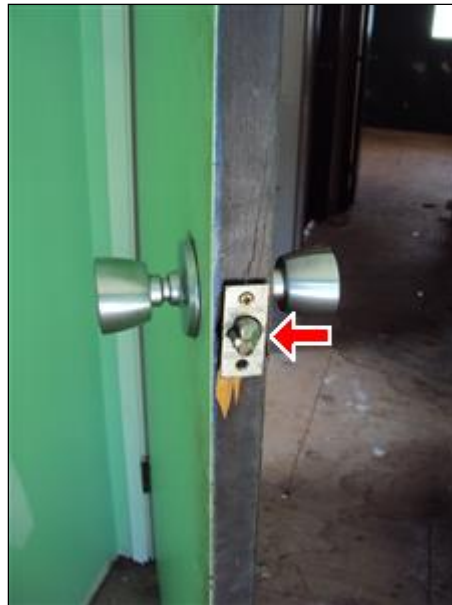
(2) The closing mechanism on this interior door is broken and should be replaced.

4.5 Picture 3 Broken Mechanism

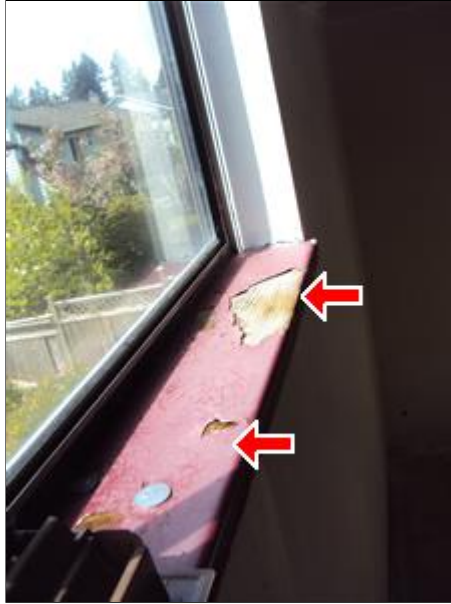
**4.6** The window sills throughout the home need to be repainted to prevent the possibility of water ingress and further damage.

4.6 Picture 1 Deteriorating Paint

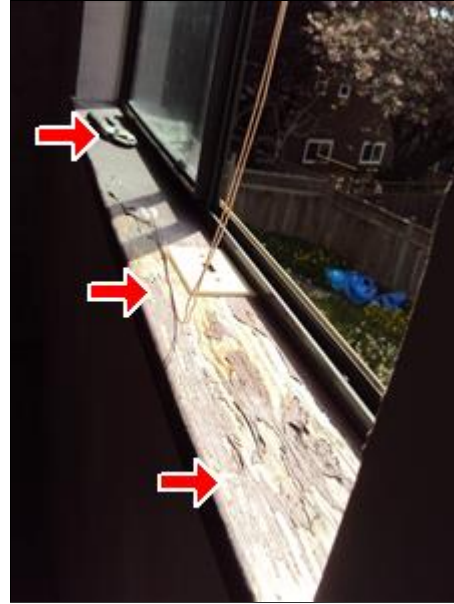
4.6 Picture 2 Deteriorating Paint

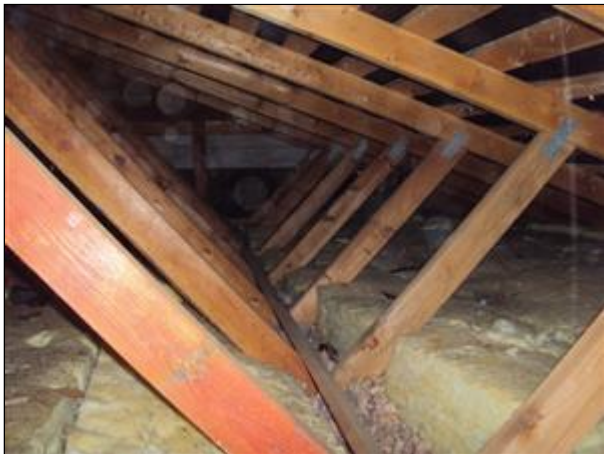
5.5 I found no evidence of damaged or cracked wooden trusses at the time of the inspection.

5.5 Picture 1 Engineered Wooden Trusses

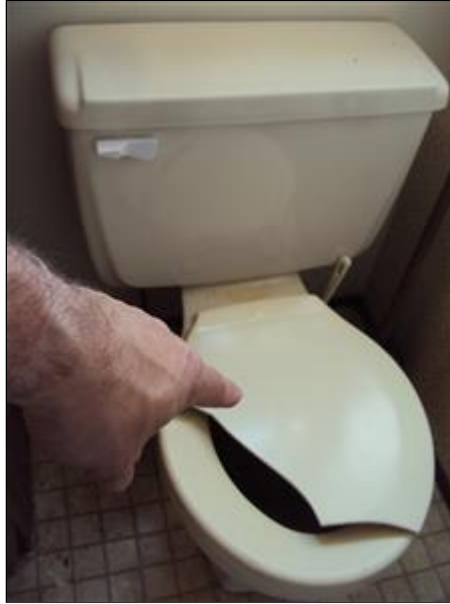
**6.1** (1) The lid on this toilet is broken and the toilet itself is loose. I found no evidence of water ingress and suspect either the securing bolts are loose or the toilet seal is beginning to fail.

6.1 Picture 1 Loose Toilet

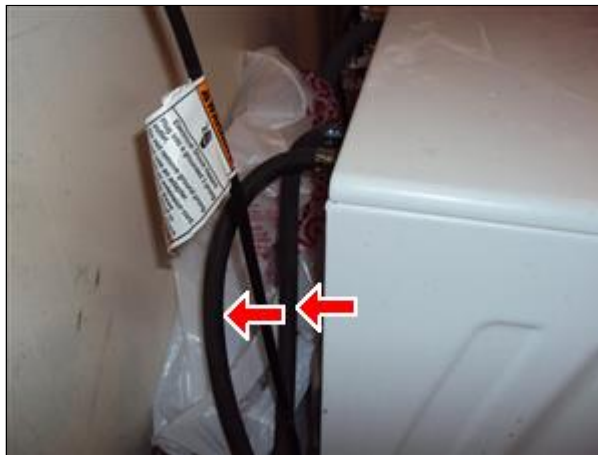
(2) Over time rubber hoses become brittle and can leak. If the leak goes unnoticed significant damage can occur to the flooring or substructure below. I recommend replacing the rubber hoses with a steel braided type to reduce the risk of a water leak. This is a minor replacement issue.

6.1 Picture 2 Washing Machine Hoses

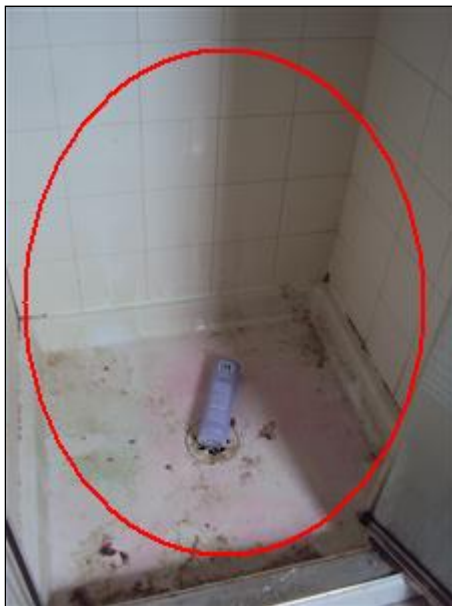
(3) Over time grout can become porous and water ingress will take place. I recommend cleaning and sealing bathroom grout once every few years depending on the amount of use the area receives. No moisture was detected at the time of then inspection and this is a preventative recommendation.

6.1 Picture 3 Clean & Seal Grout

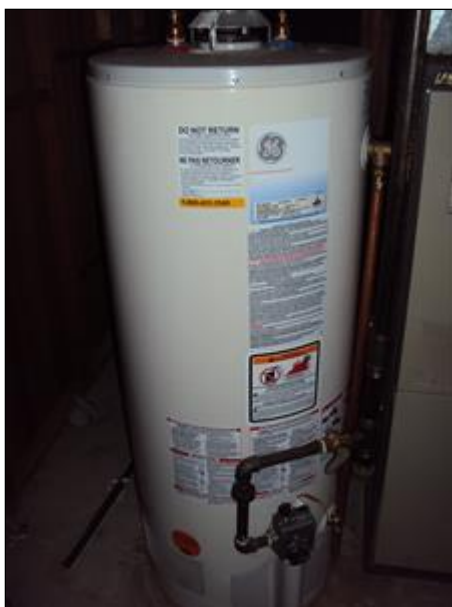
**6.2** GE is a very popular brand of hot water tank. GE embeds the MFD in the first four numbers in the serial number. In this example the first two numbers '08' represents the month (Aug) and the second two numbers '10' represents the year (2010). Generally speaking hot water tanks last between 8-10 years depending on the quality of the tank and the amount of use the tank receives.

6.2 Picture 1 GE Hot Water Tank

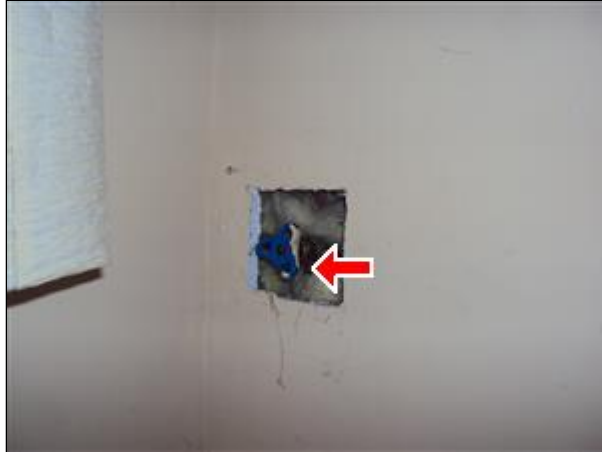
**6.3** The main water shutoff is located in the downstairs bedroom. In the event that a water leak cannot be isolated at the source turning this tap will shut the water off to the entire home.

6.3 Picture 1 Main Water Shutoff

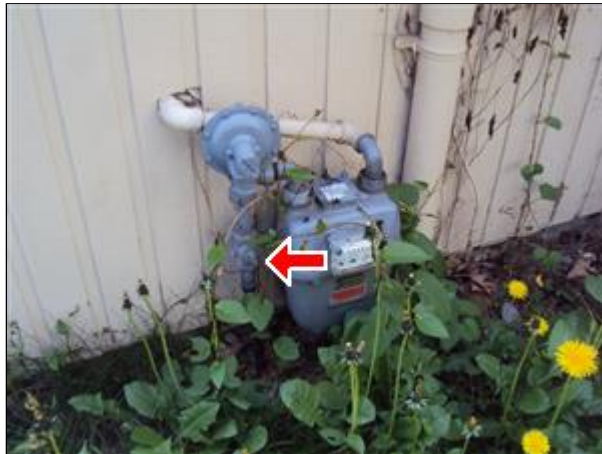
**6.5** The main fuel shutoff is located on the West side of the home. In the event of a natural disaster (i.e. earthquake) the gas should be shutoff to prevent the possibility of a leak. A crescent wrench will be required to accomplish this task.

6.5 Picture 1 Main Fuel Shutoff

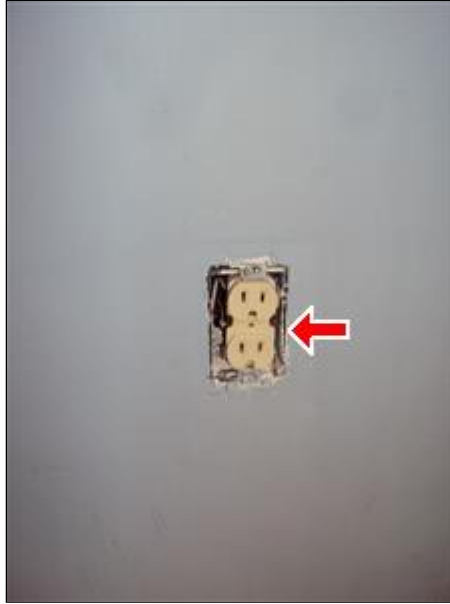
**7.3** (1) There are several electrical plates that are missing throughout the home. These covers should be replaced once the renovations are completed. This is a minor but important issue.

7.3 Picture 1 Missing Cover Plate

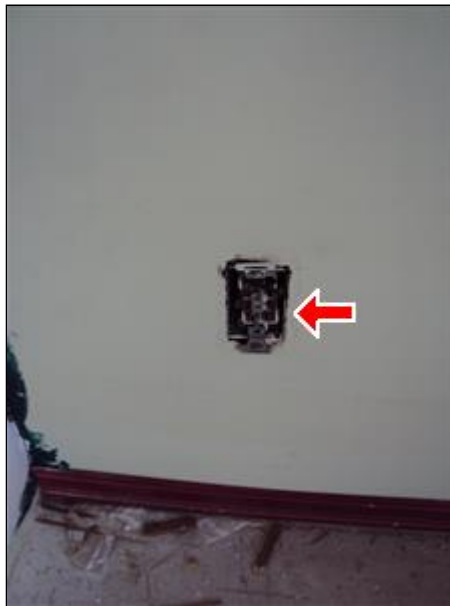
(2) This electrical outlet located upstairs is exposed and presents an electrocution hazard. This outlet should be removed and replaced with a functional outlet and cover.

7.3 Picture 2 Exposed Outlet

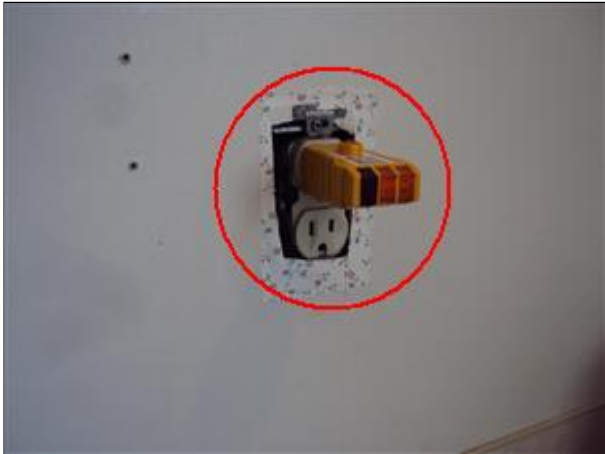
(3) Both of these outlets are non functional and should be replaced.

7.3 Picture 3 Non Operational Outlet

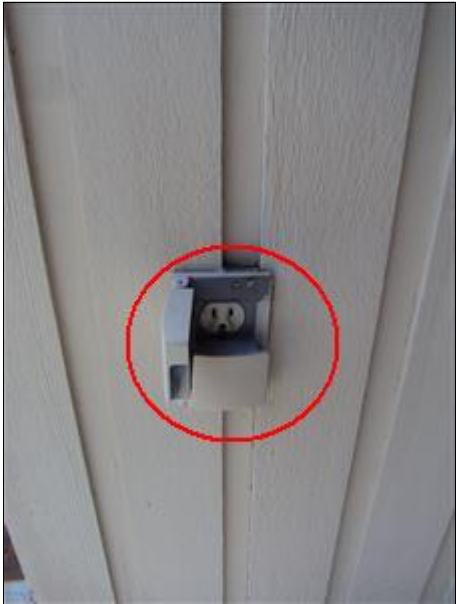
7.3 Picture 4 Non Operational Outlet

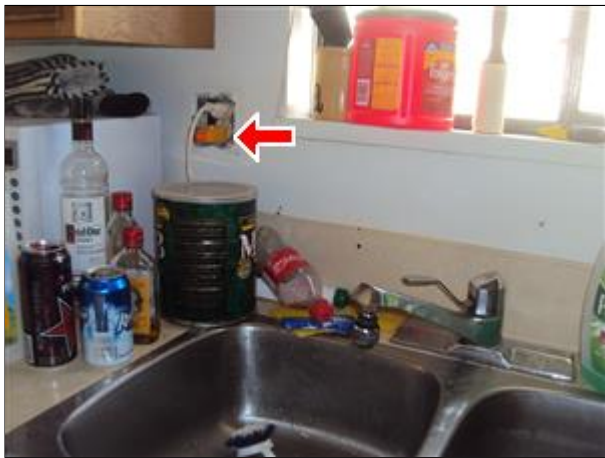
(4) Any exterior outlet or outlets that are within 3' of a water source should be GFCI protected. These outlets are not. A ground fault circuit interrupter (GFCI) is a device that shuts off an electric circuit when it detects that current is flowing along an unintended path, possibly through water or through a person. It is used to reduce the risk of electric shock. It works by measuring the current leaving the hot side of the power source and comparing it to the current returning to the neutral side. If they are not equal, this means that some of the current is flowing along an unintended path, and the GFCI shuts the power off. When the problem is corrected, the GFCI can manually be reset by pushing the reset button. There is also a test button that can be used to verify that the GFCI works. It is recommended to test GFCIs at least once a month. This is a minor but important replacement issue.

7.3 Picture 5 Not GFCI Protected

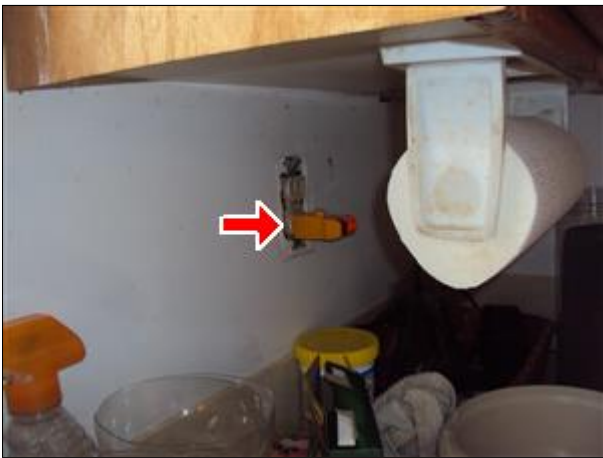
7.3 Picture 6 Not GFCI Protected

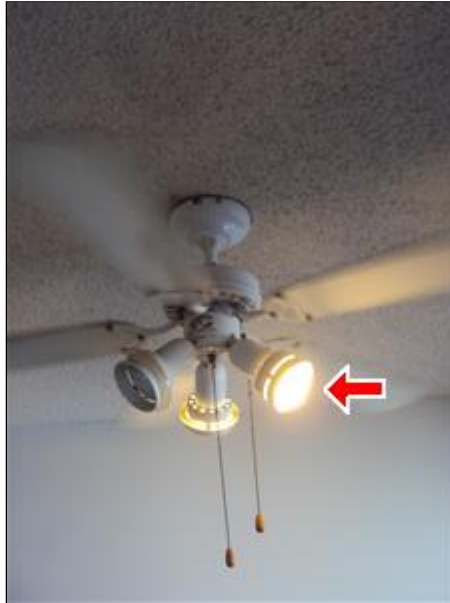
(5) Many of the fans throughout the home are loose and should be properly secured to ensure they do not pull themselves from their anchors.

7.3 Picture 7 Loose Fixtures

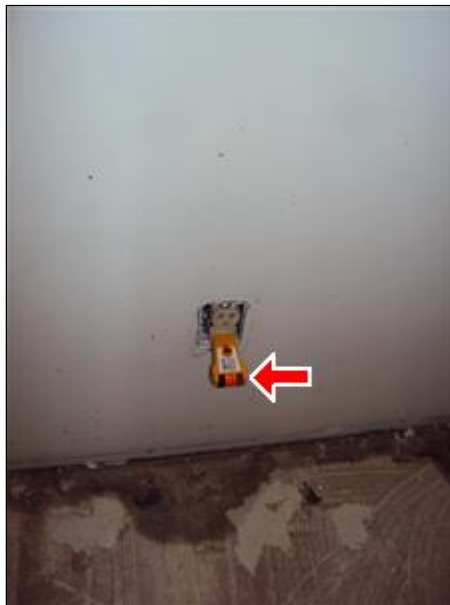
(6) This electrical outlet reads "Open" meaning the neutral wire is not properly connected. This was an error during installation and can easily be corrected.

7.3 Picture 8 Open Outlet

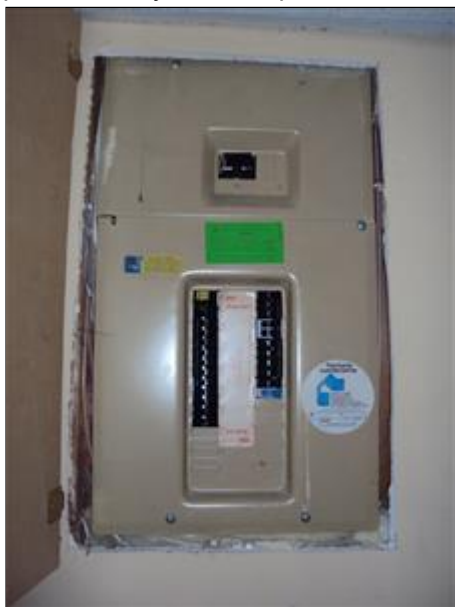
**7.6** The electrical panel is located in the downstairs bedroom. I found no evidence of tampering, arcing, double tapping, or corrosion. This was a professionally installed panel.

7.6 Picture 1 Electrical Panel

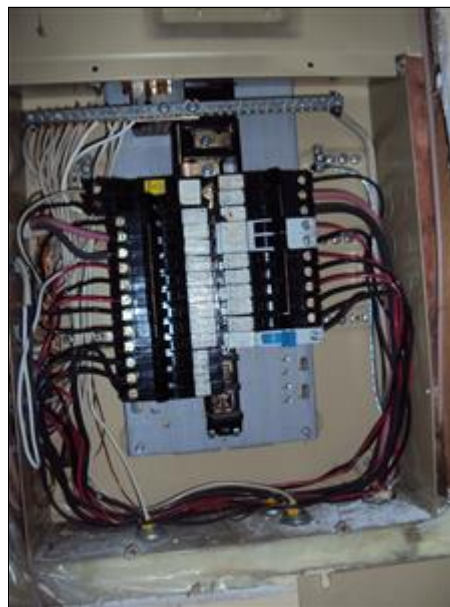
7.6 Picture 2 Branch Wiring

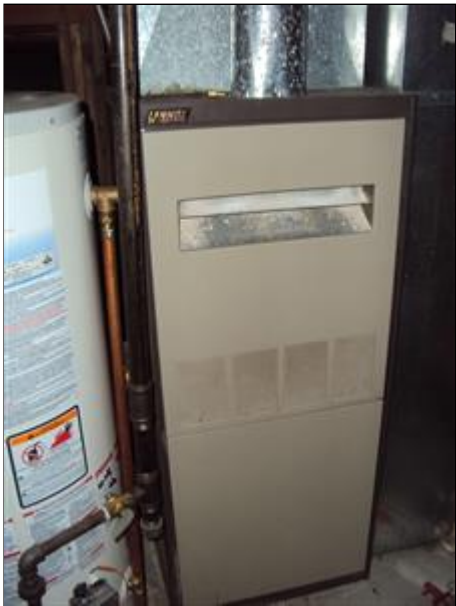
8.0 The Lennox furnace is original to the home. Generally speak furnaces last between 20-30 years depending on the quality of the unit and the maintenance it receives. This furnace has come to the end of its useful life and should be replaced. There is evidence of corrosion, damage to the heat exchanger and back drafting. Please install a carbon monoxide detector immediately.

8.0 Picture 1 Lennox Furnace

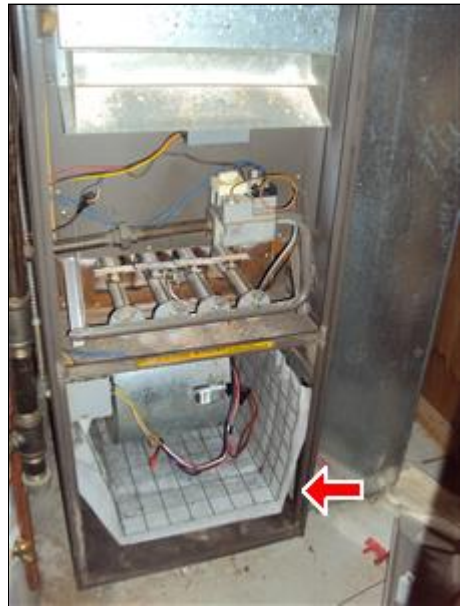
8.0 Picture 2 Filter Location

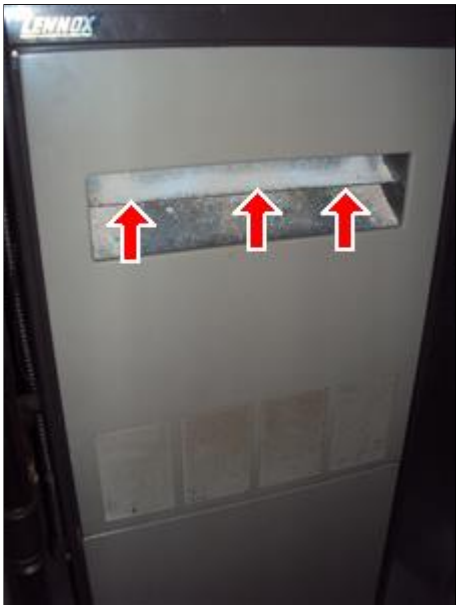
8.0 Picture 3 Backdrafting

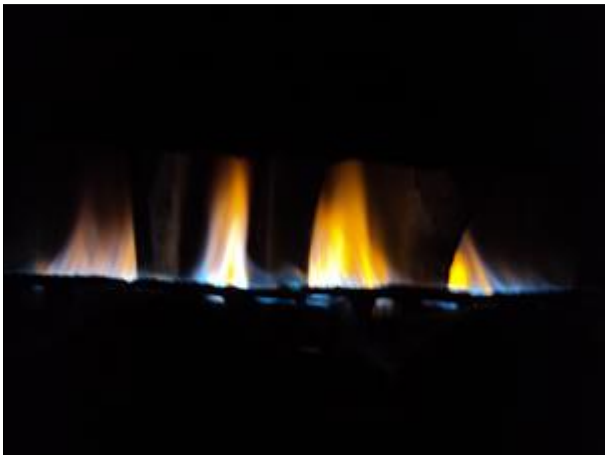
8.0 Picture 4 Orange Flame

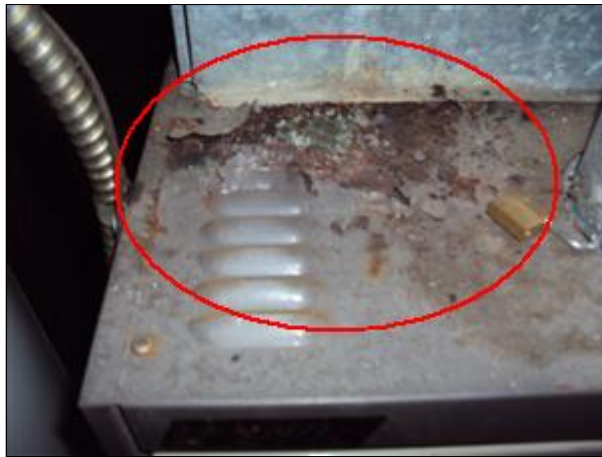
8.0 Picture 5 Corrosion

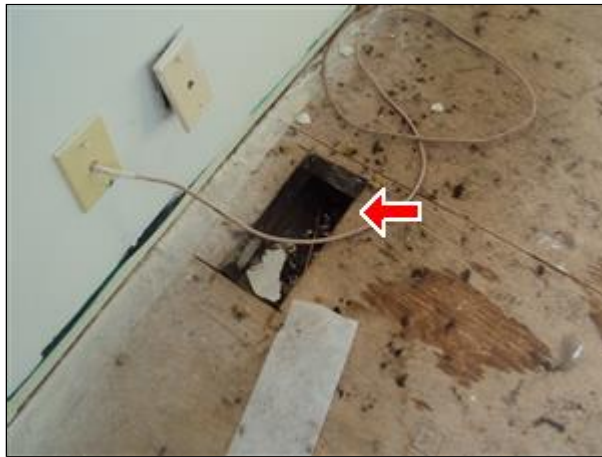
**8.3** (1) Please replace this vent cover once renovations are complete.

8.3 Picture 1 Missing Vent

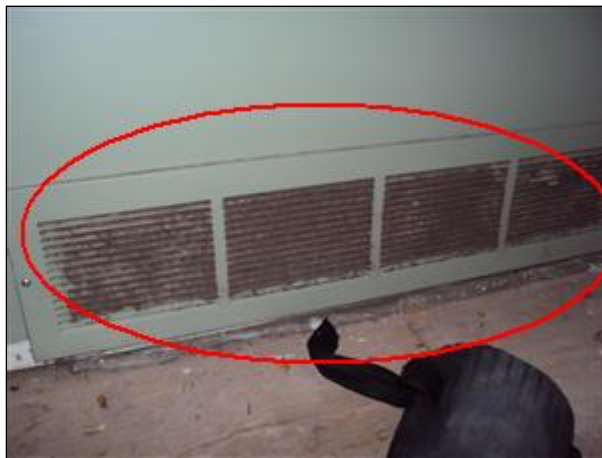
(2) Periodically cleaning the furnace ducts will improve the air quality in the home. This would be considered regular maintenance.

8.3 Picture 2 Clean Ducts

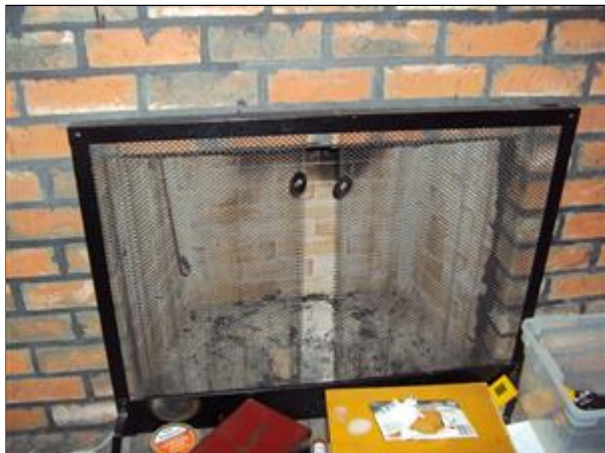
**8.6** I highly recommend having the fireplaces cleaned annually to prevent the possibility of creosote build up. Creosote is a natural by product of burning wood. The build up of creosote will potentially create a chimney fire if not cleaned regularly.

8.6 Picture 1 Downstairs Fireplace

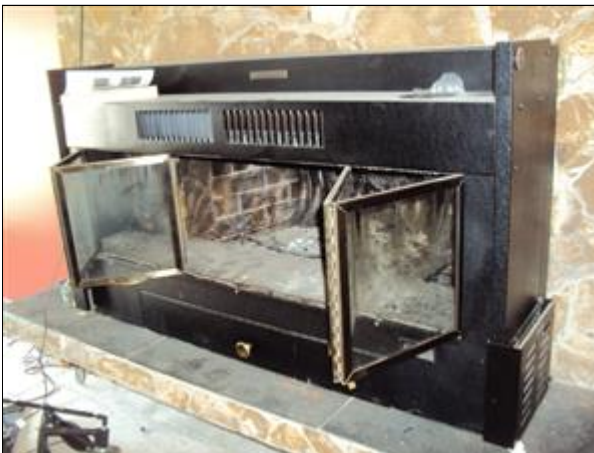
8.6 Picture 2 Main Level Fireplace

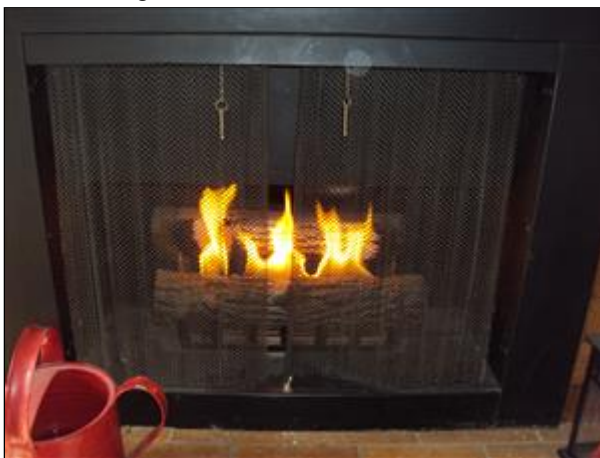
**8.7** The gas fireplace operated when called upon. I would recommend having this unit serviced to ensure the air/gas mixture is correct. This would be considered regular maintenance.

8.7 Picture 1 Gas Fireplace
