# Inspection Report

11832 Cascade Dr  
Delta BC V4E 3C2

**Brighton Home Inspections**

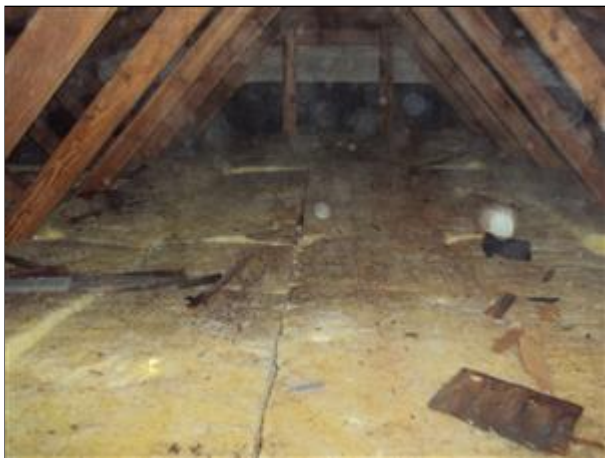
9.0 The batten and blown in insulation are original to the home. The insulation is providing approximately an R-value of R 24 which is low by today's standard. I would assess the comfort of the home and the energy costs during the colder months. In the event the home is cold or energy costs are high adding additional insulation may improve the comfort level of the home.

9.0 Picture 1 Batten Insulation

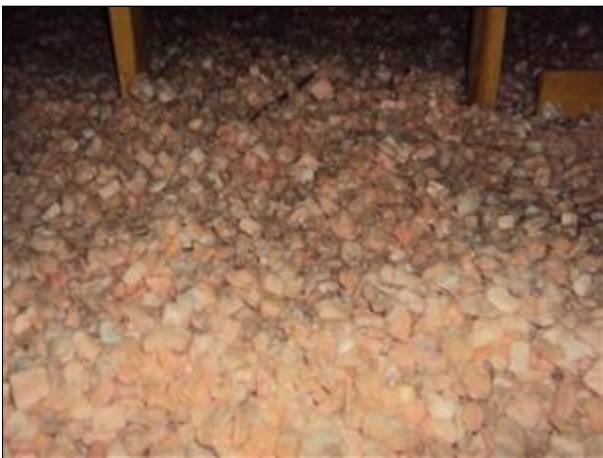
9.0 Picture 2 Blown In Insulation

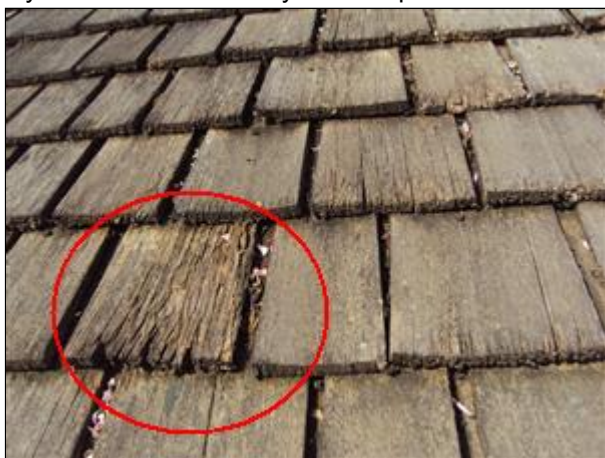
The cedar shingle roof is coming to the end of its useful life and budgeting for a new one would be prudent. This roof may last for the next 1-3 years if repairs are continued and the roof is maintained.

1.0 Picture 1 Shingle Deterioration

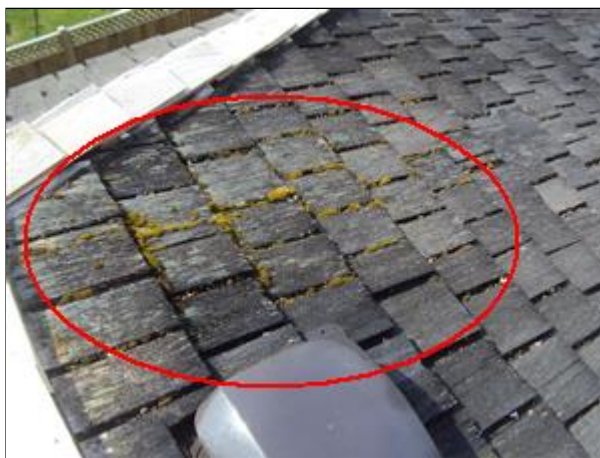
1.0 Picture 2 Moss Growth

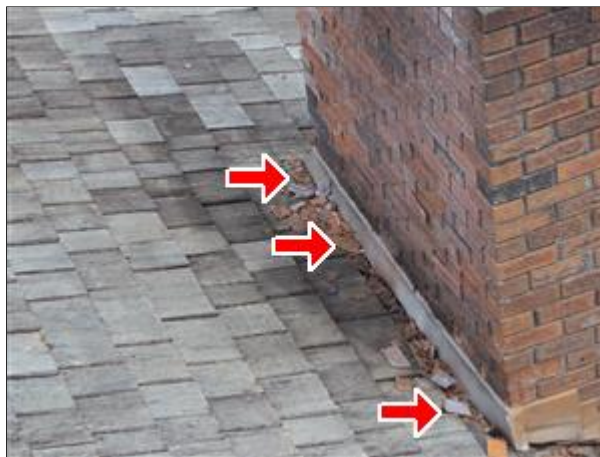
Portions of the brick chimney are beginning to flake away. This is a combination of poor quality brick and excessive heat. I would recommend having the chimney cleaned as this is potentially a fire hazard and removing any foreign matter that has formed on the exterior of the chimney.

1.2 Picture 1 Brick Debris Chimney

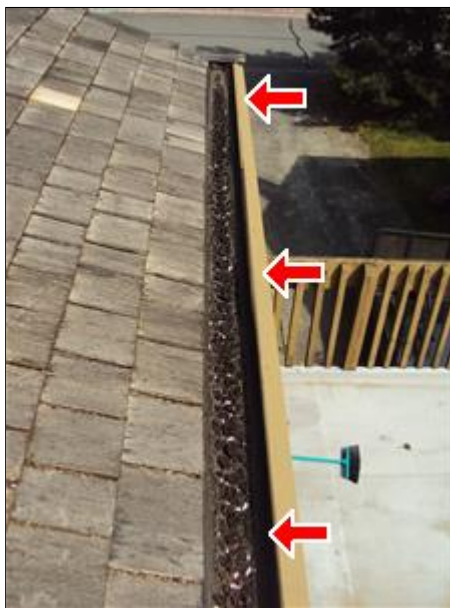
Cleaning out the gutters would be considered regular maintenance and should be done twice a year or on an as needed basis.

1.3 Picture 1 Clean Gutters

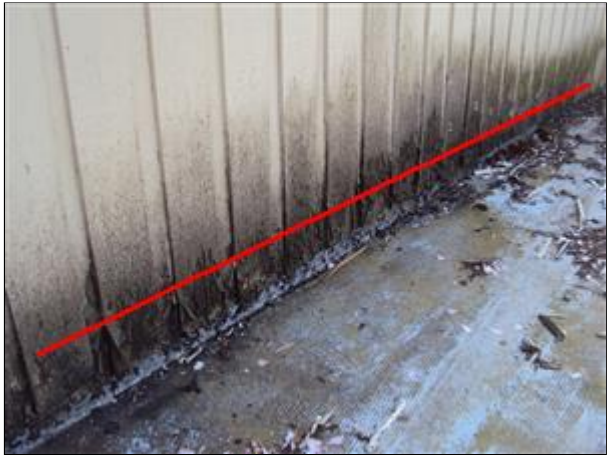
The siding around the upstairs balcony is in poor condition and should be replaced as soon as possible. Generally speaking I found the siding of the home in fair condition with the exception of the balcony area.

2.0 Picture 1 Deteriorating Siding

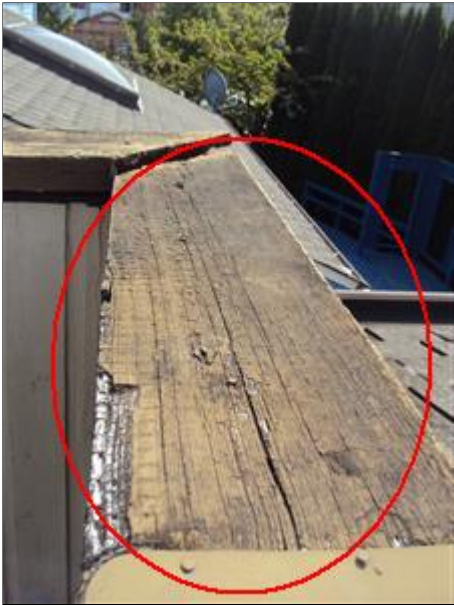
2.0 Picture 2 Deteriorating Trim

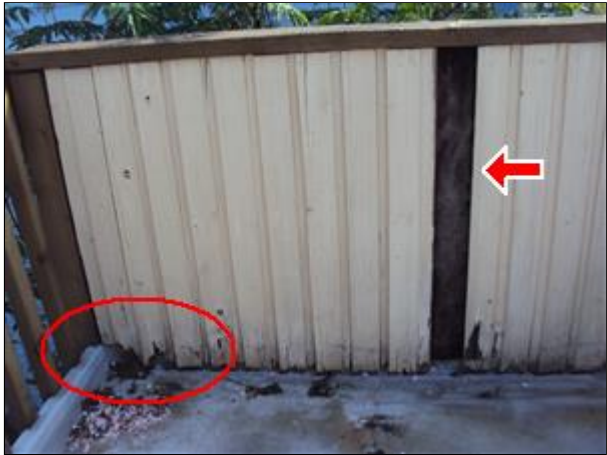
2.0 Picture 3 Missing/Deteriorating Siding

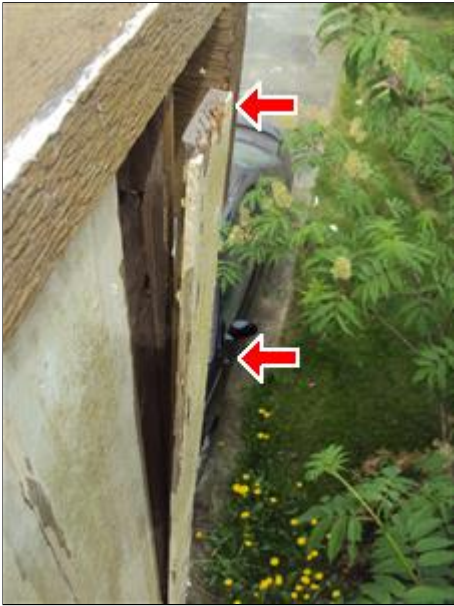
2.0 Picture 4 Loose Siding

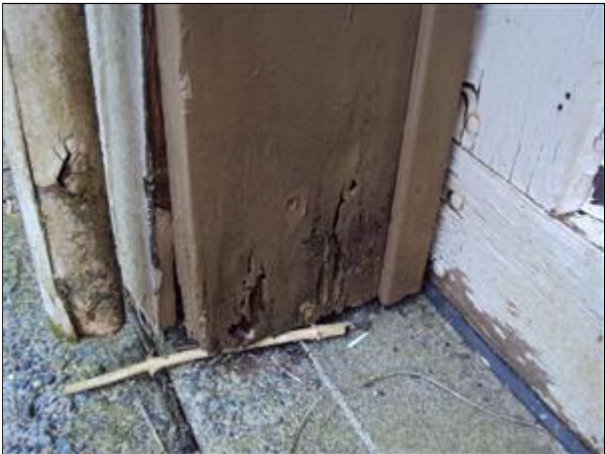
2.0 Picture 5 Deterioration Trim

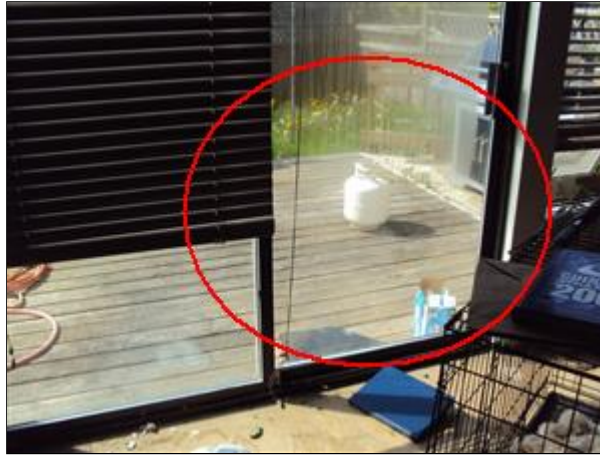
(1) I was unable to operate the sliding door as the locking mechanism was jammed. This is a minor repair.

2.1 Picture 1 Siding Door

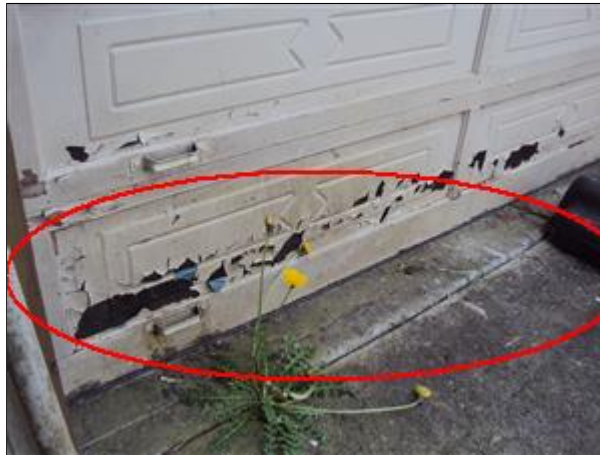
(2) The paint on the garage door is delaminating and should be repainted to protect the surface from further damage. This would be considered regular maintenance.

2.1 Picture 2 Garage Door

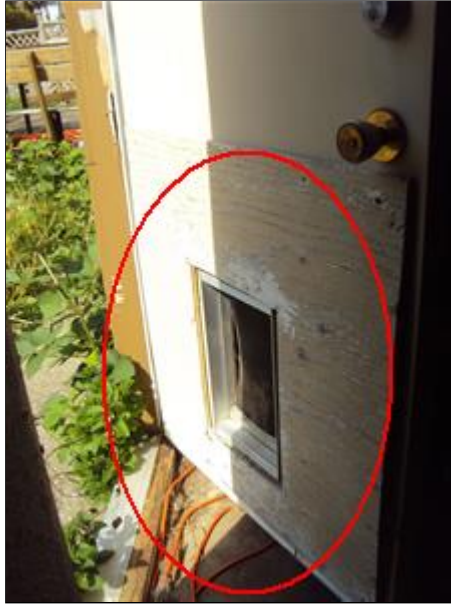
(3) This garage door is beginning to deteriorate around the pet entrance. I recommend replacing this door.

2.1 Picture 3 Deteriorating Door

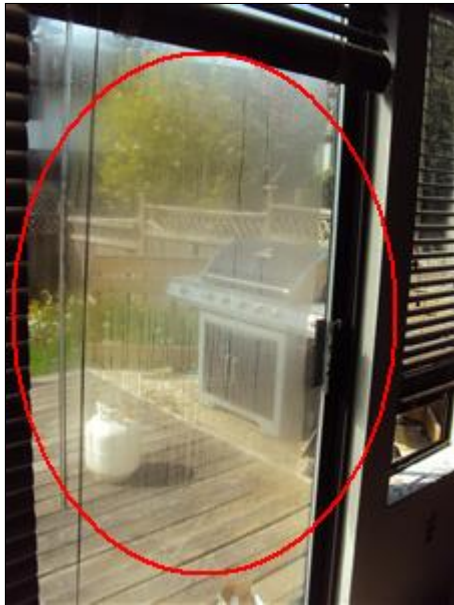
The seal on the sliding door has failed. For the most part a failed seal has little effect on the insulation value of the window/door but presents a less than desirable cosmetic effect. The estimated cost to replace/repair windows is approximately \$55.00 per sq ft.

2.2 Picture 1 Failed Sliding Door Seal

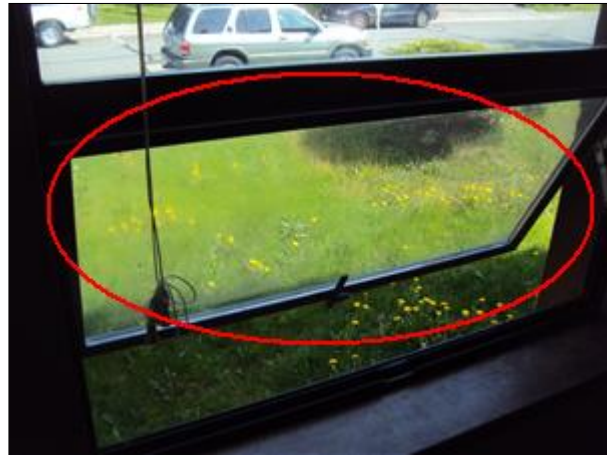
2.2 Picture 2 Failed Window Seal

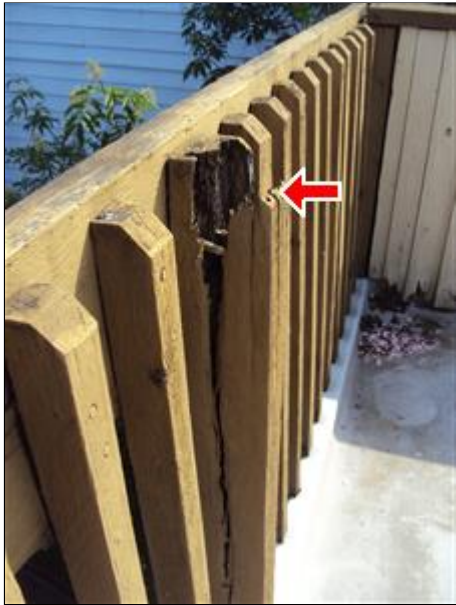
2.3 Picture 1 Rotting Support Post

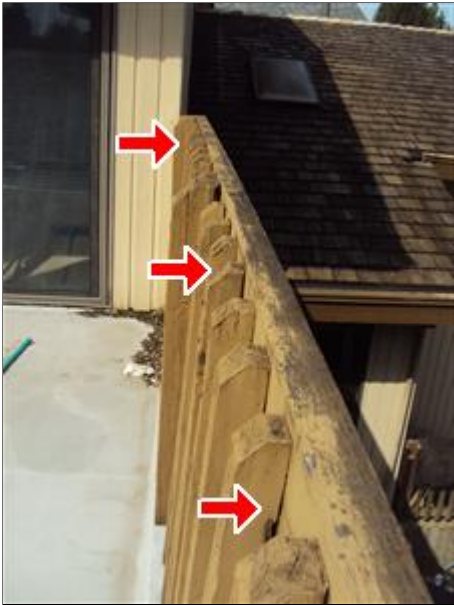
2.3 Picture 2 Loose Railing

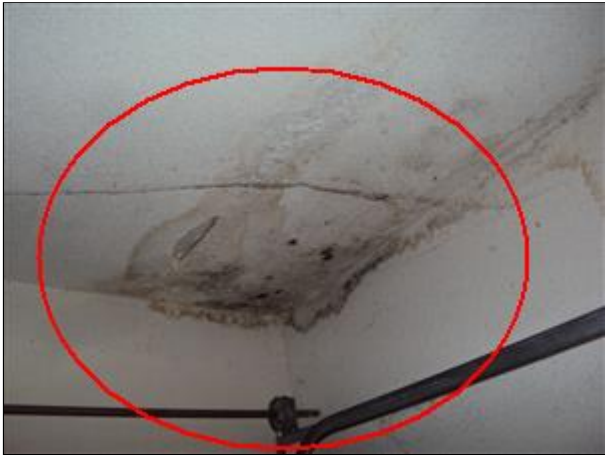
(1) The garage ceiling has been subjected to water ingress coming from the balcony above. I was unable to identify the exact location of the water ingress but suggest further investigation to identify the exact source.

2.3 Picture 3 Water Ingress Garage

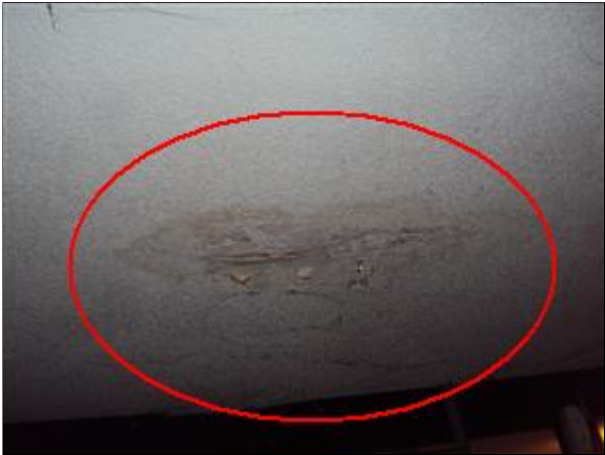
2.3 Picture 4 Water Ingress Garage

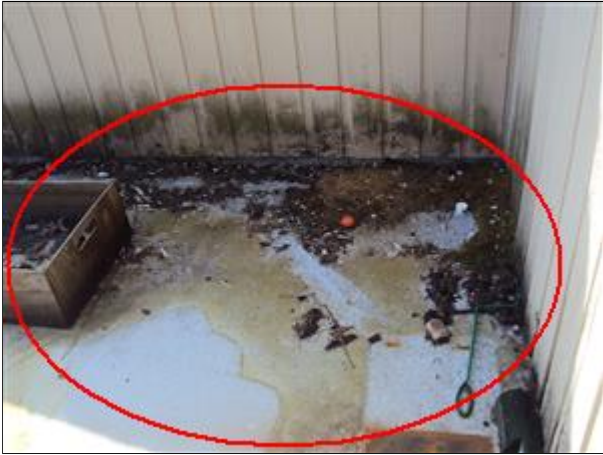
2.3 Picture 5 Balcony Deterioration

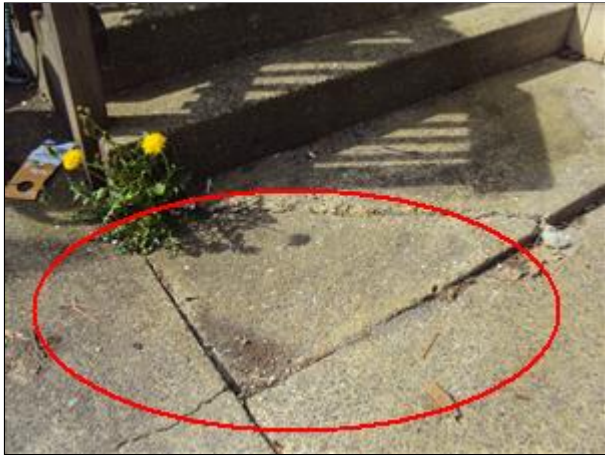
(2) Unfortunately settlement cracks are very common in large concrete structures. These cracks usually appear in the first few years after construction. In the unlikely event of the cracks becoming wider I recommend applying a concrete epoxy to fill the cracks and minimize the damage.

2.3 Picture 6 Settlement Crack

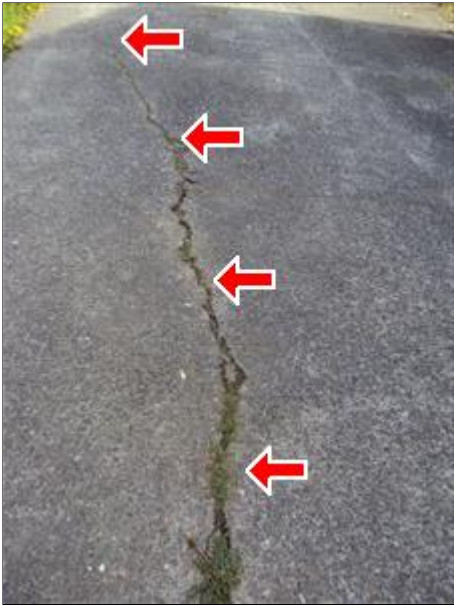
2.3 Picture 7 Settlement Crack

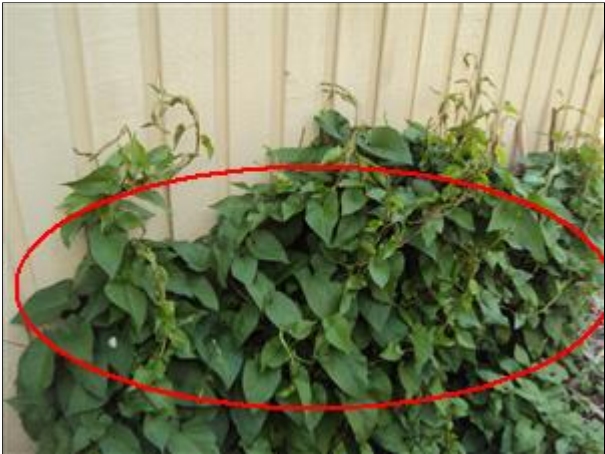
(1) Anytime vegetation has an opportunity to grow against siding premature deterioration will take place. This will also provide an opportunity for pests or insects to enter the home. I recommend removing any vegetation that is within close proximity of the home.

2.4 Picture 1 Remove Vegetation

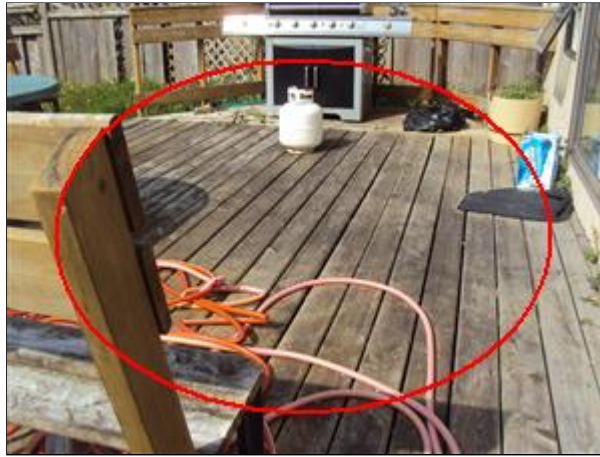
(2) The rear deck is in need of being stained and repaired. There are several loose boards and further deterioration will take place is not corrected. This would be considered regular maintenance.

2.4 Picture 2 Repair &amp; Stain Deck

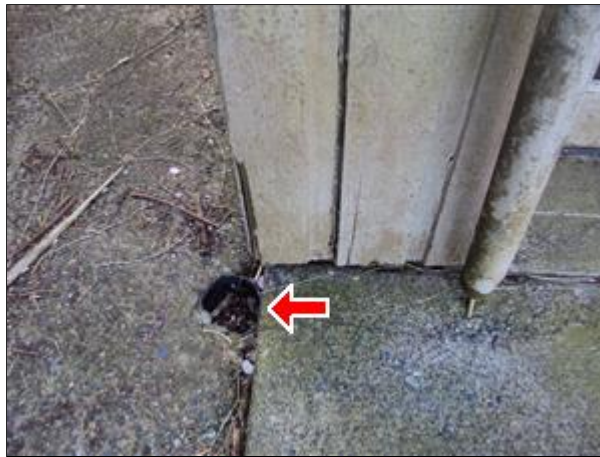
(3) The perimeter drains are full of debris and are no longer functioning.

2.4 Picture 3 Failed Perimeter Drain

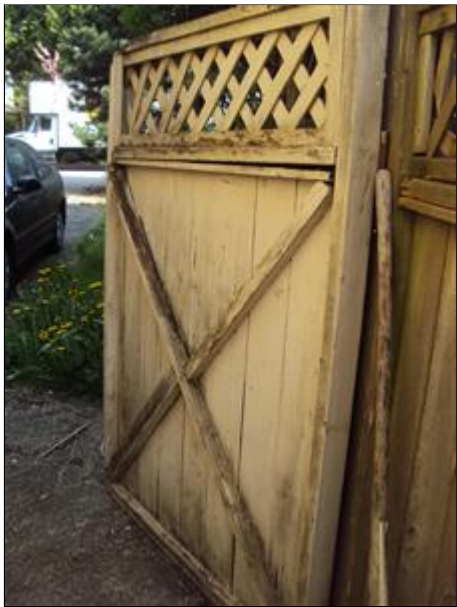
2.6 Picture 1 Non Operational Gate

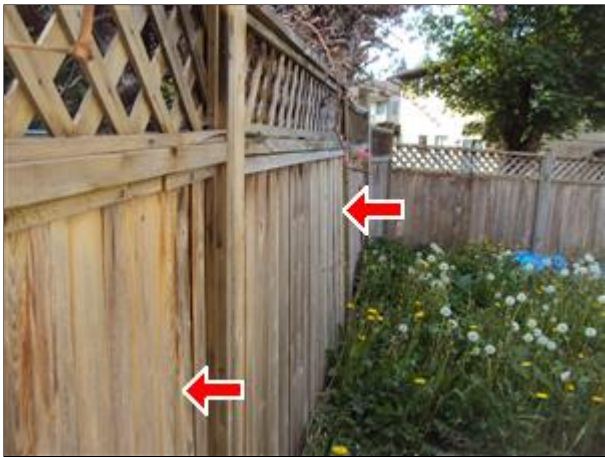
The fence and gate around the home have either collapsed or are starting to fail. I would recommend replacing these items before complete failure.

2.6 Picture 2 Perimeter Fencing

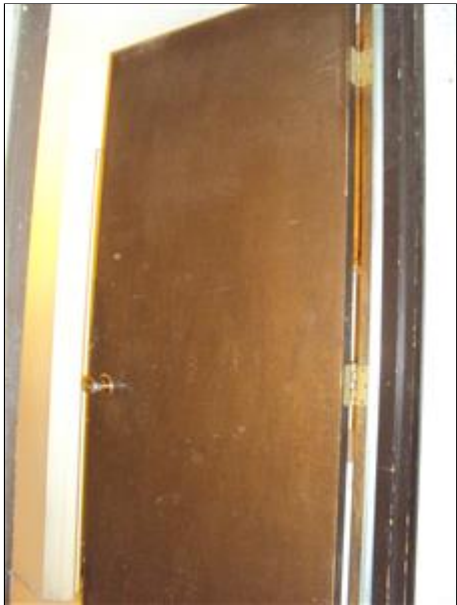
The occupant door from the garage to the home should be on a self closing mechanism and properly sealed to prevent the possibility of carbon monoxide from entering the home. This is a minor but important safety issue.

3.4 Picture 1 Garage Door

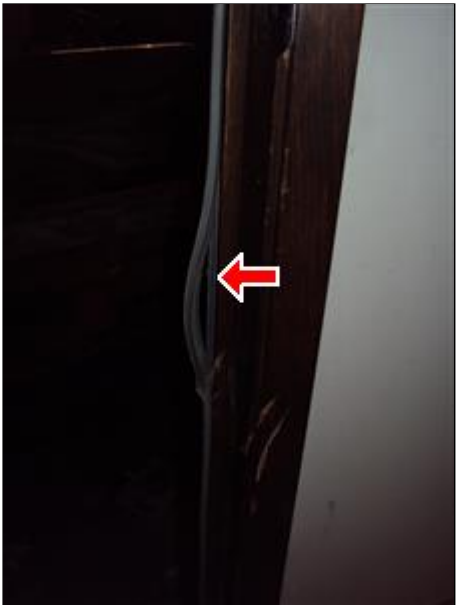
3.4 Picture 2 Failed Door Seal

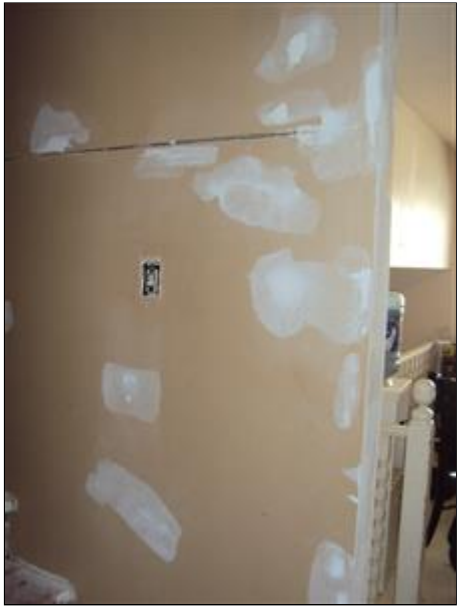
- 4.0 CEILINGS
- Repair or Replace
- The interior of the home is in the midst of replacement/repair and cosmetic repairs are required throughout.
- 4.1 WALLS
- Repair or Replace
- (1) The interior of the home is in the midst of replacement/repair and cosmetic repairs are required throughout.

4.1 Picture 1 Interior Walls

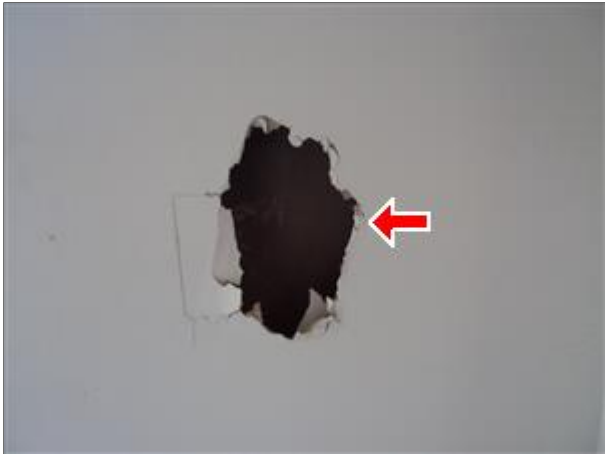
4.1 Picture 2 Interior Walls

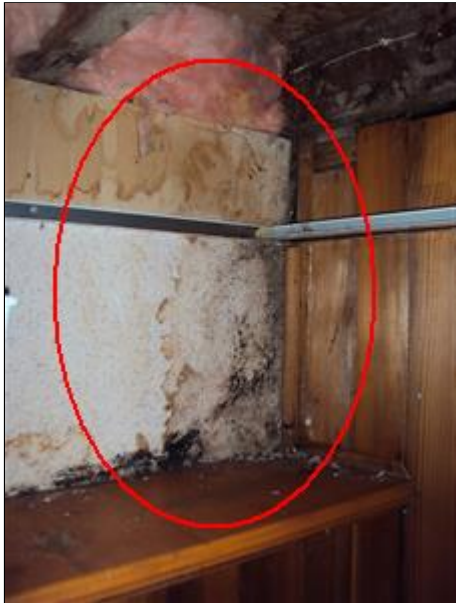
(2) Downstairs in the basement is evidence of water ingress. I suspect this is related to the failure of the perimeter drain and, during a heavy rain, water enters into the home. I recommend having the perimeter drains assessed and repaired as necessary.

4.1 Picture 3 Water Ingress

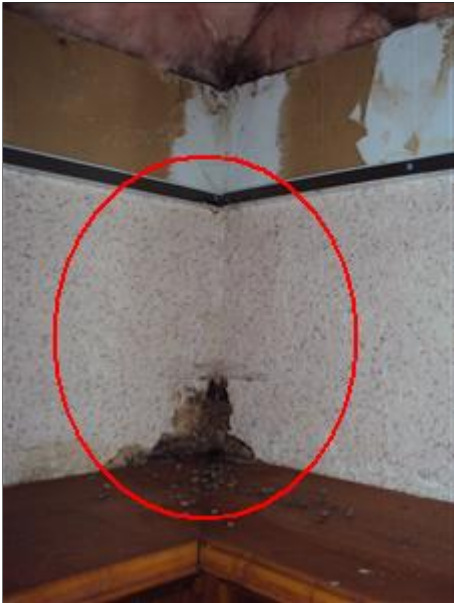
4.1 Picture 4 Water Ingress

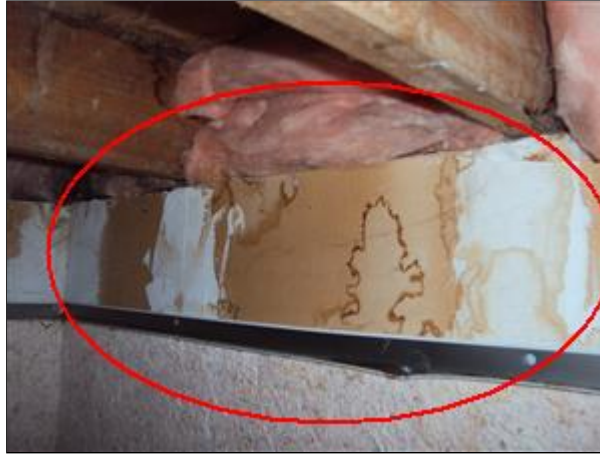
4.1 Picture 5 Water Staining

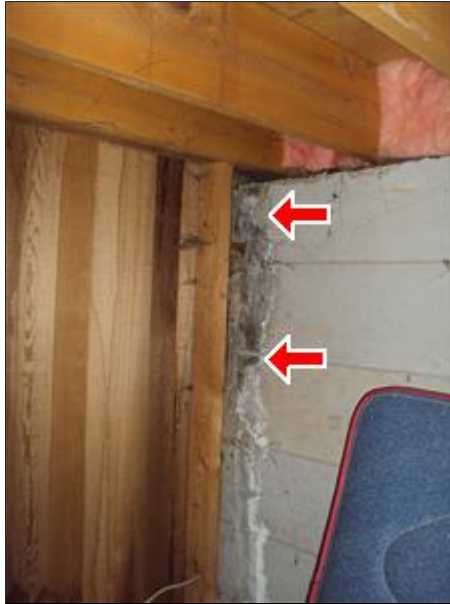
(3) Efflorescence is when moisture pushes the natural salts and minerals from brick, stone, concrete, and mortar. I was unable to identify a fracture in the wall where moisture was entering the home or whether it was purely the direct result of hydrostatic pressure. I suspect this is related to the failure of the perimeter drain as this area is not far from the water ingress mentioned earlier in this report.

4.1 Picture 6 Efflorescence

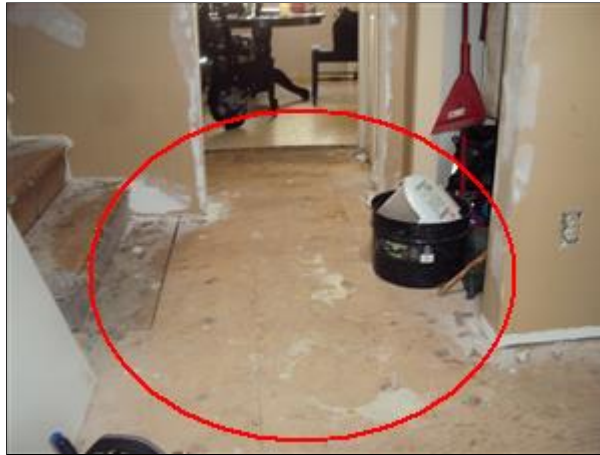
(1) The interior of the home is in the midst of replacement/repair and cosmetic repairs are required throughout.

4.2 Picture 1 Interior Flooring

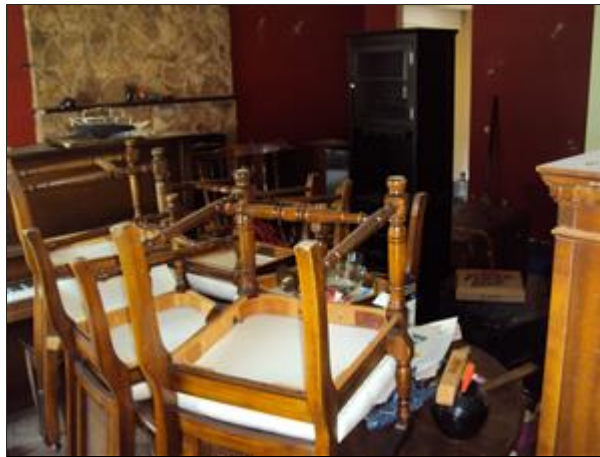
(2) I was unable to inspect all portions of the floor due to excessive clutter.

4.2 Picture 2 Excessive Clutter

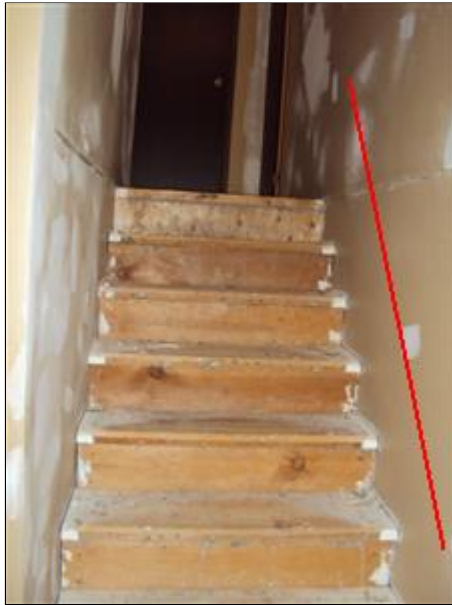
Staircases that exceed three or more steps should have a handrail. The handrails are missing on these staircases.

4.3 Picture 1 Missing Handrail

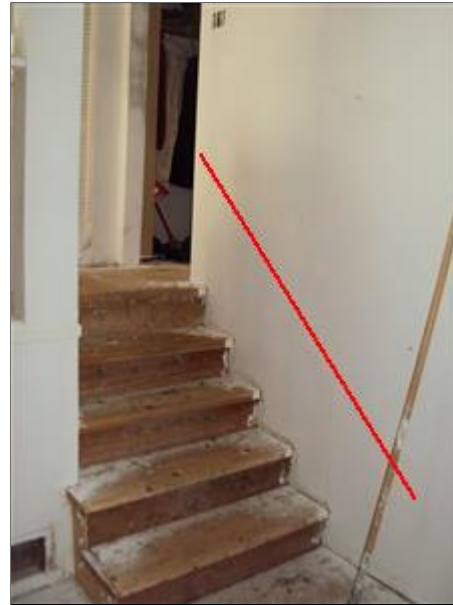
4.3 Picture 2 Missing Handrail

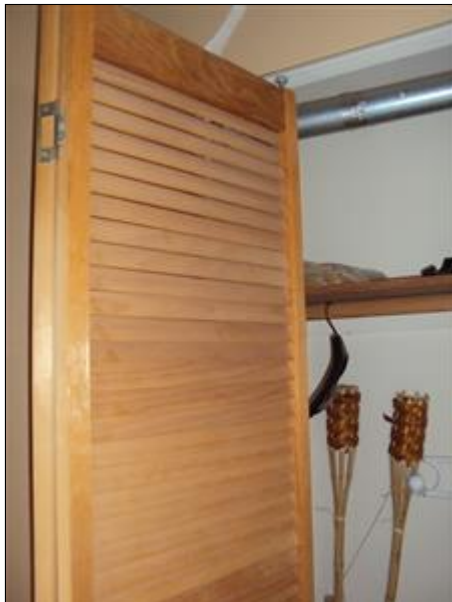
(1) There are several doors throughout the home that are in need of either repair or replacement.

4.5 Picture 1 Non Operational Door

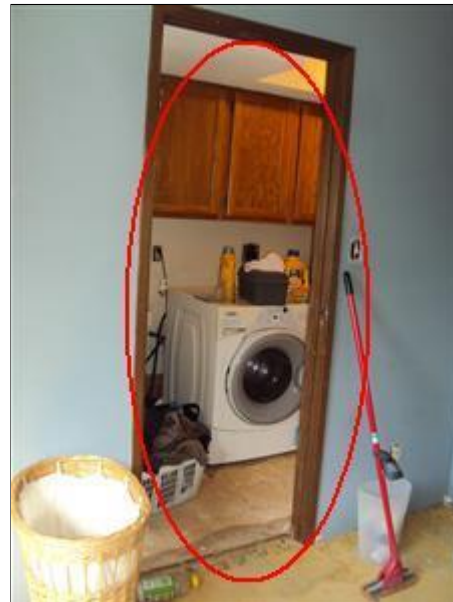
4.5 Picture 2 Missing Door

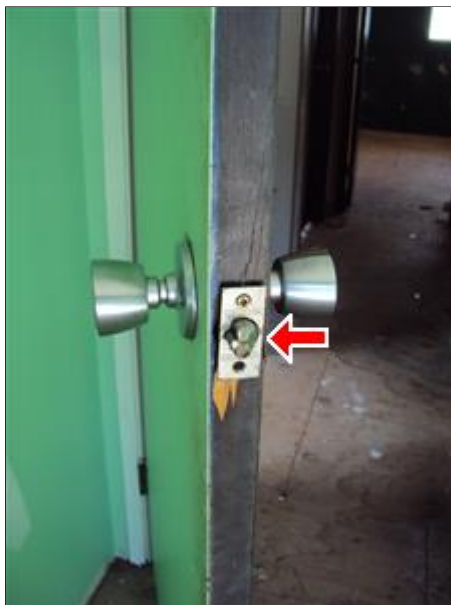
(2) The closing mechanism on this interior door is broken and should be replaced.

4.5 Picture 3 Broken Mechanism

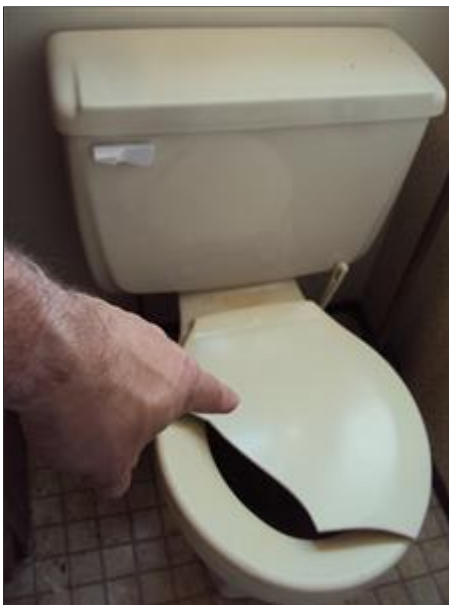
(1) The lid on this toilet is broken and the toilet itself is loose. I found no evidence of water ingress and suspect either the securing bolts are loose or the toilet seal is beginning to fail.

6.1 Picture 1 Loose Toilet

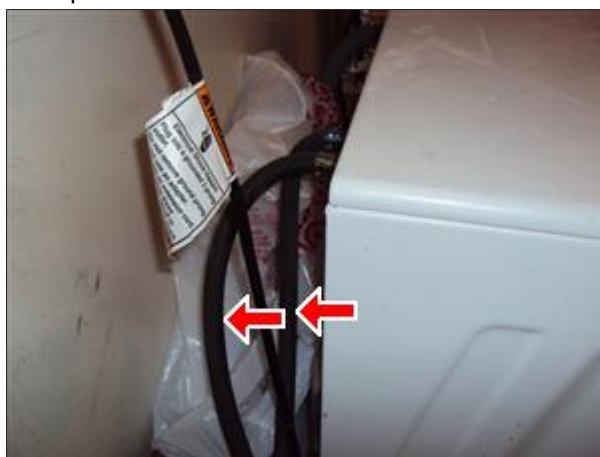
(2) Over time rubber hoses become brittle and can leak. If the leak goes unnoticed significant damage can occur to the flooring or substructure below. I recommend replacing the rubber hoses with a steel braided type to reduce the risk of a water leak. This is a minor replacement issue.

6.1 Picture 2 Washing Machine Hoses

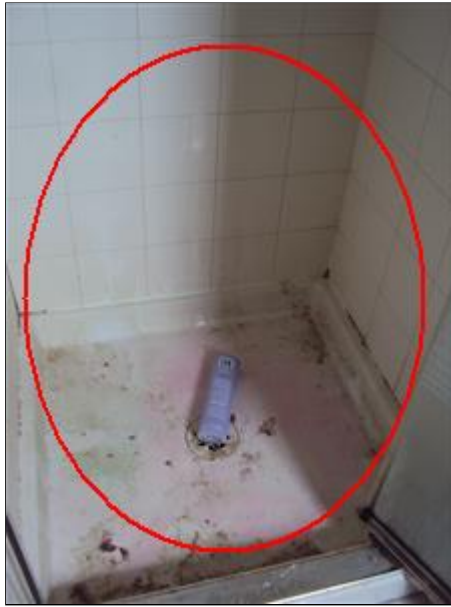
(3) Over time grout can become porous and water ingress will take place. I recommend cleaning and sealing bathroom grout once every few years depending on the amount of use the area receives. No moisture was detected at the time of then inspection and this is a preventative recommendation.

6.1 Picture 3 Clean & Seal Grout

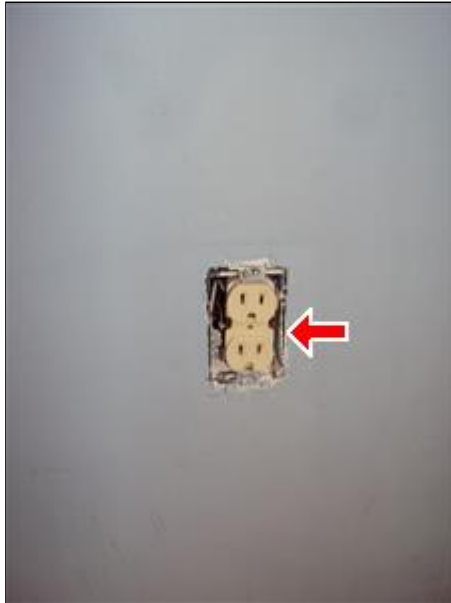
(1) There are several electrical plates that are missing throughout the home. These covers should be replaced once the renovations are completed. This is a minor but important issue.

7.3 Picture 1 Missing Cover Plate

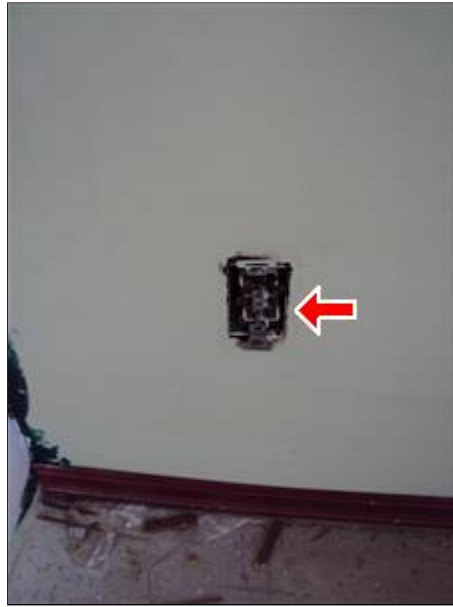
7.3 Picture 2 Exposed Outlet

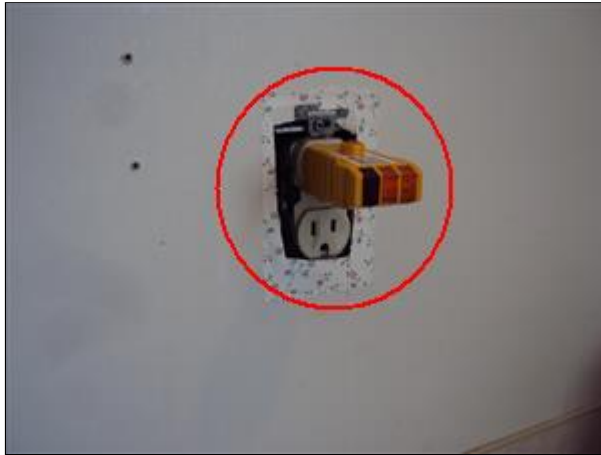
(3) Both of these outlets are non functional and should be replaced.

7.3 Picture 3 Non Operational Outlet

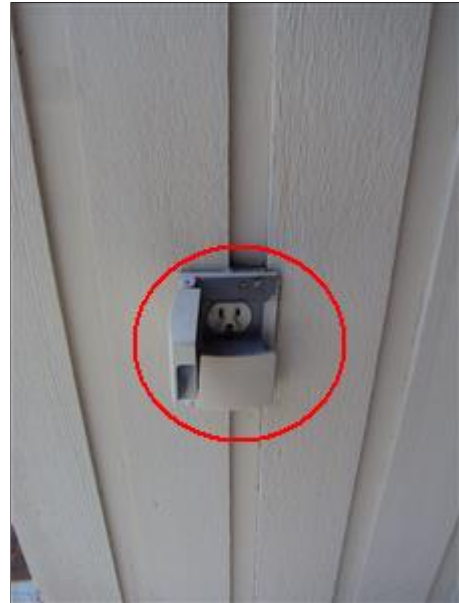
7.3 Picture 4 Non Operational Outlet

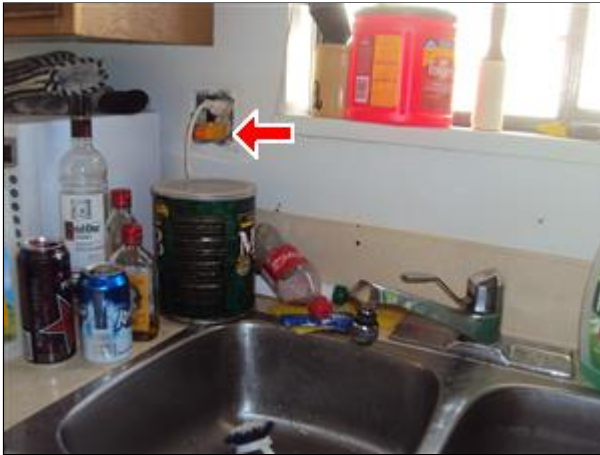
7.3 Picture 5 Not GFCI Protected

(4) Any exterior outlet or outlets that are within 3' of a water source should be GFCI protected. These outlets are not. A ground fault circuit interrupter (GFCI) is a device that shuts off an electric circuit when it detects that current is flowing along an unintended path, possibly through water or through a person. It is used to reduce the risk of electric shock. It works by measuring the current leaving the hot side of the power source and comparing it to the current returning to the neutral side. If they are not equal, this means that some of the current is flowing along an unintended path, and the GFCI shuts the power off. When the problem is corrected, the GFCI can manually be reset by pushing the reset button. There is also a test button that can be used to verify that the GFCI works. It is recommended to test GFCIs at least once a month. This is a minor but important replacement issue.

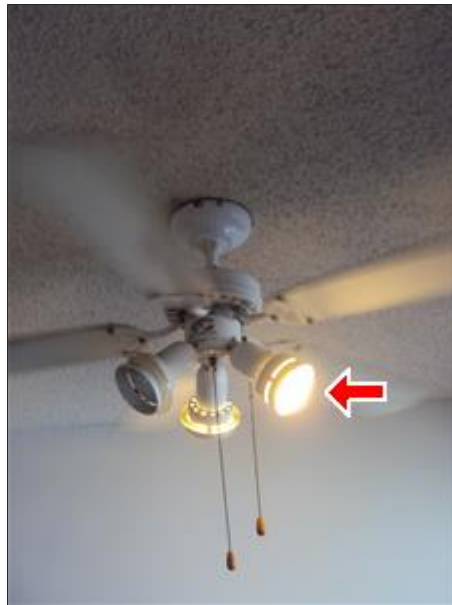
7.3 Picture 7 Loose Fixtures

(5) Many of the fans throughout the home are loose and should be properly secured to ensure they do not pull themselves from their anchors.

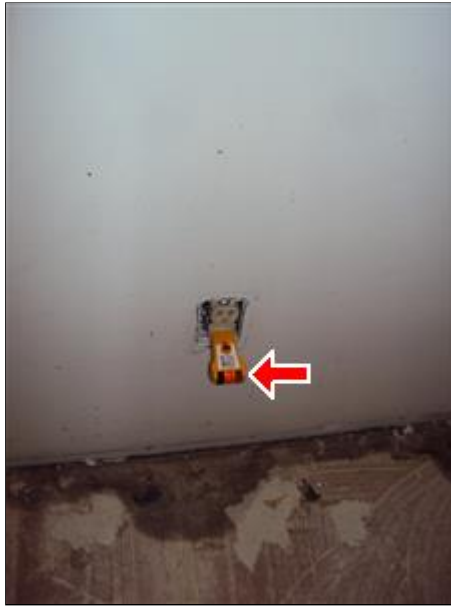
7.3 Picture 8 Open Outlet

(6) This electrical outlet reads "Open" meaning the neutral wire is not properly connected. This was an error during installation and can easily be corrected.

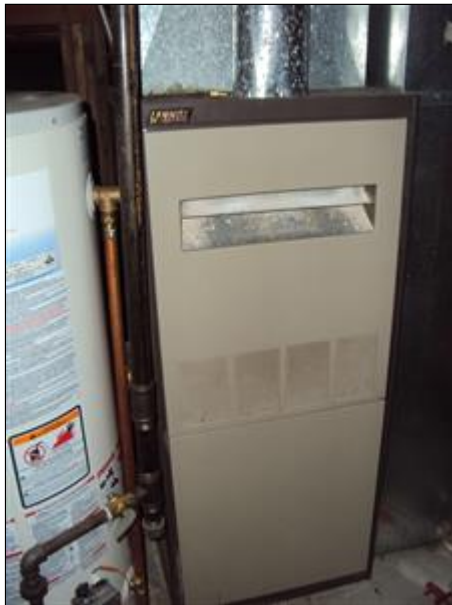
8.0 Picture 1 Lennox Furnace

The Lennox furnace is original to the home. Generally speak furnaces last between 20-30 years depending on the quality of the unit and the maintenance it receives. This furnace has come to the end of its useful life and should be replaced. There is evidence of corrosion, damage to the heat exchanger and back drafting. Please install a carbon monoxide detector immediately.

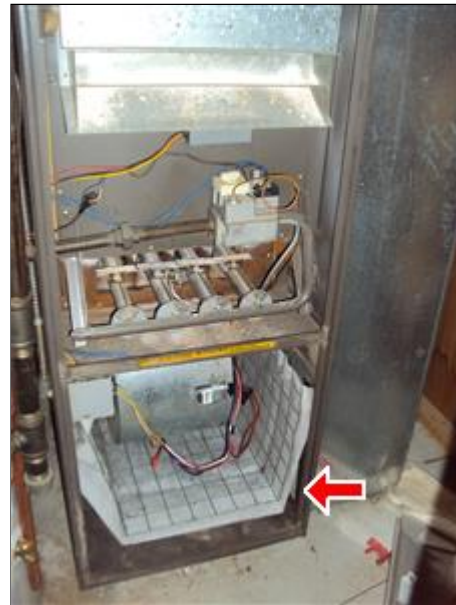
8.0 Picture 2 Filter Location

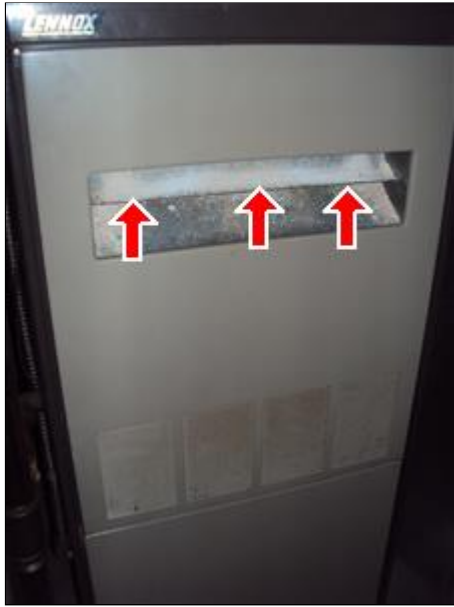
8.0 Picture 3 Backdrafting

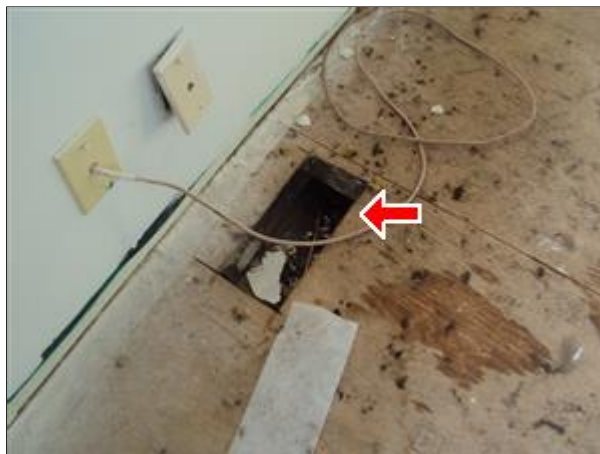
8.3 Picture 1 Missing Vent

(1) Please replace this vent cover once renovations are complete.

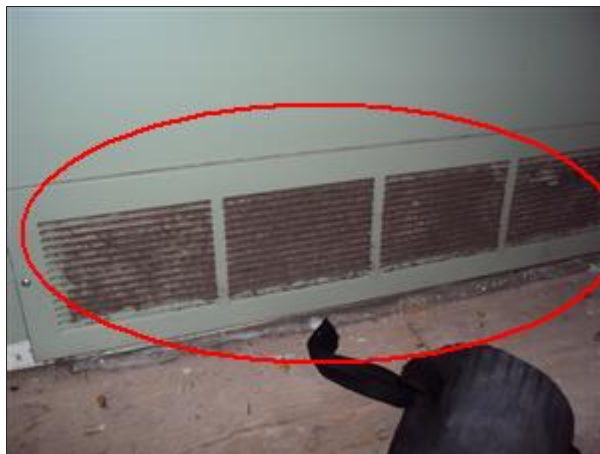
8.3 Picture 2 Clean Ducts

(2) Periodically cleaning the furnace ducts will improve the air quality in the home. This would be considered regular maintenance.

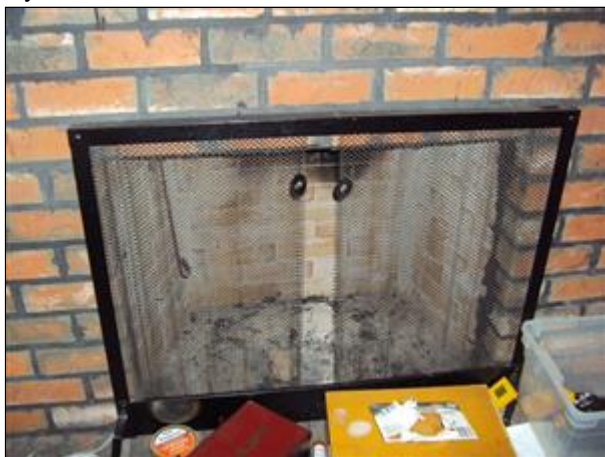
8.6 Picture 1 Downstairs Fireplace

I highly recommend having the fireplaces cleaned annually to prevent the possibility of creosote build up. Creosote is a natural by product of burning wood. The build up of creosote will potentially create a chimney fire if not cleaned regularly.

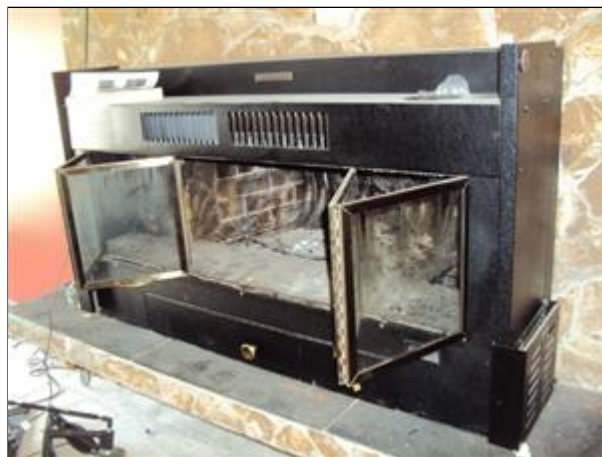
8.6 Picture 2 Main Level Fireplace
