# Pre-Inspection Report

11818 Dorcas Street  
Omaha, Nebraska 68144

| <b>2</b> | <b>Home Inspection Report</b> ..... | <b>4</b> |
| | Harvest Home Inspections September 11, 2026 | |

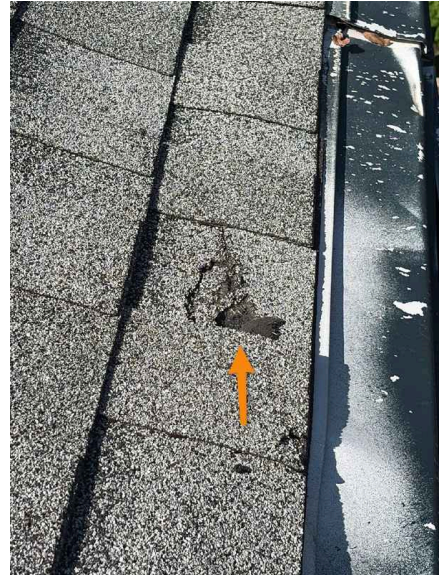
##### **DAMAGED (GENERAL)**

Roof coverings showed moderate damage. Recommend a qualified roofing professional evaluate and repair.

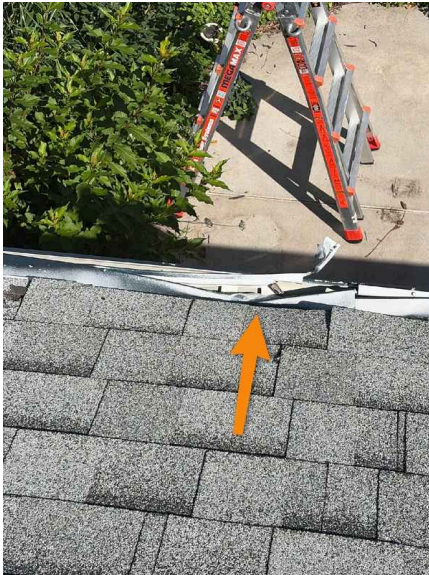
#### 2.2.1 Roof Drainage Systems

##### **GUTTER DAMAGED**

Gutters were damaged. This can result in excessive moisture in the soil at the foundation, which can lead to foundation/structural movement. Recommend a qualified contractor evaluate and repair.

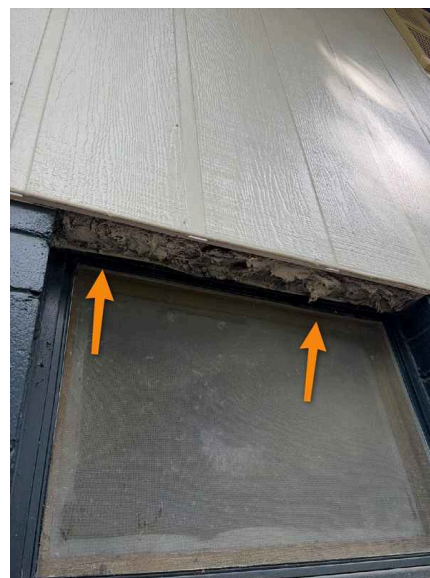
##### **MISSING TRIM**

Trim is missing from the exterior siding and flashing area. This exposes underlying materials to weather and moisture infiltration, potentially leading to water damage and deterioration.

Contact a qualified professional.

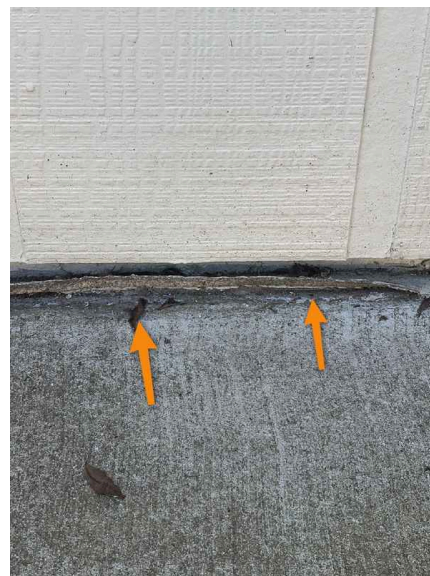
#### 3.2.1 Walkways, Patios & Driveways

##### **CONCRETE SEALING DETERIORATING**

Sealant on expansion joints deteriorating. Recommend re-sealing of joints.

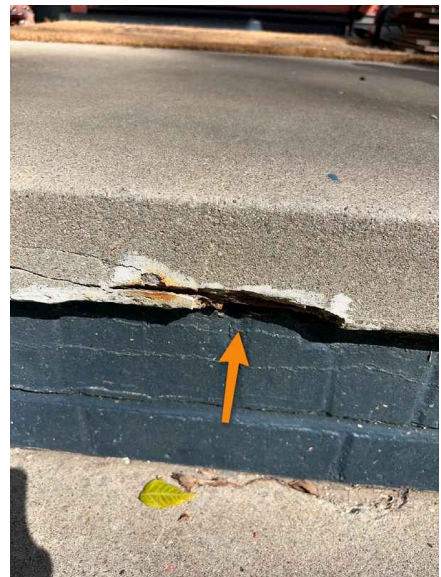
## 3.3.2 Decks, Balconies, Porches &amp; Steps

**CONCRETE CRACKING**

Contact a qualified professional.

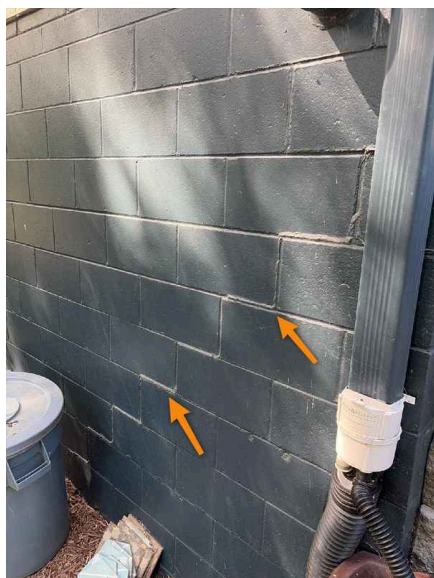
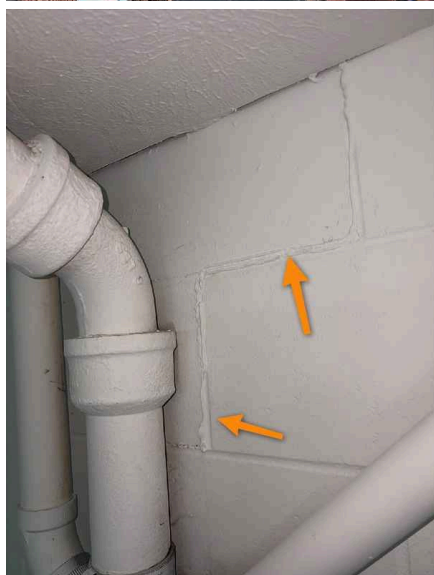
4.1.1 Foundation

#### **FOUNDATION WALL MOVEMENT**

Foundation wall has evidence of movement. Recommend evaluation by foundation specialist.

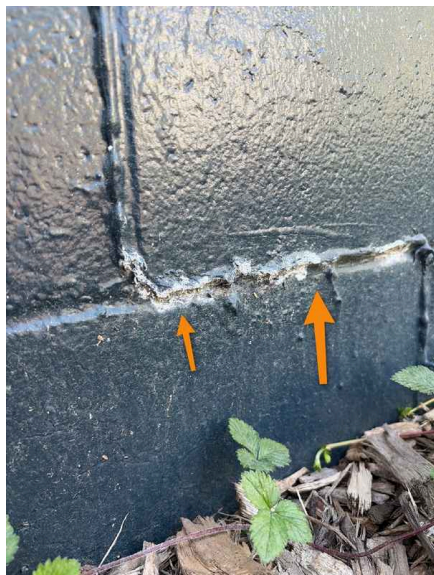
#### 4.1.2 Foundation

### **CORROSION ON MASONRY BLOCK**

Corrosion observed on masonry block foundation during inspection. This deterioration can weaken the structural integrity of the foundation over time and may indicate moisture intrusion issues. A masonry contractor should evaluate the extent of damage and recommend appropriate repairs or protective measures.

Contact a qualified professional.

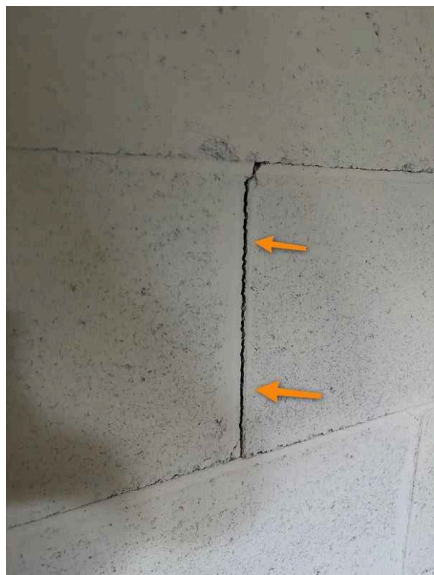
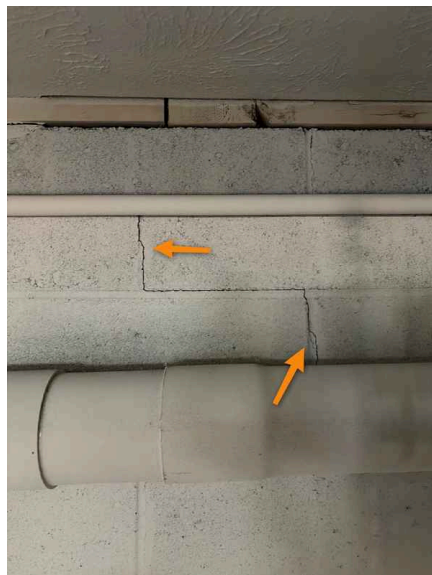
#### 4.1.3 Foundation

### FOUNDATION WALL CRACK

A crack was observed in the foundation wall during inspection. Foundation cracks can indicate settlement, moisture infiltration, or structural stress, and may allow water entry into the basement. A foundation contractor should evaluate the crack's pattern, width, and depth to determine if it requires repair or monitoring.

Contact a qualified professional.

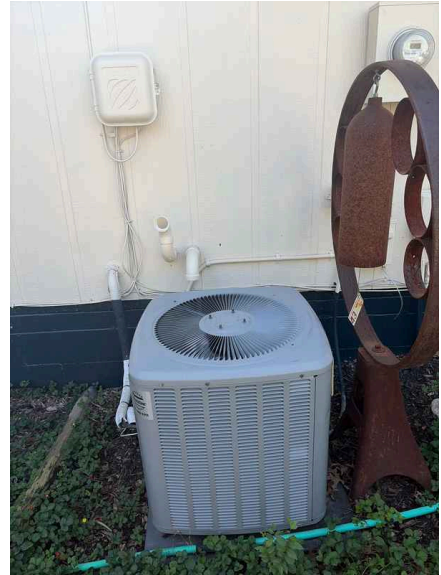
Concrete pad supporting the outdoor condensing unit is not level. This can cause accelerated deterioration of components. Recommend licensed HVAC contractor level the unit.

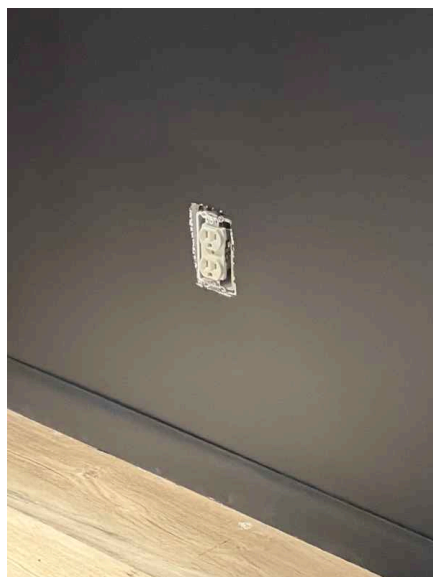
#### 8.4.1 Lighting Fixtures, Switches & Receptacles

##### **COVER PLATES MISSING**

One or more receptacles are missing a cover plate. This causes short and shock risk. Recommend installation of plates.

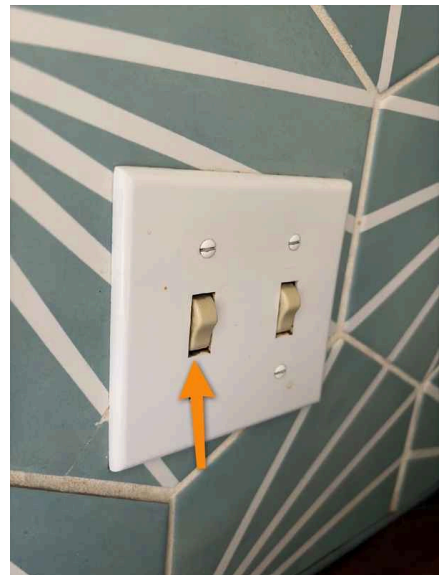
Switch not working. Recommend evaluation from qualified electrician

Contact a qualified electrical contractor.

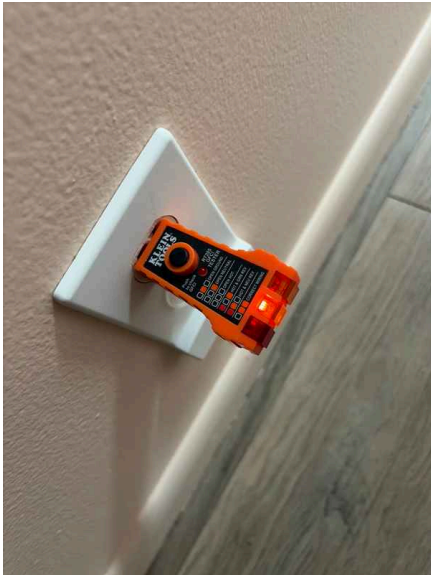
## 8.4.4 Lighting Fixtures, Switches &amp; Receptacles

Open ground detected in electrical receptacle during testing. This indicates a missing or broken ground wire connection, which eliminates the safety ground protection for that outlet. An electrical contractor should inspect and repair the outlet to restore proper grounding.

Contact a qualified professional.

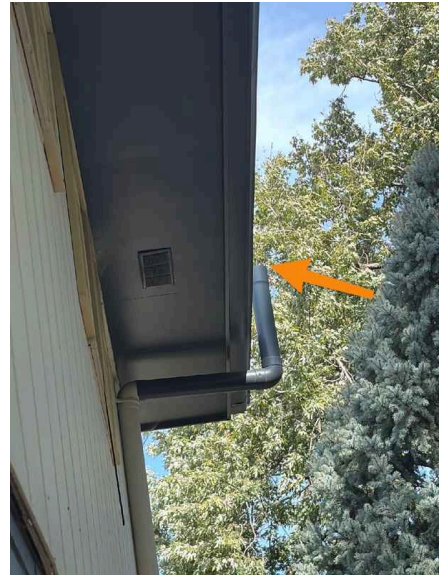
#### 9.3.1 Ventilation

##### **MISSING BATHROOM EXHAUST FAN CAP**

The bathroom exhaust fan is missing its termination cap. Install a proper vent cap to prevent outdoor air, pests, and moisture from entering the ductwork.

Contact a qualified professional.

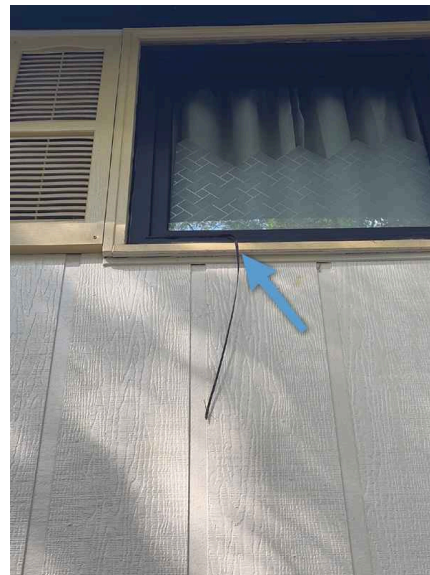
##### CAULK FAILING

Caulking on interior window cracking. Recommend resealing to help efficiency.

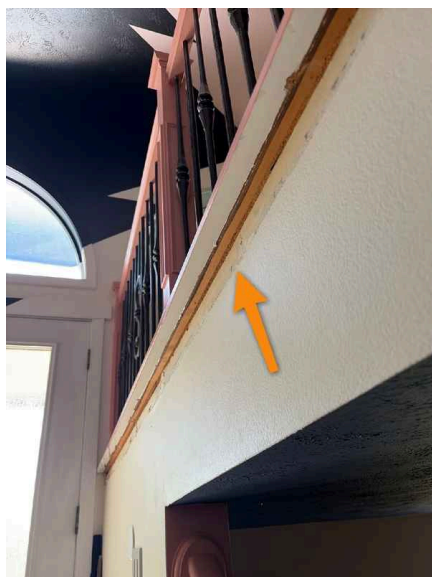
#### 10.4.1 Walls

##### MISSING INTERIOR TRIM

Interior trim is missing from one or more wall areas. Have a carpentry contractor assess the scope and provide repair or replacement estimates.

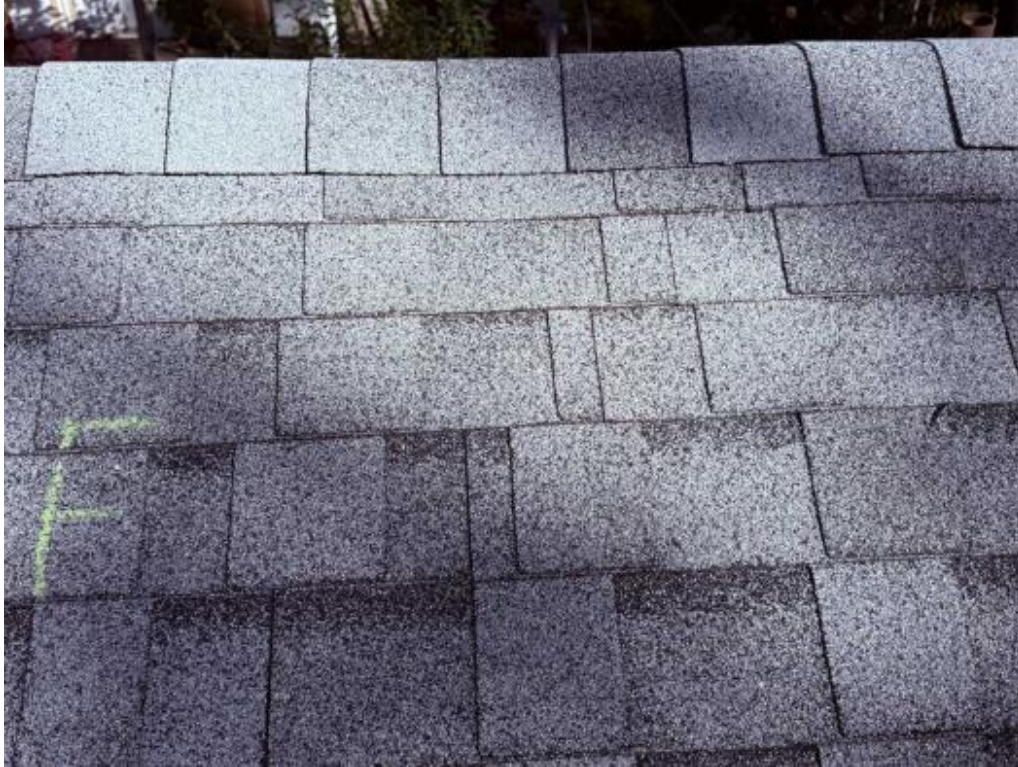
## 17-Front slope

No visible storm related damage to the roof

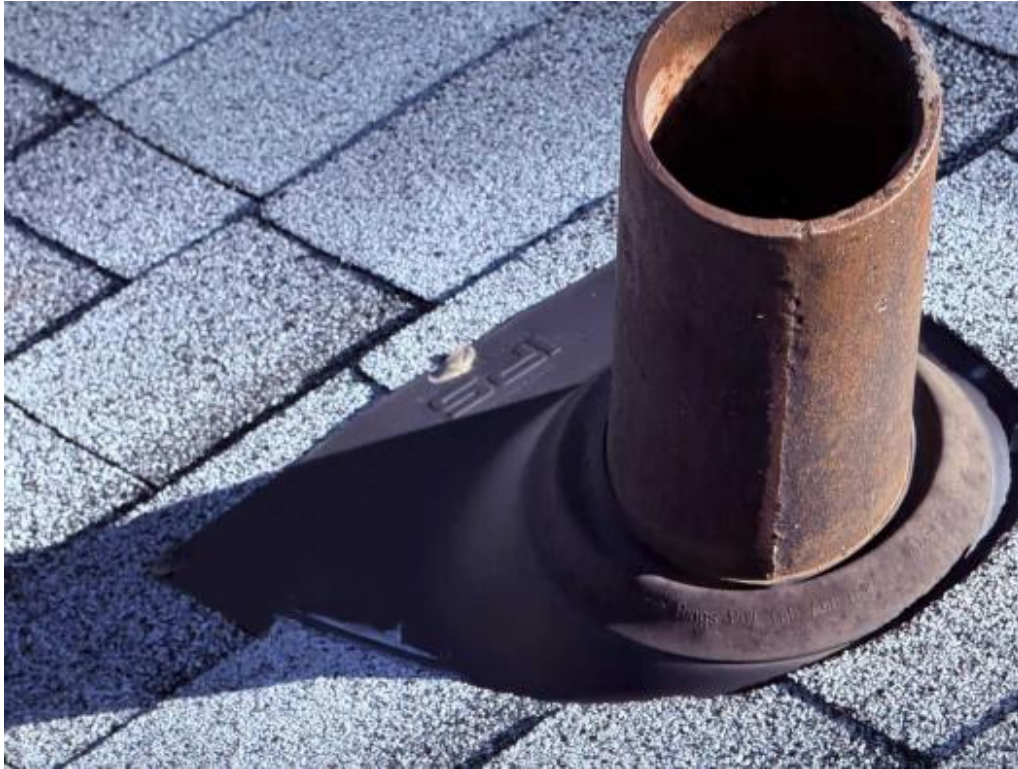
## 27-Back slope

No visible storm related damage to the pipe jack

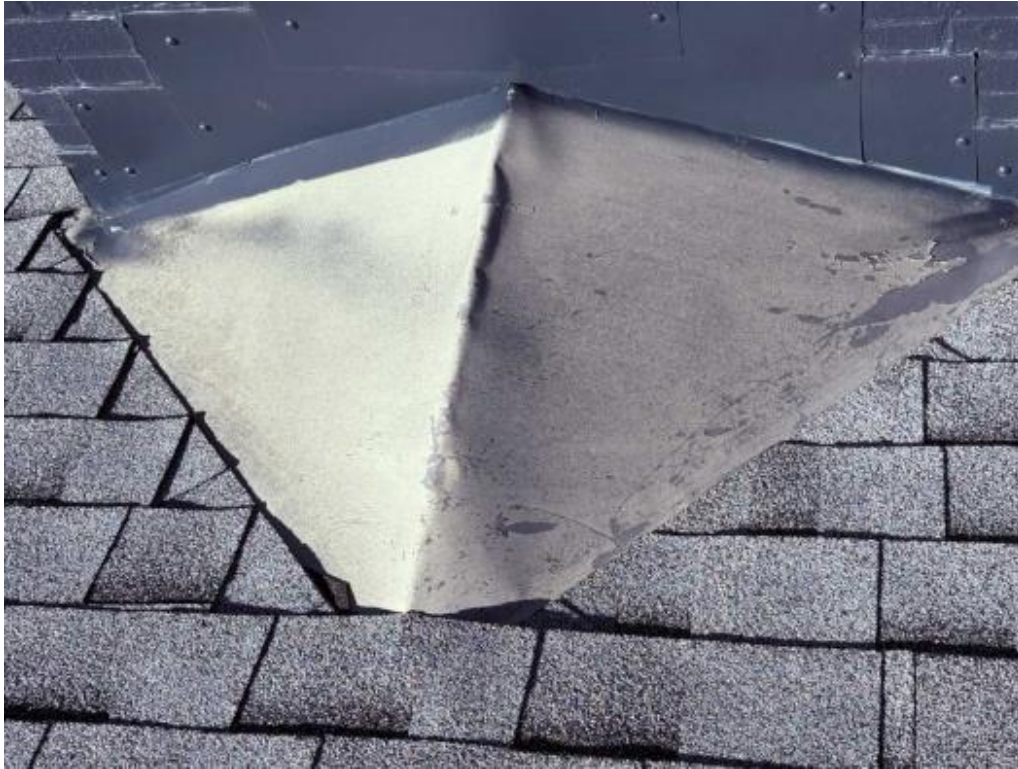
## 33-Left slope

No visible storm related damage to the chimney flashing

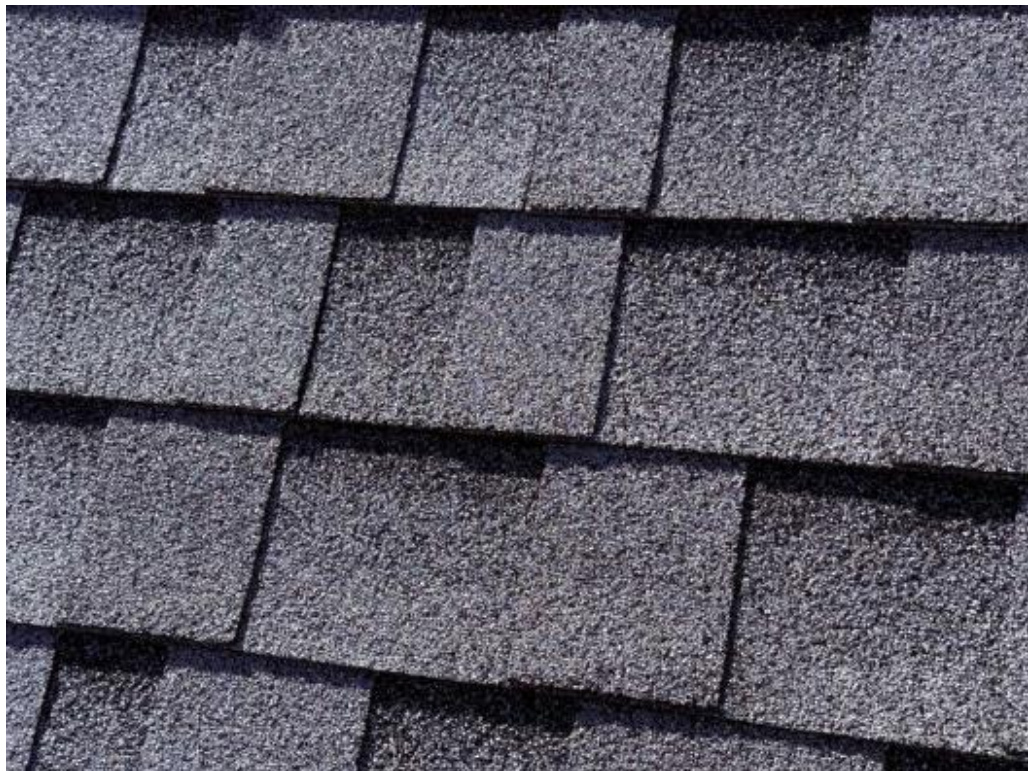
**39-Rear slope**

No visible storm related damage to the roof

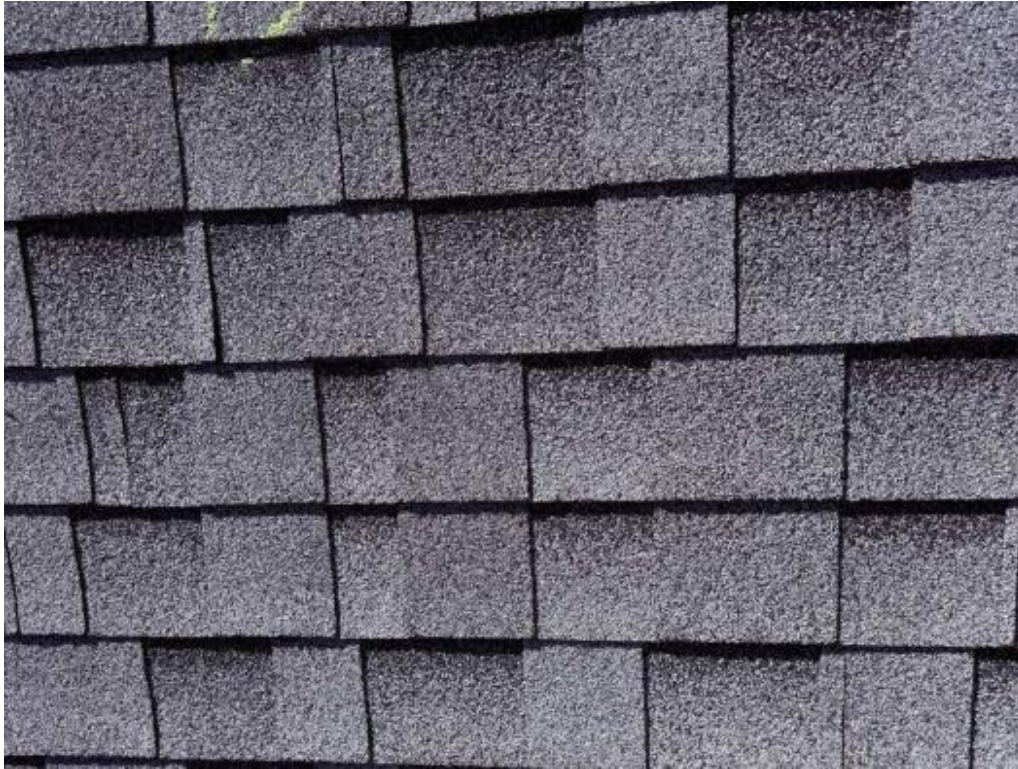
## 41-Rear slope

No visible storm related damage to the roof

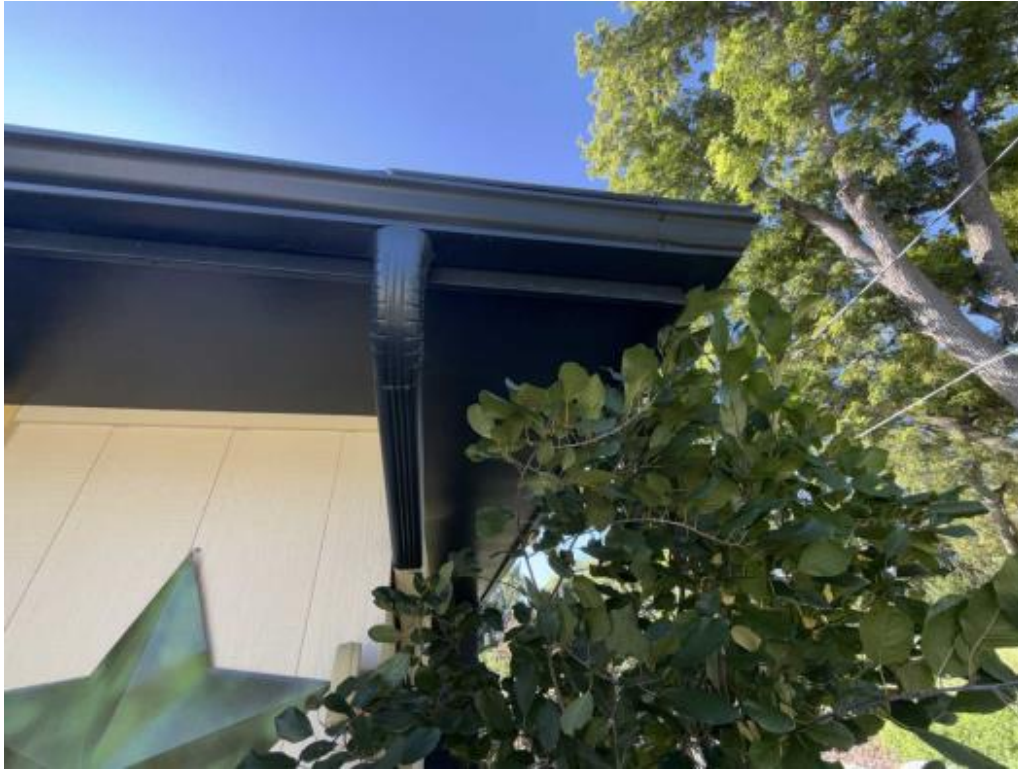
## 57-Rear elevation

The downspout is slight separated from the gutters

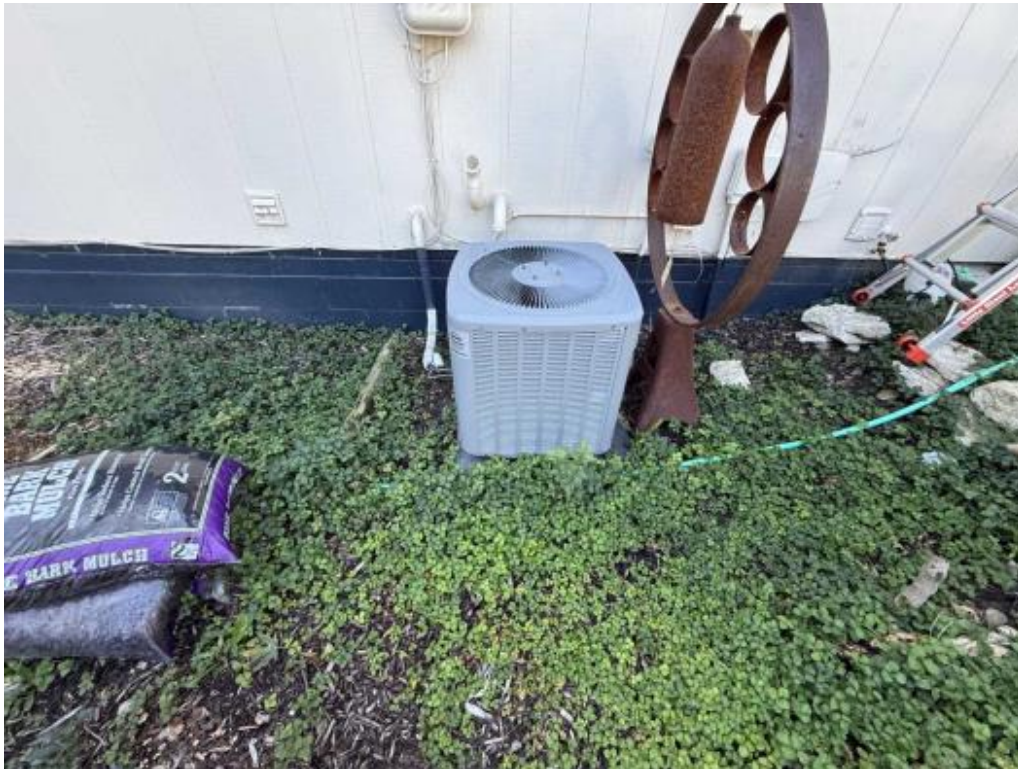
## 61-Rear elevatin

No visible related damage to the a/c unit
