### Test Report EN2477

| VIBRATION TEST REPORT | |
| EQUIPMENT TESTED | Four Button-fix Type 1 Metal |

**LABORATORY TESTING OF BUTTON- FIX  
SYSTEM - TYPE 1 - METAL**

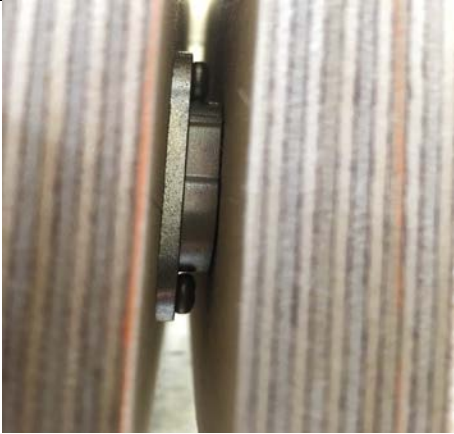
Four Button-fix Type 1 Metal quick release fasteners were attached to two pieces of plywood 70cm x 70cm x 1.8cm at 60cm centres. The total weight of buttons and outer plywood was 5.7Kgs.

| Side view of Button-fix assembly | Button-fix latch |

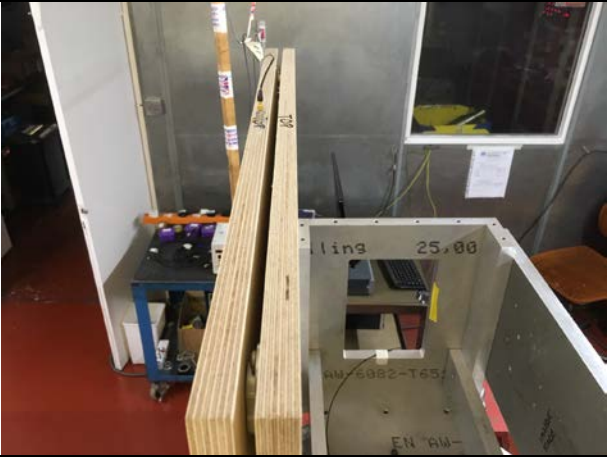
| Top view of items under test | Plywood showing the four latches |

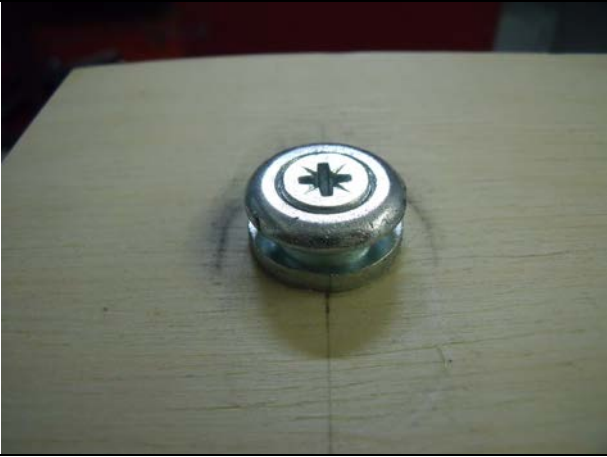
| Button | |

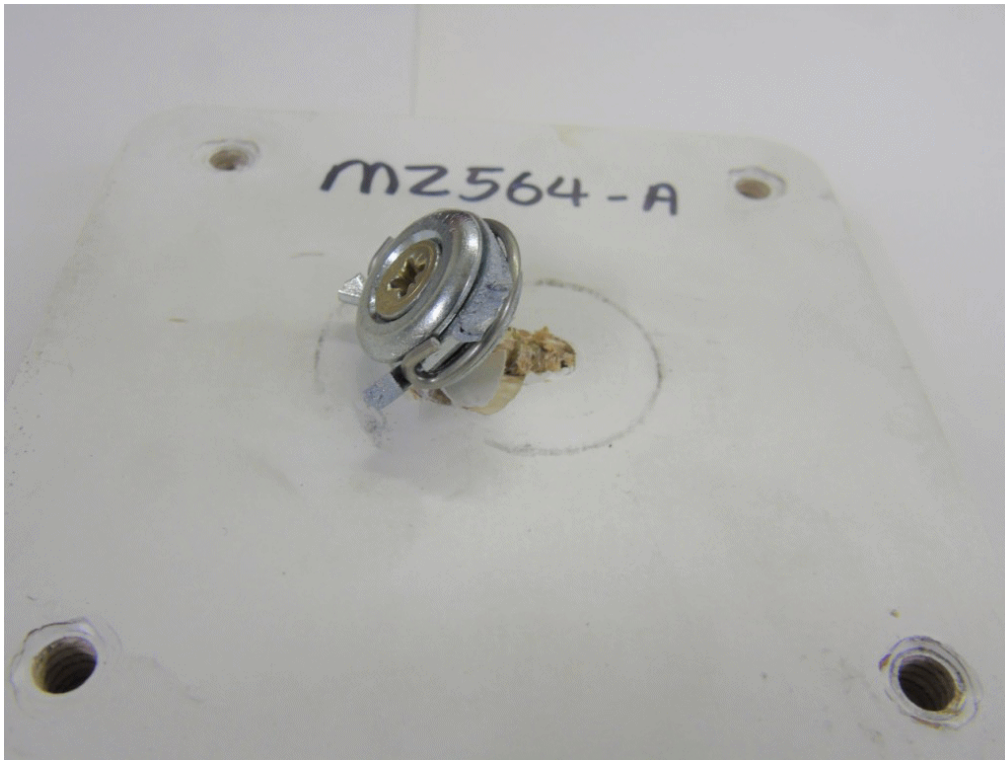
**Photograph 1** A view showing the general condition of the button after a vertical shear test on a type 1 - metal fixing.

| Sample Reference | Load Direction | Maximum Failure Load (kN) | Comments |
|---|---|---|---|
| MZ 564-A | X - Vertical Shear<br>Surface Mounted | 2.940<br>(299.8 kg) | Fractured in zinc<br>& pulled out screw |
| MZ 564-B | X - Vertical Shear<br>Surface Mounted | 3.405<br>(347.2 kg) | Fractured in zinc<br>& pulled out screw |
| MZ 564-C | X - Vertical Shear<br>Surface Mounted | 3.450<br>(351.8 kg) | Fractured in zinc<br>& pulled out screw |

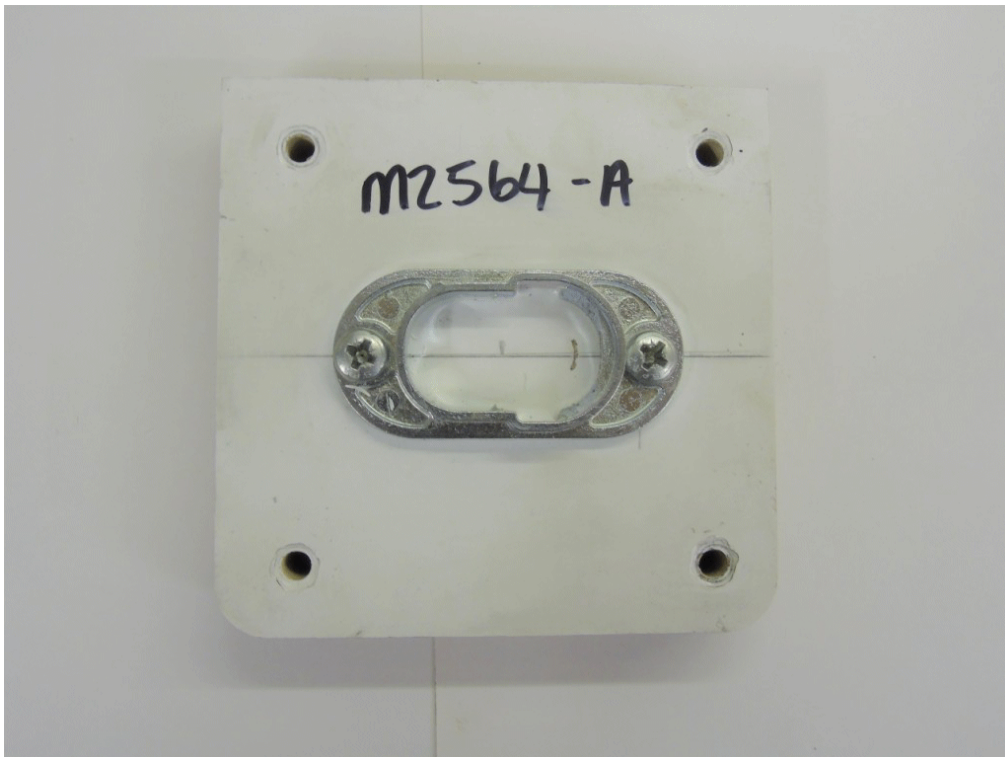
**Photograph 2** A view showing the general condition of the fixing after a vertical shear test on a type 1 - metal fixing.

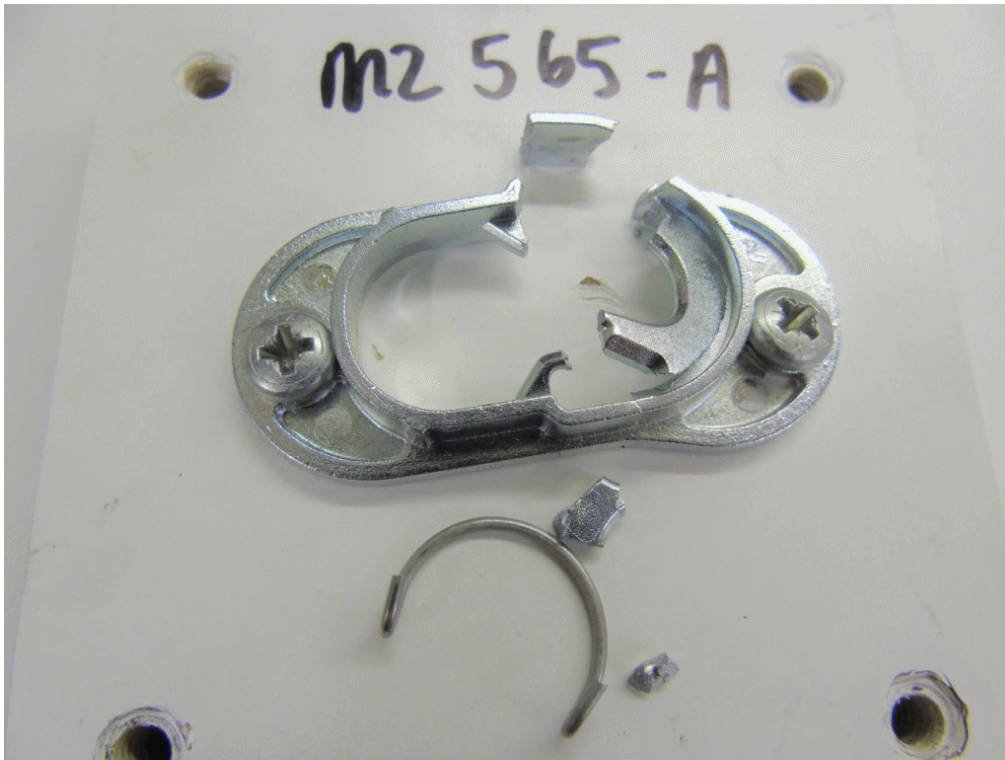
**Photograph 3** A view showing the general condition of the fixing after a horizontal shear test on a type 1 - metal fixing.

| Sample Reference | Load Direction | Maximum Failure Load (kN) | Comments |
|---|---|---|---|
| MZ 565-A | Y - Horizontal Side Shear<br>Surface Mounted | 3.680<br>(375.2 kg) | Fix plate fractured<br>Fractured in zinc<br>& pulled out screw |
| MZ 565-B | Y - Horizontal Side Shear<br>Surface Mounted | 3.485<br>(355.4 kg) | Fractured in zinc<br>& pulled out screw |
| MZ 565-C | Y - Horizontal Side Shear<br>Surface Mounted | 3.055<br>(311.5 kg) | Fractured in zinc<br>& pulled out screw |

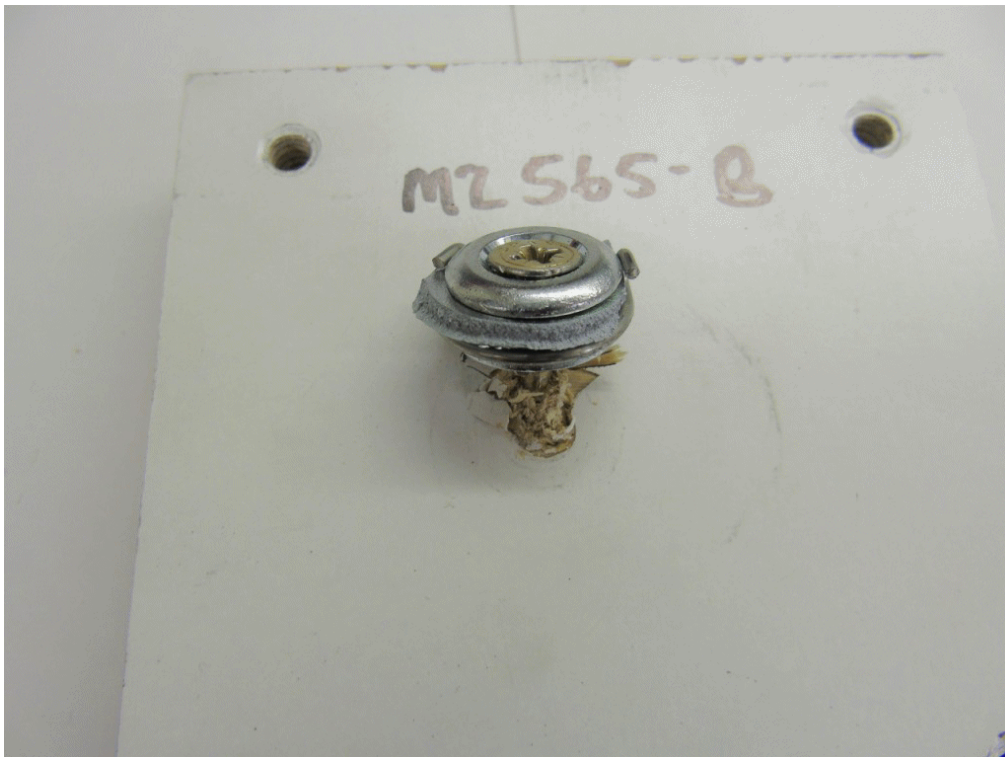
**Photograph 4** A view showing the general condition of the button after a horizontal shear test on a type 1 - metal fixing.

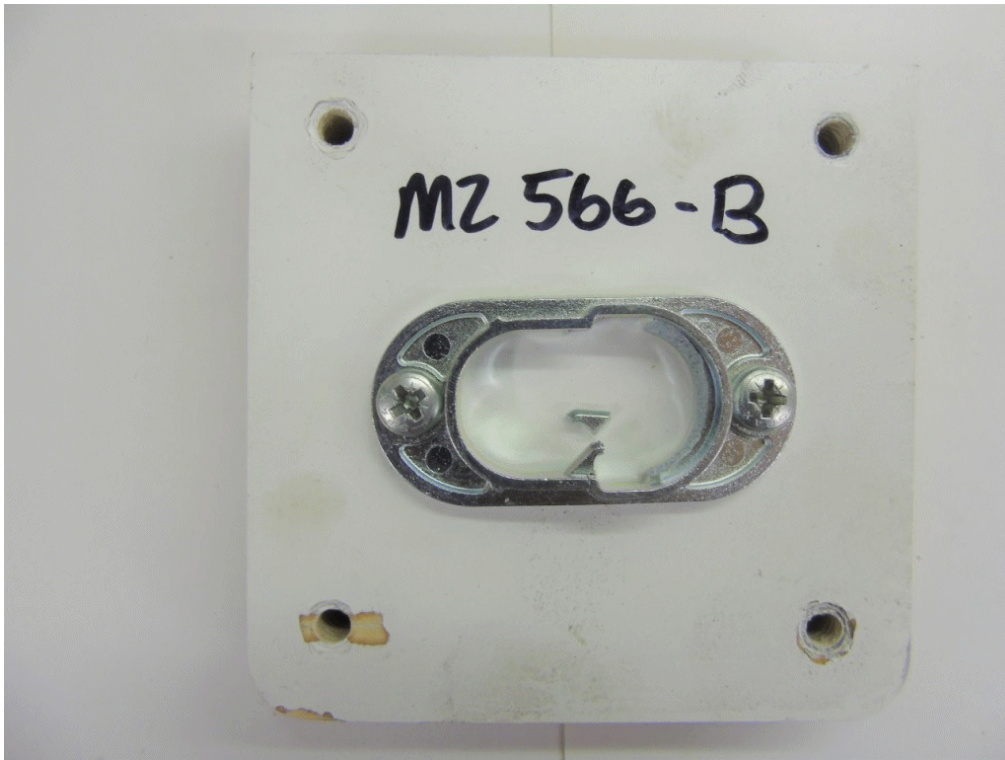
**Photograph 5** A view showing the general condition of the fixing after a pull apart test on a type 1 - metal fixing.

| Sample Reference | Load Direction | Maximum Failure Load (kN) | Comments |
|---|---|---|---|
| MZ 566-A | Z - Pull Out from Panel<br>Surface Mounted | 2.130<br>(217.2 kg) | Fractured in zinc |
| MZ 566-B | Z - Pull Out from Panel<br>Surface Mounted | 2.105<br>(214.6 kg) | Fractured in zinc |
| MZ 566-C | Z - Pull Out from Panel<br>Surface Mounted | 2.290<br>(233.5 kg) | Fractured in zinc |

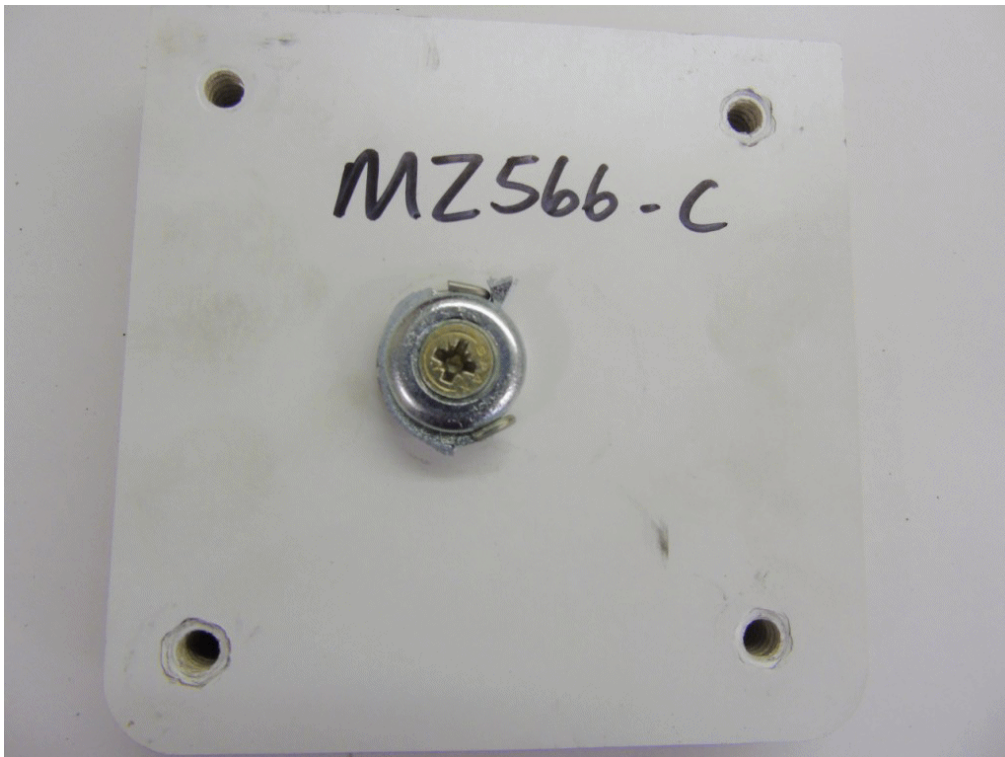
**Photograph 6** A view showing the general condition of the button after a pull apart test on a type 1 - metal fixing.
