# TROUBLESHOOTING & MAINTENANCE

## WOODFORD MANUFACTURING COMPANY

## Model 21, 24 or 26 Mild Climate Non-Freeze Area Wall Faucets

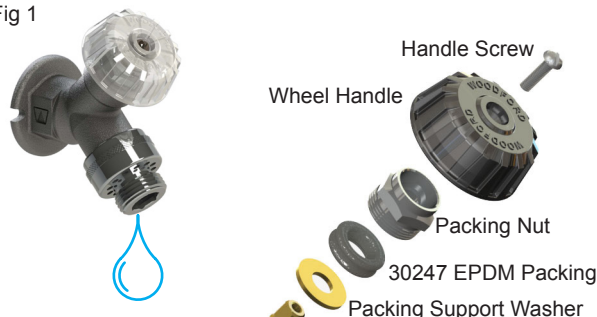
Fig 1

- **Water leaks from the nozzle when faucet is off. Fig 1**  
Valve seat (30008) Washer (Fig 2) is worn out or damaged and needs to be replaced or the Washer Screw is loose. Follow instructions below on how to remove the Operating Stem. If this does not fix the leak, the faucet may have a damaged seat and the faucet will need to be replaced.
