PARKING LOTS SAFETY

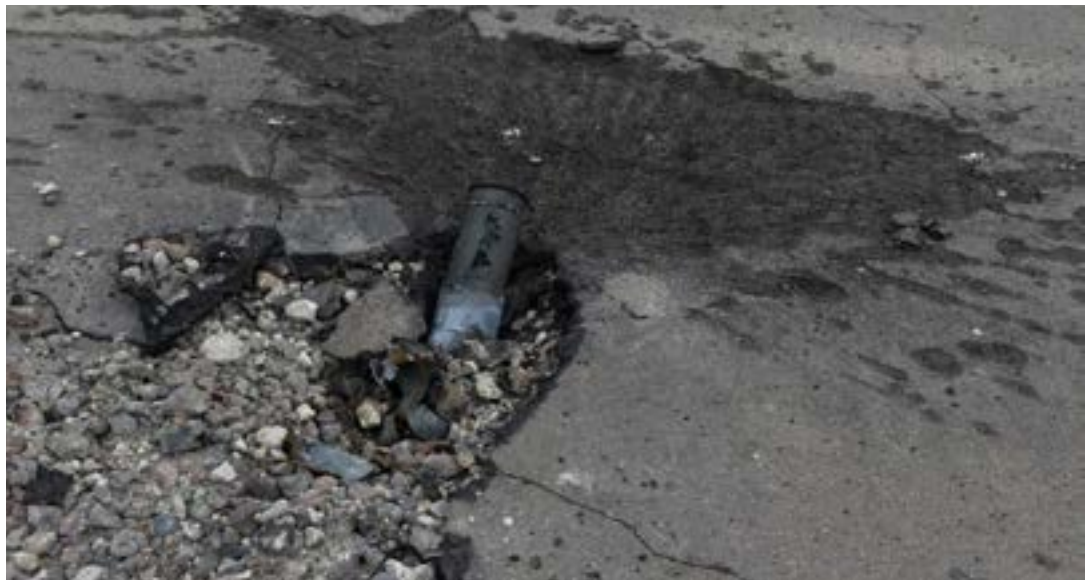
Image 1: A pothole in the pavement.

As mentioned previously, poor maintenance is one of the deficiencies we see a lot. Things like potholes, worn paint striping, loose pavement, and askew wheel stops can turn a parking lot into a hazardous place for pedestrians to traverse.

Many parking lots are part of the exit discharge portion of a means of egress, which is defined in section 3.3.90 of the NFPA 101 Life Safety Code as the portion of the means of egress between an exit and a public way. NFPA states that means of egress must be unobstructed and unimpeded at all times (7.1.10.1*). Potholes, changes in elevation, wheel stops obstructing the path, slippery conditions, etc. would all be considered an impediment or obstruction to the means of egress. This code applies in most states, including Florida.

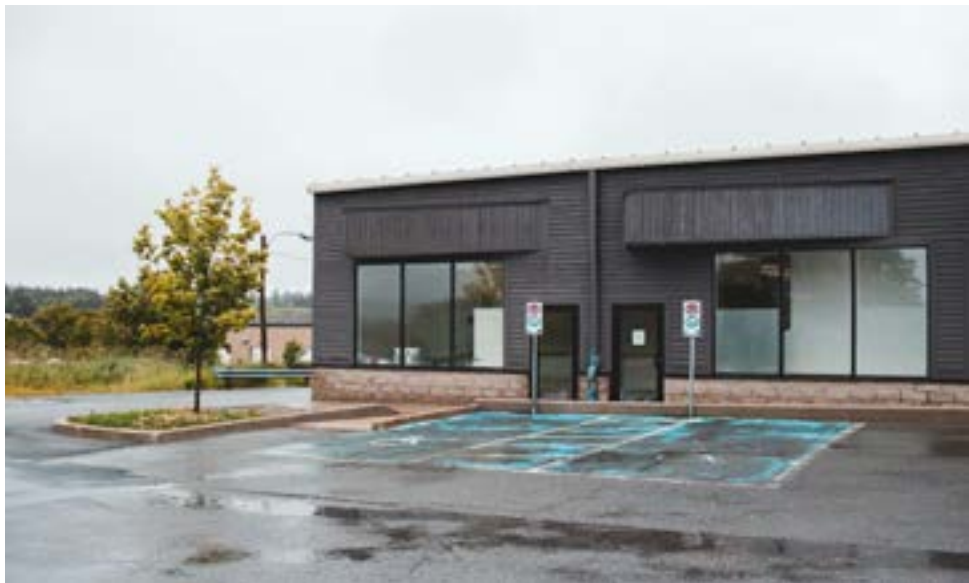
Image 2: Accessible route would require pedestrian travel behind parked vehicles into the drive aisle.

Accessible routes are required to connect all accessible elements on a site, such as parking spaces and building entrances, and are even required to connect to public sidewalks and bus stops. Accessible routes are not allowed to pass behind parked vehicles, and if they cross a drive aisle, should be conspicuously marked with a crosswalk or similar. Details about these requirements can be found in section 553.5041 of the Florida Statutes, and within sections 206 and 502 of the Florida Building Code, Accessibility. If you are outside of Florida, you can look at the 2010 ADA Standards for Accessible Design, sections 206 and 502.

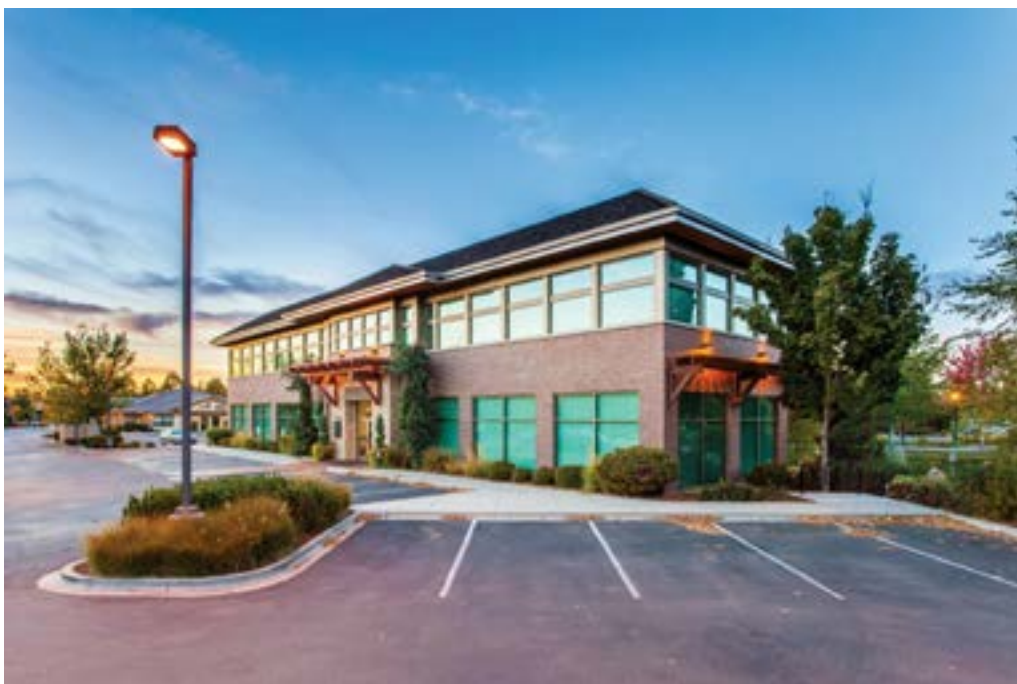
Image 3: Ample space to back out, low shrubbery to not obstruct sightlines, accessible parking connects to sidewalk.
