HISTORIC PRESERVATION COMMISSION

Case #: HPC 2018.025
Date: April 17, 2018

PRESERVATION STAFF REPORT

Site: 14 Flint Street

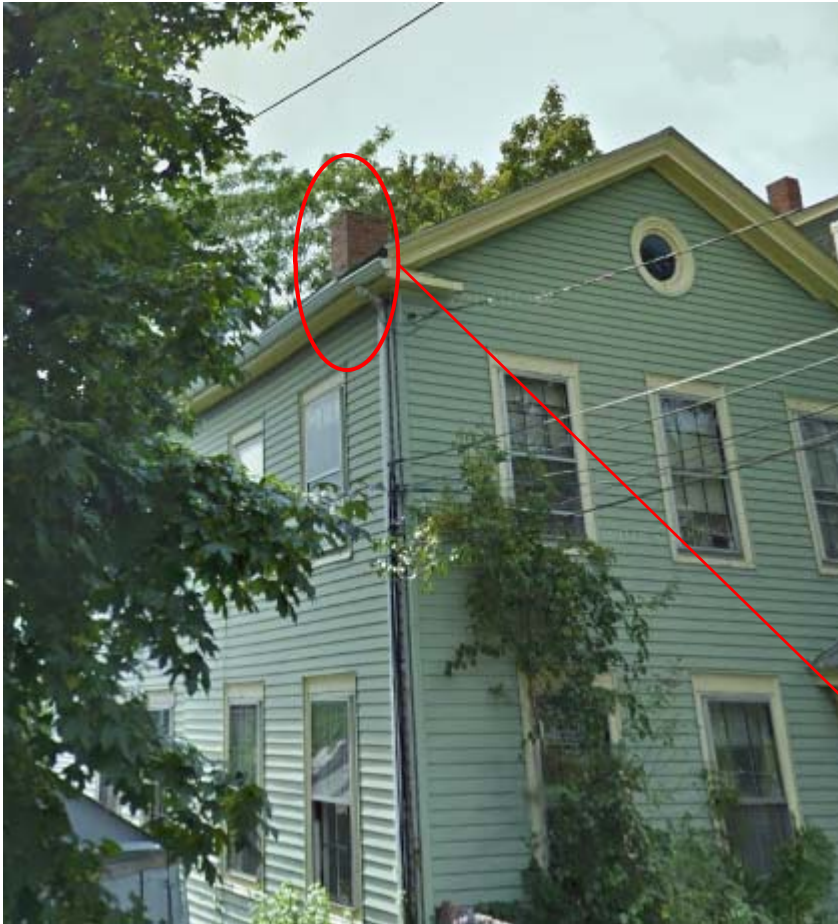
Chimney visibility

Staff finds that the removal of the chimney would be detrimental to the Flint Street Historic District and the understanding of the building within as originally constructed.

Based on the information provided and an assessment of the proposal against the Somerville LHD guidelines, Staff recommends denying a Certificate of Appropriateness to remove the chimney and replace the existing wood windows with aluminum clad double-paned and double-hung windows. Staff recommends a Certificate of Appropriateness to replace the white vinyl replacement windows with higher quality replacement windows that approximate the original c. 1850 windows. A Certificate of Non-Applicability may be issued to repair the existing wood windows and the reconstruction of the chimneys in-kind.

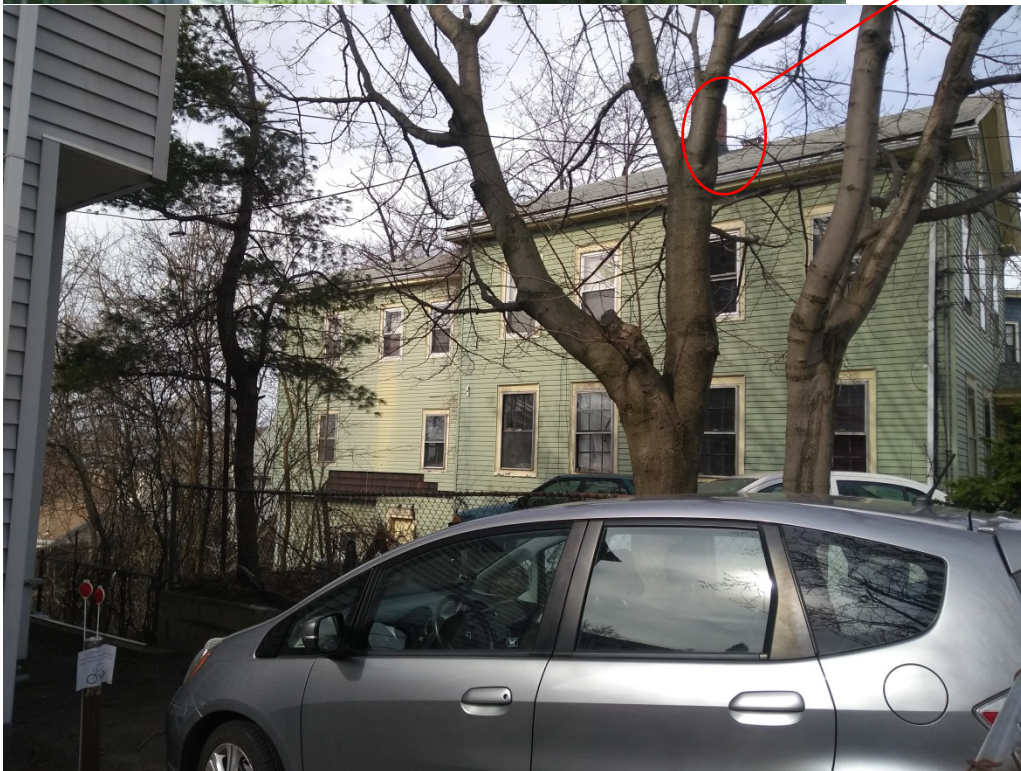
The Applicant would also like to remove the chimney to rearrange the interior of the building.

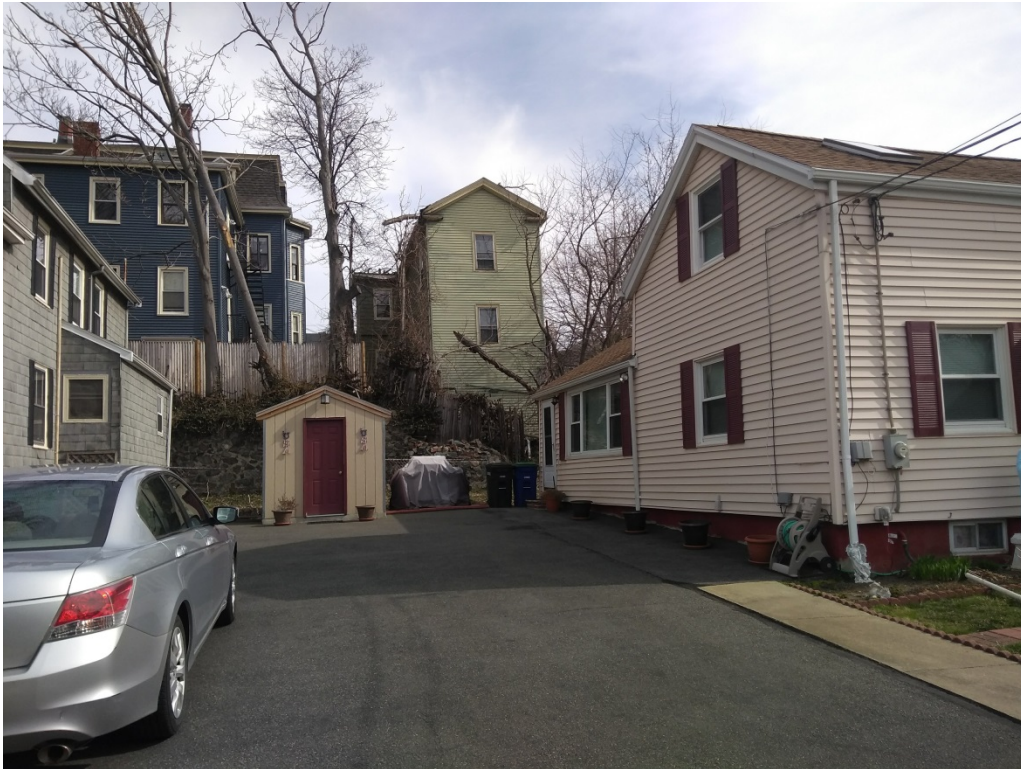
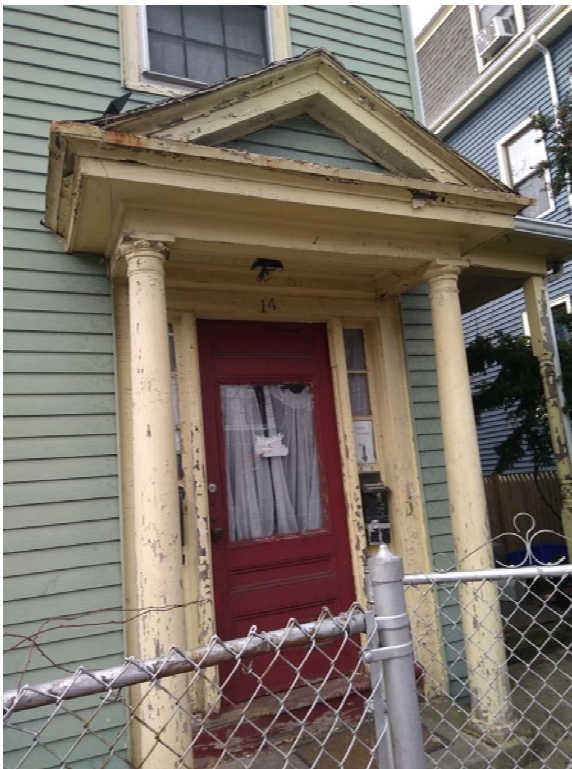
1st floor window 1

Staff finds that the existing windows on the front of the house are in poor condition with broken sash cords, missing pulleys, broken and missing muntins. While the broken and damaged components can be replicated to replace the damaged portions of the windows the question is whether these windows are damaged beyond repair and whether the proposed aluminum clad windows with differing dimensions for the stiles and rails. Pulleys and weights are replaceable. Staff finds that the windows may be reparable but would need extensive work by a qualified historic window repair person.

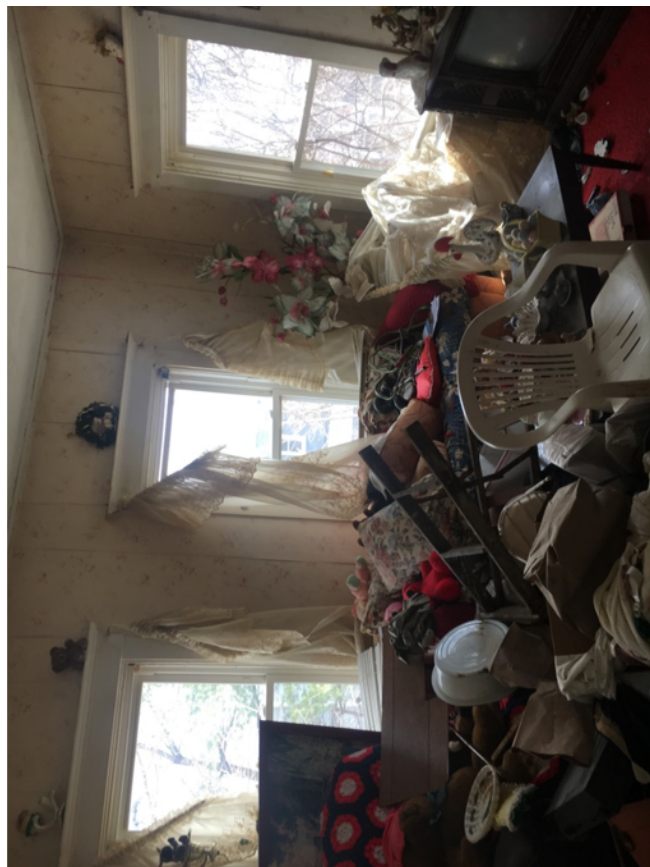
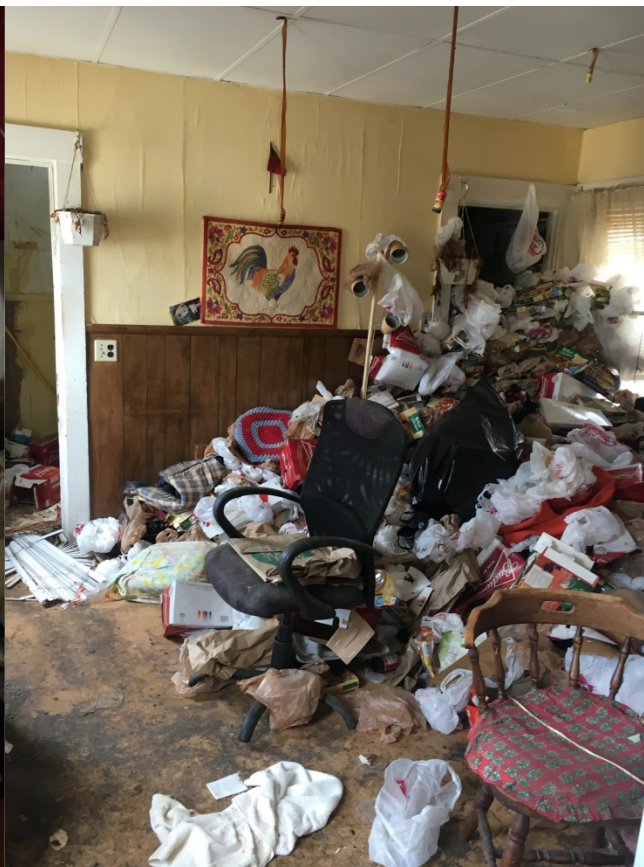
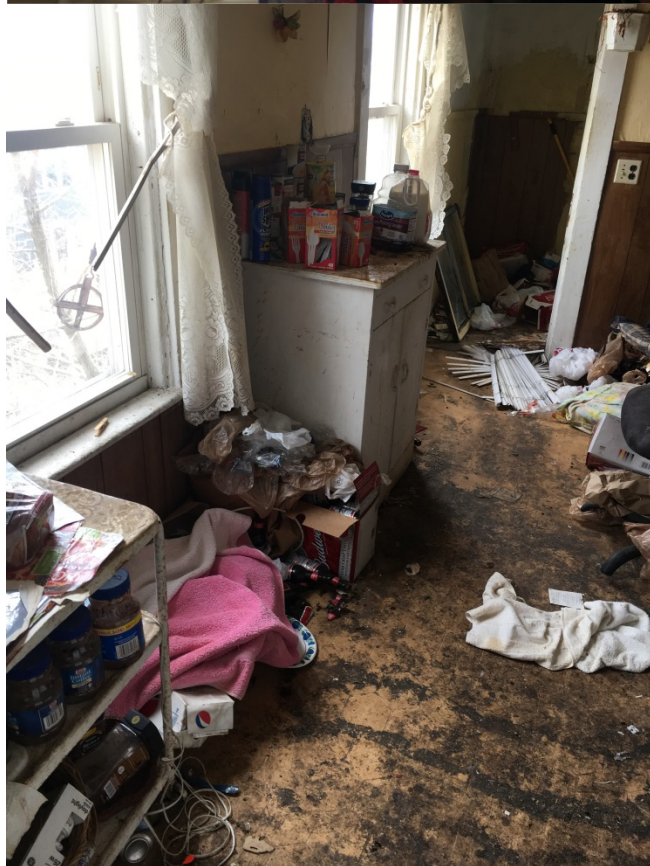
Because several of the windows have been replaced with vinyl sash, replacing these windows with the roughly equivalent to the existing replacement sash would be an upgrade to a more consistent image of the house.

Rear portion of the building, all windows are double hung white vinyl.
