**Case #:** HPC 2019.054  
**Date:** October 15, 2019

**PRESERVATION STAFF REPORT**  
*for*  
**Determination of Preferably Preserved**

**Site:** 15 Woodbine Street

**Petition:** Applicant seeks to demolish the 1 ½-story wood-framed house

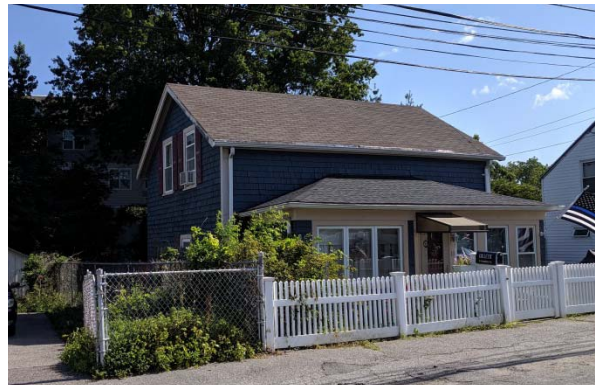
1. **Subject Property:** The subject property is a c.1890 1 ½-story wood-framed house
2. **Proposal:** The Applicant seeks to demolish the existing structure.

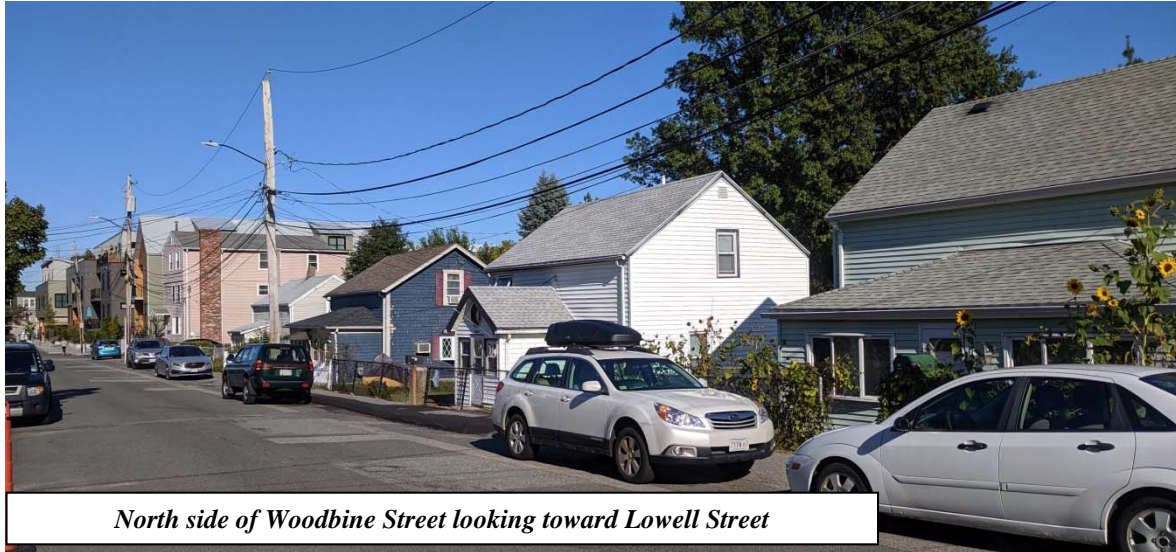
*North side of Woodbine Street looking toward Lowell Street*

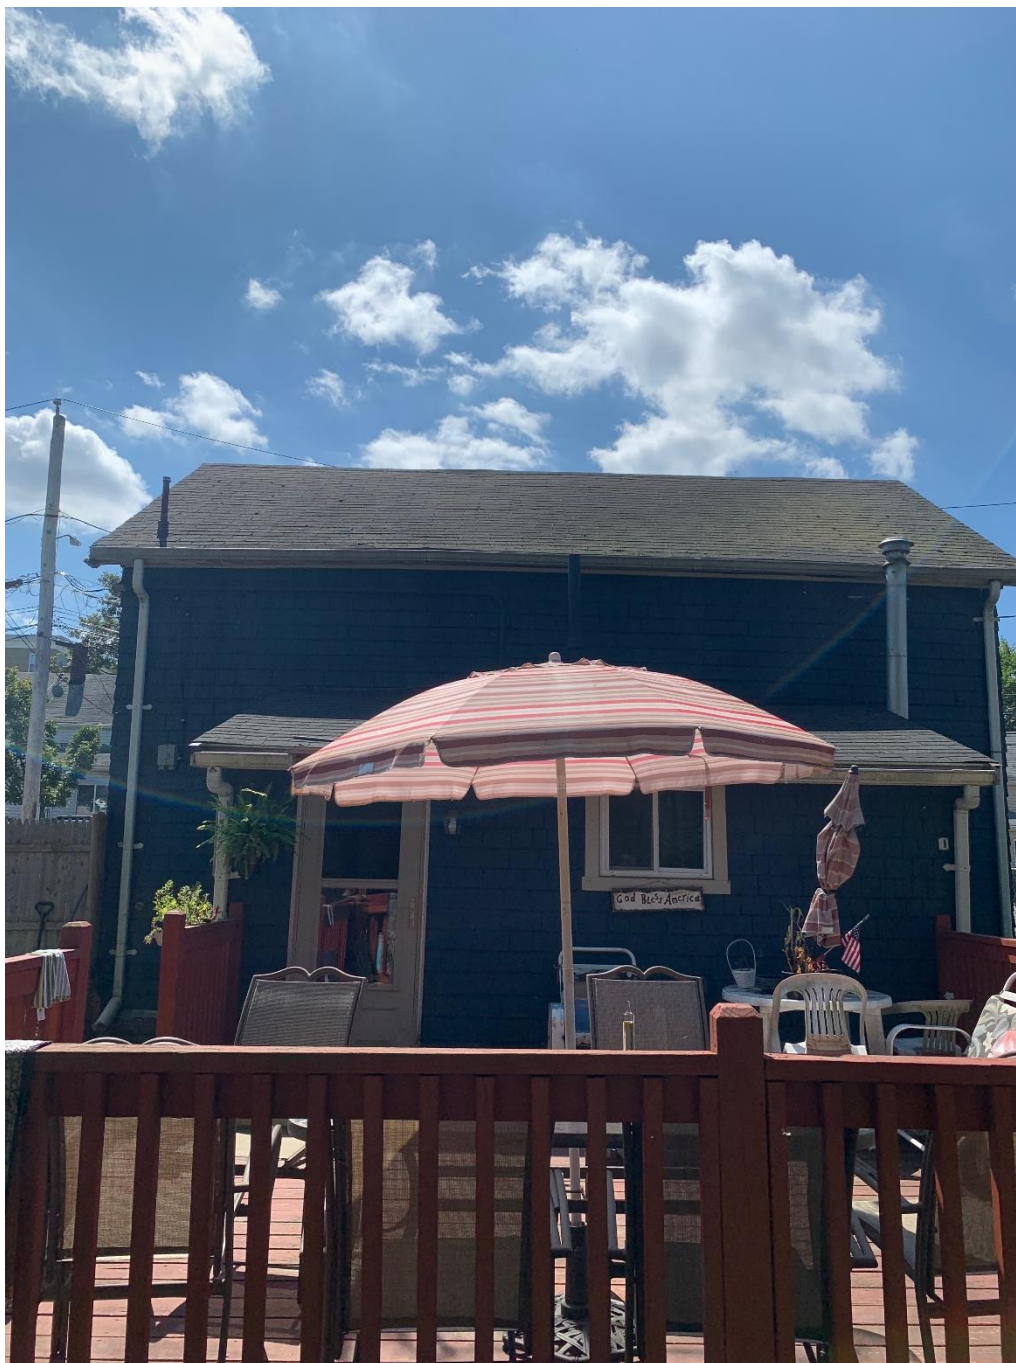
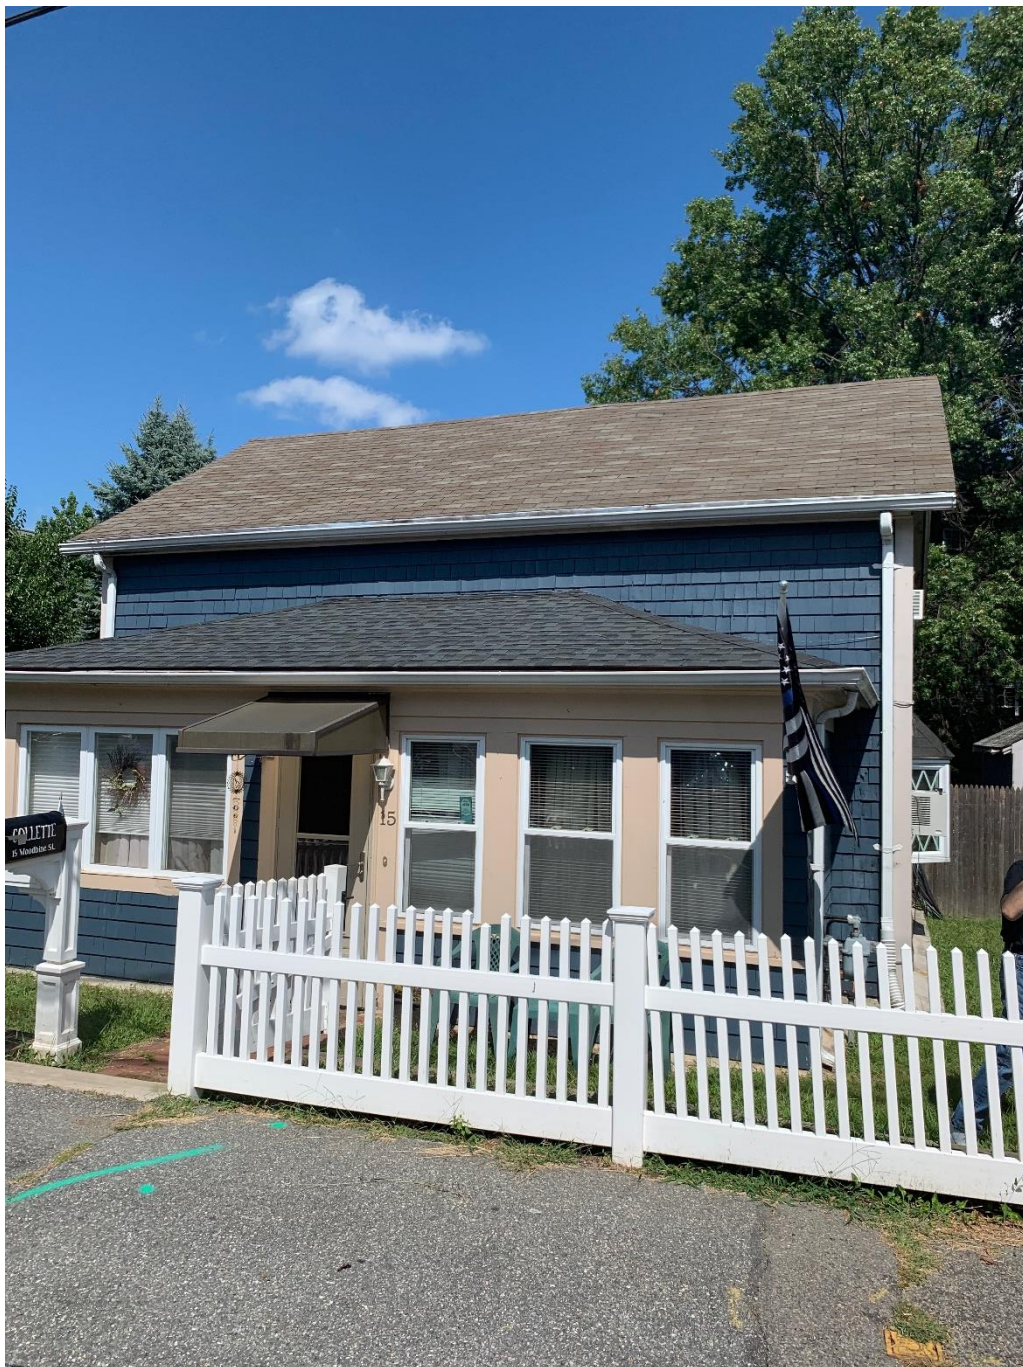
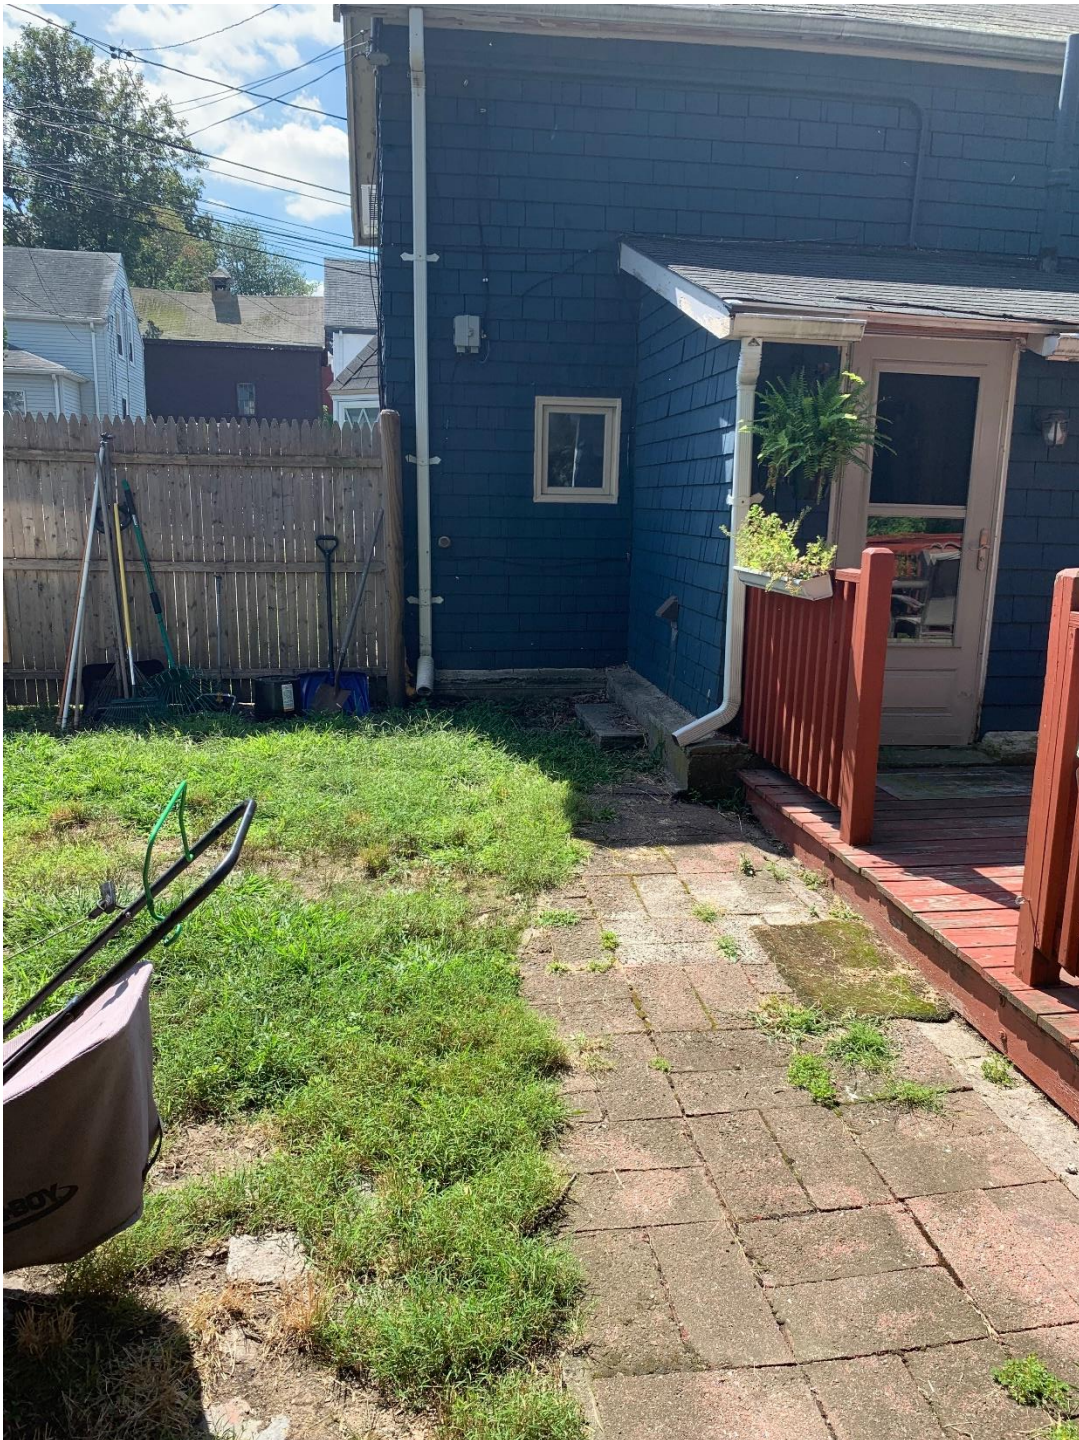
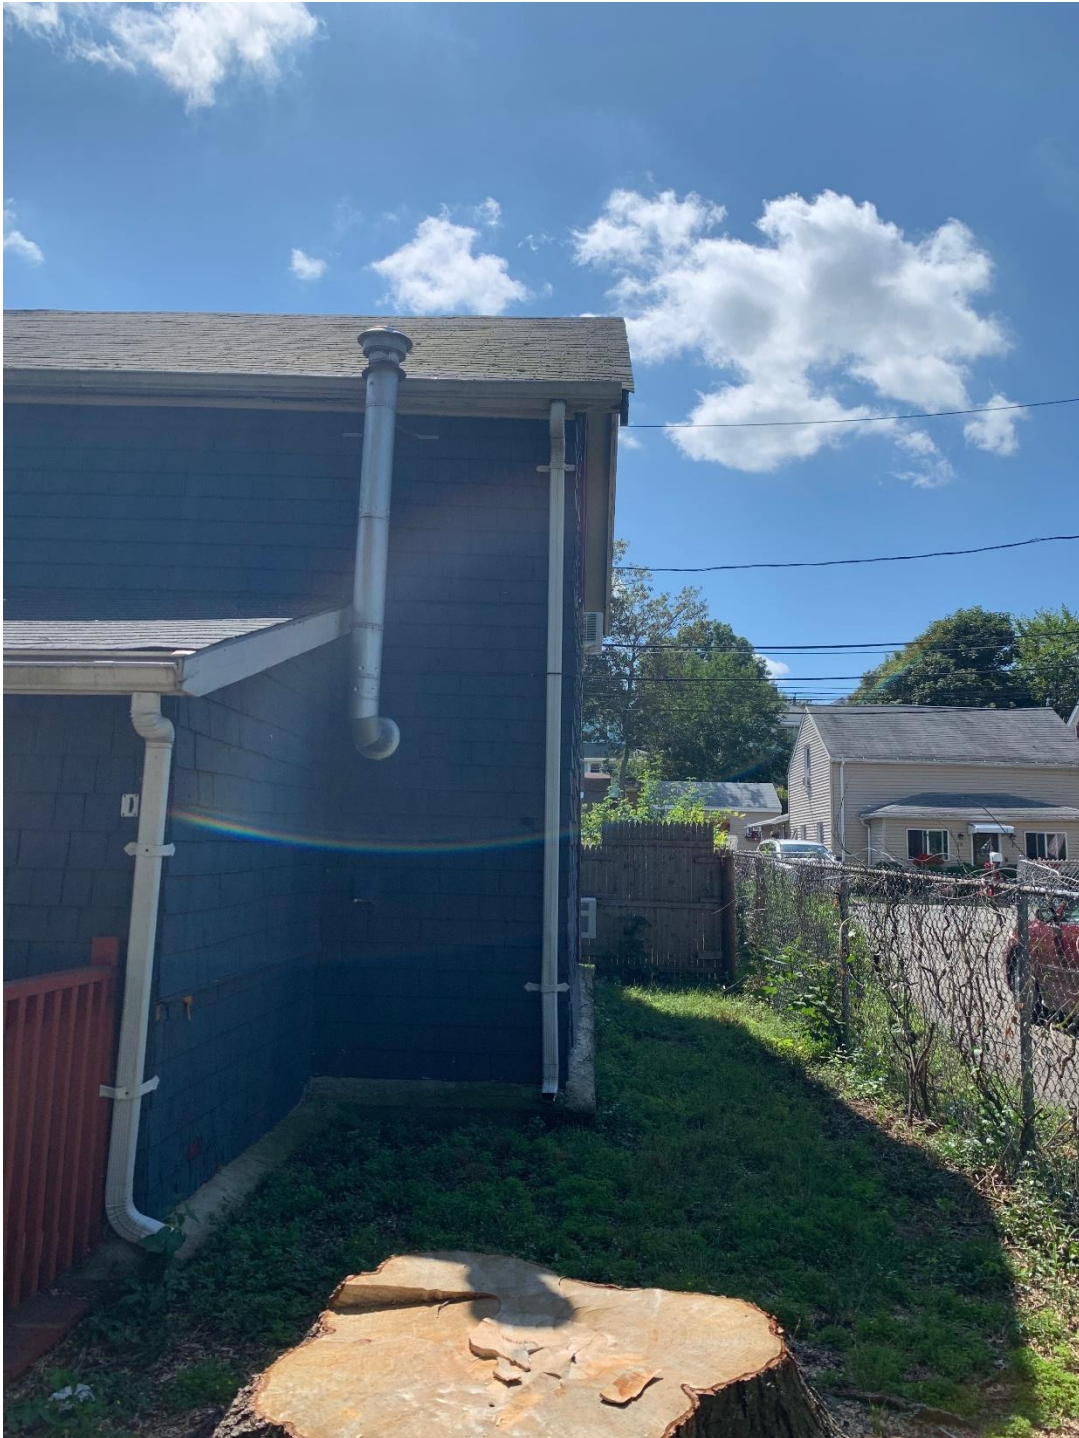
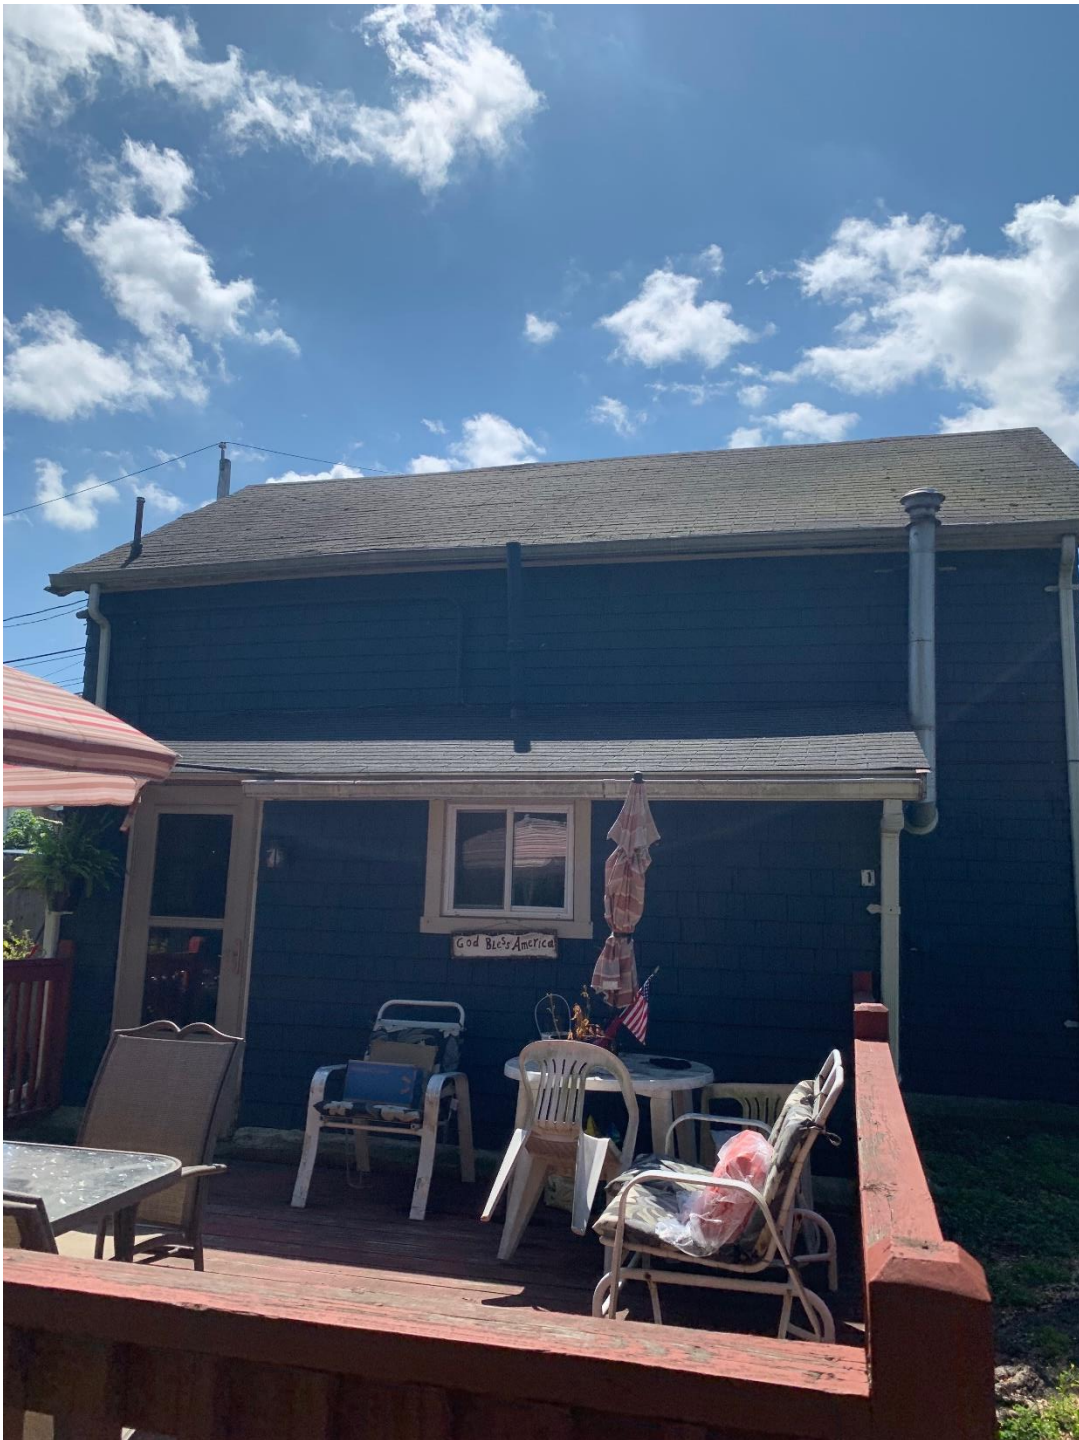
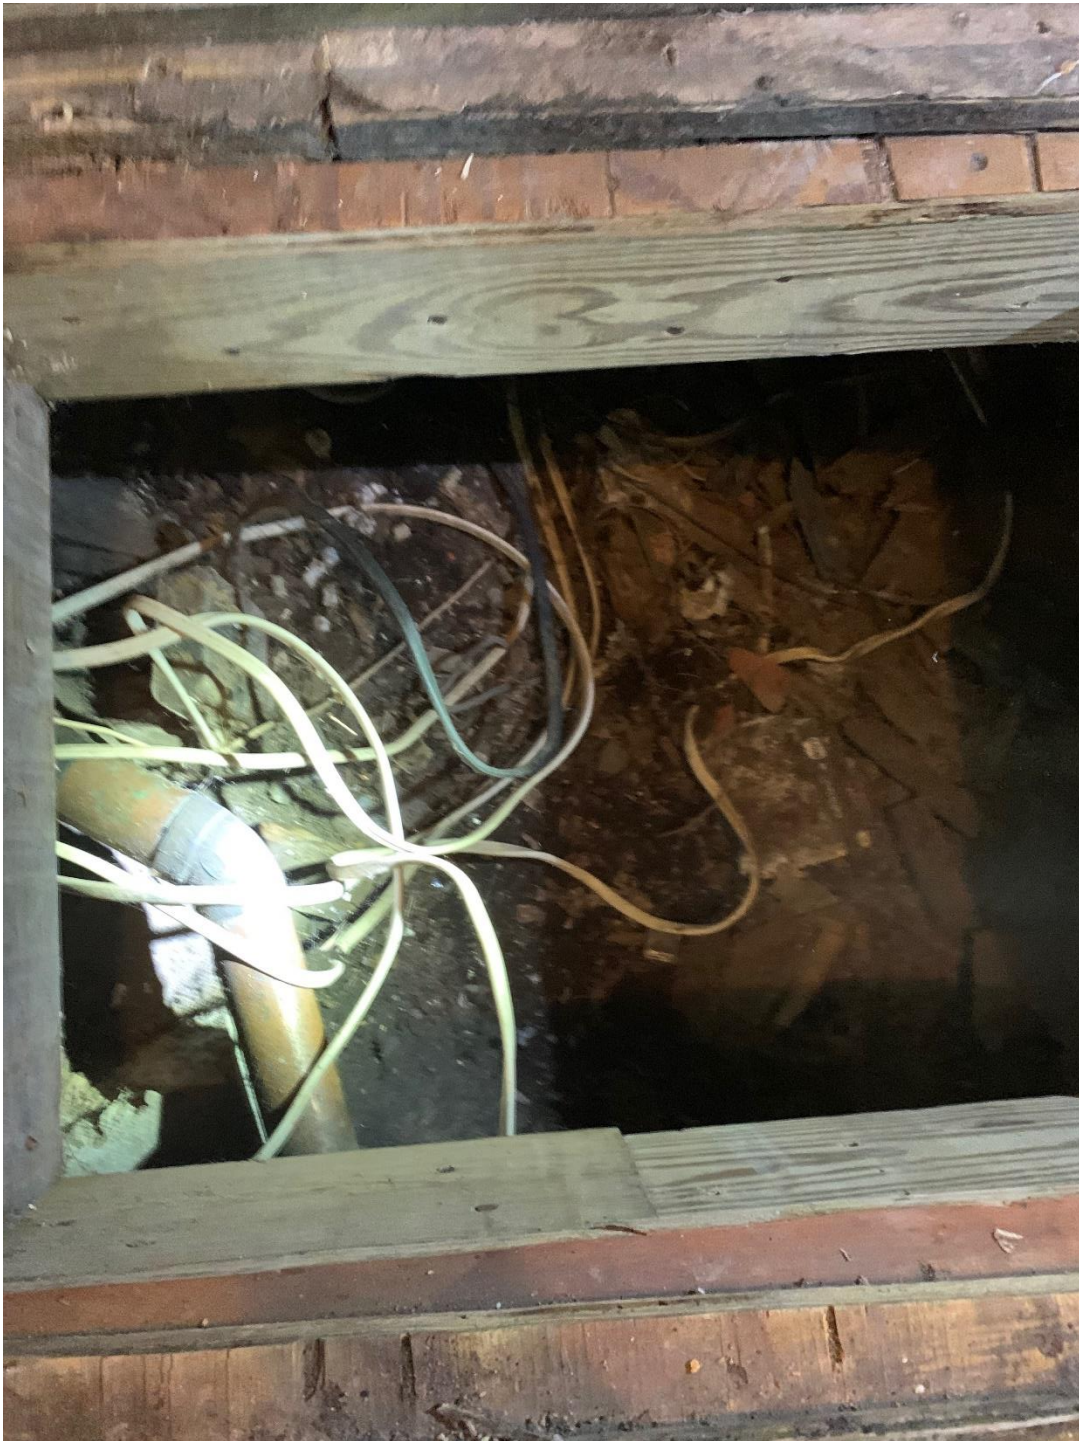
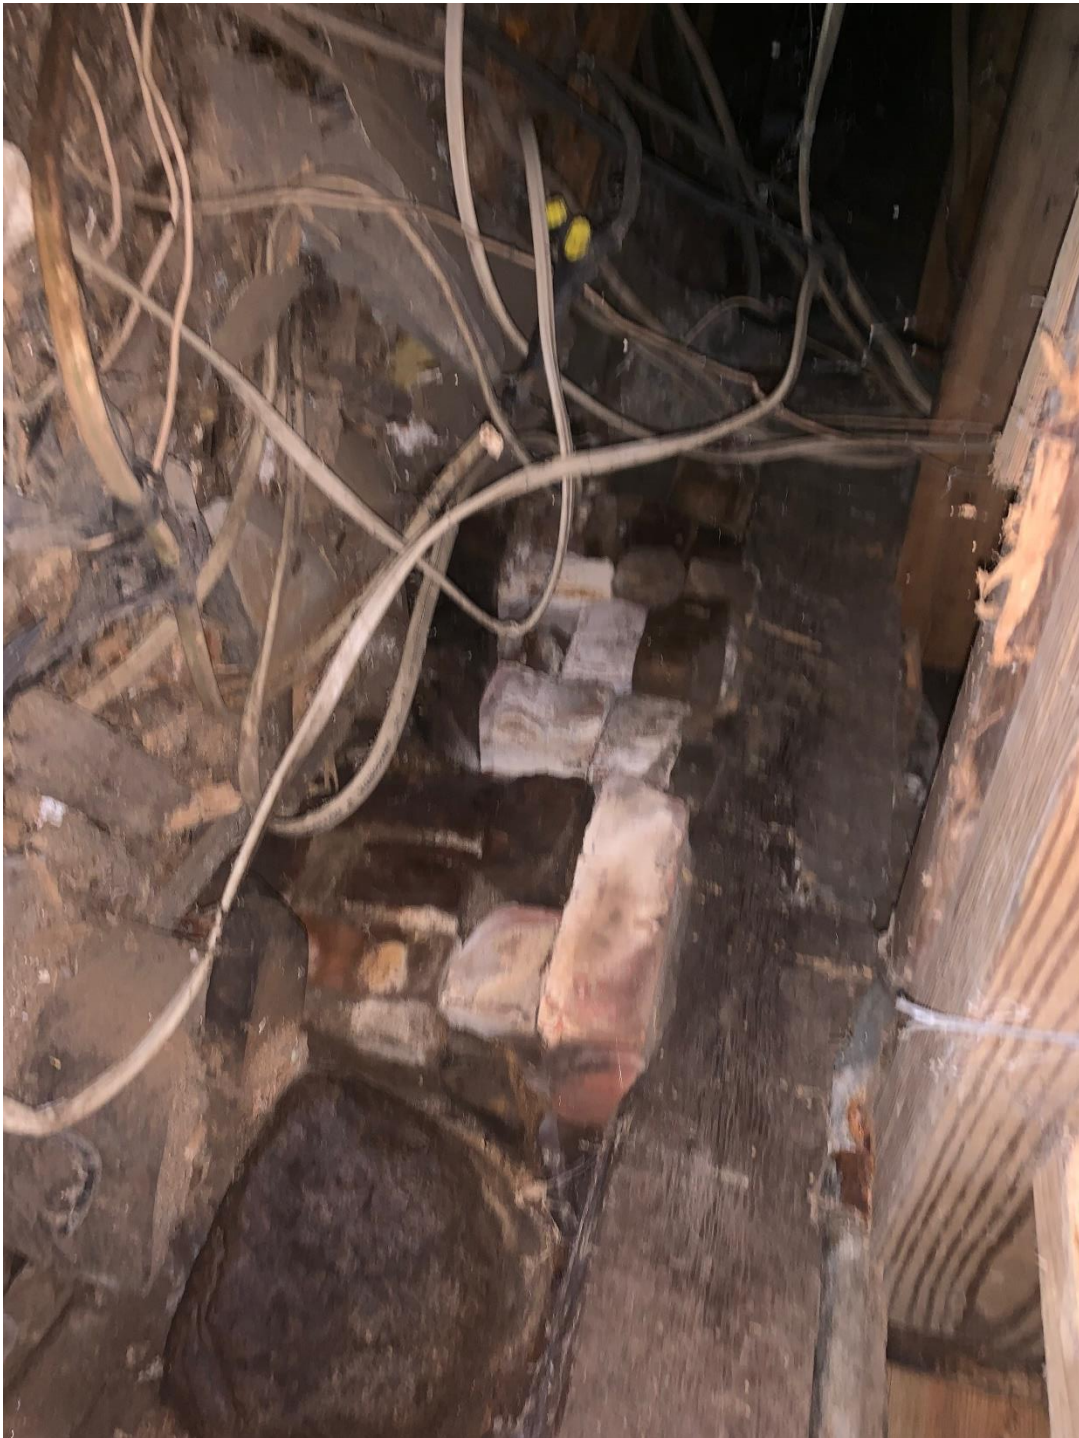
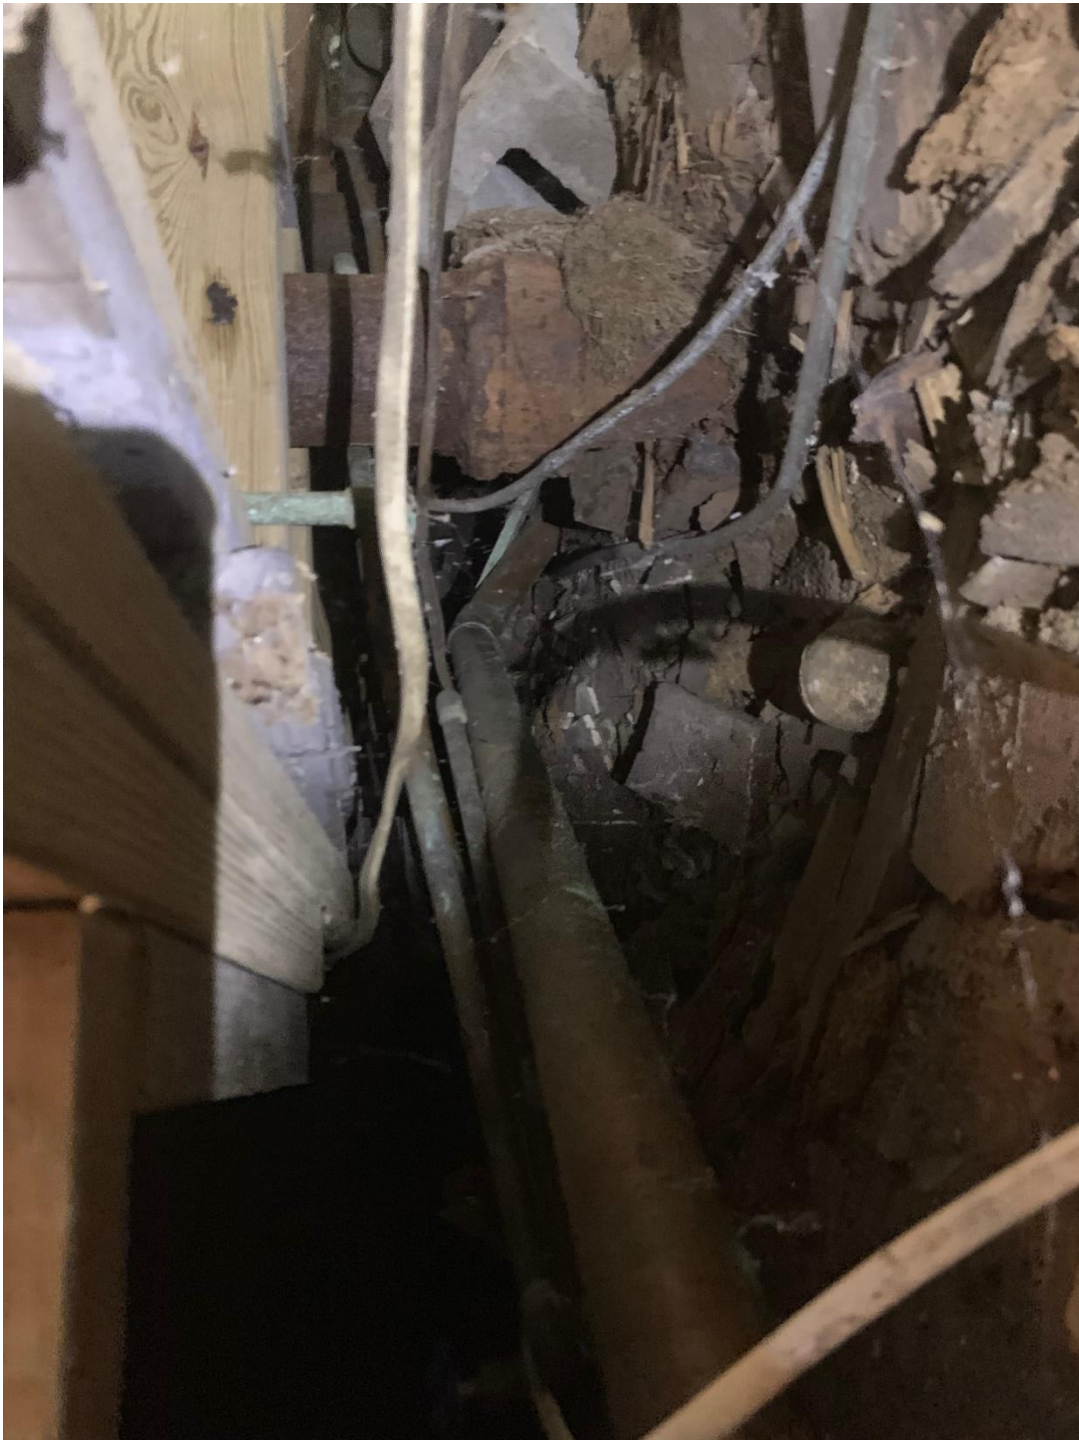
Upon arrival at the above mentioned property a distance of 50' away from the property I visually recognized that the existing structure was sagging and leaning to the North East and to the rear of the property. This is generally a sign of a failing foundation and or rotten sub base and floor joist. Upon entrance of the structure it was apparent the the house was leaning from to rear and to a large factor degree. The current homeowner indicated areas that he was aware of framing issues as well as structural foundation issues. See attached pictures.

The foundation as well as wood framing needs further review and from my engineering experience and structural education but limited to that and not certifying as a licensed structural engineer this structure does not appear to be salvageable. The house needs to be removed in order to repair the crawl space stone foundation and in doing so the house does not appear to be structurally sound enough to withstand this work.
