Commonwealth of Massachusetts Massachusetts Office On Disability

Advanced CAM Training

By: Jeffrey Dougan, Assistant Director: Jeff.Dougan@mass.gov

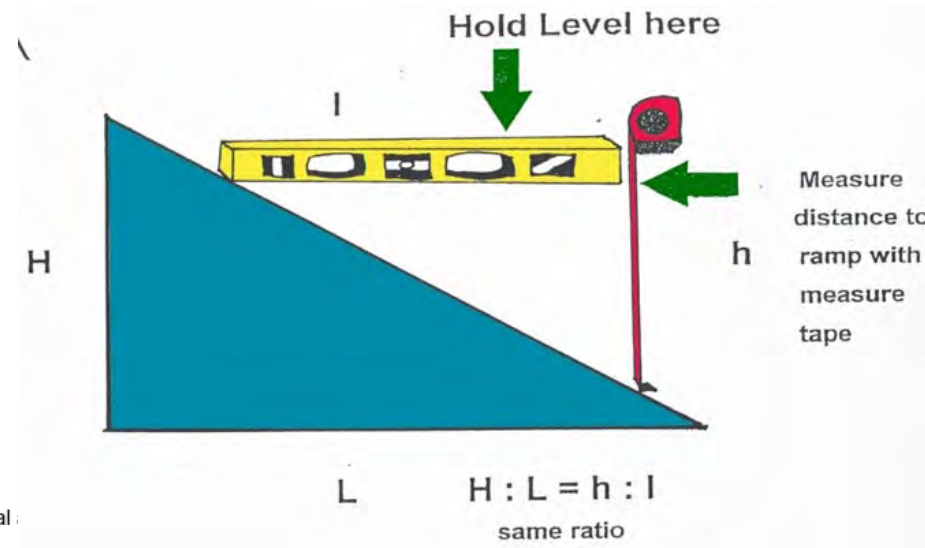
Site Visit – How to Measure Slopes

Common Slope Conversions Using a 2-Foot Level:

- ▶ The codes state: X inch(es) of rise for Y inches of run.
- ▶ To convert the code requirements (**bolded**) to use with a 2-foot (24-inch) level, see below for the inch(es) of rise allowed within a 24-inch run segment, along with some examples of where those slopes are required.
 - ✓ **1":12"** = 2":24" = 8.3% - Ramps, Curb Cuts
 - ✓ **1":20"** = 1 1/4":24" = 5% - Walkways, Sidewalk Transitions
 - ✓ **1":50"** = 3/8": 24" = 2% - "Level", Cross Slopes, Landings, Patios, Maneuvering, Accessible Parking and Access Aisles
 - ✓ **1":10"** = 2 1/3": 24 = 10% - Limited Use Short Ramp Run, Curb Flares When Landing Provided
