STEP 1: DETERMINATION OF SIGNIFICANCE
STAFF REPORT

Site: 76 Curtis Street

Case: HPC.DMO 2022.29

Legal Ad: *The Applicant seeks to demolish a principal and accessory structure constructed a minimum of 75 years ago.*

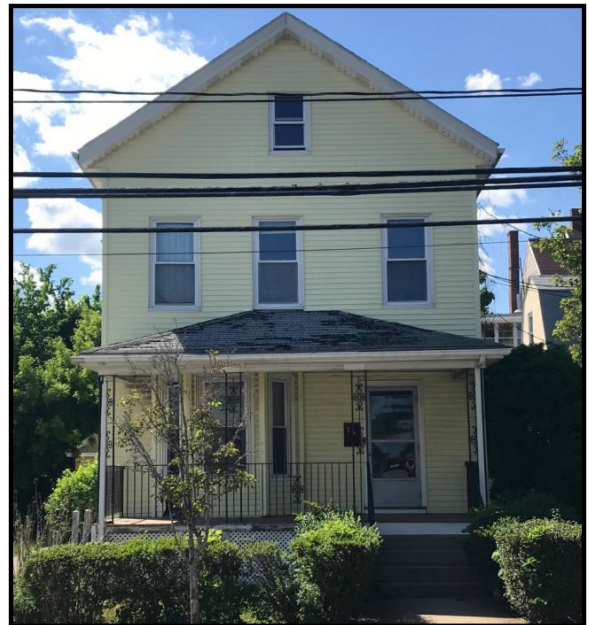
Top: Front elevation of primary residence

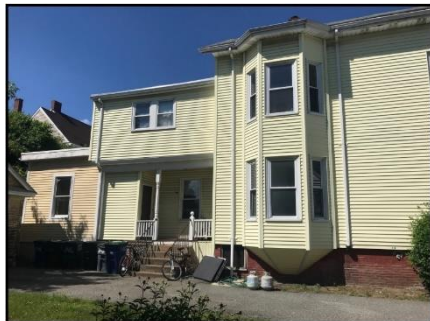
Bottom, left: Left elevation of primary residence

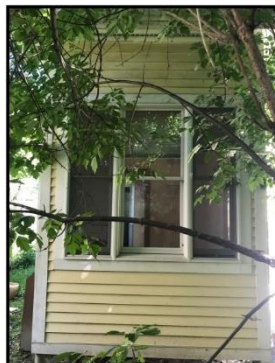
Bottom, middle: Rear elevation of primary residence

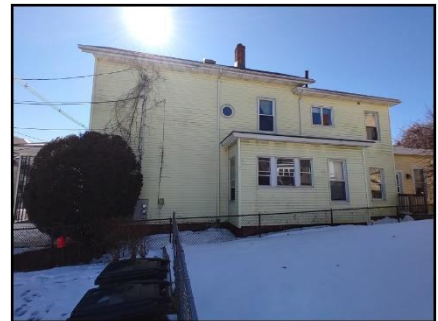
Bottom, right: Right elevation of primary residence

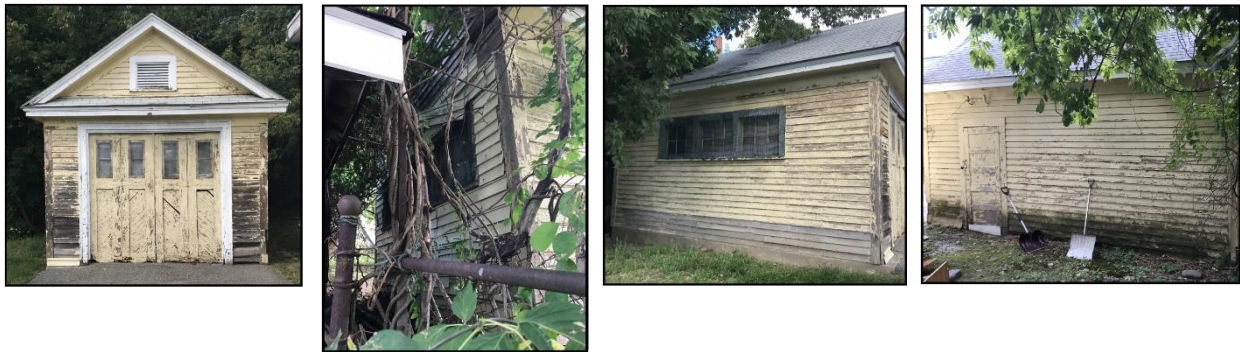
Above, left: Front elevation of the garage

Above, middle left: Rear elevation of the garage

Above, middle right: Left elevation of the garage

Above, right: Right elevation of the garage

The accessory structure is a one-story, wood frame, gable ended carriage house or barn with shingled projection connecting the front gable ends; vent between the gable vertex and the shingled projection; double bi-folding wood carriage doors with each panel containing a single one-over-one window (4 in total); fenestration on left and rear elevation includes three two-over-one fixed windows; wood door on the right elevation.

- 2. *Garage:* wood clapboard; wood windows; wood garage doors; asphalt shingle roof.
- d. Alterations: Rear addition; replacement windows and doors; second floor addition above left porch; addition of the porch on the front elevation; addition of wood porch on the right elevation; replacement vinyl siding; port window and casement or horizontal sash windows on right elevation; mid to late 20th century iron railings and columns.

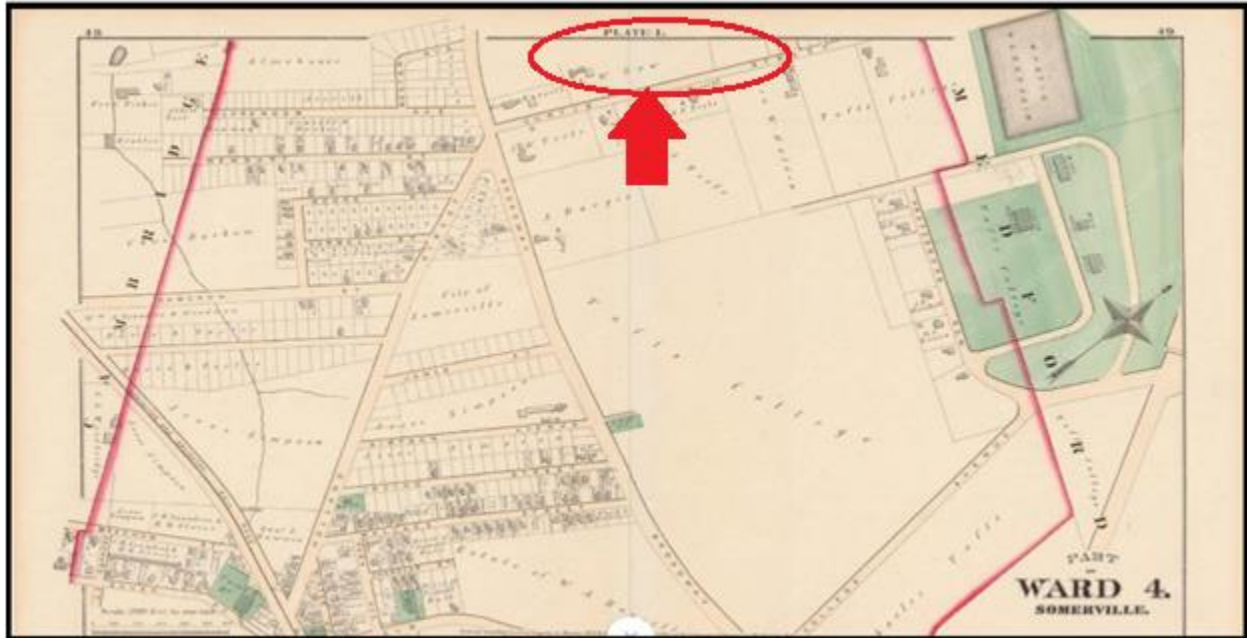
Above: 1874, Plate L Hopkins Map, indicating location of Lorenzo Dow's property holdings

Plate L shows that the land currently occupied by 76 Curtis Street was owned by a Lorenzo W Dow and is part of a larger lot under Dow's ownership. Speculative real estate development was in full swing in Somerville during this time.

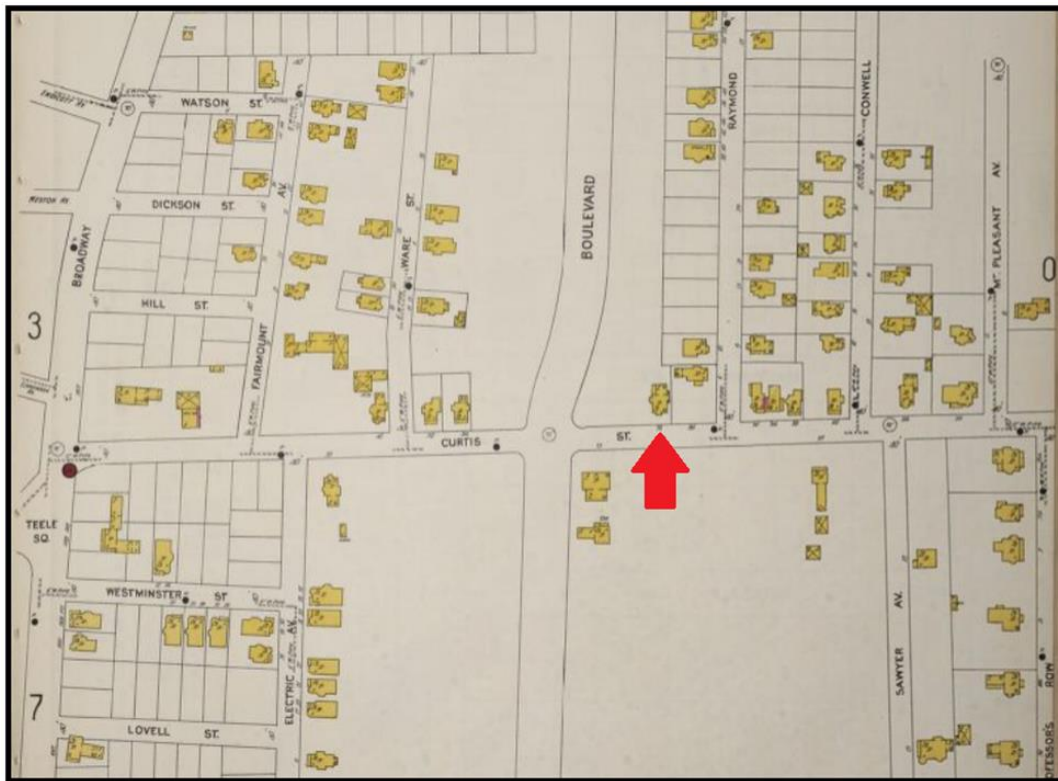
Above: 1900 Sanborn Map, Sheet 4, specifying the location of 76 Curtis St.

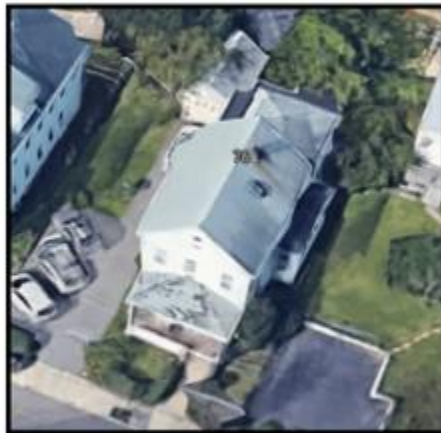
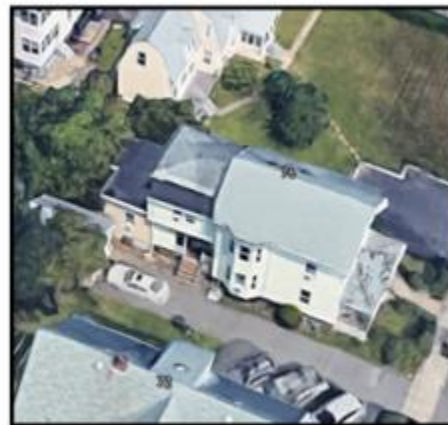
Above: Fig 4

Fig 4 & 5: Satellite images of 76 Curtis St

- A covered porch has been added to the front elevation.
- The addition of a second-floor space above the first-floor porch on the left elevation transforming it into a covered porch.
- One-story addition on the rear.
