**STEP 1: DETERMINATION OF SIGNIFICANCE**  
**STAFF REPORT**

**Site:** 627 Somerville Ave

**Case:** HPC.DMO 2022.34

**Legal Ad:** The Applicant seeks to demolish a principal structure constructed a minimum of 75 years ago.

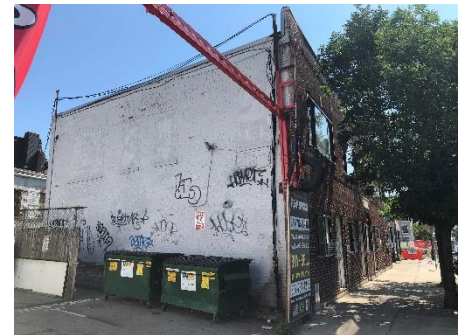
*Right, top: Left elevation*

- a. Location: The building appears to be in its original location.
- b. Design: Two story, flat roofed, brick commercial building with decorative brick detailing and a stone inset that reads “627”. Brick façade with mainly running bond design segmented in to four sections on the first floor by columns of bricks arranged in stack bonds. The columns of stack bond bricks have soldier course brick detailing. Between the first and second floor are two rows of soldier course bricks that run the length of the front façade. The two rows of soldier course bricks are replicated between the second-floor windows and the roofline. Four doors lead into the building through the front façade, three of which appear to be vinyl or aluminum. One door is wood with window insert containing 2/2 muntin pattern. Doors are elevated slightly off the ground. Fenestration of the front elevation includes five horizontal sash windows on the first floor; and on the second floor includes one horizontal sash window, two windows containing a fixed center window with one horizontal sash window on either side, a single one-over-one double sash window, and four one-over-one sash window. Second story windows all have a row of soldier course bricks and stone keystones above the window. Fenestration on the rear includes one-over-one double hung sash windows. Running bond brick on the rear elevation with metal staircase leading to a second-floor entrance.

- c. **Materials:** Brick building. Left and rear façades are painted. Staircase at rear is metal. All doors and windows are wood or fiberglass/vinyl. Roof is likely rubber or asphalt. Granite or concrete curb at base of front façade.

- d. **Alterations:** A two-story addition has been added to the right side of the building: first story addition is masonry with a vertical rolling garage door; second story addition is vinyl- or aluminum-clad with horizontal sliding casement windows. All doors and windows have been replaced but are in their original locations. On rear façade, evidence of some window openings shifting or being closed entirely. Left façade has clear evidence of four windows on the second floor being bricked over (three are single width, one is double width) and currently has no windows.

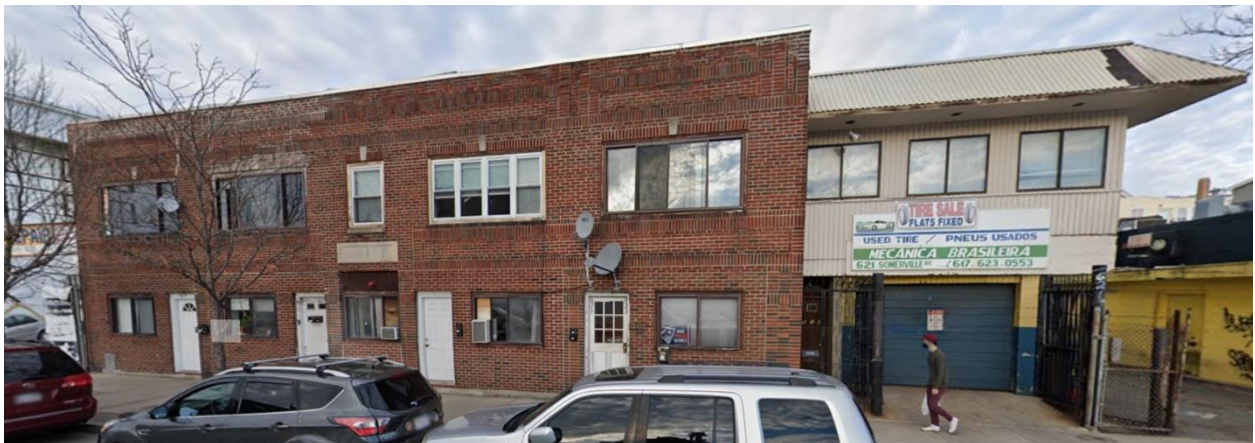
*Bottom: Front elevation*

- e. **Evaluation of Integrity of 627 Somerville Ave:** Based on the observations of the building and a study of the historic maps, it is Staff's position that the building retains the integrity of its original form, with additions. The original massing of the brick building remains, and the modifications to the front façade and additions to the side and possibly rear façade do not obscure the building to a significant extent.

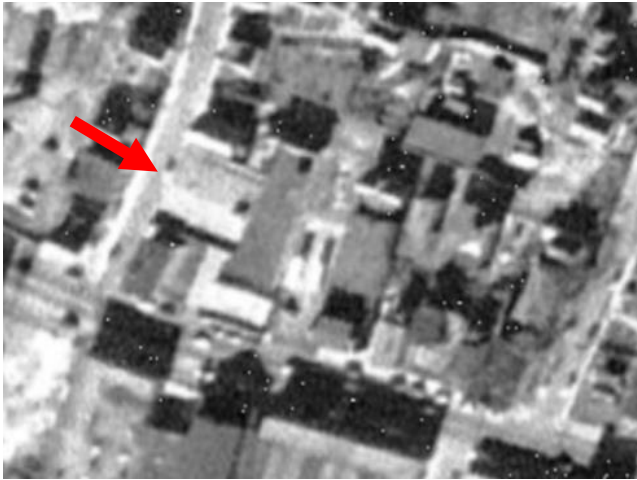
1955 USGS Aerial Image of the Boston area. Accessed from <http://www.bostonplans.org/3d-data-maps/historical-maps/the-boston-atlas/aerial-photos>

The wood structures facing Belmont St were likely demolished sometime between 1925 and 1955, as a USGS aerial image from 1955 appears to show a single large structure in that location, likely the brick structure that exists there today. Please see the section immediately below which discusses location, design, materials, and any alterations as the same information would be written here, just in longer form.
