**STEP 1: DETERMINATION OF SIGNIFICANCE**  
**STAFF REPORT**

**Site:** 36 Hancock Street

**Case:** HPC.DMO 2023.04

**Legal Ad:** *The Applicant seeks to demolish  
a building constructed a minimum  
of 75 years ago.*

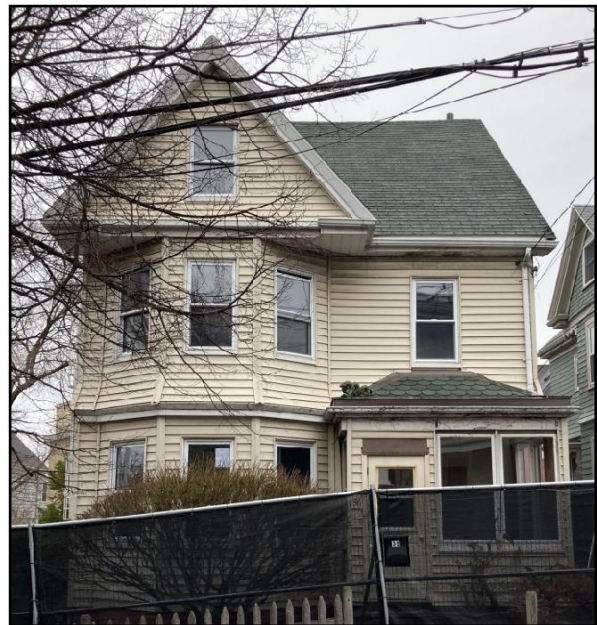
*Top: Front elevation*

*Bottom, left: Left elevation*

*Bottom, middle: Right elevation*

*Bottom, right: Rear elevation*

- Location: The structure is in the original location and was built on-site.
- Design: The primary structure is two and ½ stories, wood framed, gable roof parallel to the street; brick chimney; vinyl clapboard; gabled wall dormer on front elevation above two-story bay; enclosed porch entryway; on the left elevation is a late 19<sup>th</sup>, early 20<sup>th</sup> century iron spiral stair to top floor; on the rear elevation is a gable ended ell on right side

of rear elevation, one-story, later addition on left of rear; one-story later addition on rear ell with sliding glass doors with later rooftop porch; wood porch to left of later rear addition; fenestration consists of one one-over-one, double-hung, replacement sash windows; on the right elevation fenestration consists of one-over-one double hung sash windows and fixed square windows; on basement level fenestration appears to be fixed or pivot windows.

- c. **Materials:** Vinyl clapboard; replacement front door; wood porches and steps; brick steps on front; metal stairwell; brick chimney stack; asphalt shingle roof; brick foundation.
- d. **Alterations:** Rooftop porch; rear porch, the one-story rear-most addition; replacement windows and doors; asphalt shingles; wall dormer; one-story addition on the left rear.
- e. **Evaluation of Integrity of 36 Hancock Street** Based on the observations of the building and a study of the historic maps, it is Staff's position that the building largely retains the integrity of its original form. Alterations have occurred to this structure that do obscure original architectural details; the original massing mostly intact.

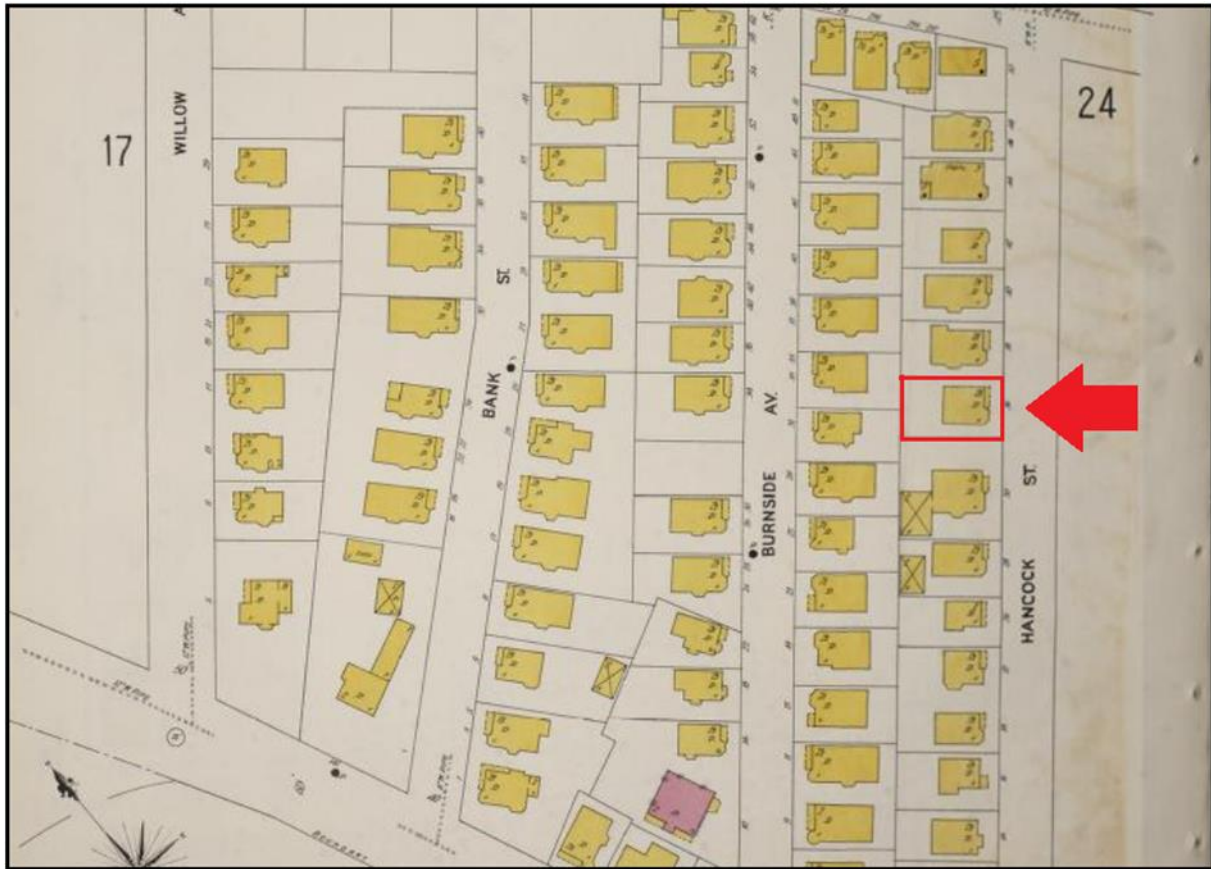
By 1925 the Gurnham family had added an addition to the rear of the property and a front porch. Interestingly, looking at the 1895 Bromley and 1925 Sanborn maps we can see that a number of the neighboring properties also added front porches within this same time.

*Above: 1925 Sanborn Map, Sheet 23, specifying the location of 36 Hancock Street.*

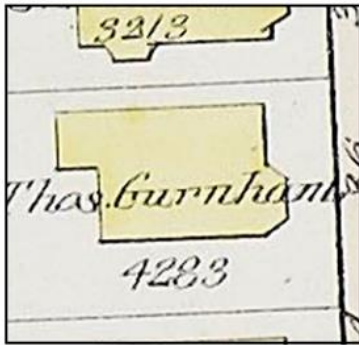
Above: Fig 1

Fig 1: 1895 Hopkins Map, close-up of 36 Hancock St

- The 1884 Map is the first time the current structure is shown. It is a plain square building with a projection towards the right of the rear and a bay on the front left elevation.

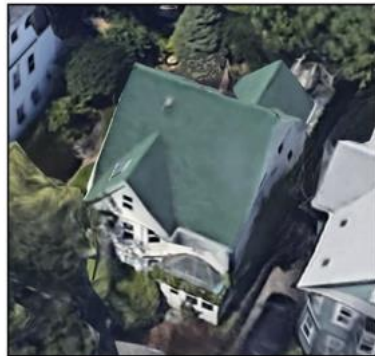
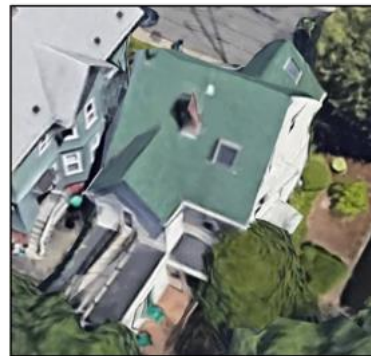
Fig 4 &amp; 5: Satellite image of 36 Hancock Street

- Front porch has been enclosed.
- Later addition with porch added to rear gabled ell.
- Metal stairwell added to the left elevation to access top floor.
