STEP 1: DETERMINATION OF SIGNIFICANCE STAFF REPORT

Site: 236 Pearl Street

Case: HPC.DMO 2023.02

Legal Ad: The Applicant seeks to

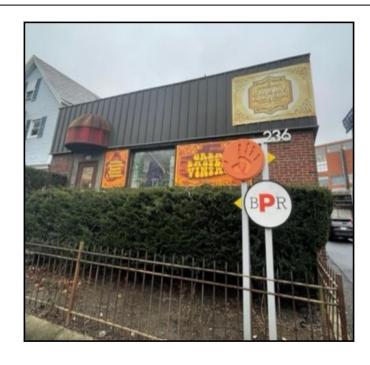
Top: Front elevation Bottom, left: Left elevation Bottom, middle: Right elevation Bottom, right: Rear elevation

- a. <u>Location</u>: The structure is in the original location and was built on-site.
- b. <u>Design:</u> The structure is a one-story, masonry structure with brick facade, flat roof; standing seam metal exterior along top portion of building; fenestration on front elevation includes one large picture window to the right and a glass entry door to the left; on right elevation fenestration includes one-over-one double-hung sash windows; entry door towards rear of right elevation; garage door on right elevation towards rear; enclosed window opening at basement level on right elevation; mixture of wood clapboard and stone façade; enclosed windows on rear elevation; mixture of wood clapboard and stone façade along rear; rear garage door; mixture of brick and wood clapboard on right elevation; enclosed window or door on right elevation; brick chimney stack.

- c. <u>Materials:</u> Wood clapboard; brick exterior walls; aluminum siding; aluminum and glass doors; brick chimney stack; aluminum or vinyl windows.

- d. <u>Alterations:</u> Enclosed windows and door; standing seam metal siding; replacement windows and doors.
- e. Evaluation of Integrity of 236 Pearl Street Based on the observations of the building and a study of the historic maps, it is Staff's position that the building largely retains the integrity of its original 1934 form and likely retains portions of earlier structures. Alterations have occurred to the current structure that obscure original architectural details; the original massing remains largely intact.

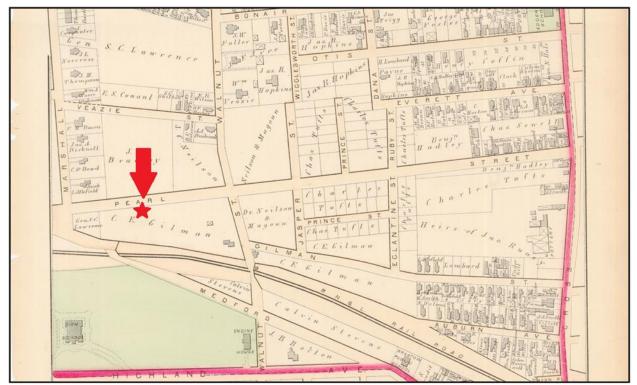
Above: 1874, Plate H, Hopkins Map, specifying the approximate location of 236 Pearl Street.

Charles E. Gilman, who served as town clerk and later city clerk between 1842 and 1886, was one of the major landholders in the area prior to the subdivision of large tracts for residential development. The 1874 Hopkins Map shows him as the owner of the land that later became 236 Pearl Street.

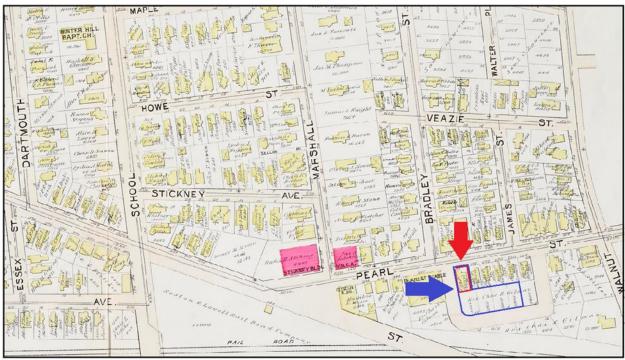
Above: 1895, Plate 2, Bromley Map, specifying current location (blue) and 1895 location (red) of 236 Pearl Street.

The 1895 Bromley Map is the earliest map depicting a structure at 236 Pearl Street. This original structure was a residential property built by 1890 as the first listed homeowners in the Somerville City Directory are Elizabth and John Waugh. Interestingly the Bromley Map lists 'Eliza Waugh' as the owner and not her husabnd despite him being alive in 1895. This is an anomoly for a time when men were property owners. Few married women of this period were considered property owners in their own right. During the Waugh's ownership, they rented out rooms at 236 Pearl to a number of individuals as a secondary form of income. Records show that the Waughs lived at 236 Pearl between 1890 and 1920 (John passed a year earlier in 1919).

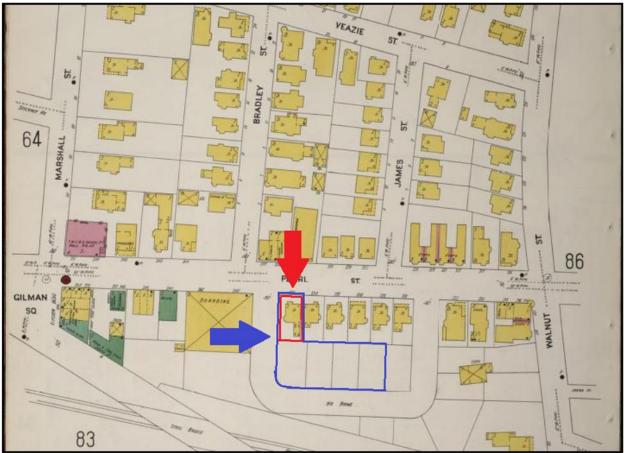
Above: 1900 Sanborn Map, Sheet 85, specifying current location (blue) and 1900 location (red) of 236 Pearl Street.

- 236 Pearl was a single lot; what is 236 Pearl today included a lot with a wood framed structure and four vacant lots along Skilton Ave.
- Original wood framed building had a projection from the mass on the right side of front elevation and a projection on the center rear.

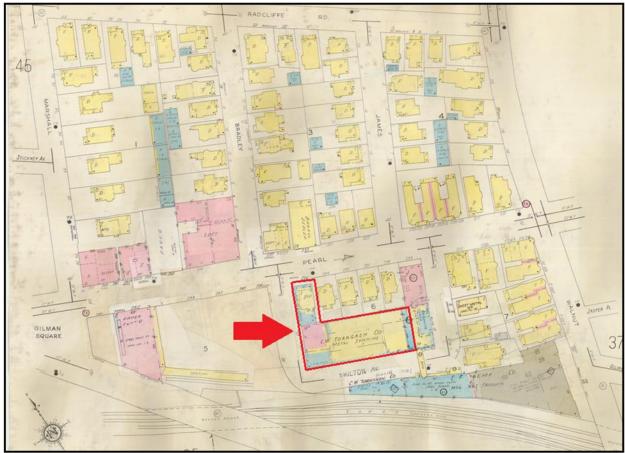
Above: 1934 Sanborn Map, Sheet 36, specifying the location of 236 Pearl Street.

The 1934 Sanborn Map shows that the residential wood structure at 236 Pearl Street has been subsumed into a commercial structure that includes the original 236 Pearl Street lot and an additional four lots behind 236 Pearl along Skilton Ave. Interestingly, the map shows that along with the wood residential structure at 236 Pearl, a large wooden structure that had been constructed on the four lots along Skilton Ave had also been incorporated into the larger structure. The map makes clear that these wood buildings were not demolished to build the commercial structure but incorporated into the larger building.

- The wood building at 236 Pearl has been subsumed in a concrete and brick one story commercial building.
- The wood building is indicated as an office.
- The larger building that is today's 236 Pearl appears to have encased the wood structure on Pearl St as well as a brick structure and a large wood structure on Skilton Ave.
- Sanborn map indicates that the exterior of the building is mixed construction of C.B. and brick with one wall of solid brick.

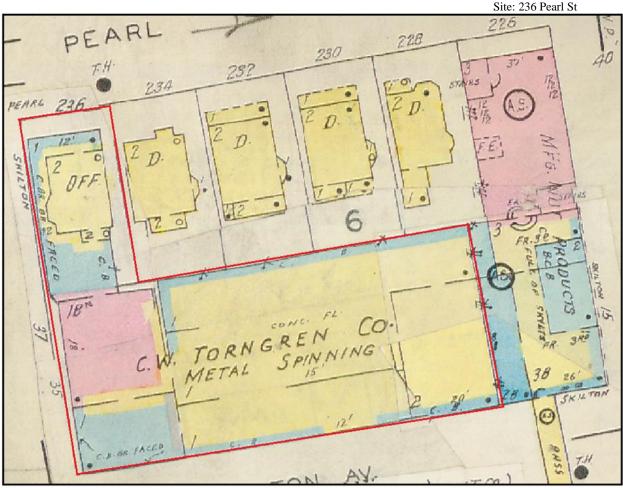
Above: Close up 236 Pearl St from 1934 Sanborn Map, Sheet 36

The use of yellow on a Sanborn Map indicates a wood frame building. Blue, depending on the additional abbreviations, means concrete block. In this instance the blue with the abbreviation; 'C Br Br Faced' indicates 'mixed construction of concrete block and brick with one wall faced with 4" brick'. In the instance of this building determining the material of the pink portion is slightly harder as the pink designation in Sanborn keys can have several corresponding meanings. Likely it indicates this portion is made of tile or incorporates brick and/or stone.

Furthermore, we know that the original wood structure at 236 Pearl is being used as an office in 1934 based on the 'OFF' placed on the building in the 1934 Sanborn Map and is still two stories in height. At the same time, the C.W. Torngren Company owned and operated at least the portion of the building along Skilton Avenue if not the entirety of the new structure (including 236 Pearl). The Torngren Company was a metal working company. Advertisements placed in the Boston Globe during World War II indicate that they supported the war effort. Prior to WWII factories such as Torngren would have made metal for commercial use such as automobiles, appliances, etc. After the bombing of Pearl Harbor President Franklin D Roosevelt ordered such factories to be converted to help the war effort. Metal factories such as Torngren would be converted into producing materials to help American soldiers such as metal for guns, tanks, ships, etc. After WWII had finished, Torngren also made an effort to support American veterans by making a point to advertise for veterans in their job advertisements.
