STEP 1: DETERMINATION OF SIGNIFICANCE  
STAFF REPORT

**Site:** 246 Broadway

**Case:** HPC.DMO 2023.11

**Legal Ad:** *The Applicant seeks to demolish a building constructed a minimum of 75 years ago.*

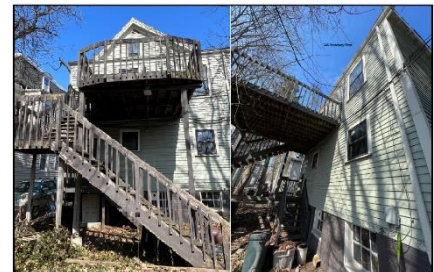
*Top: Front elevation*

*Bottom, left: Left elevation*

*Bottom, middle: Right elevation*

*Bottom, right: Rear elevation*

- Materials:* Wood clapboard; vinyl or aluminum replacement front doors; wood front porch and steps and landing on front; wood stairs, railings and porches in rear; concrete chimney stack; shingle roof; concrete or concrete with brick parging foundation.

- d. Alterations: Concrete Chimney; replacement windows and doors; likely enclosure of windows on right elevation; removal of dormer window on rear elevation.
- e. Evaluation of Integrity of 246 Broadway Based on the observations of the building and a study of the historic maps, it is Staff’s position that the building largely retains the integrity of its original form. Minimal alterations have occurred to this structure; largely retaining original architectural details; the original massing remains largely intact.

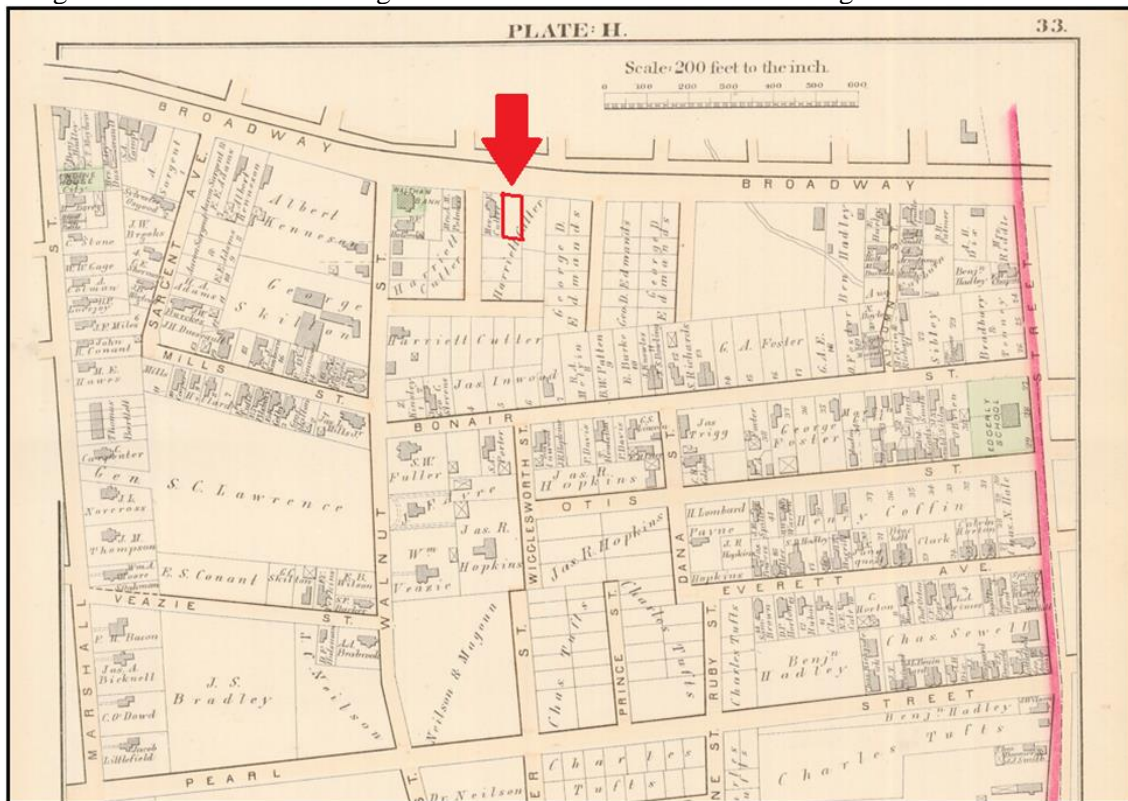
Above: 1874, Plate H, Hopkins Map, specifying the location of 246 Broadway.

By 1874, the lot that would contain 246 Broadway had been platted but no house had yet been constructed. The property is listed on the 1874 Hopkins Maps as owned by 'Harriett Cutter'. Staff was unable to find information on Harriett in either the City Directories or local publications.

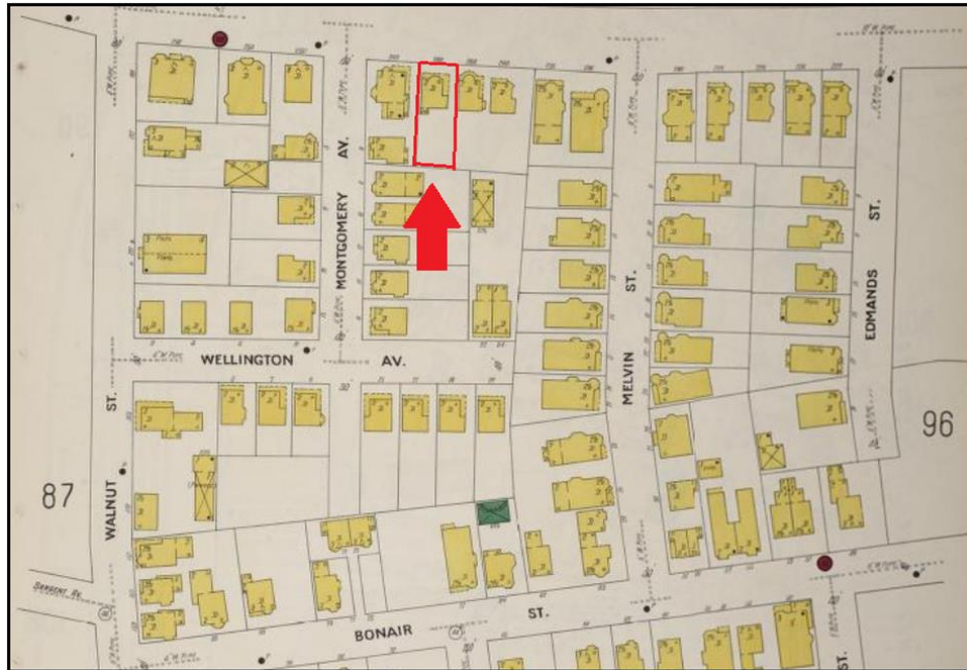
*Above: 1900 Sanborn Map, Sheet 47, specifying the location of 246 Broadway.*

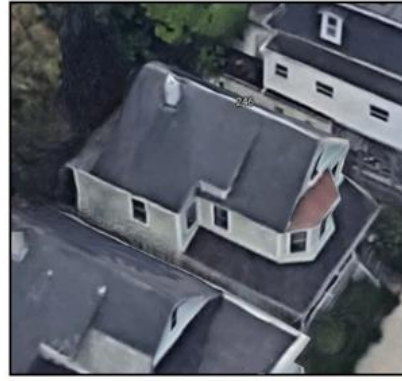
Above: Fig 4

Fig 4 & 6: Satellite images of 246 Broadway

- Steps leading up to front porch are visible.
