STEP 1: DETERMINATION OF SIGNIFICANCE
STAFF REPORT

Site: 25 Warwick Street

Case: HPC.DMO 2023.10

Legal Ad: *The Applicant seeks to
demolish a building
constructed a minimum
of 75 years ago.*

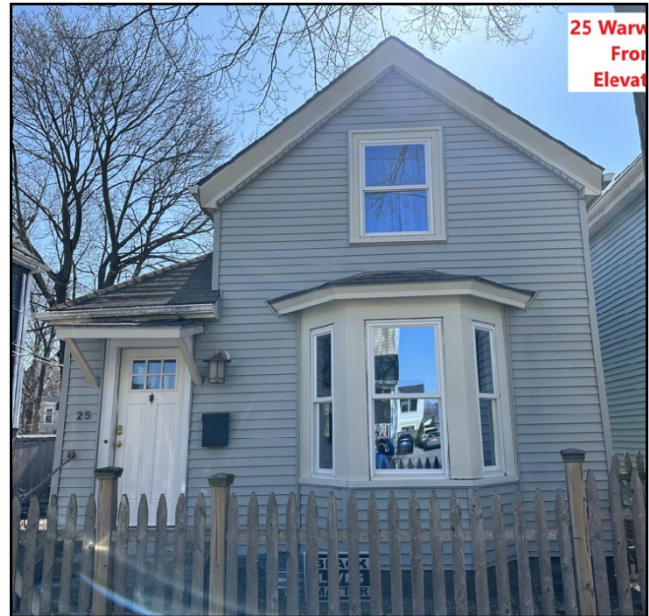
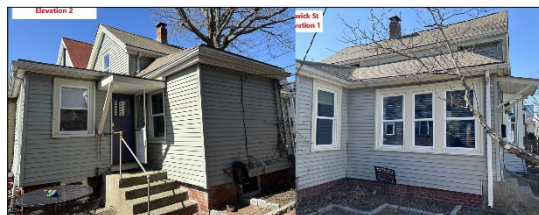
Top: Front elevation

Bottom, left: Left elevation

Bottom, middle: Right elevation

Bottom, right: Rear elevation

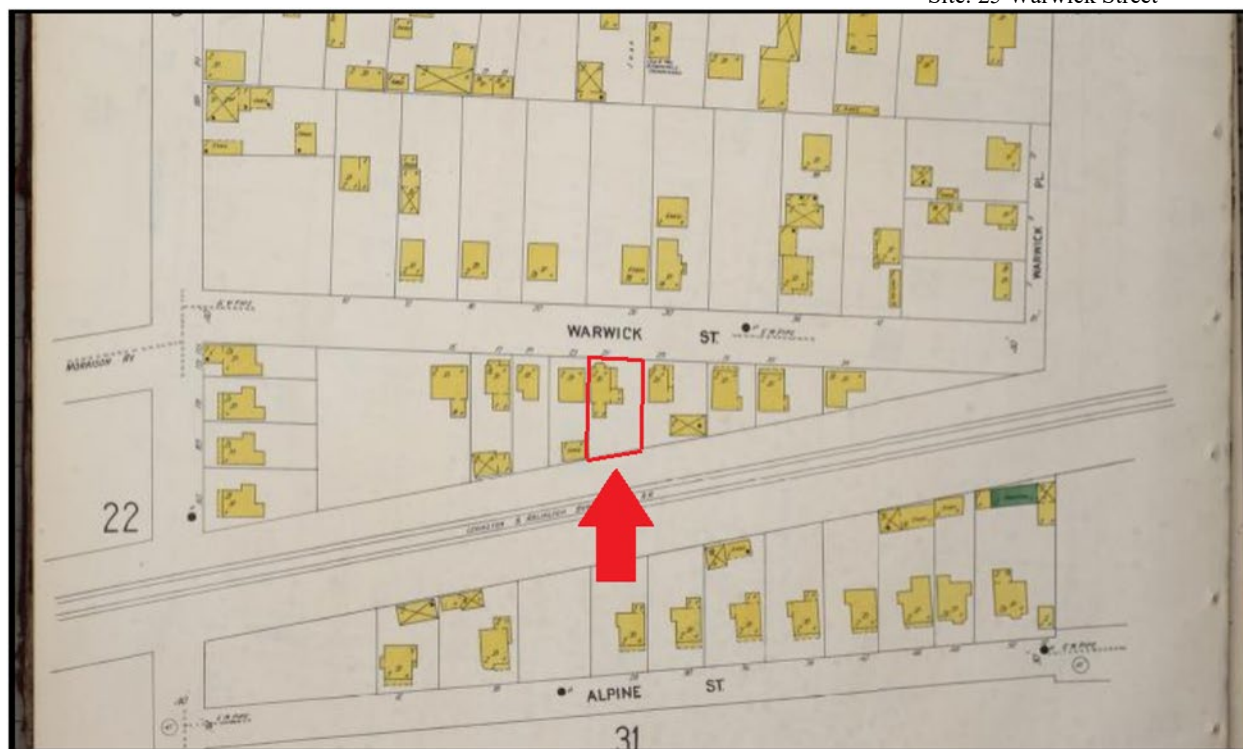
The 1900 Map shows that a bay had been added to the front elevation as well as a porch on the left elevation in front of the ell.

Above: 1900 Sanborn Map, Sheet 33, specifying the location of 25 Warwick Street.
