**STEP 2: DETERMINATION OF PREFERABLY PRESERVED  
STAFF REPORT**

**Site:** 101 Highland Avenue

**Case:** HP23-000025

**Applicant:** Somerville Young Men's Christian  
Association

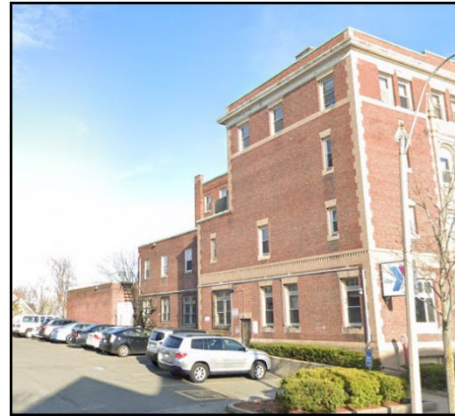
***Right: Left Elevation***

3. Rear Elevation: The rear of 101 Highland is a one-story building with large arched cementitious glass blocks with rounded brick arches above and stone aprons.
4. Left Elevation: The ground floor design of the four-story portion of the building uses a white brick in a running bond capped with cast capstones; above this on the first floor, the fenestration consists of four, single one-over-one double-hung sash windows with three pane transoms above, and a set of double one-over-one,

double-hung sash windows with three pane transoms above; the windows have cast stone blocks window aprons, and white bricks in a flat arch that create the window lintels above each window with a cast stone keystone. Another band of white brick in a running bond is capped by a dimensional stone band. Windows on the second and third floor are one-over-one, double-hung sash windows with cast stone aprons and brick flat arch lintels. On the fourth floor are three windows of the same design and function as below, this is topped with a further band of white brick coursing and a steep wood or stone cornice with a red brick stepped cornice roofline.

Past the four-story portion of the building, it becomes a two-story building. On the bottom floor are what appear some of the few remaining original, or early replacement, windows. These are wood one-over-one double hung sash windows with multi-pane pivot transoms above. The second story has unadorned, replacement one-over-one, double-hung sash windows with stone aprons. Farther to the rear is the one-story portion which is unadorned with the exception of a garage door opening on the front elevation as well as a 20<sup>th</sup> century metal staircase leading to its roof.

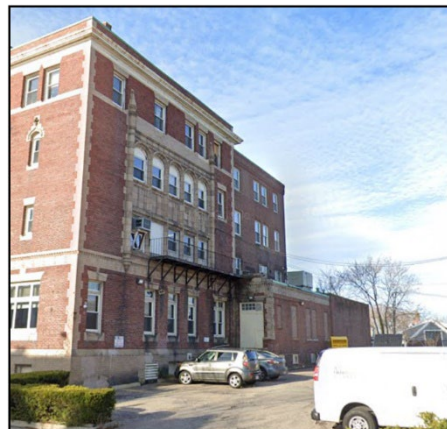
***Right: Right Elevation***

2. Right Elevation: The ground floor design uses a white brick in a running bond capped with cast capstones. Above this on the first floor the fenestration consists of four, single, one-over-one, double-hung sash windows with a three-pane transom above, and a set of double, one-over-one, double-hung sash windows with three pane transoms above. The windows have cast stone block window aprons, and white bricks in a flat arch create the window lintels above each window with a cast stone keystone. Another band of white brick in a running bond are capped by a dimensional stone band. The second and third floors are marked by a two-story decorative window arrangement consisting of cast stone with gothic revival pinnacles on either side. This decorative feature includes five, one-over-one, double-hung sash windows topped with cast stone paneling and another five windows above. Outside of the second-floor windows is a 20<sup>th</sup> century iron balcony. The windows on the third floor each have a precast stone arch. Each third-floor window was once arched to meet the shape of the stone arches, but now the windows are one-over-one double-hung sash windows with the space above each window enclosed. On the fourth floor are five windows of the same design and function as below, this is topped with a further band of the white brick coursing and a steep wood or stone cornice with a red brick stepped cornice roofline.

Towards the rear behind this front portion of the building on the right elevation is a four-story segment with undecorated windows. To the right of this is a one-story portion of the building. A wood garage door opens on to the front of this portion of the building, white brick creates the effect of stone quoining on the right edge and is used as a flat arch above the door; a decorative roofline is made with white brick and dentil detailing. Windows on the right elevation of this portion are fully enclosed with brick. Further down on this one-story structure the building is a plain brick wall.

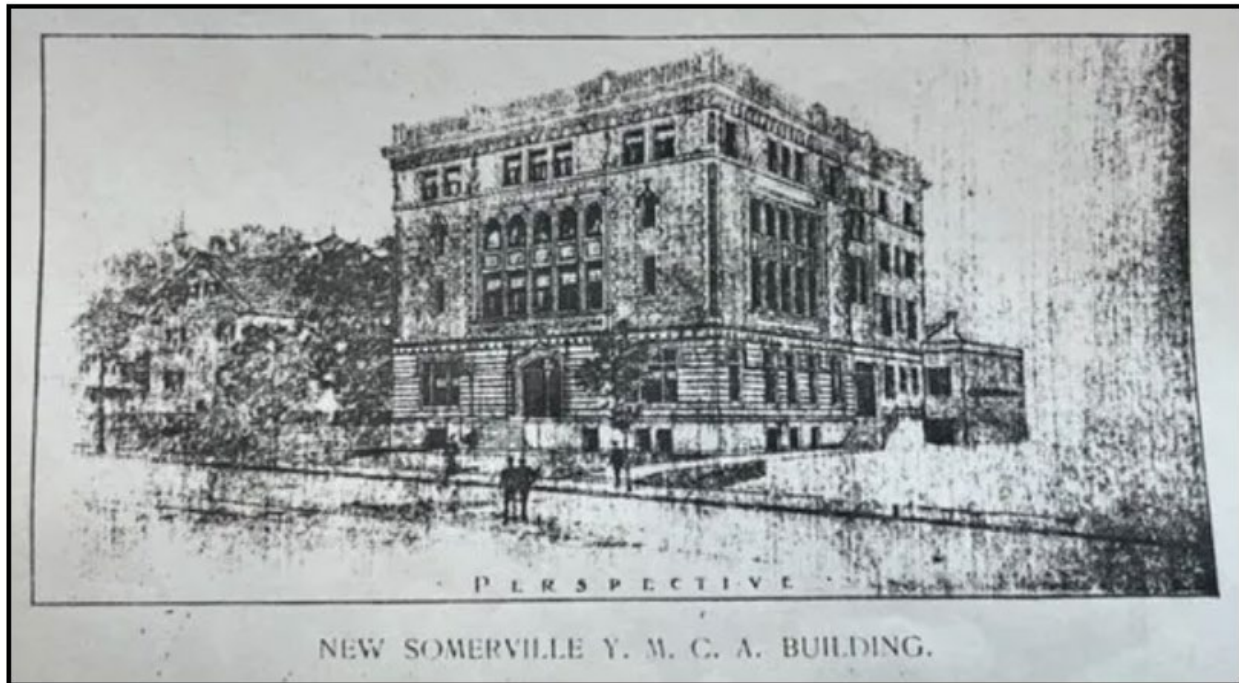
Prints advertising the building prior to its construction show cast stone block detailing along the first floor, but postcards from 1906 do not show this detail. It is likely that the print showed the intended design for the building but it was too expensive so they opted for a combination of red and white brick.

*Above: Sketch of 101 Highland Avenue*

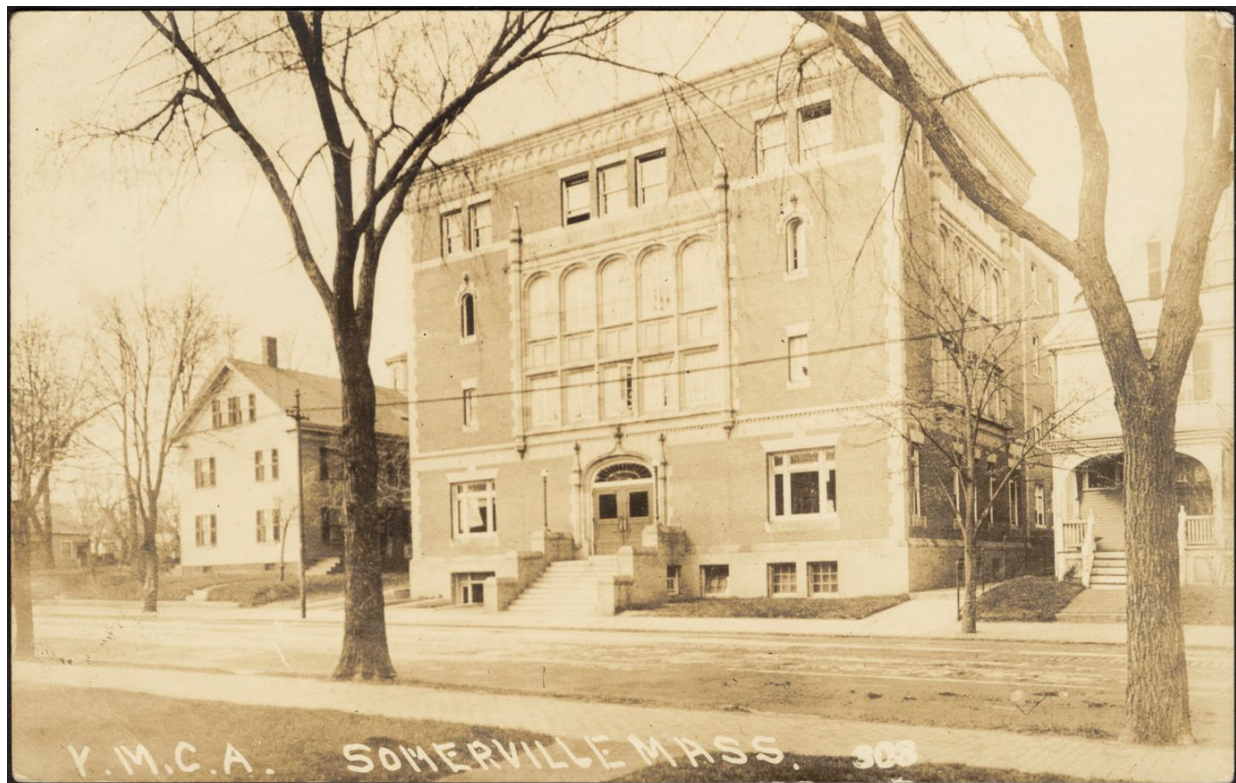
*Above: 1910 Photo of 101 Highland Ave*

Comparing old postcards that predated the fire to the current structure, the gothic revival frieze is the only exterior change to the building. It is likely that during the fire the roof was severely damaged and with its replacement a new frieze was constructed.

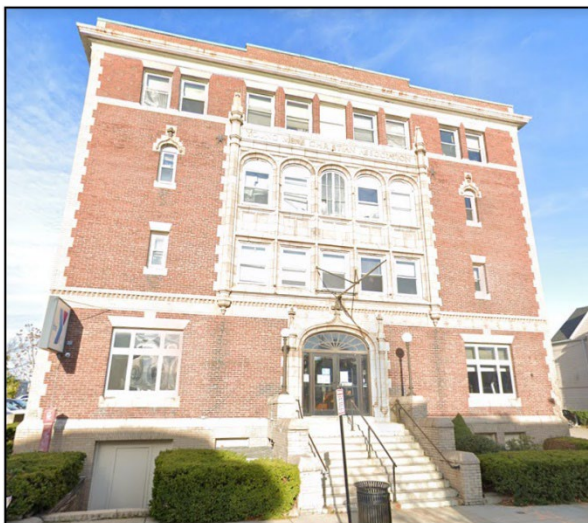
*Above: 2023 Photo of 101 Highland Ave*

Comparing current photos of the building to postcards and photos of 101 Highland prior to the fire we can see that the roof has been changed and the front façade of the top floor has a different arrangement of windows. These are the only noticeable exterior effects of the 1921 fire, which clearly destroyed largely the top floor and roof.

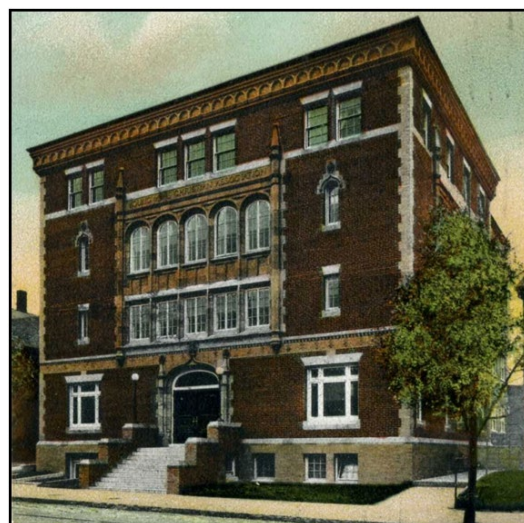
*Above: 1906 Postcard of 101 Highland Ave*

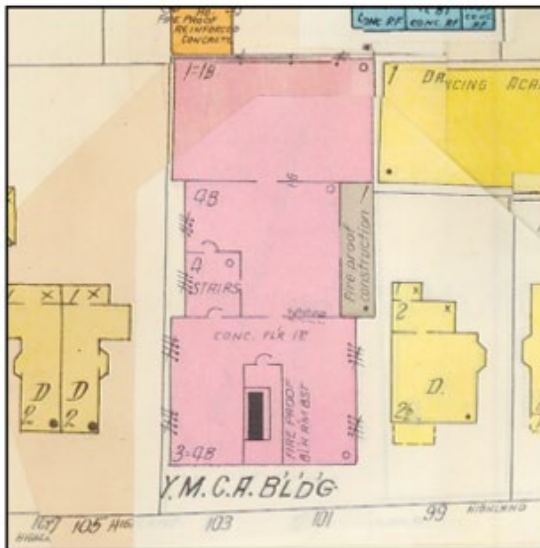
Above: Fig 1

Fig 1: 1925 Sanborn Map, close-up of 101 Highland Ave

- The 1925 Map shows that the original structure was a brick, rectangular structure with four stories in the front, one-story portions in the rear and right elevation.

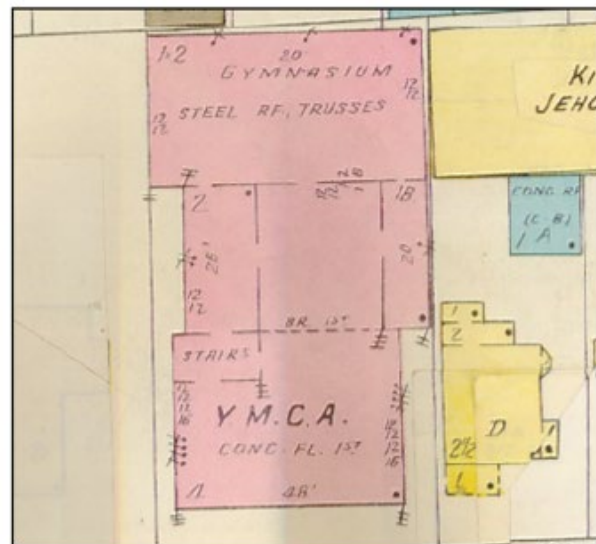
Above: Fig 2

Fig 2: 1938 Sanborn Map, close-up of 101 Highland Ave

- The 1938 Map shows that to the left of the middle of the structure is a two-story section. It is likely that this was just an oversight in the 1925 Map rather than two stories were removed.

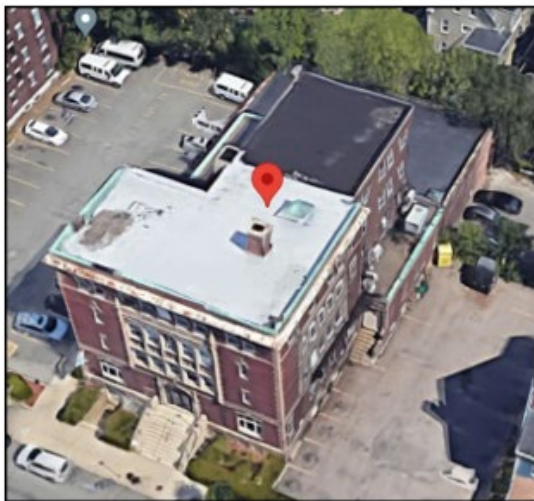
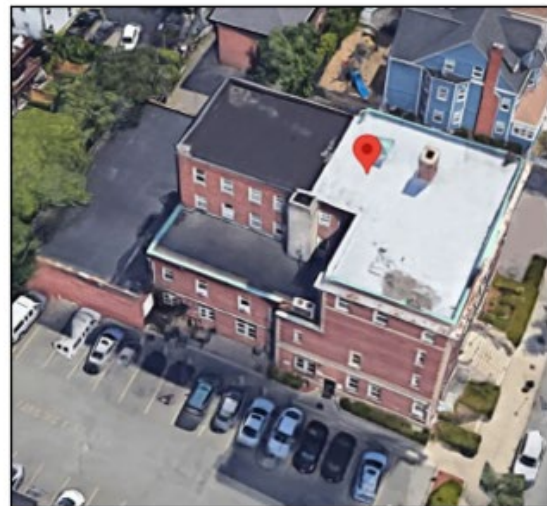
Fig 3&4: 2023 Satellite images of 101 Highland Ave

- These images largely reflect the same building footprint as the 1925 structure.
