# CITY OF SOMERVILLE, MASSACHUSETTS MAYOR'S OFFICE OF STRATEGIC PLANNING & COMMUNITY DEVELOPMENT KATJANA BALLANTYNE MAYOR

# STEP 1: DETERMINATION OF SIGNIFICANCE STAFF REPORT

**Site:** 11 Auburn Avenue

Case: HP23-000043

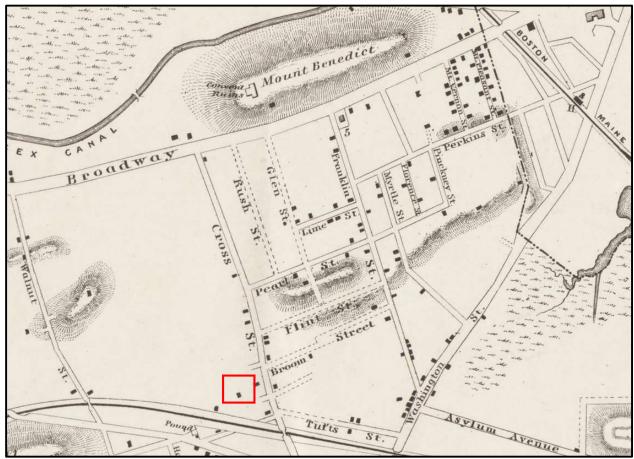
Above: 1852 Draper Map with general location of 11 Auburn Avenue indicated.

The 1852 Draper map above demonstrates that much of the residential development in the first half of the 19<sup>th</sup> century was concentrated along Washington Street and in proximity to the passenger station of the

Boston-Maine Railroad. The approximate location of Auburn Avenue (which had not yet been formally laid out) is shown in red.

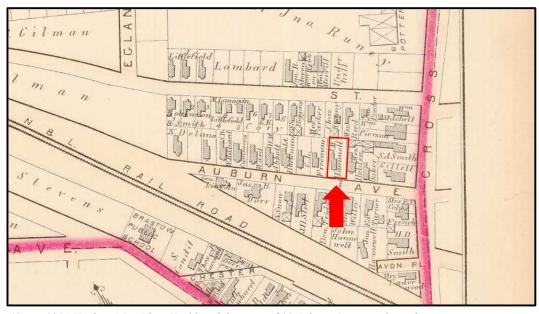
By 1874 (as demonstrated by the 1874 Hopkins map below), Auburn Avenue had been developed with approximately 12 residences along the odd side of the street and seven along the even side.

Above: 1874 Hopkins Map Plate H - 33 with location of 11 Auburn Avenue indicated.

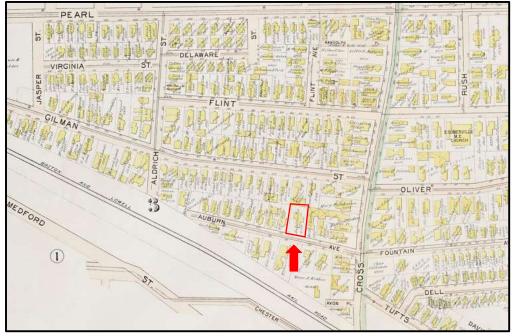
By 1895 the entire western side of Cross Street, between Pearl Street and the Boston & Lowell Railroad, had been developed.

Above: 1895 Bromley Map Plate 9 with location of 11 Auburn Avenue indicated.
