STEP 1: DETERMINATION OF SIGNIFICANCE
STAFF REPORT

Site: 9 Olive Avenue

Case: HP23-000071

Legal Ad: *The Applicant seeks to demolish a principal structure constructed a minimum of 75 years ago.*

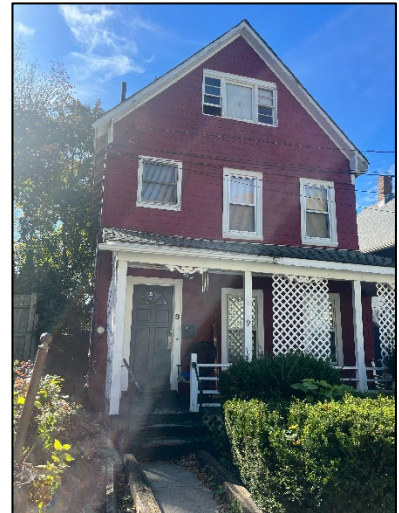
Top: Front elevation

- Front Elevation
 - The structure has a symmetrical front-gabled, high pitched roof
 - Covered front porch
 - Wooden stairway with mid to late 20th century iron railings leading into entryway

- First floor includes aluminum or wood one-over-one double-hung sash windows. On the second story are three of these same type of windows of with the right most window a smaller size. The ½ -story window under the gable peak is a triptych window with double-hung sash on either side and large stationary window in the center.

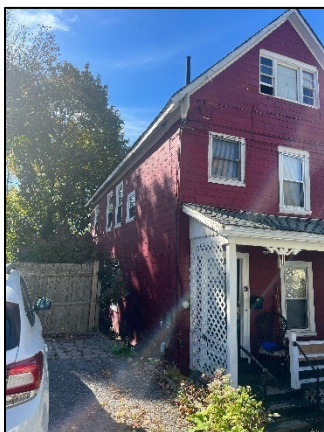
Bottom, left: Left elevation

- Wrap around porch comes along this side of the building.
 - A portion of porch has been enclosed.
 - Left Elevation
 - Fenestration includes four one-over-one double-hung windows on the second story with one of these windows smaller than the other three.

- At least two one-over-one double-hung windows on the first story.

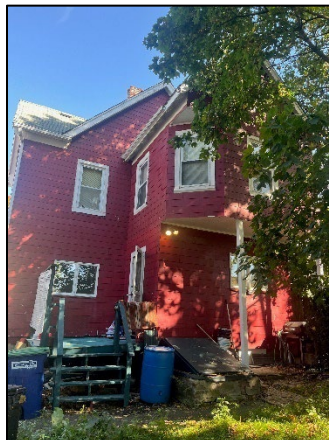
Bottom, middle: Rear elevation

- Rear Elevation
 - Two story, slightly shorter, section of building on rear with a deep eave.
 - The aforementioned rear portion of the building has a larger enclosed second floor with the first story containing wood pillars creating an almost overhang covered area.

- Fenestration on the first story there are a double horizontal sliding sash window on the first story. On the second story there are at least four one-over-one double hung sash windows

- Wooden bulkhead door with access to basement
 - Wooden staircase and porch leading to rear door.
 - Right Elevation
 - Fenestration includes four aluminum or wood one-over-one double-hung windows and two fixed square windows.

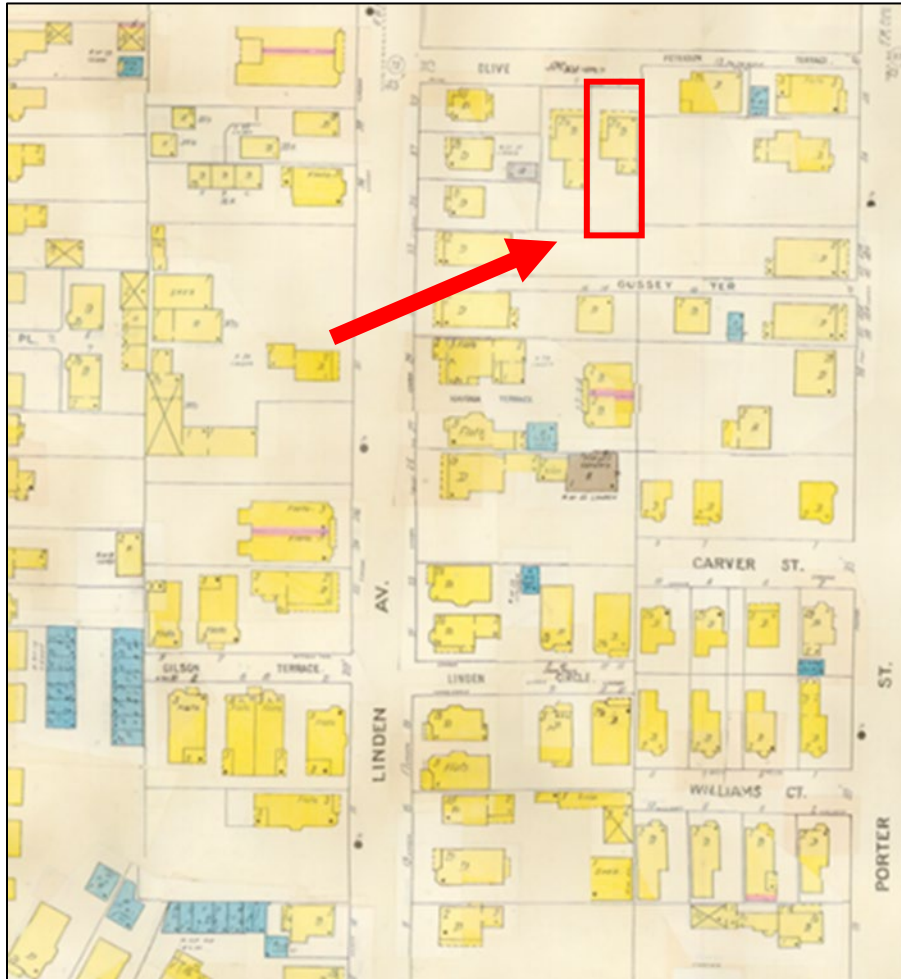
Above: 1900 Sanborn Map – 1925 additions, Plate 027, with location of 9 Olive Avenue indicated.

The map above shows that in 1925, the surrounding area was still mostly the same. There is a change in the footprint on this map from the previous versions. This change is likely the result of the addition of a wrap-around porch, which covers the front and right elevations of the building.
